WING CENTER SECTION

LOWER PANEL STRINGER S-3

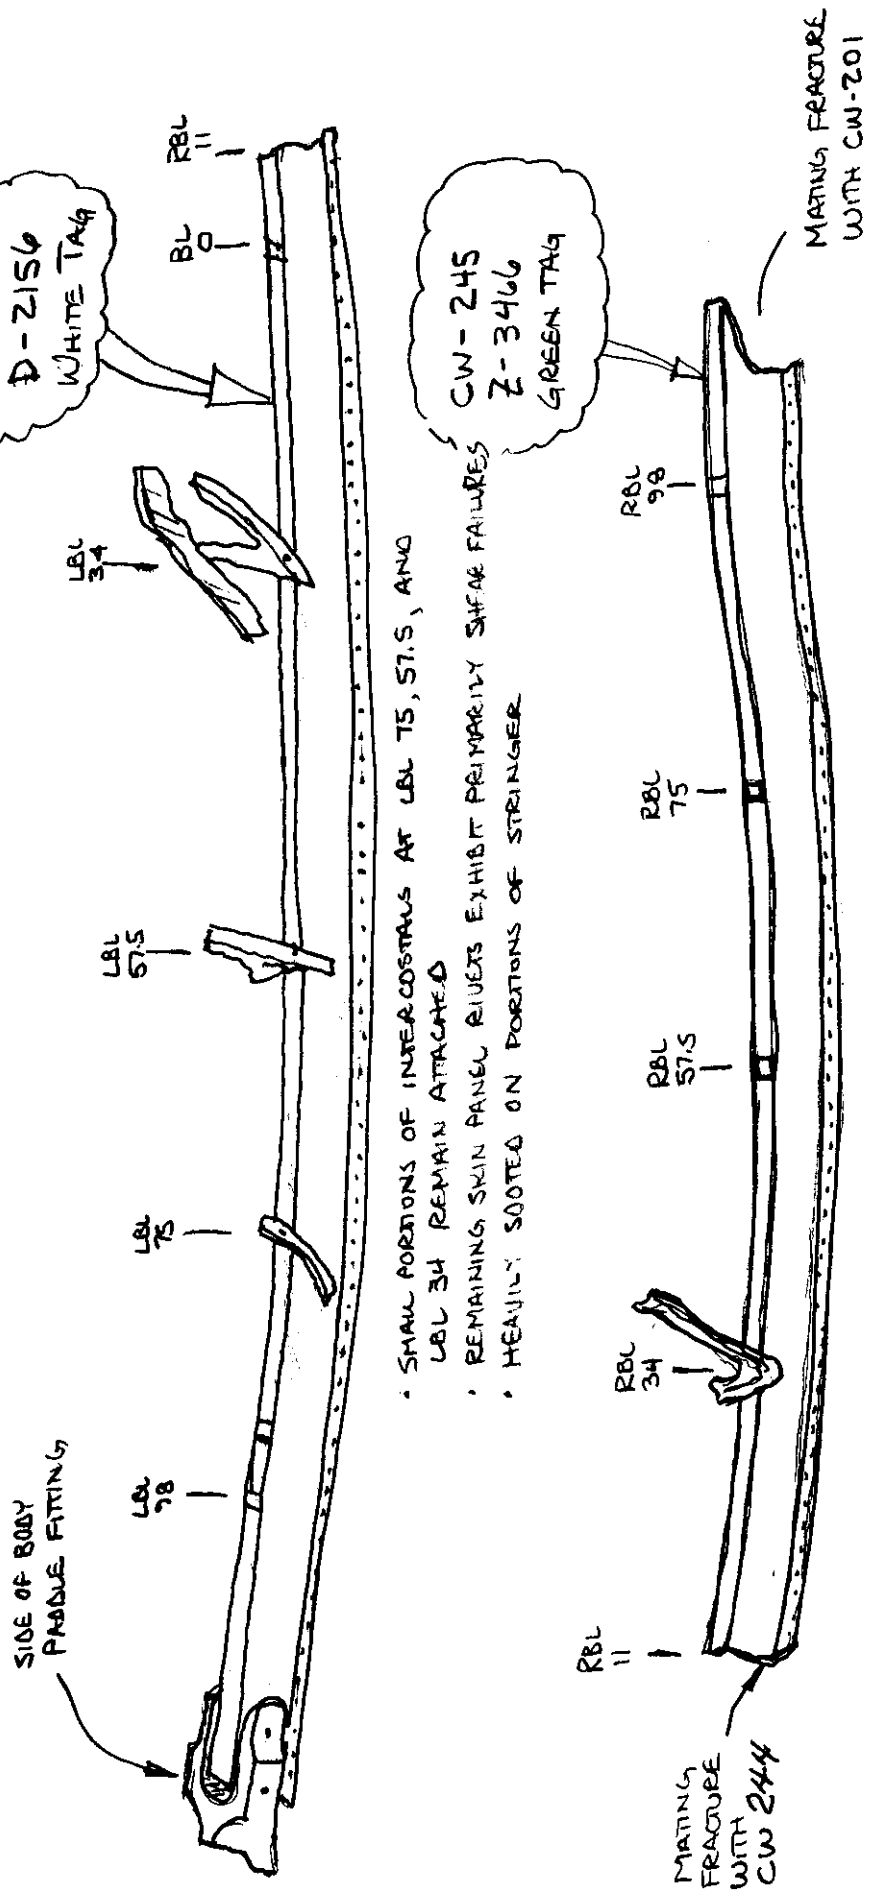
SMALL PORTIONS OF INTERCOSTALS AT LBL 75, 57.5, AND LBL 34 REMAIN ATTACHED
 REMAINING SKIN PANEL RIVETS EXHIBIT PRIMARILY SHEAR FAILURES
 HEAVILY SOOTED ON PORTIONS OF STRINGER

- SMALL PORTION OF INTERCOSTAL AT RBL 34
- REMAINING RIVETS COMMON TO SKIN EXHIBIT PRIMARILY SHEAR FAILURES
- HEAVILY SOOTED ON PORTIONS OF STRINGER

MATING FRACTURE WITH CW 244

MATING FRACTURE WITH CW-201
