SIDE OF BODY RIB - RIGHT WING - WING CENTER TANK

CW-303
C-239
GREEN

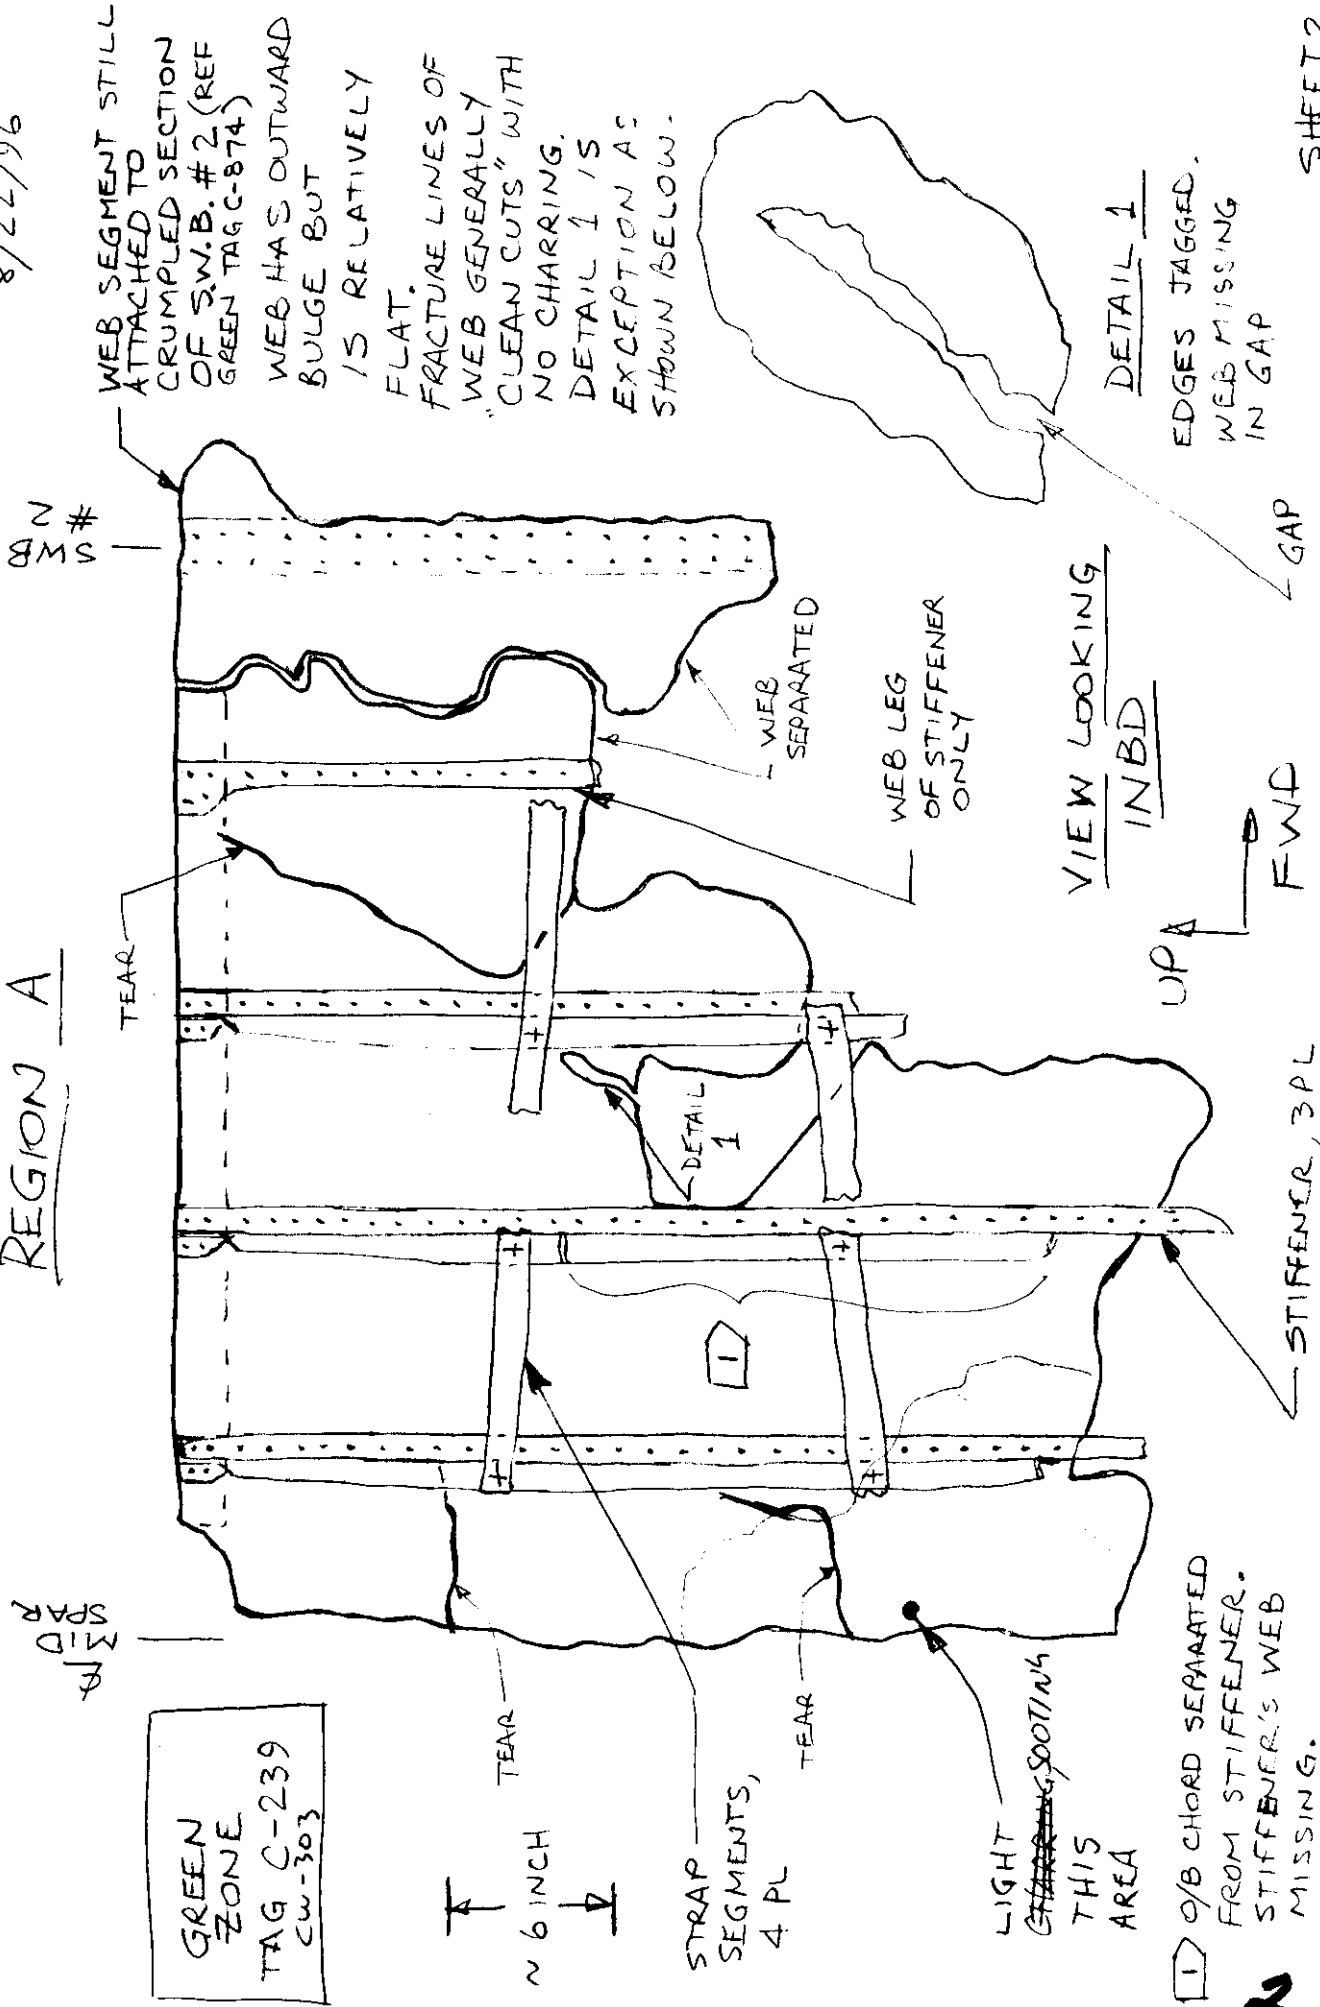
GREEN ZONE
TAG C-239
CW-303

This segment is the side of body rib web and portions of stiffeners that extends fwd 36" from the midspar location and is 40" high. The upper edge of this segment remains attached to the double plus chord vertical flange located between CW-301 and CW-302.

The fracture of the double plus chord vertical flange is just below the fillet radius of the chord. The web is generally flat except for the lower fracture edge which has slight curvature inbd. The following sketch contains specific information on location and shape of remaining stiffeners, stabilization straps, and web fractures within the part. All fractures are ductile.

There are soot deposits on this part. See the fire and explosion group report for complete documentation.

WEB SEGMENT STILL ATTACHED TO CRUMPLED SECTION OF S.W.B. # 2 (REF GREEN TAG C-874)
WEB HAS OUTWARD BULGE BUT IS RELATIVELY FLAT.
FRACTURE LINES OF "WEB GENERALLY CLEAN CUTS" WITH NO CHARRING.
DETAIL 1 IS EXCEPTION AS SHOWN BELOW.

LIGHT ~~CHORD~~ CHORD THIS AREA

CHORD SEPARATED FROM STIFFENER. STIFFENER'S WEB MISSING.

DETAIL 1
EDGES JAGGED. WEB MISSING IN GAP
