SIDE OF BODY RIB - RIGHT WING - WING CENTER TANK

CW-306

C-196

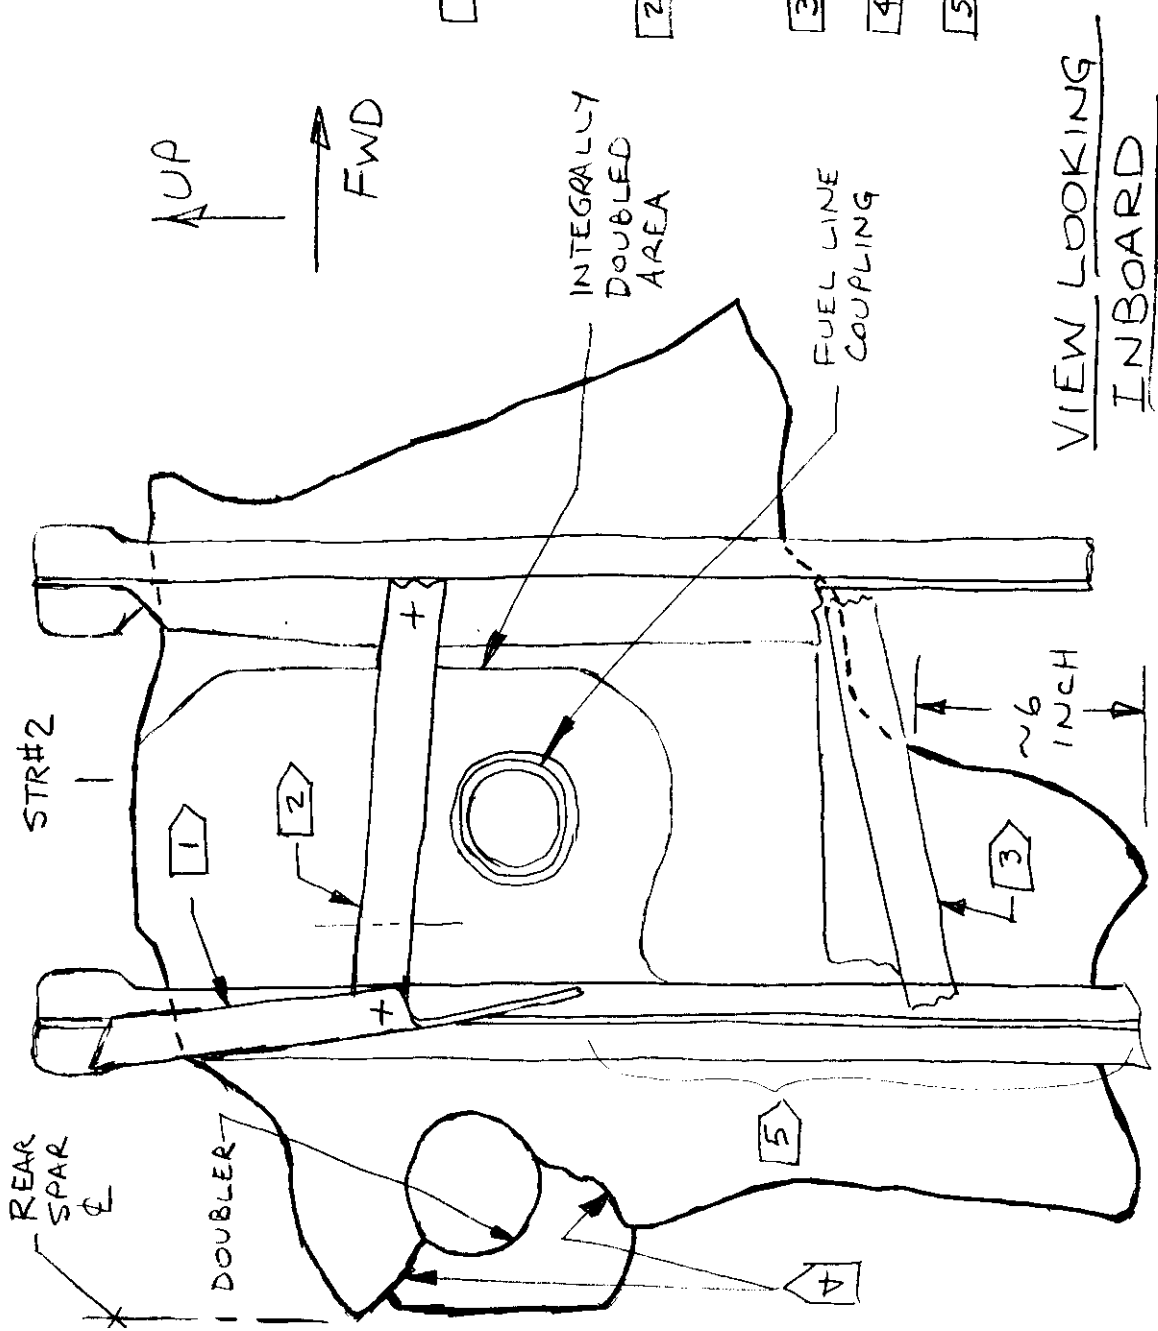
REGION D

This segment is a 28" x 28" segment of side of body rib web and partial stiffeners. The aft edge of the segment is at the rear spar. The fracture surfaces of this segment mate with CW-302 on the upper side, CW-305 on the fwd side, CW-311 on the lower side, and CW-312 on the aft side. The aft end of the segment has two holes for fuel lines and a portion of fuel line remains attached.

The following sketch gives complete description of the condition of the parts. There is no evidence of fatigue on any fracture surface.

FRACTURE LINES OF WEB GENERALLY "CLEAN-CUT" IN THINNER AREAS BUT EXHIBITS "INTER-LAMINAR" SHEARING IN THICK REGIONS. NO APPARENT CHARRING.

- 1) STIFFENER OUTER CHORD AND WEB SEPARATED FROM LEG ATTACHED TO WEB, BUT HELD IN PLACE BY STABILIZATION INTERCOSTAL [2].
- 2) STABILIZATION INTERCOSTAL OUTBOARD CHORD CRUSHED INBOARD ABOUT 1 INCH FWD OF VERTICAL STIFFENER.
- 3) STABILIZATION INTERCOSTAL LAID OVER
- 4) WEB FAILURE LINES IN REINFORCED CUTOUT AREA
- 5) OUTER CHORD & STIFFENER WEB MISSING.
