CW-501
A-018
RED

FRONT SPAR

LOG # CW-501
 TARGET # LLS 52 (A018)
 COORD: LAT 40 38 38.54
 LONG 072 39 08.71

~~WING FRONT SPAR~~
**WING FRONT SPAR
 CENTER SECTION**

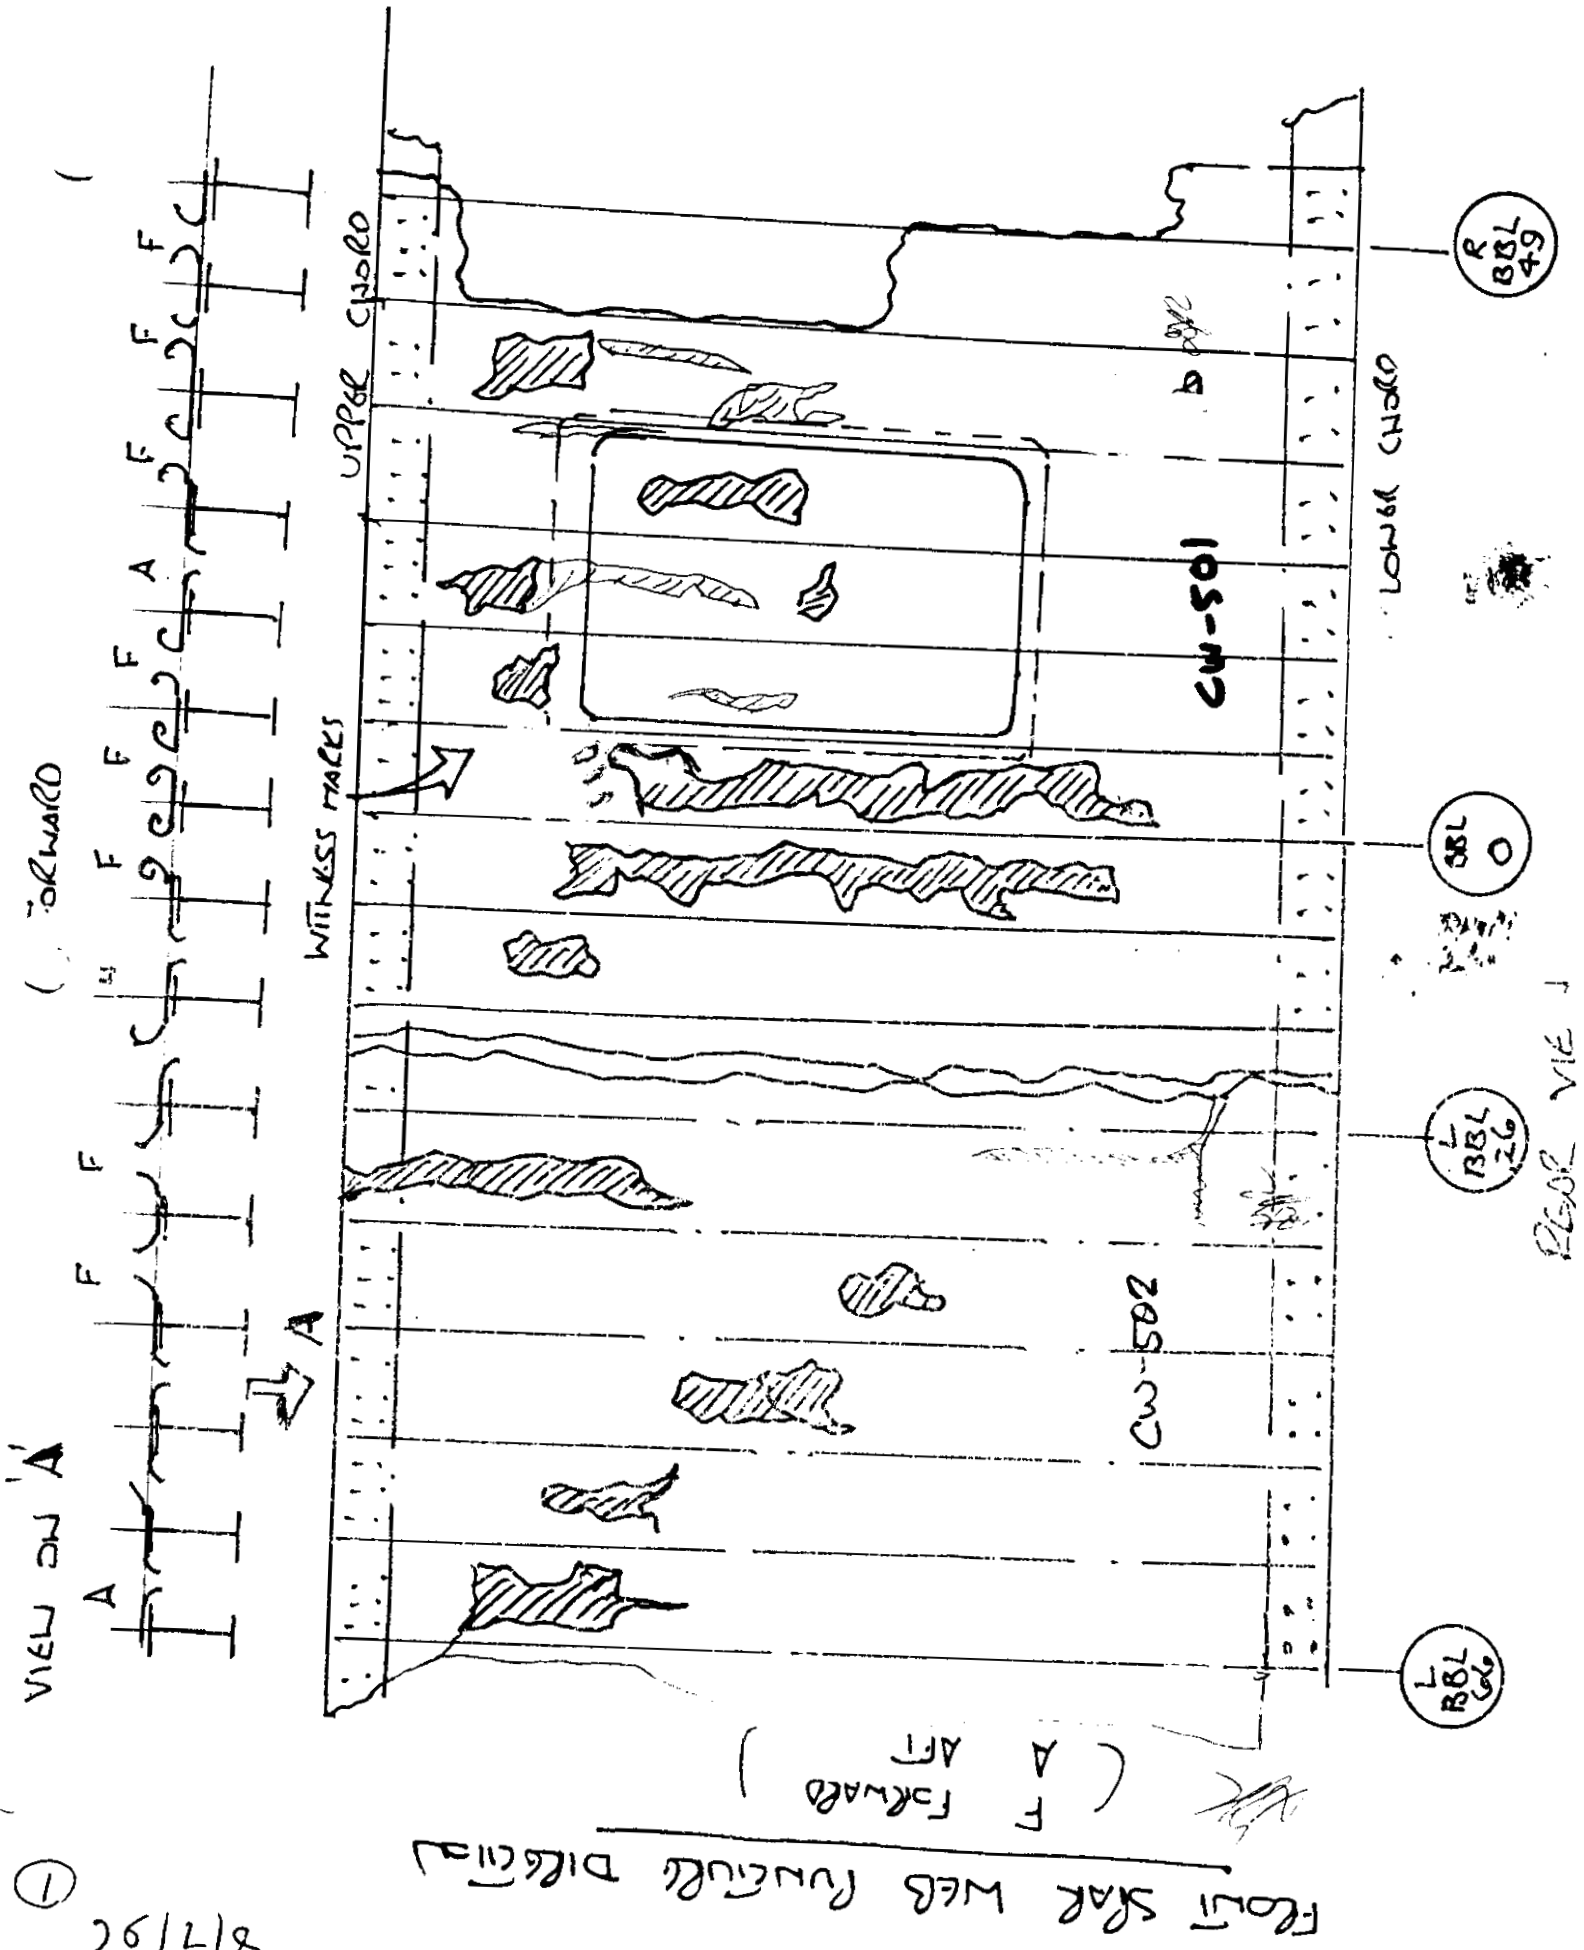
This section of the front spar spans from RBL 66.65 to LBL 26.00. CW-512, CW-513 and CW-514 connect to this section on the right side, and CW-502 on the left side. The upper and lower connections separated along the radius of the upper/lower skin/spar chords. The sides separated by a tearing action.

The web right side is torn vertically, in steps, from RBL 66.65 to RBL 44.77. The torn web edges are curled forward at RBL 44.77. All the stiffeners remained attached to the front spar web and suffered severe impact damage on the back side. There is long hole in the web 6" to the right of BL0 (between BL0 and RBL 9.10). This hole is about 36" long and about 5" wide. The web around the hole is curled in forward direction. There are some 360 degree web curls in the lower portion of the hole. There is another long hole 44" long on the left side of BL0 (between BL0 and LBL 9.10). The upper end of the hole has a horizontal tear 6" wide and the lower end of the hole has a horizontal tear of 2.5" wide. The majority of the web torn around the hole has curled in a forward direction. There are numerous small holes on the web which exhibit evidence of forward and aft curling, and a detail documentation of the direction of the curls is documented in a diagram. The stiffener on this section of the front spar remained attached and suffered severe impact damage.

All the stiffeners suffered 3" wide impact damage about 11"-14" below the upper shear ties. This damage is consistent horizontally in all the stiffeners of this section. The aft flanges are crushed forward at this location. For some of the stiffeners, the web is also crushed at this location. The left corner of the aft flange of RBL 9.10 stiffener exhibited several impact damage marks consistent with metal gouging. These impact marks, typically, are 1.5" apart and have a slight black color signature. The web forward of the aft flange (which has a 36" long hole) had black color gouge marks. These black color gouge marks are from top to bottom at about a 45 degree angle approximately 1.5" apart (typical). The impact marks on the aft flange of the stiffener and the gouge mark on the web is aligned 45 degrees from a horizontal line going down and forward. The stiffeners separated from the upper chord with their shear tie attached. The "L" shaped lower chord fractured at the radius, and the lower shear ties separated from the stiffeners.

There is a piece of plastic embedded between the stiffener at LBL 9.10 and the front spar web.

The direction of failure of upper and lower shear ties are documented in the shear tie study which determined that the stiffeners of this section of the front spar moved in forward direction.

There is no evidence of any pre-existing cracking or corrosion to this section of the front spar.

There are spike tooth fractures located in the web between the stiffeners at BBL 0 and RBL 11, at RBL 26 and 33, and at RBL 33 and 41.

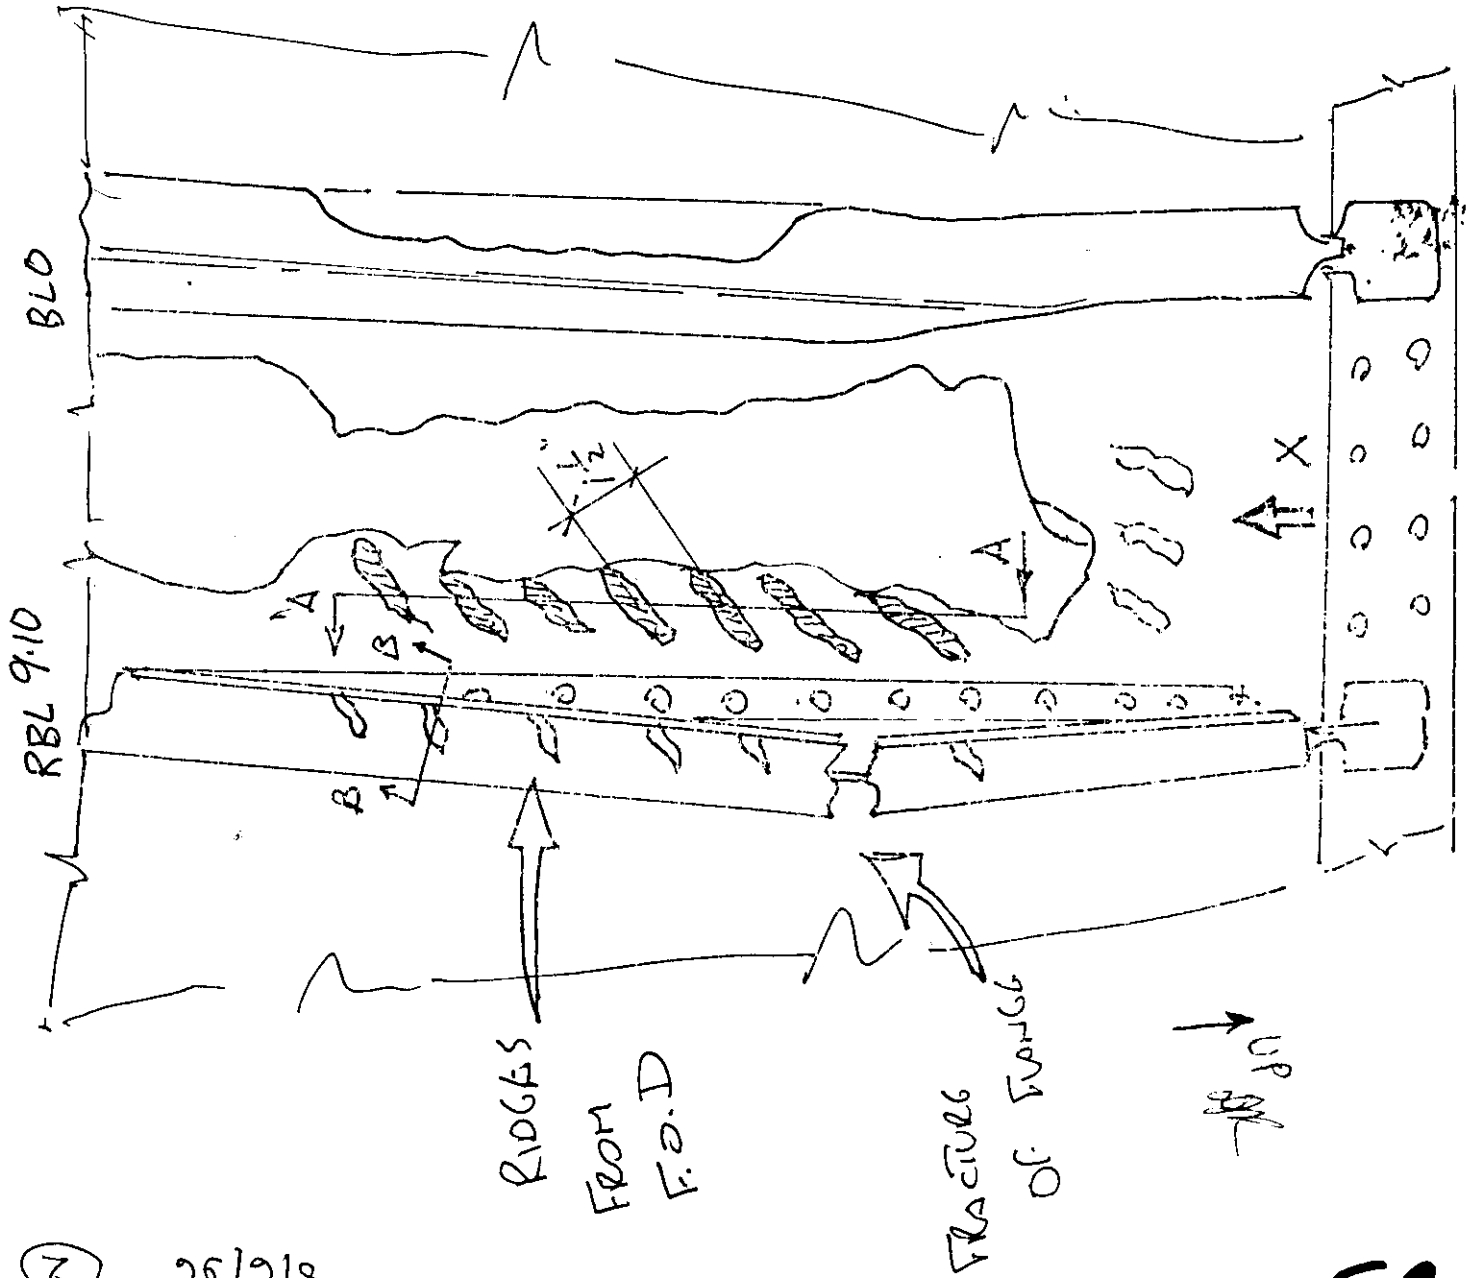
DAMAGE TO L16B

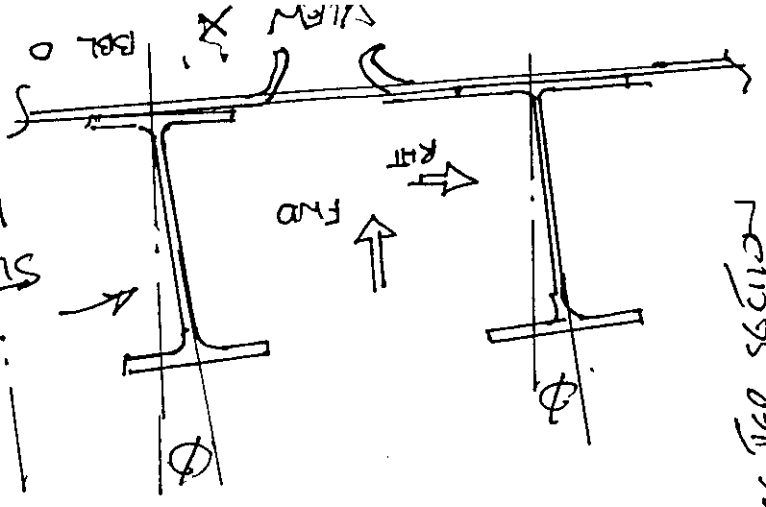
SKIN RUPTURE

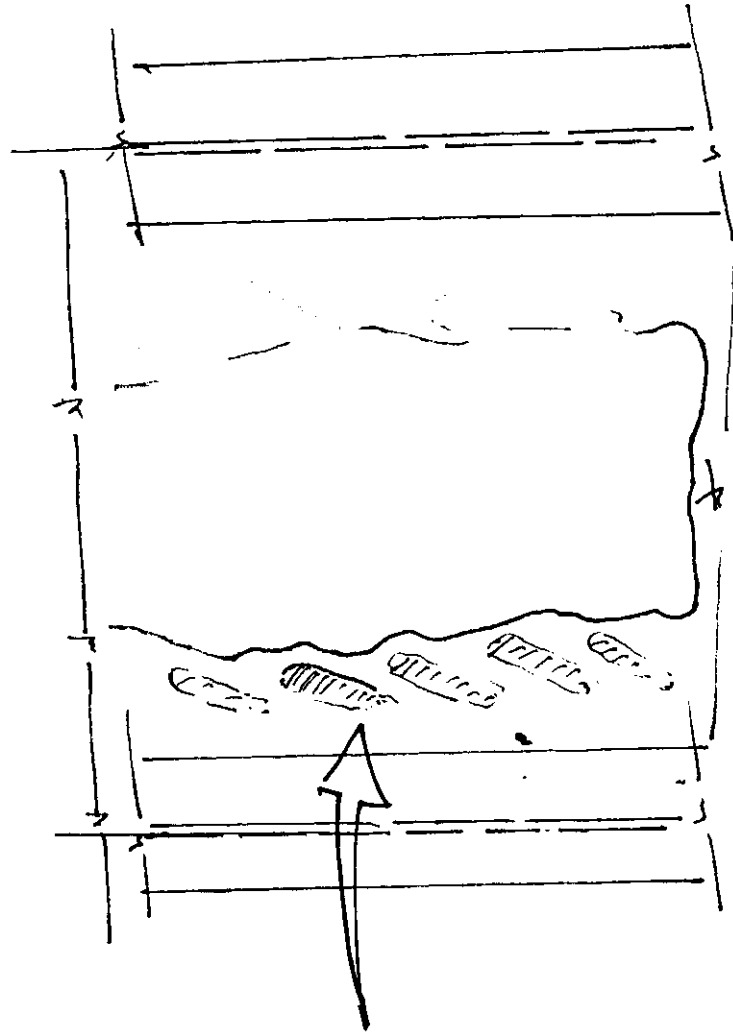
CENTER SECTION FRONT SPAR SECTION

WITNESS MARKS ALONG AFT EDGE

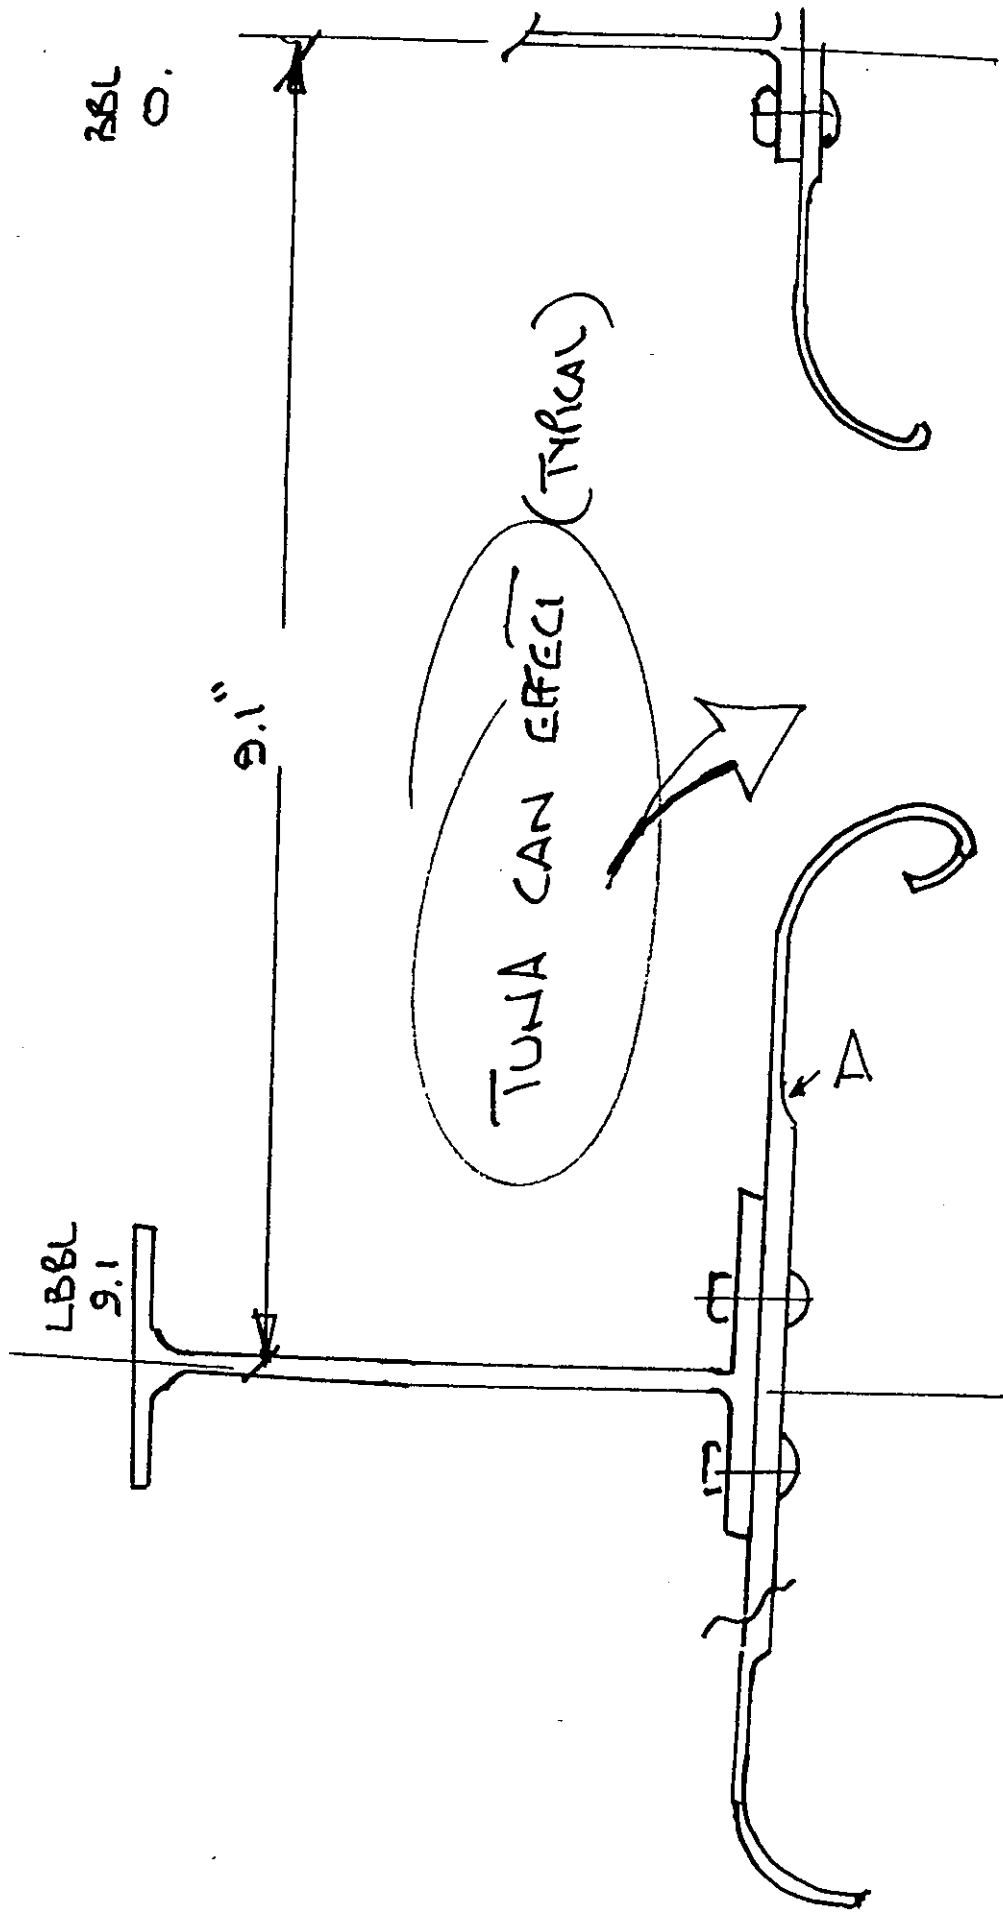
SECTION A-A

TUNJA CAN EFFECT (TYPICAL)

▷ LINES OF FRACTURE EXTENDS INTO FILLET RADIUS IN SOME AREAS.

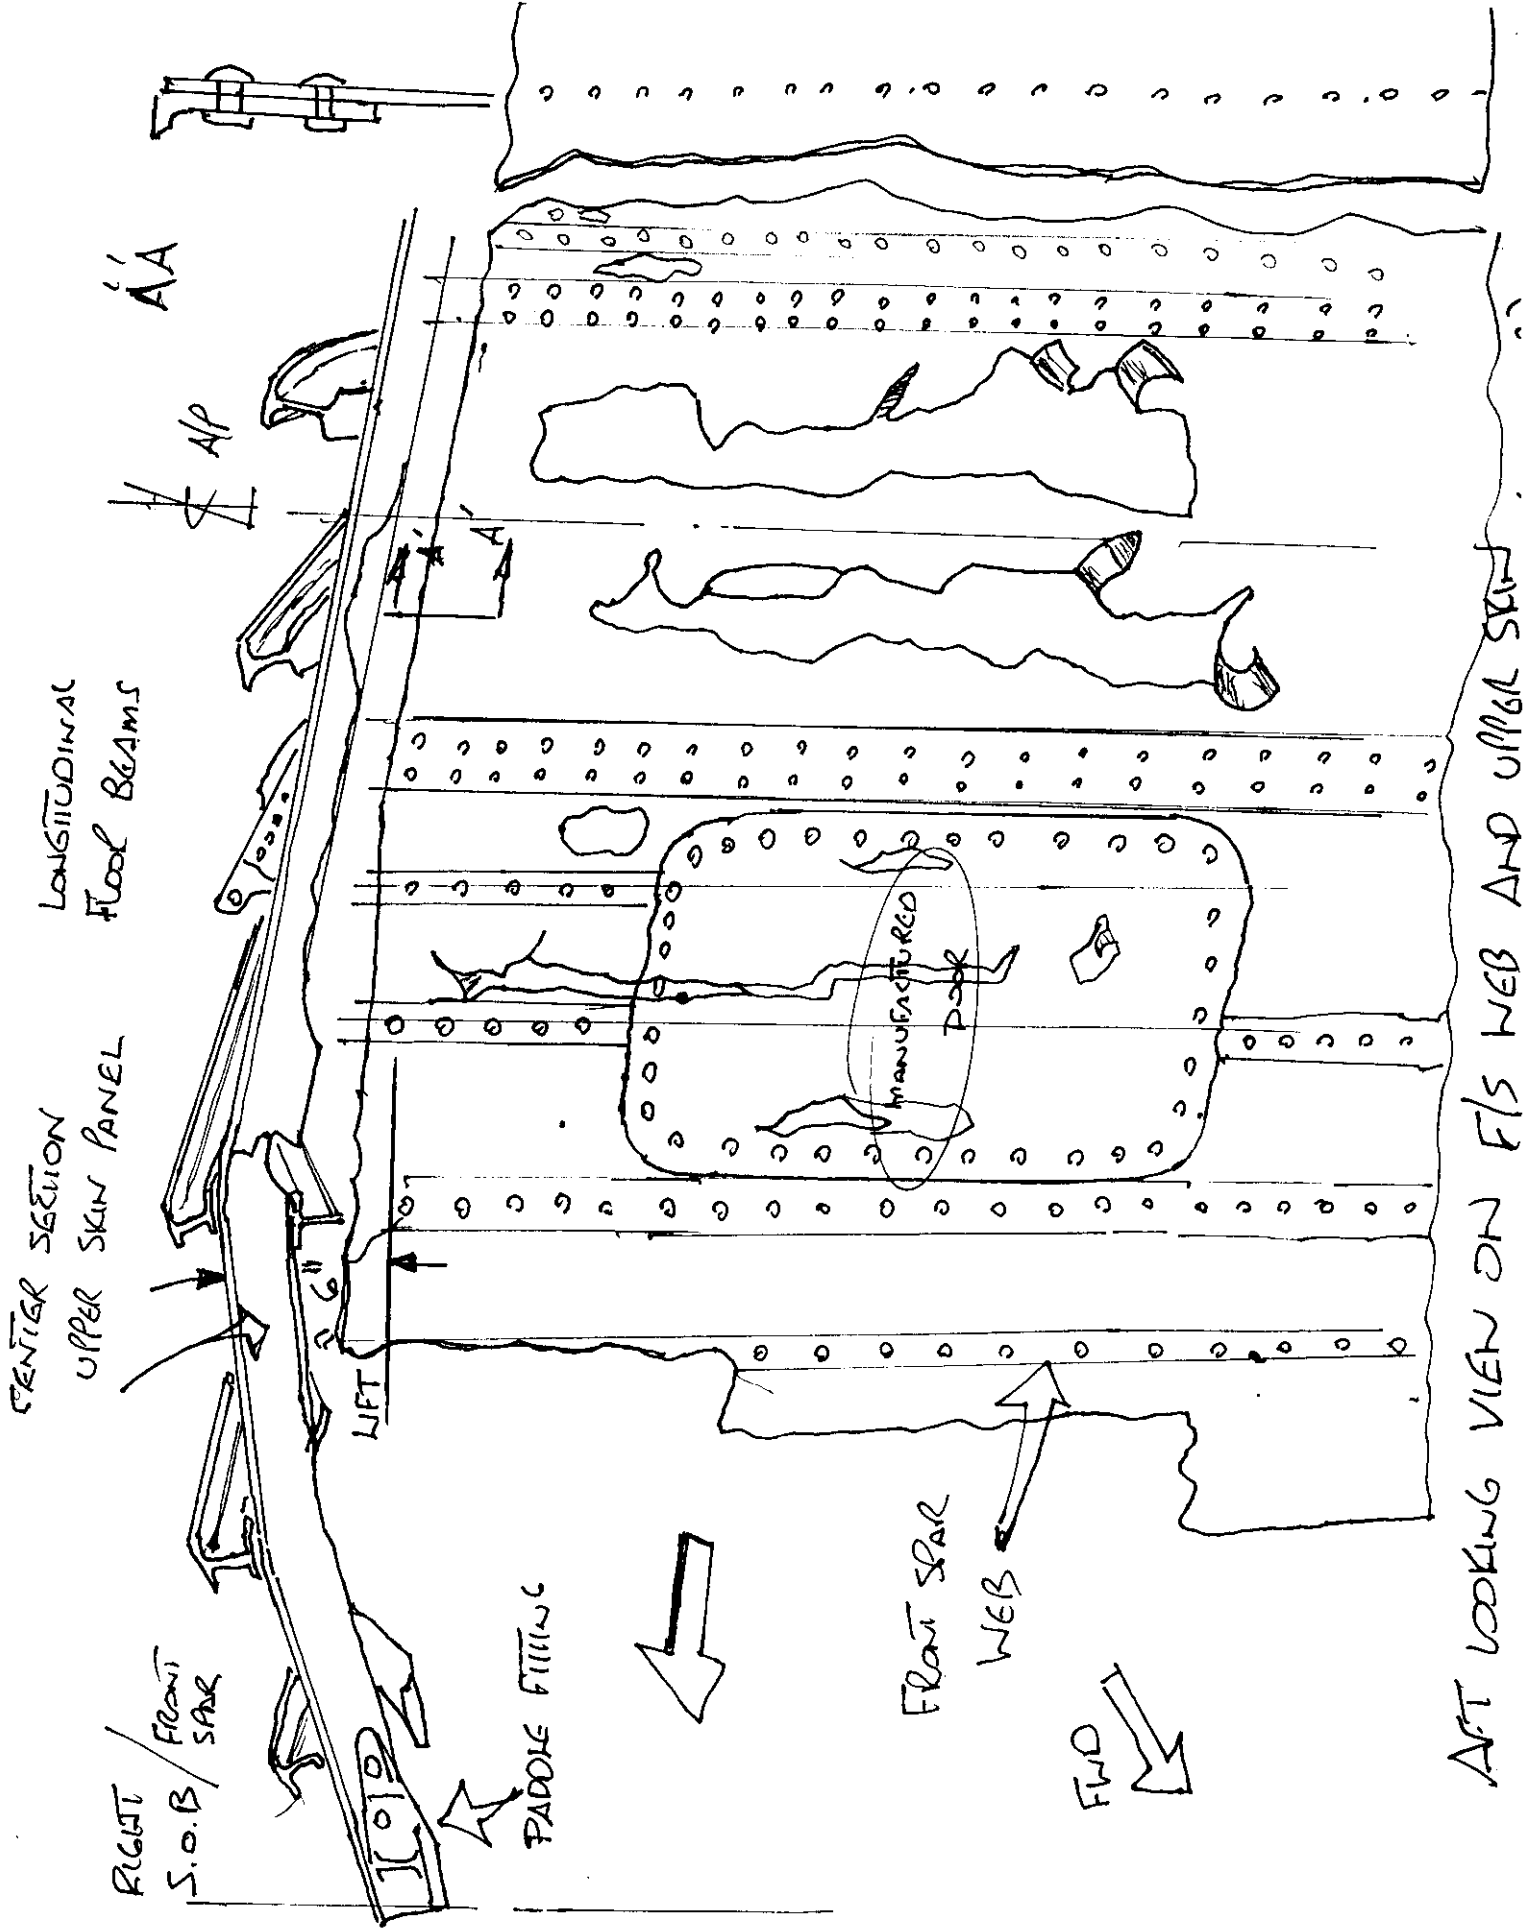
AFT LOOKING VIEW ON F/S WEB AND UPPER SKIN

FRONT SPAL SECTION OF WEB

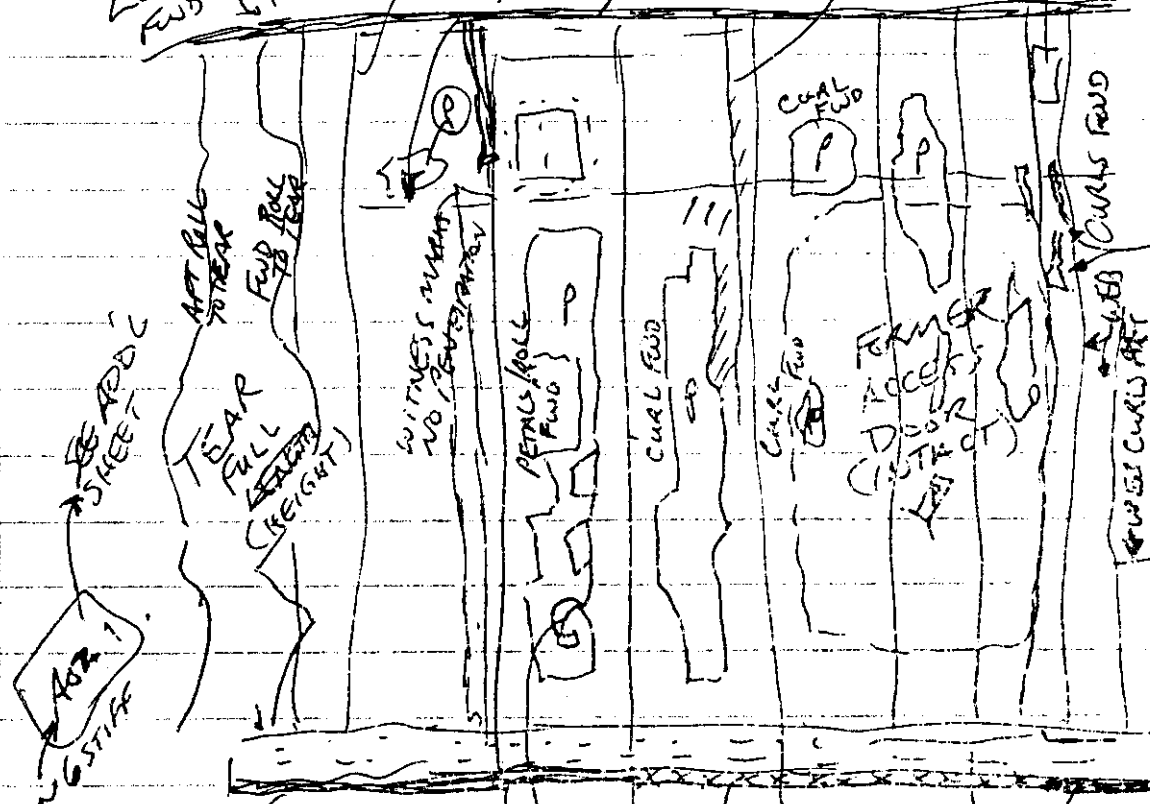
ABOUT 9 MARKS
 1"-2" SPACING
 METAL-TO-METAL
 CONTACT ON
 STIFFENER
 P = PENETRATION

AFT SIDE
 LOOKING
 FWD
 SHEAR TIES
 PARTS PULLED
 OFF (TP)

STIFFENED
 BACK LOG
 IMPACTOR
 ~ 14/16" FROM
 TOP CHORD

AFT FLANGE
 DUCTILE
 RUPTURE
 LWR CHORD

L8 STIFF

* C ALONG
 TOP CHORD
 (SOME #W
 AT SHEAR
 TIES)

SOME #B
 AT KNIFE-
 LIKE CUTS

LWR CHORD
 LWR
 FLANGE
 DUCTILE
 RUPTURE

CURL
 ~ 270
 KEEL
 BEAM
 SPACE

FASTENERS
 SHEARED
 @ STIFFENER
 FWD SIDE
 LWR FLANGE
 DUCTILE
 RUPTURE
 LWR
 CHORD
