CW-502  
A-021  
RED

FRONT SPAR

~~FRONT SPAR~~  
FRONT SPAR  
WING CENTER SECTION

DEBRIS FIELD # 3 (RED)

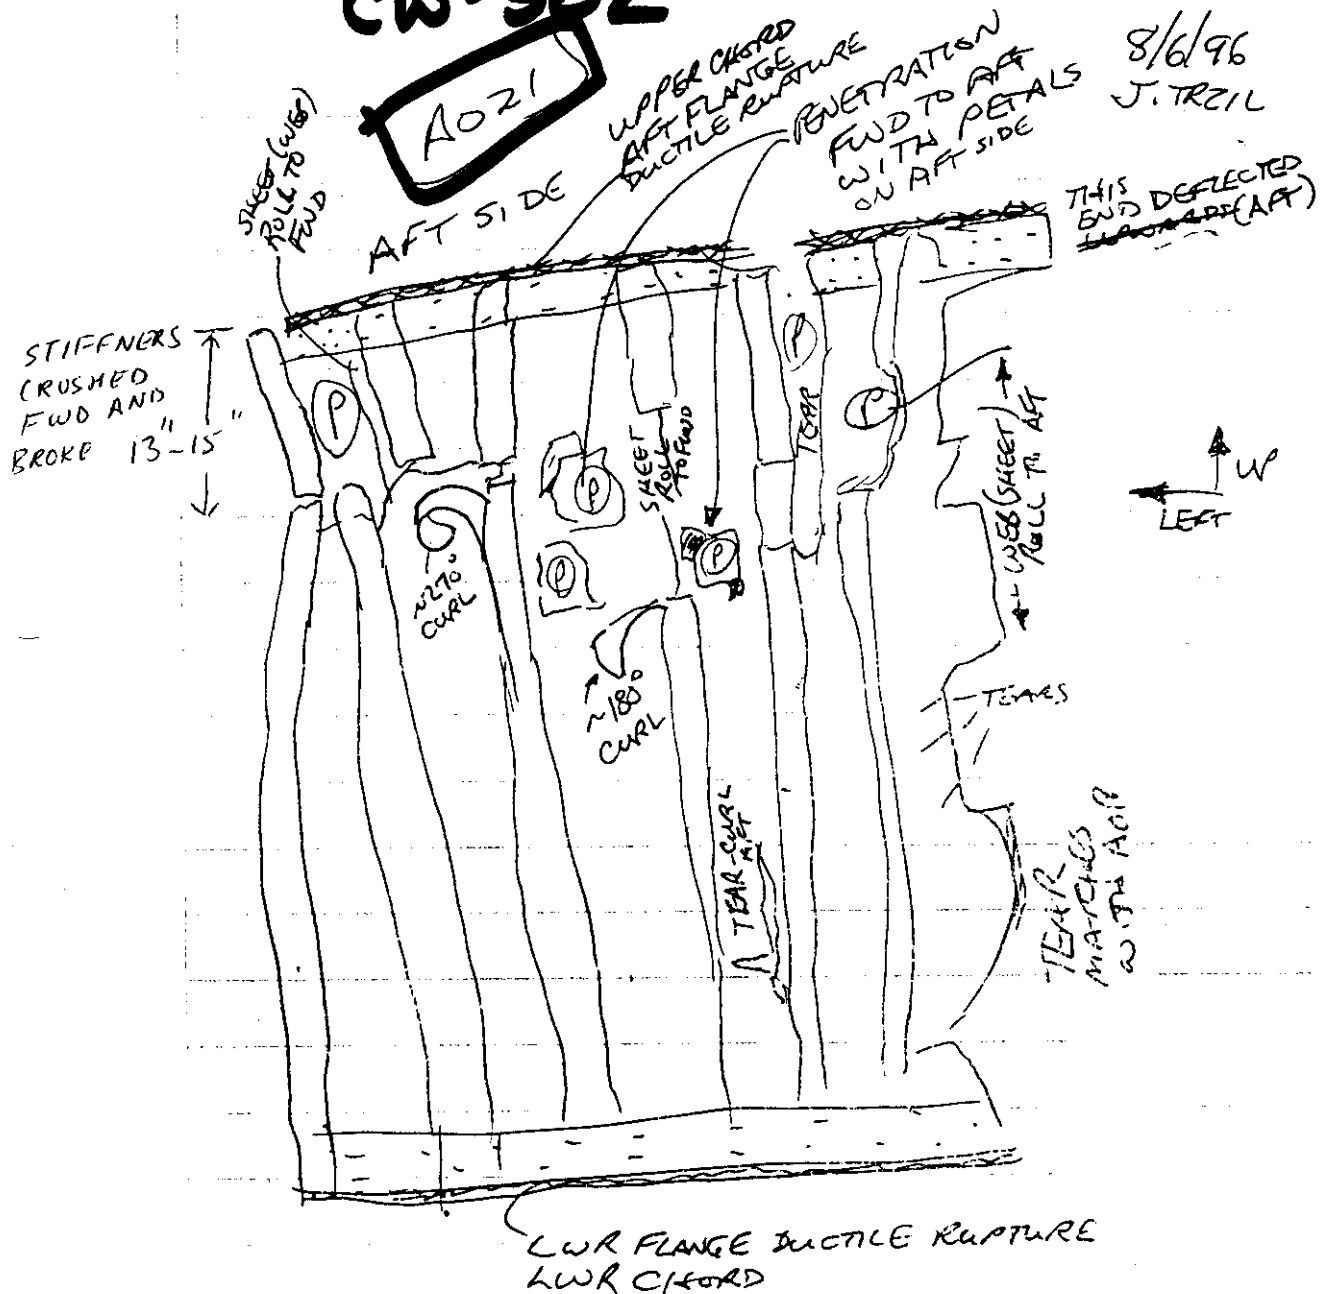
**CW-502**

This section of the front spar is located between CW-501 on its right side, and CW-504 on its left side. The upper and lower connections separated along the radius of the upper/lower skin/spar chords. The sides separated by a tearing action. The panel extends from LBL 17 to LBL ~~61.66~~ 73.00.

The front spar web is bowed forward in the middle about a vertical axis and all the stiffeners remain attached to the web. The stiffeners at LBL 33.89, 41.77, and 49.6 are crushed 13"-15" from the upper shear ties. The aft flange and the stiffener web around this area is crushed forward. The associated front spar web is bowed forward. The upper shear ties of the stringers separated from the upper skin and the "L" shaped upper chord fractured at the chord radius. The lower shear ties of the stiffeners separated from the lower skin.

The direction of failure of the upper and lower shear ties are documented in the shear tie study which determined that the stiffeners of this section of the front spar moved in forward direction.

There is no evidence of any pre-existing cracking or corrosion to this section of the front spar.

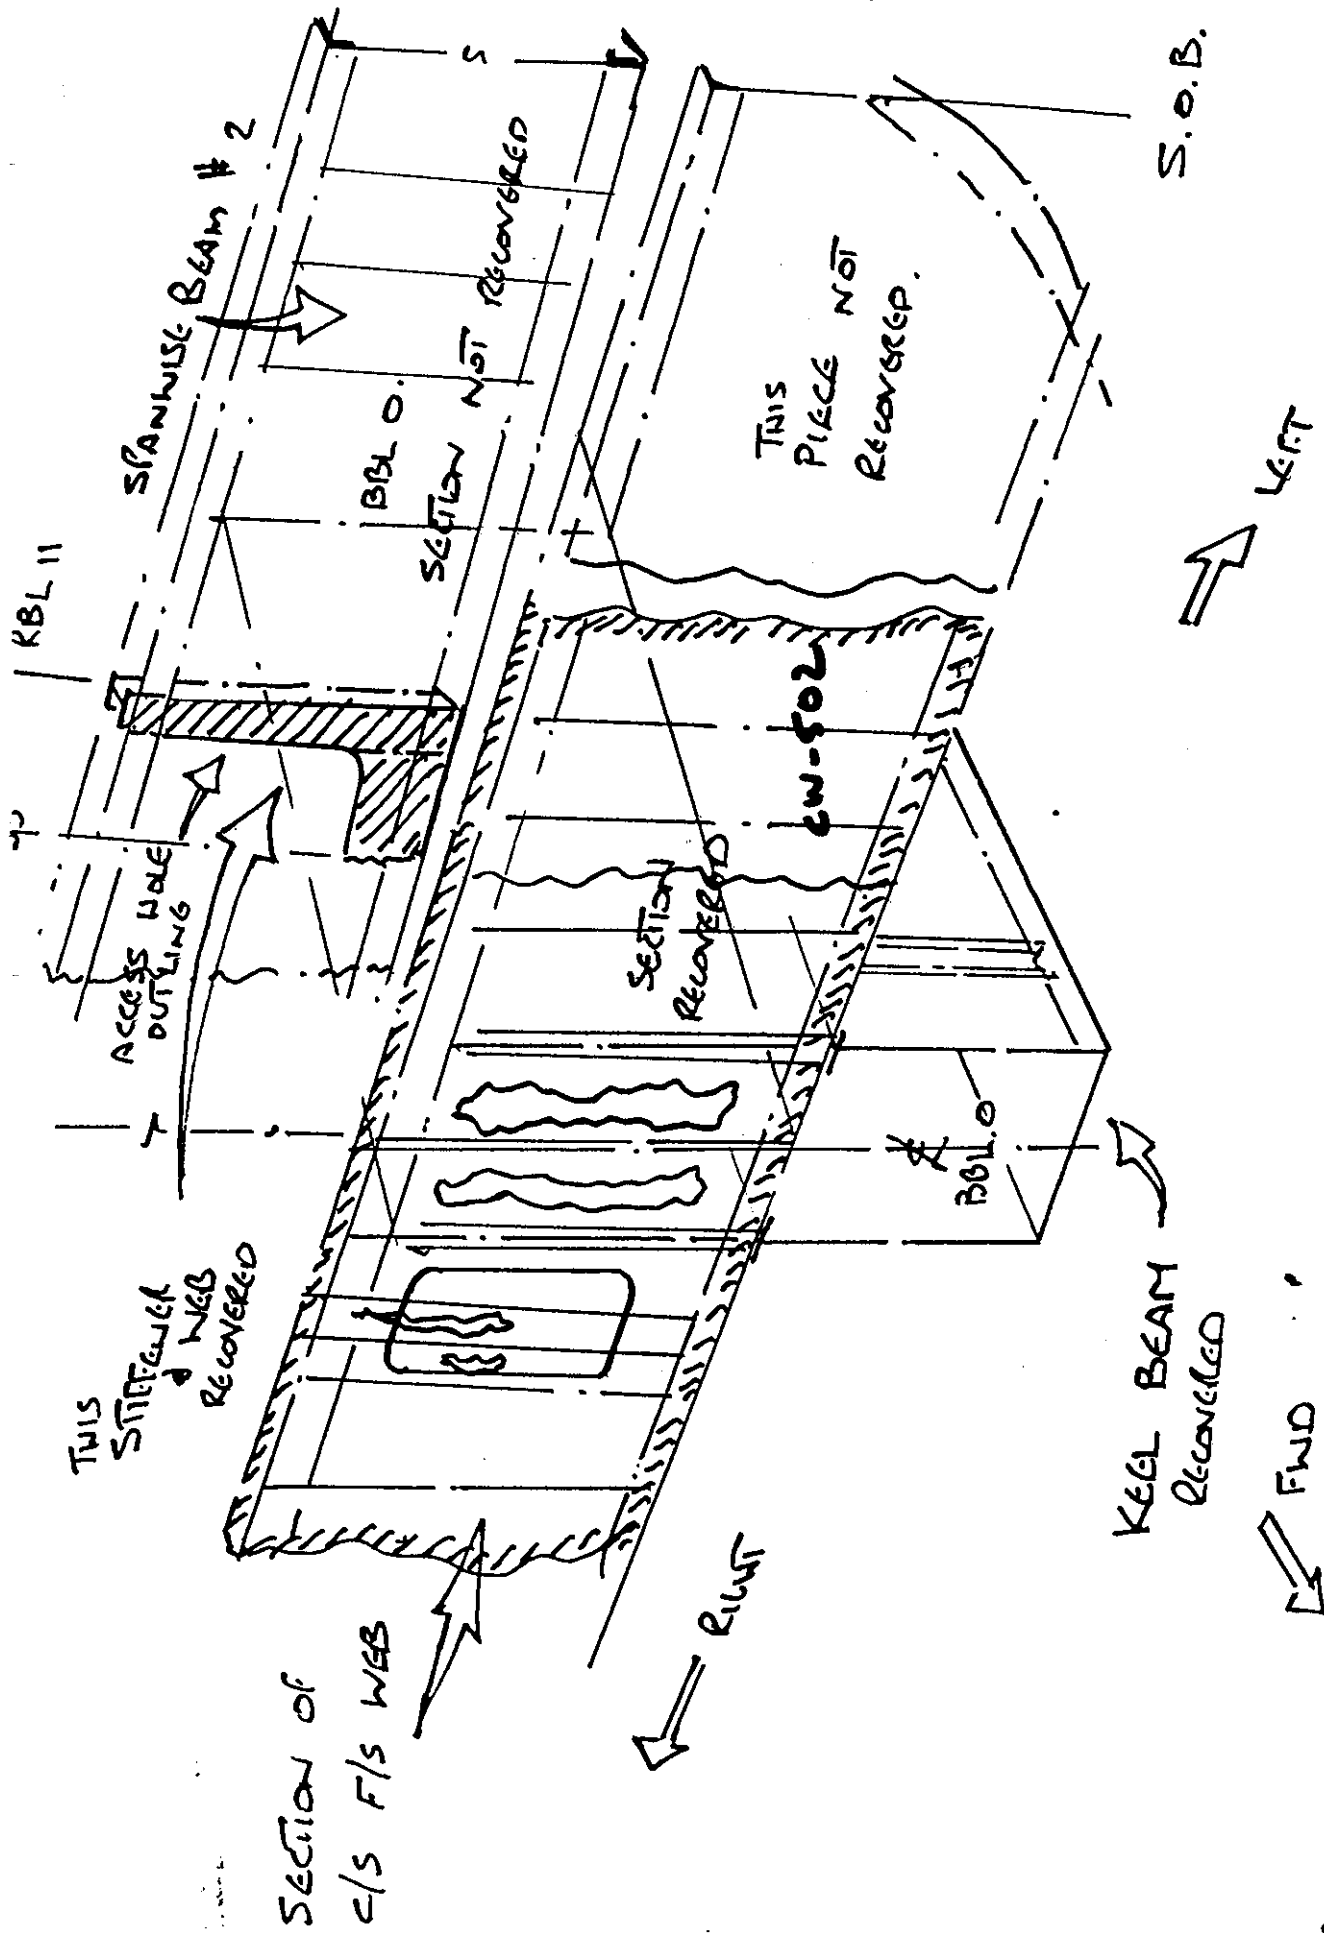
NOTE SPANWISE BEAM NO 3 NOT SHOWN  
 FOR CLARITY. AND NOT RECOVERED
