CW-503
C-251
GREEN

FRONT SPAR

WING CENTER SECTION -

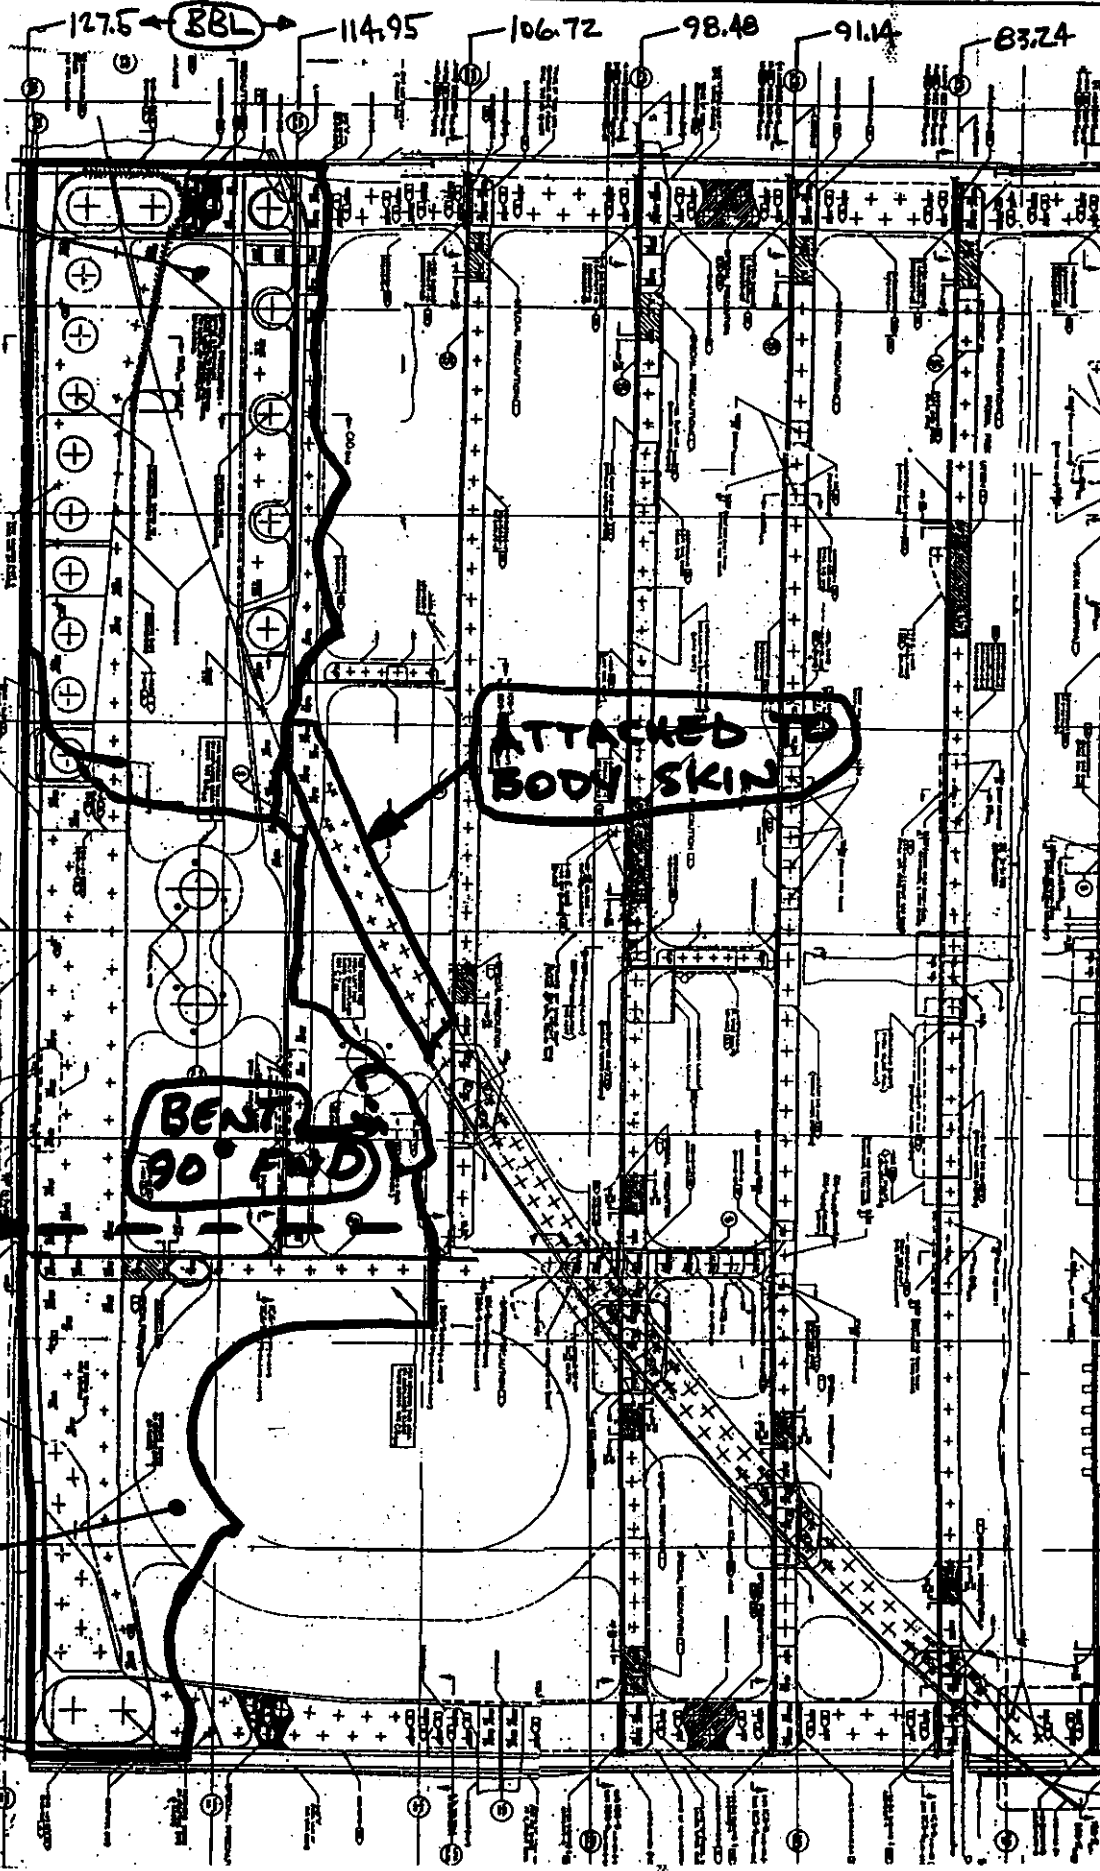
This section is at the extreme right and lower side of the front spar and is about 54" X 54" and connects to CW519. The right primary jack pad is part of this item. The section has 44" of outboard wing front spar attached to it. The inboard edge of the part generally runs through the center of the access hole along a vertical axis.

The upper half of this section is bent aft 30" at 45 degrees from its original position. The outboard end of the access hole exhibits heavy soot damage and is bent slightly aft. Above the access hole, a part of the web is bent forward 120 degrees. There is a puncture above and outboard of the access hole.

The lower outboard wing front spar web section is bent forward and separated at the lower spar chord radius. Outboard of the WBL 140 rib location, there is heavy sooting on the front face of the spar web. See the fire and explosion group notes for appropriate documentation. The paddle fittings at lower stringers 22 & 23 remain intact for both the outboard and center wing structure. The outboard wing lower stringers 22 & 23 are bent 30 degrees forward.

There is no evidence of any pre-existing cracking or corrosion.

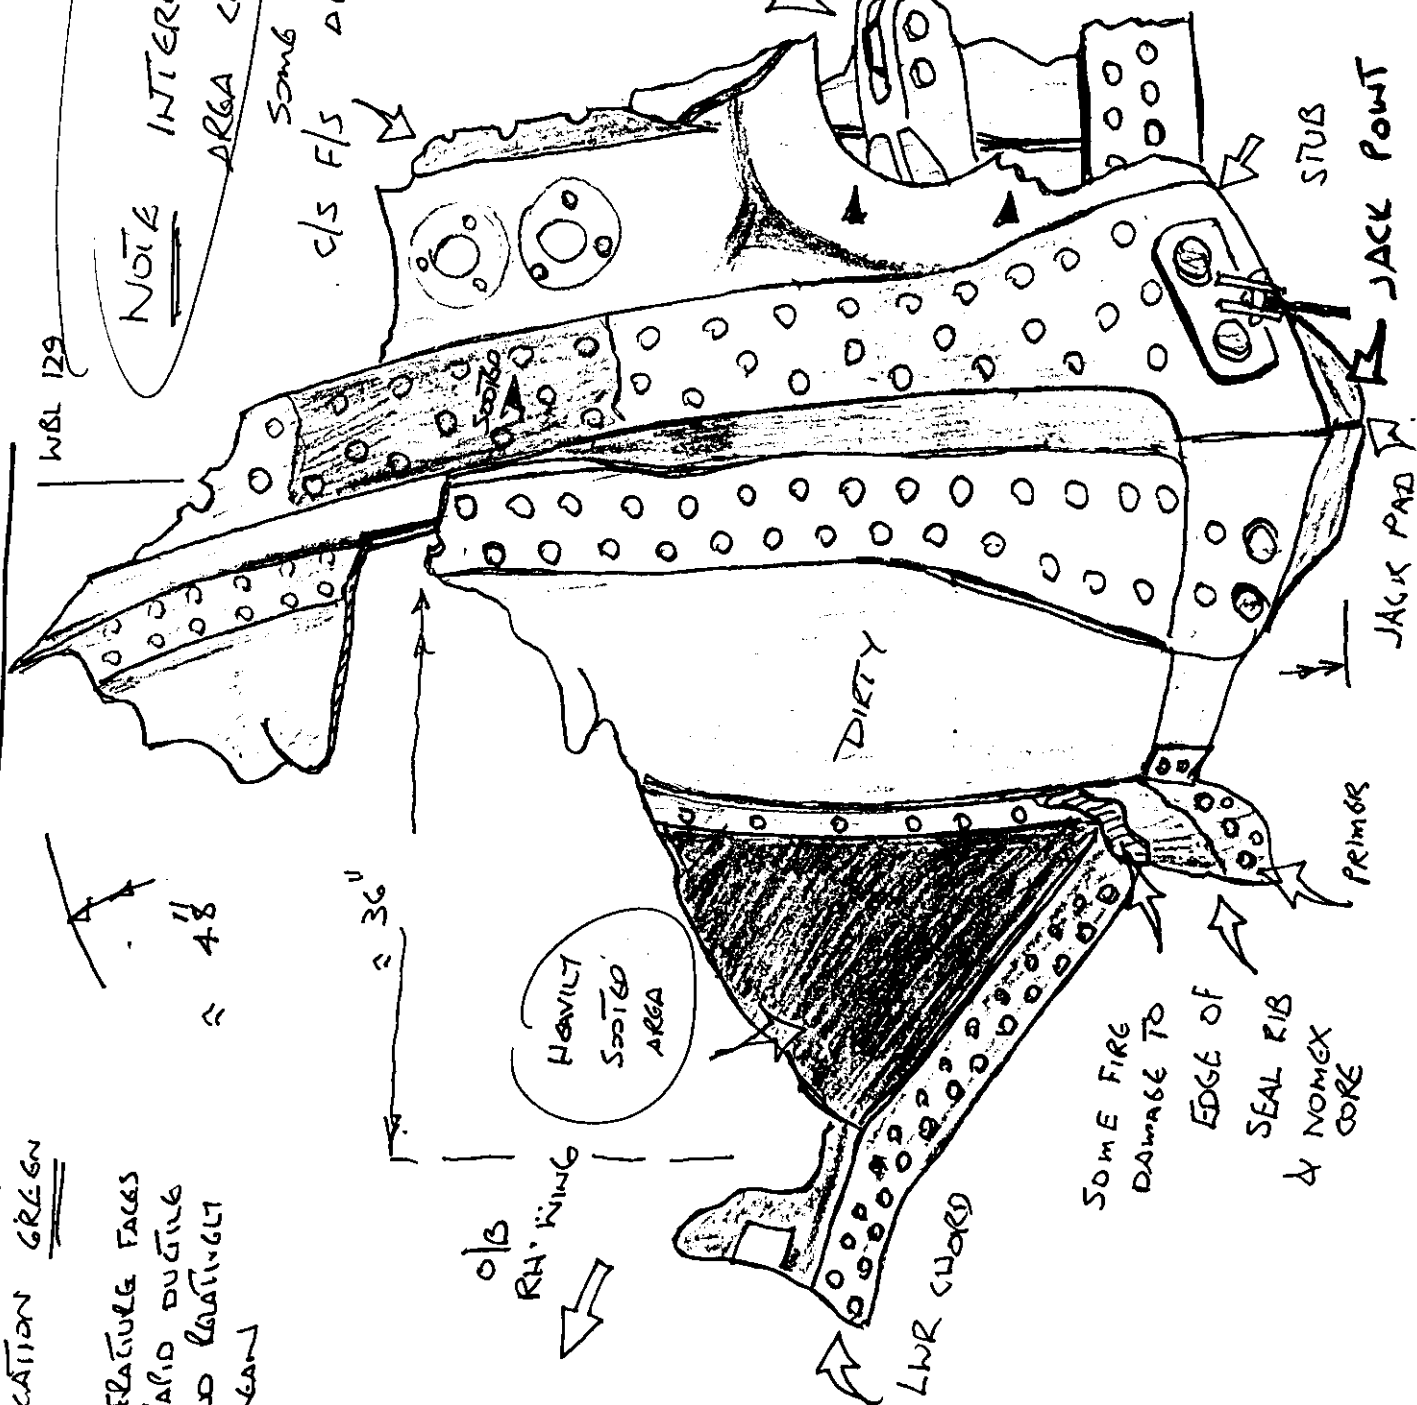
FRONT SPAR - R.H. SIDE
A. REIMER 9/2/96

BENT 45°
AFT

BENT 90°
FWD

TERMINAL FITTINGS ATTACH LOWER RIB
FRONT STAR TO CLS.

INTERNAL SURFACE
AREA CLEAN, EXCEPT FOR
SOME LOCALIZED SOOT ON
C/S F/S AFT FACE F/S

11
SOOTED
(LIGHTLY)
