CW-504  
A-236  
RED

## FRONT SPAR

# WING BOX FRONT SPAR

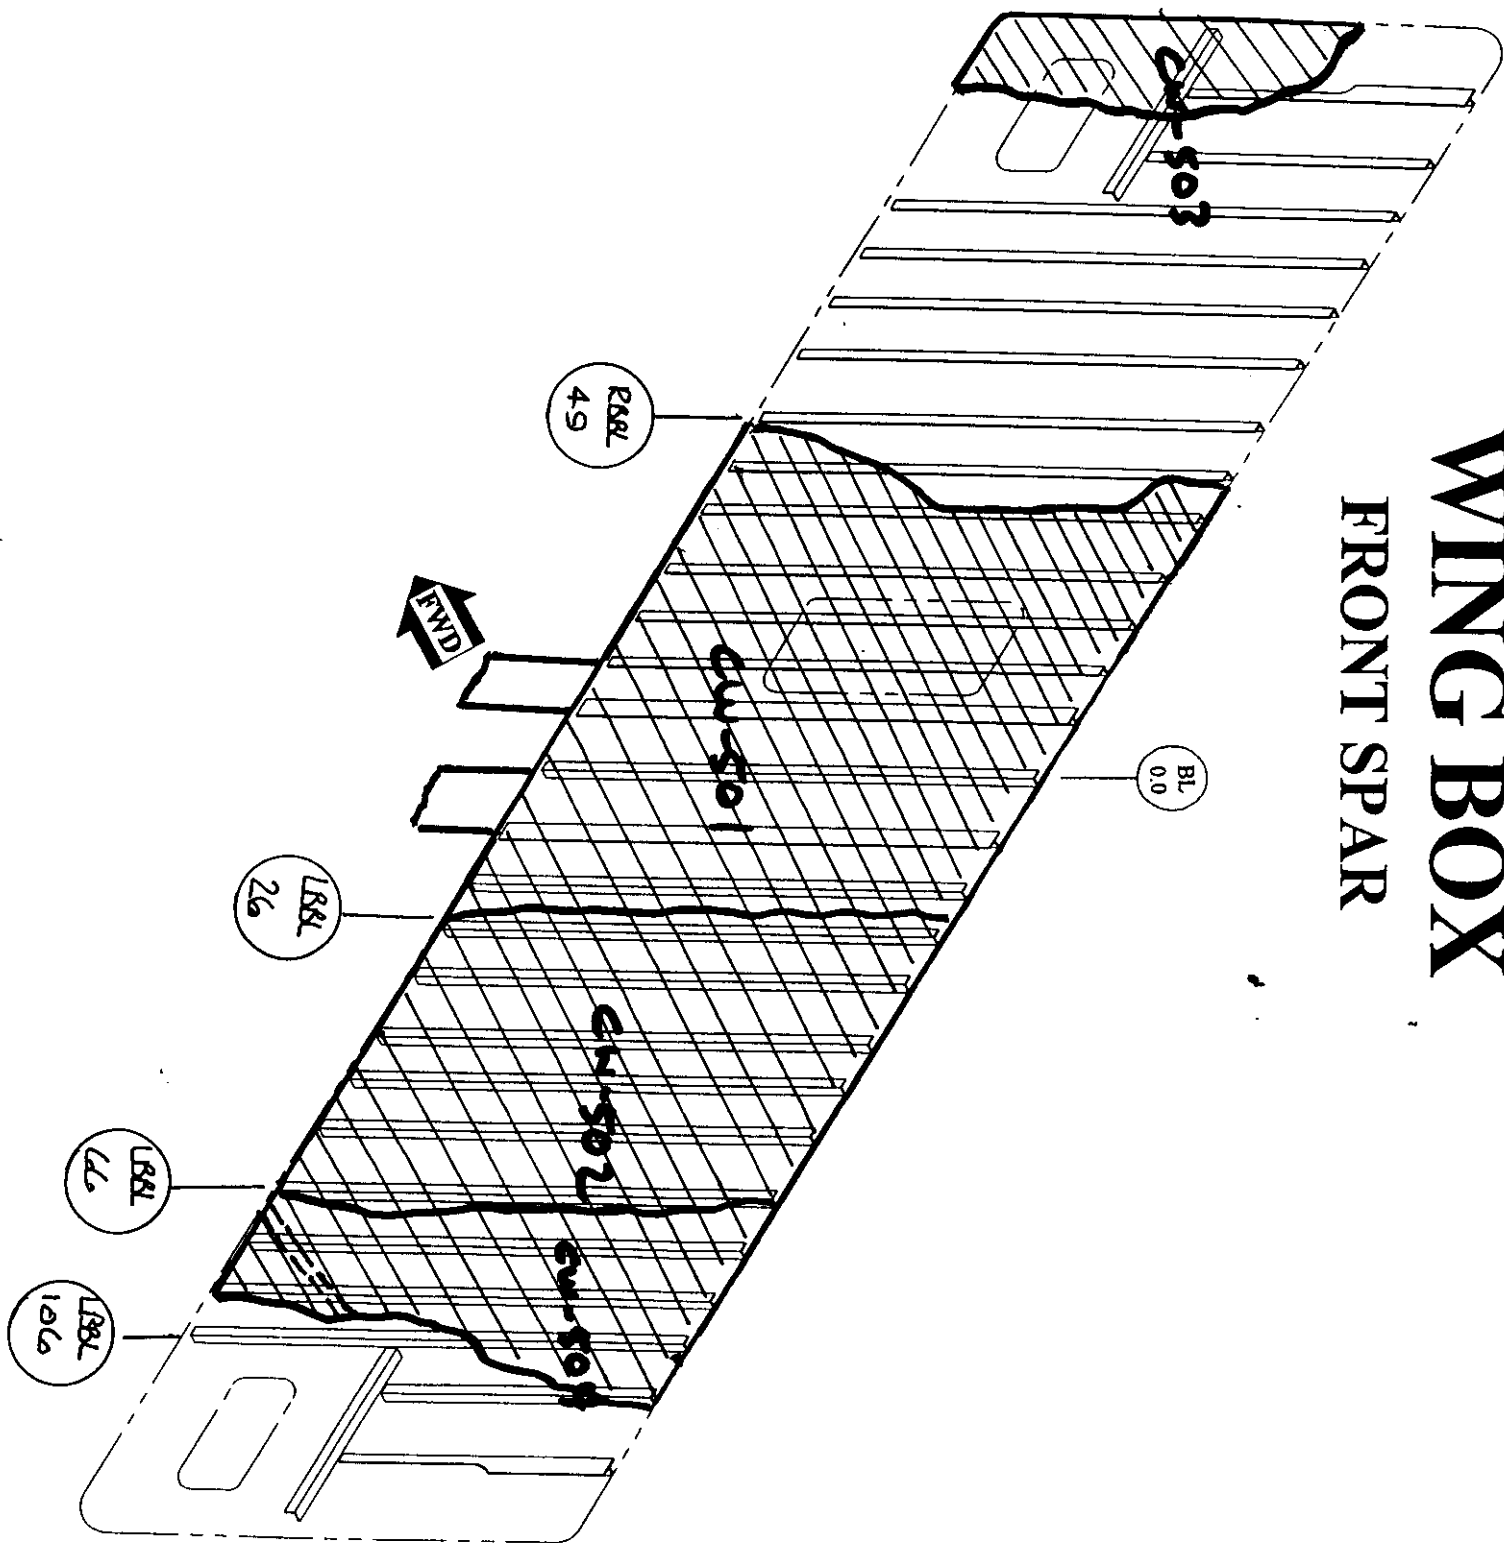
This section of the front spar spans from LBL 75.92 to LBL 114.95. CW-502 connects to this section on the right side, and CW-507, CW-510, CW-516, and CW-518 on the left side. CW-515 forms part of the upper boundary of this section. The upper and lower connections separated along the radius of the upper/lower skin/spar chords. The sides separated by a tearing action.

The stiffeners at LBL 75.82, 83.24 and 91.14 suffered severe impact damage and fractured at 18", 15" and 12" from the upper shear ties respectively. The aft flange and the stiffener web at the impact location was crushed forward. A 2.5" wide impact mark was observed on the aft flange of the stiffeners. The stiffener at LBL 98.48 remained attached to the front spar web and the aft flange suffered impact damage from 17" to 23" from the upper shear tie. The shear ties are missing from the stiffeners at the bottom.

For fatigue cracking found on the horizontal flange of the shear ties, attached to the lower skin at approximately LBL 83.24 and 91.14, see the shear tie study.

Other than the fatigue damage mentioned above, pre-existing cracking or corrosion to this section of the front spar.

There is a black, oily residue on the aft side in the upper outboard area; this is similar to the residue on the upper surface of the upper skin panel.

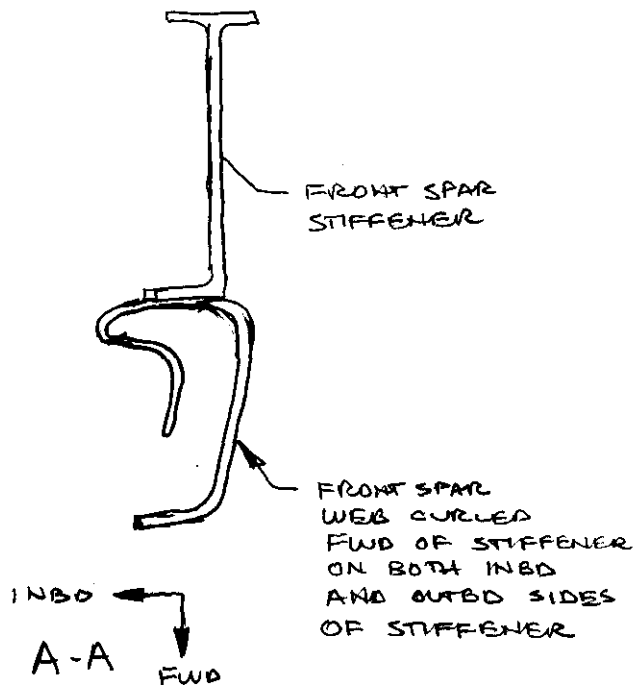
CW 504

AFT SIDE OF CW-504 AT INTERFACE WITH CW-515 SHOWS SAME EVIDENCE OF BEING STRUCK BY SWB #3 AS OTHER FRONT SPAR SECTIONS. STIFFENERS ARE BUCKLED AND DISTORTED AT UPPER END COMMON TO CW-504.

SIGNIFICANT EVIDENCE OF FWD APPLIED FORCE TO LWR WEB AROUND ACCESS HOLE CAUSING WEB TO FRACTURE AND TOTALLY CURL AROUND ON ITSELF AT SEGMENTS CWS10, CWS08, AND CWS07. RADIUS OF CURVATURE OF APPROX 7"

NO EVIDENCE OF ANY BURNING OR SOOT EXCEPT ON INTERCOSTAL ATTACHED TO STIFFENER WHICH SHOWS BURNING AND SOOT.

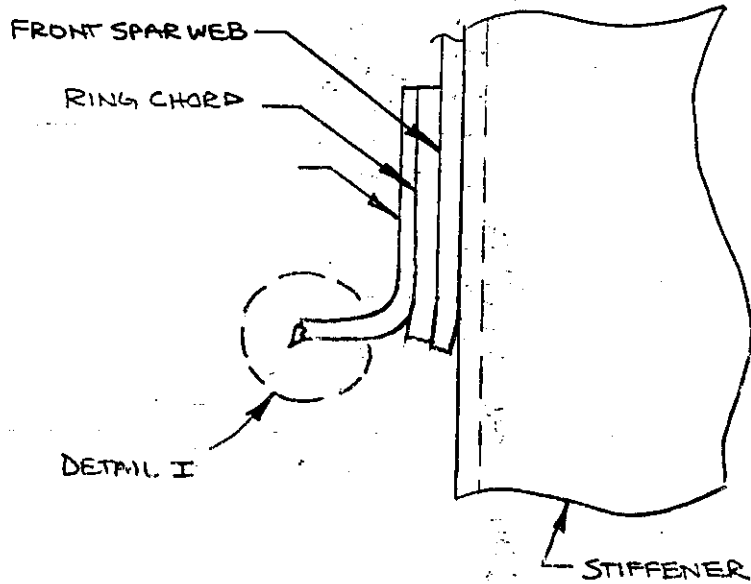
A-A

DEFORMATION AT FASTENER LOCATIONS
