FRONT SPAR - L.H. SIDE

VIEW LOOKING AFT AT LEFT CENTER SECTION FRONT SPAR

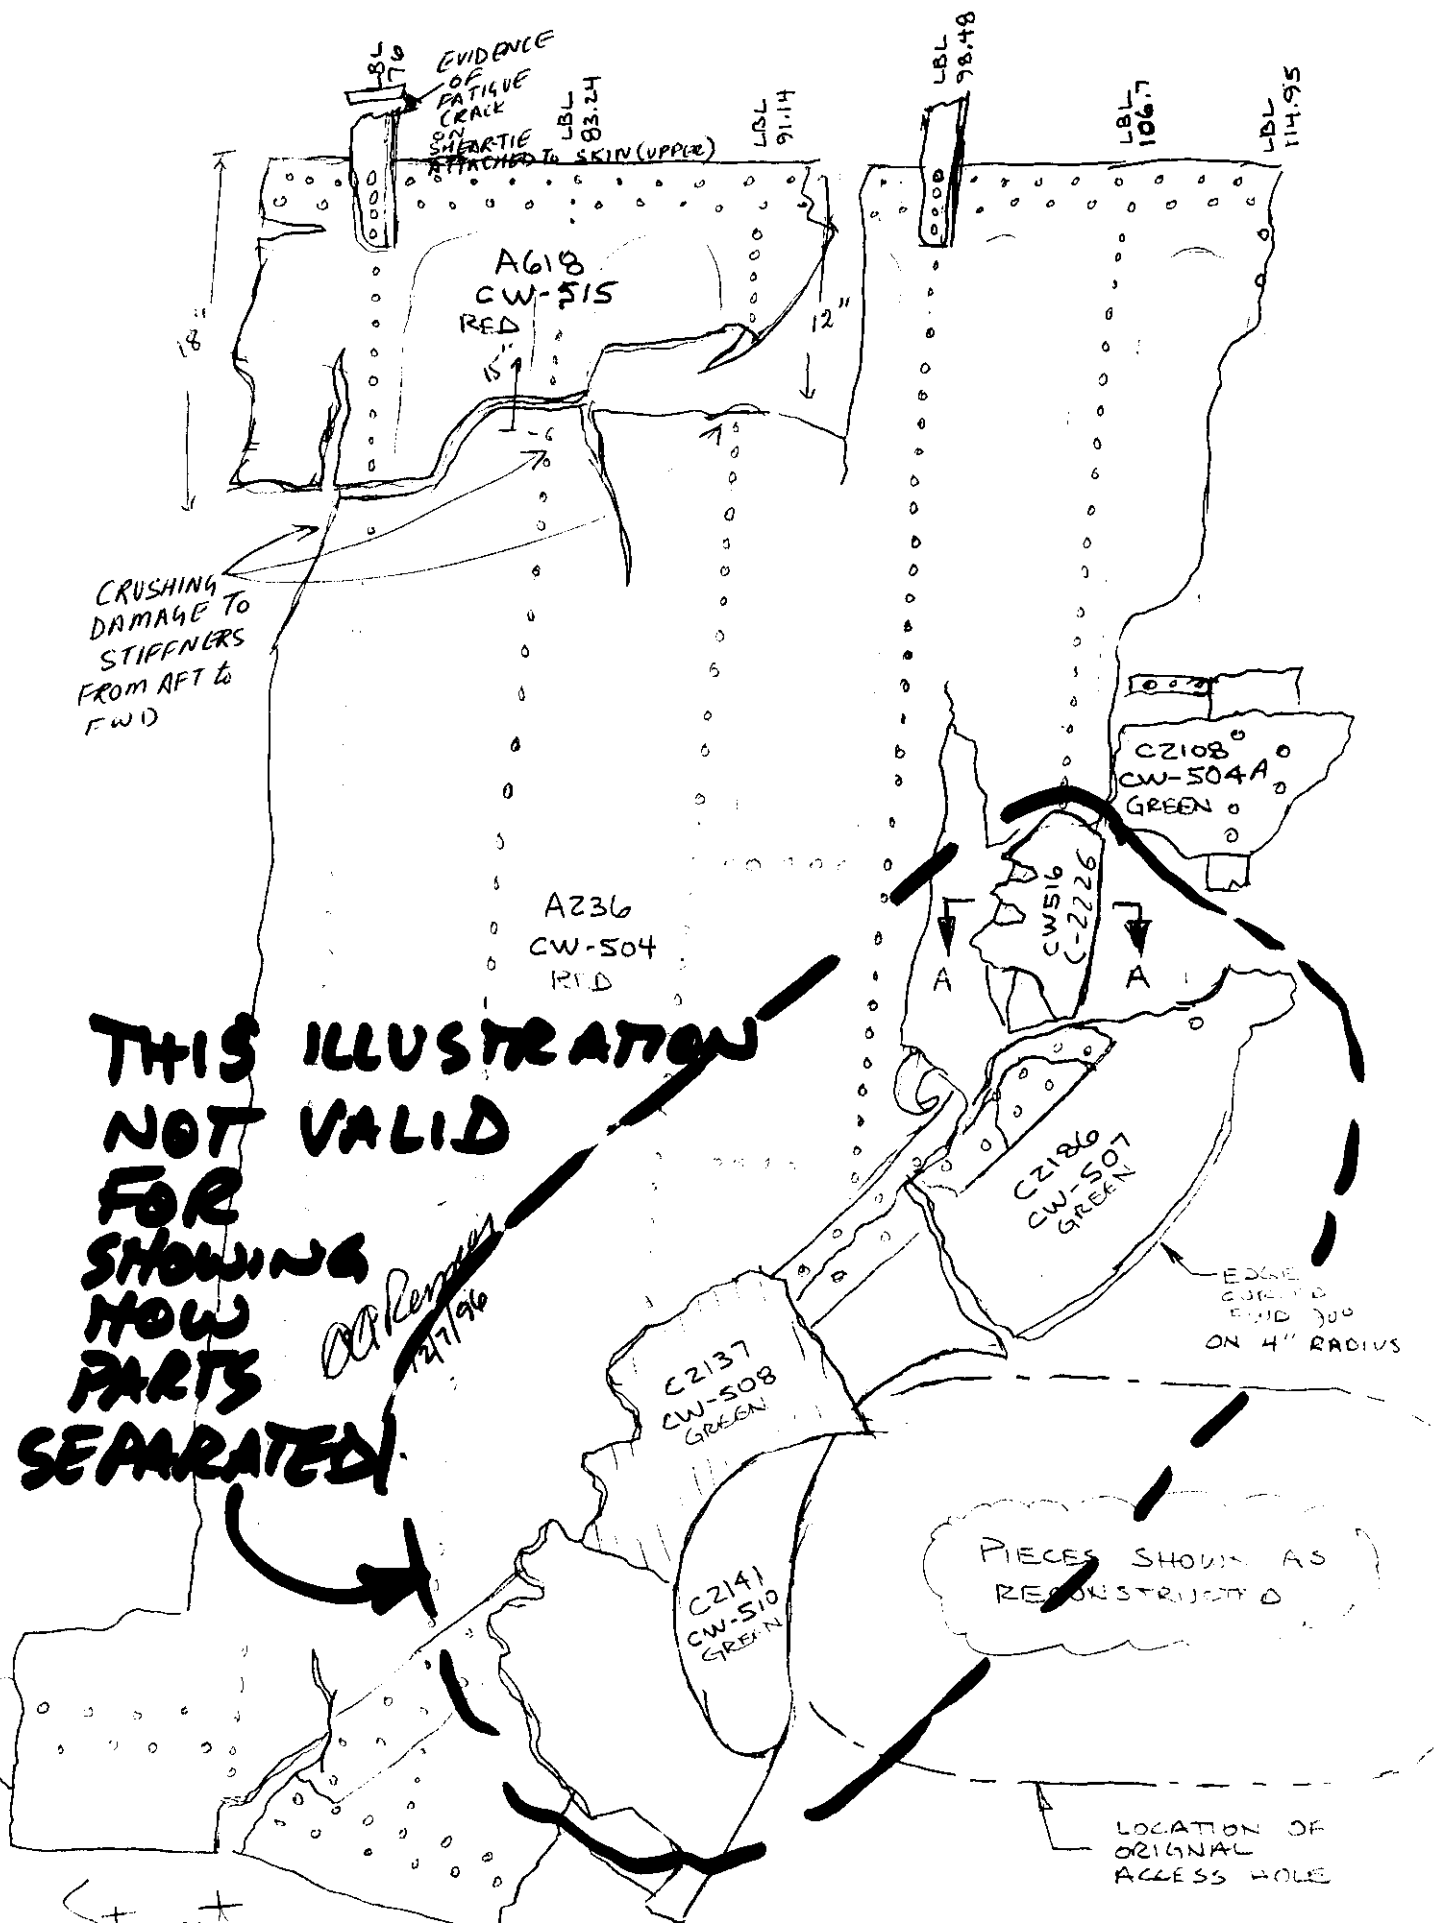
- CW-504A PIECE OF WEB ATTACHED TO PIECE OF LBL114 STIFFENER WITH INTERCOSTAL. I/C BENT, AND WAS BURNED.
- CW-505 HEAVY WEB BENT FORWARD 90° ALONG VERTICAL LINE 6" FROM OUTBD SIDE, GROOVES FROM BOLTS RUBBING. AFT SIDE.
- CW-506 PART OF TERMINAL FTG, TORN, FLAT.
- CW-507 BOTTOM 4" DEFORMED FWD 90°. UPR OUTBD DEFORMED 45° AFT. SCRAPE MARKS
- CW-508 PIECE DEFORMED AND HAS SCRAPE MARKS. 180° FROM ORIGINAL ORIENT.
- CW-509 LWR PART OF TERMINAL FITTING.
- CW-510 LWR PART OF WEB WITH ACCESS HOLE. ROLLED 180° FWD AND ~~IN~~ ^{OUT} FLAT ALONG RING CHORD.
- CW-511 PART OF OUTBD, LWR WING F.S. WEB. CAME OFF OF TERM. FTG. 14" HIGH, 12" INBD-OUTBD, AFT 6" BENT ^{AFT} 90° TO F.S. PLANE.

AFT SIDE OF CW-504 AT INTERFACE WITH CW-515 SHOWS SAME EVIDENCE OF BEING STRUCK BY SWB #3 AS OTHER FRONT SPAR SECTIONS. STIFFENERS ARE BUCKLED AND DISTORTED AT UPPER END COMMON TO CW-504.

SIGNIFICANT EVIDENCE OF FWD APPLIED FORCE TO LWR WEB AROUND ACCESS HOLE CAUSING WEB TO FRACTURE AND TOTALLY CURL AROUND ON ITSELF AT SEGMENTS CWS10, CWS08, AND CWS07. RADIUS OF CURVATURE OF APPROX 7"

NO EVIDENCE OF ANY BURNING OR SOOT EXCEPT ON INTERCOSTAL ATTACHED TO STIFFENER WHICH SHOWS BURNING AND SOOT.
