CW-515 FRONT SPAR  
A-618  
RED

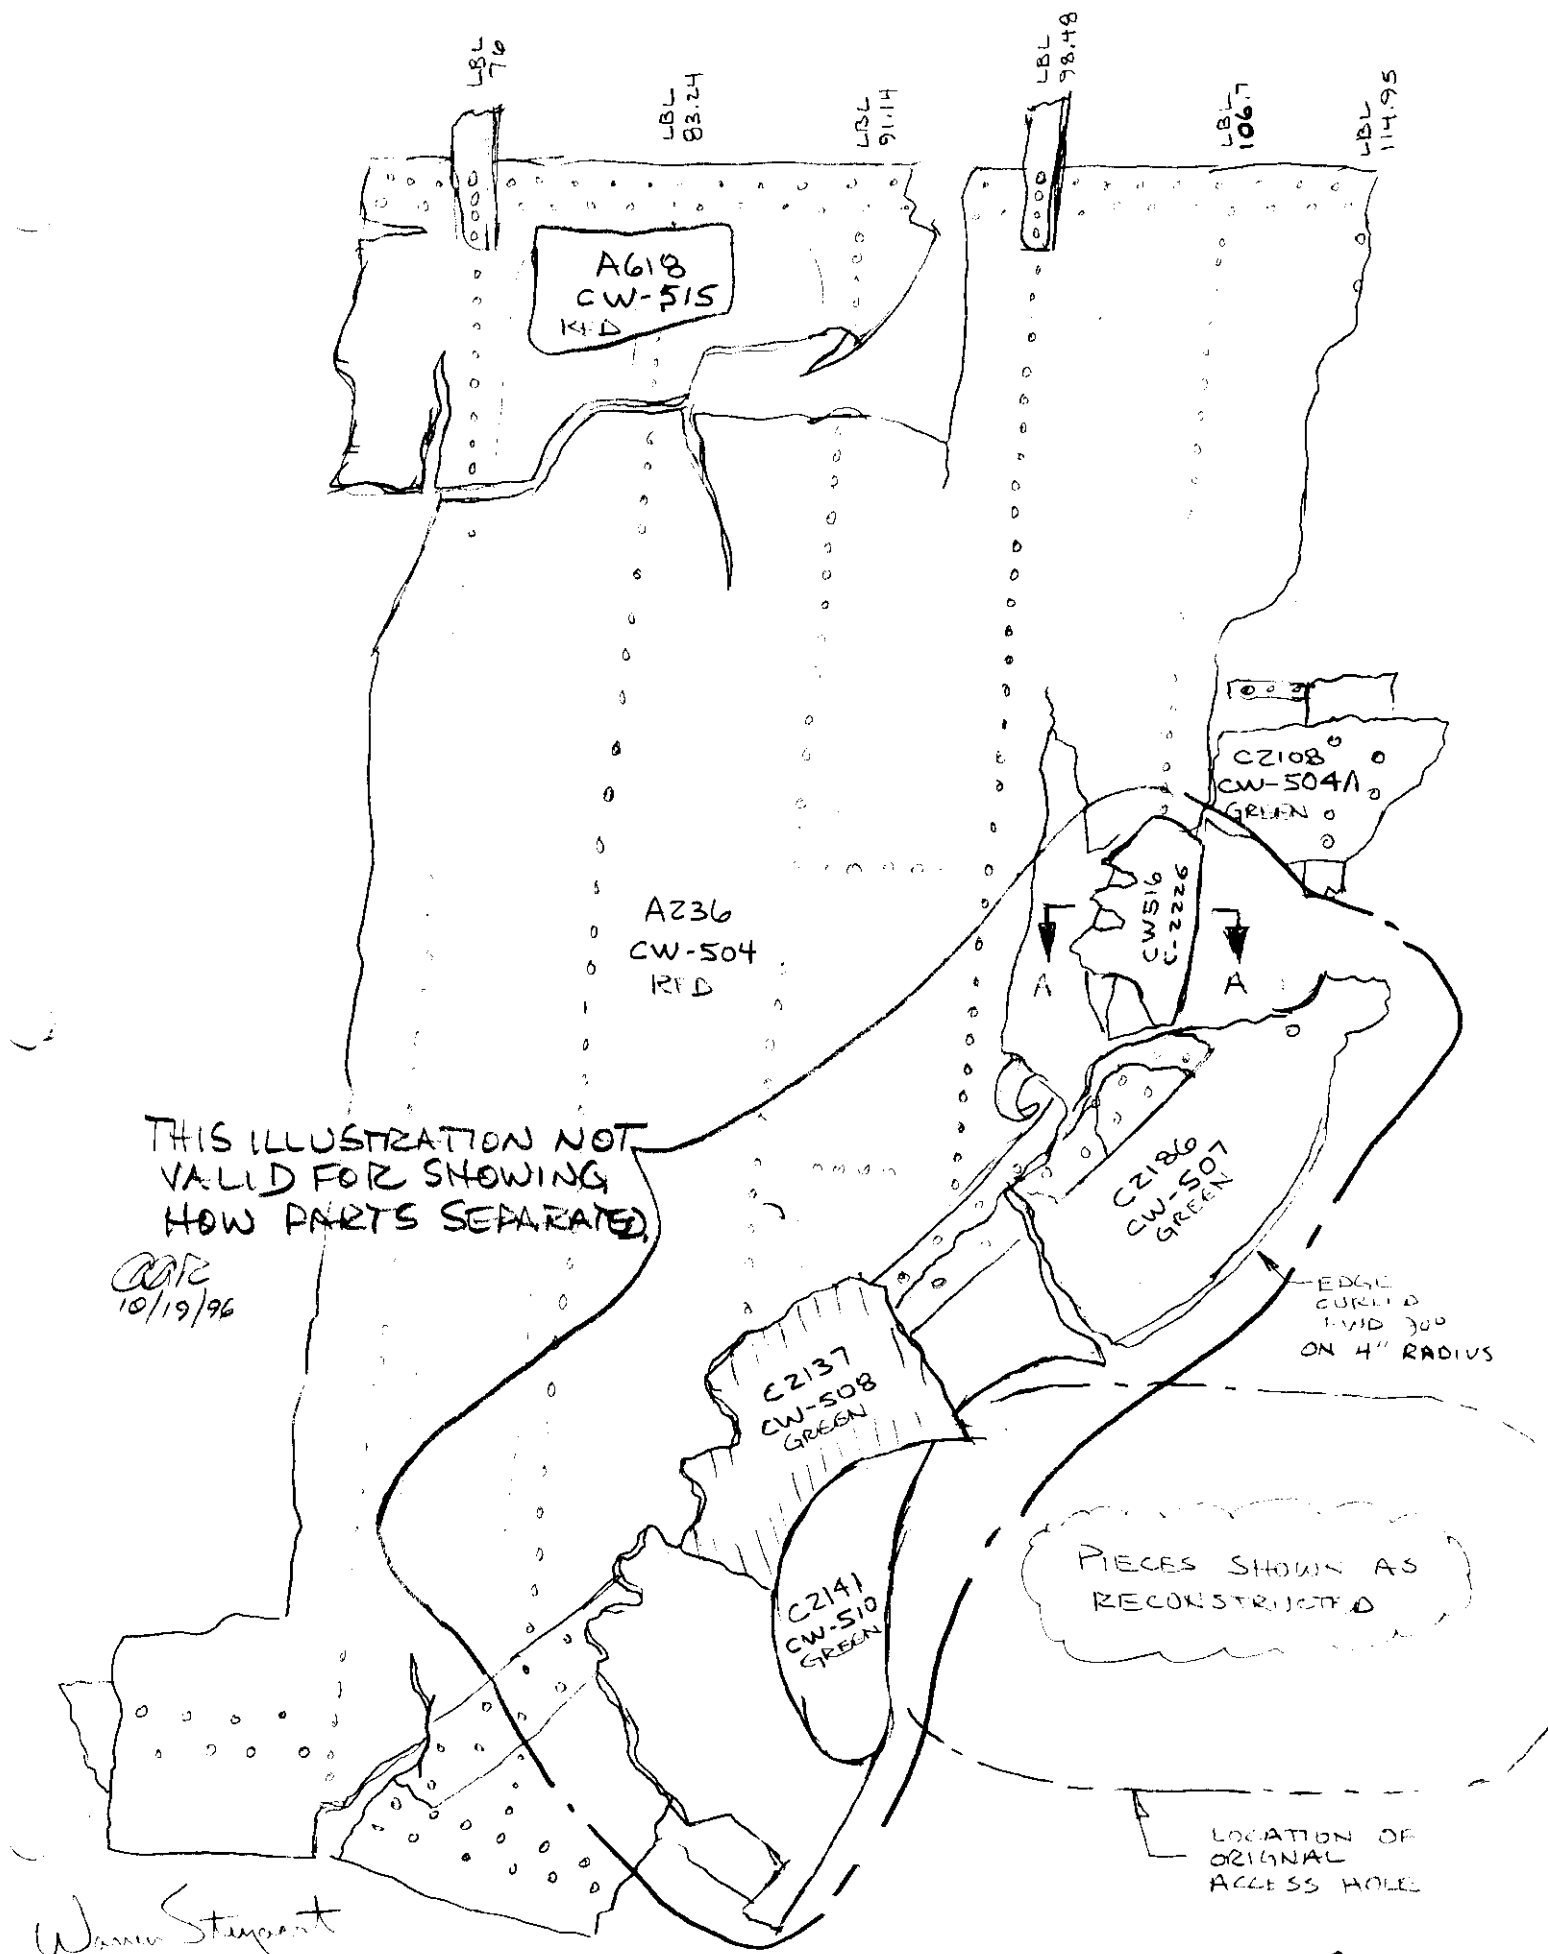
VIEW LOOKING AFT AT LEFT  
CENTER SECTION FRONT SIDE

This section of the front spar is about 24" X 22" and attaches to CW-504 at the bottom and CW-502 on the right side. The upper connection separated along the radius of the upper skin/spar chord. The bottom separated by a tearing action.

The stiffeners at LBL 75.82, 83.24 and 91.14 broke off at 18", 15" and 12" from the top respectively. These stiffener fractures match the fracture surfaces of the stiffeners as described in CW-504. The shear ties on the stiffener remained attached to the stiffener, except for LBL 75.82. The horizontal flange of the shear tie remained attached to the upper skin at LBL 75.82.

The shear tie fracture surface exhibited evidence of a fatigue crack at the aft end of the vertical flange. Detail documentation of this fatigue crack is in the metallurgical field notes.

~~There is no evidence of any fire damage to this section of~~ The front spar and the remaining fracture surfaces exhibited no evidence of any pre-existing cracking or corrosion.
