CW-519
Z-3029
GREEN

FRONT SPAR

FRONT SPAR SECTION RBL 65→112

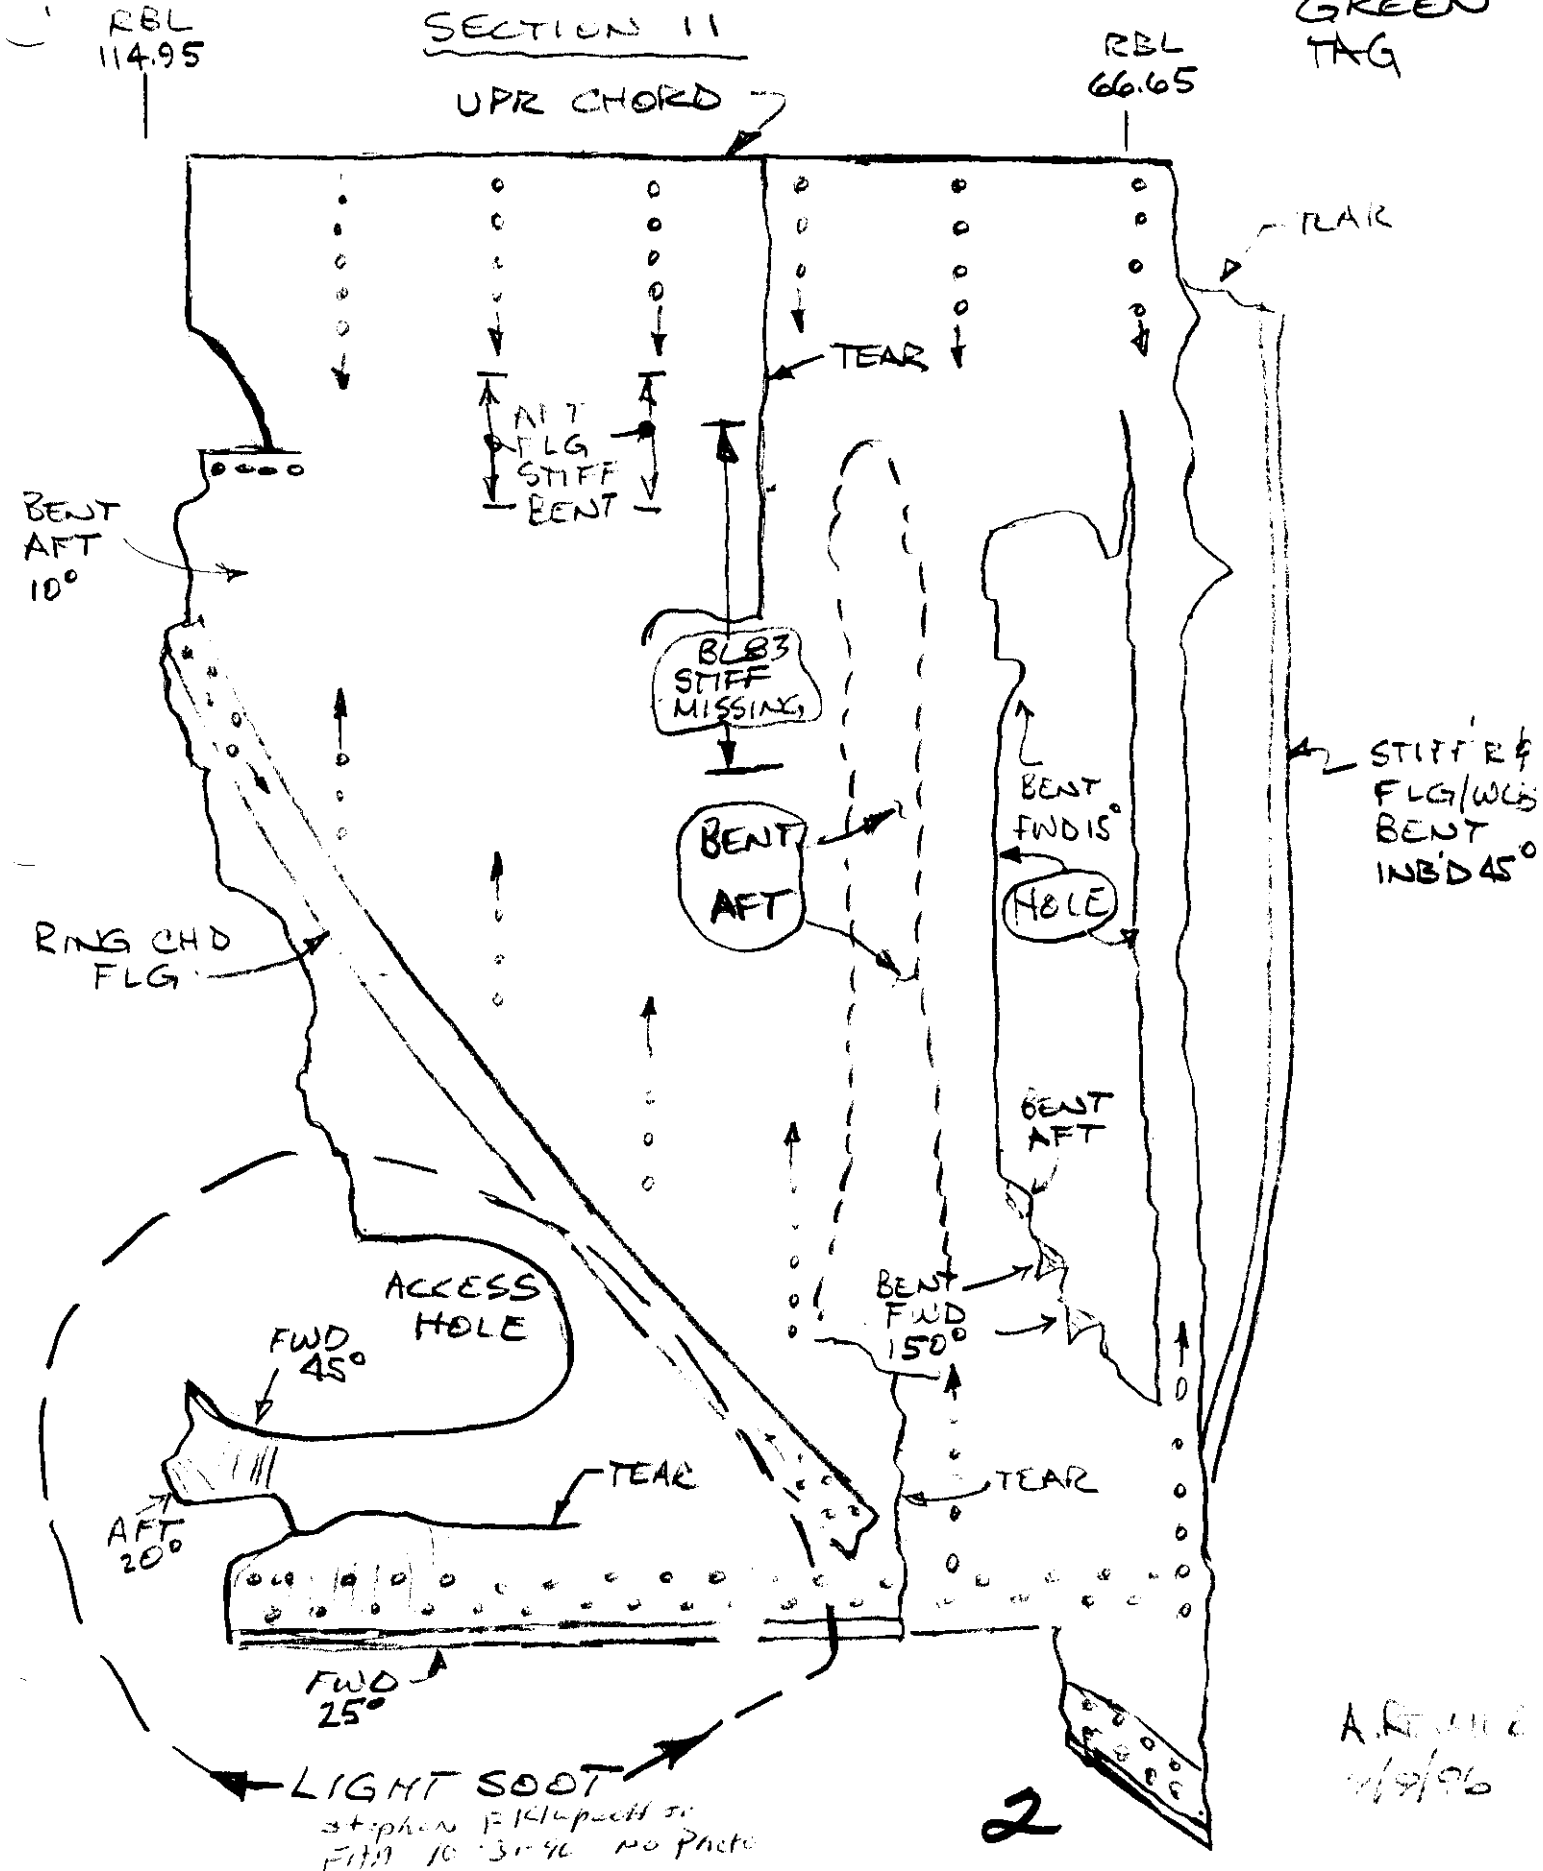
FRONT SPAR - R.H. SIDE

This section extends from RBL 114.95 to RBL 66.65 and is on the right side of the front spar. The upper connection separated along the radius of the upper skin/spar chord. The outboard side separated along a vertical line in line with the fuselage bulkhead fitting. The inboard side separated just inboard of RBL 66.65. The bottom separated along the radius of the lower skin/spar chord.

The extreme right bottom corner near the access hole exhibited evidence of sooting. The outboard end of the web near the access hole is bent forward 45 degrees and a small section of this web is bent aft about 20 degrees.

There is a hole in the web about 6" wide X 48" near RBL 66.65. The front spar web is curled in a forward direction at various locations around this hole edge. The web at the bottom of the hole exhibits tight curls up to 150 degrees. The "I" shaped stiffener at RBL 66.65 retains a partial shear tie at the bottom, a complete shear tie at the top, and is twisted inboard from the bottom all the way up to a web fracture about 18 inches below the top. The remaining 5 stiffeners to the right of RBL 66.65 separated from their shear ties at the lower and upper skin, and remained attached to the front spar skin. These stiffeners suffered severe impact damage to their flanges in the dry bay side. There is evidence of impact damage to the aft flange of the stiffeners about 63" from the bottom. This impact damage is about 3" wide and is consistent for all the stiffeners except at RBL 83.24. The stiffener web and flange at RBL 83.24 broke off.

There is no evidence of any pre-existing fracture or corrosion on this section of the front spar.

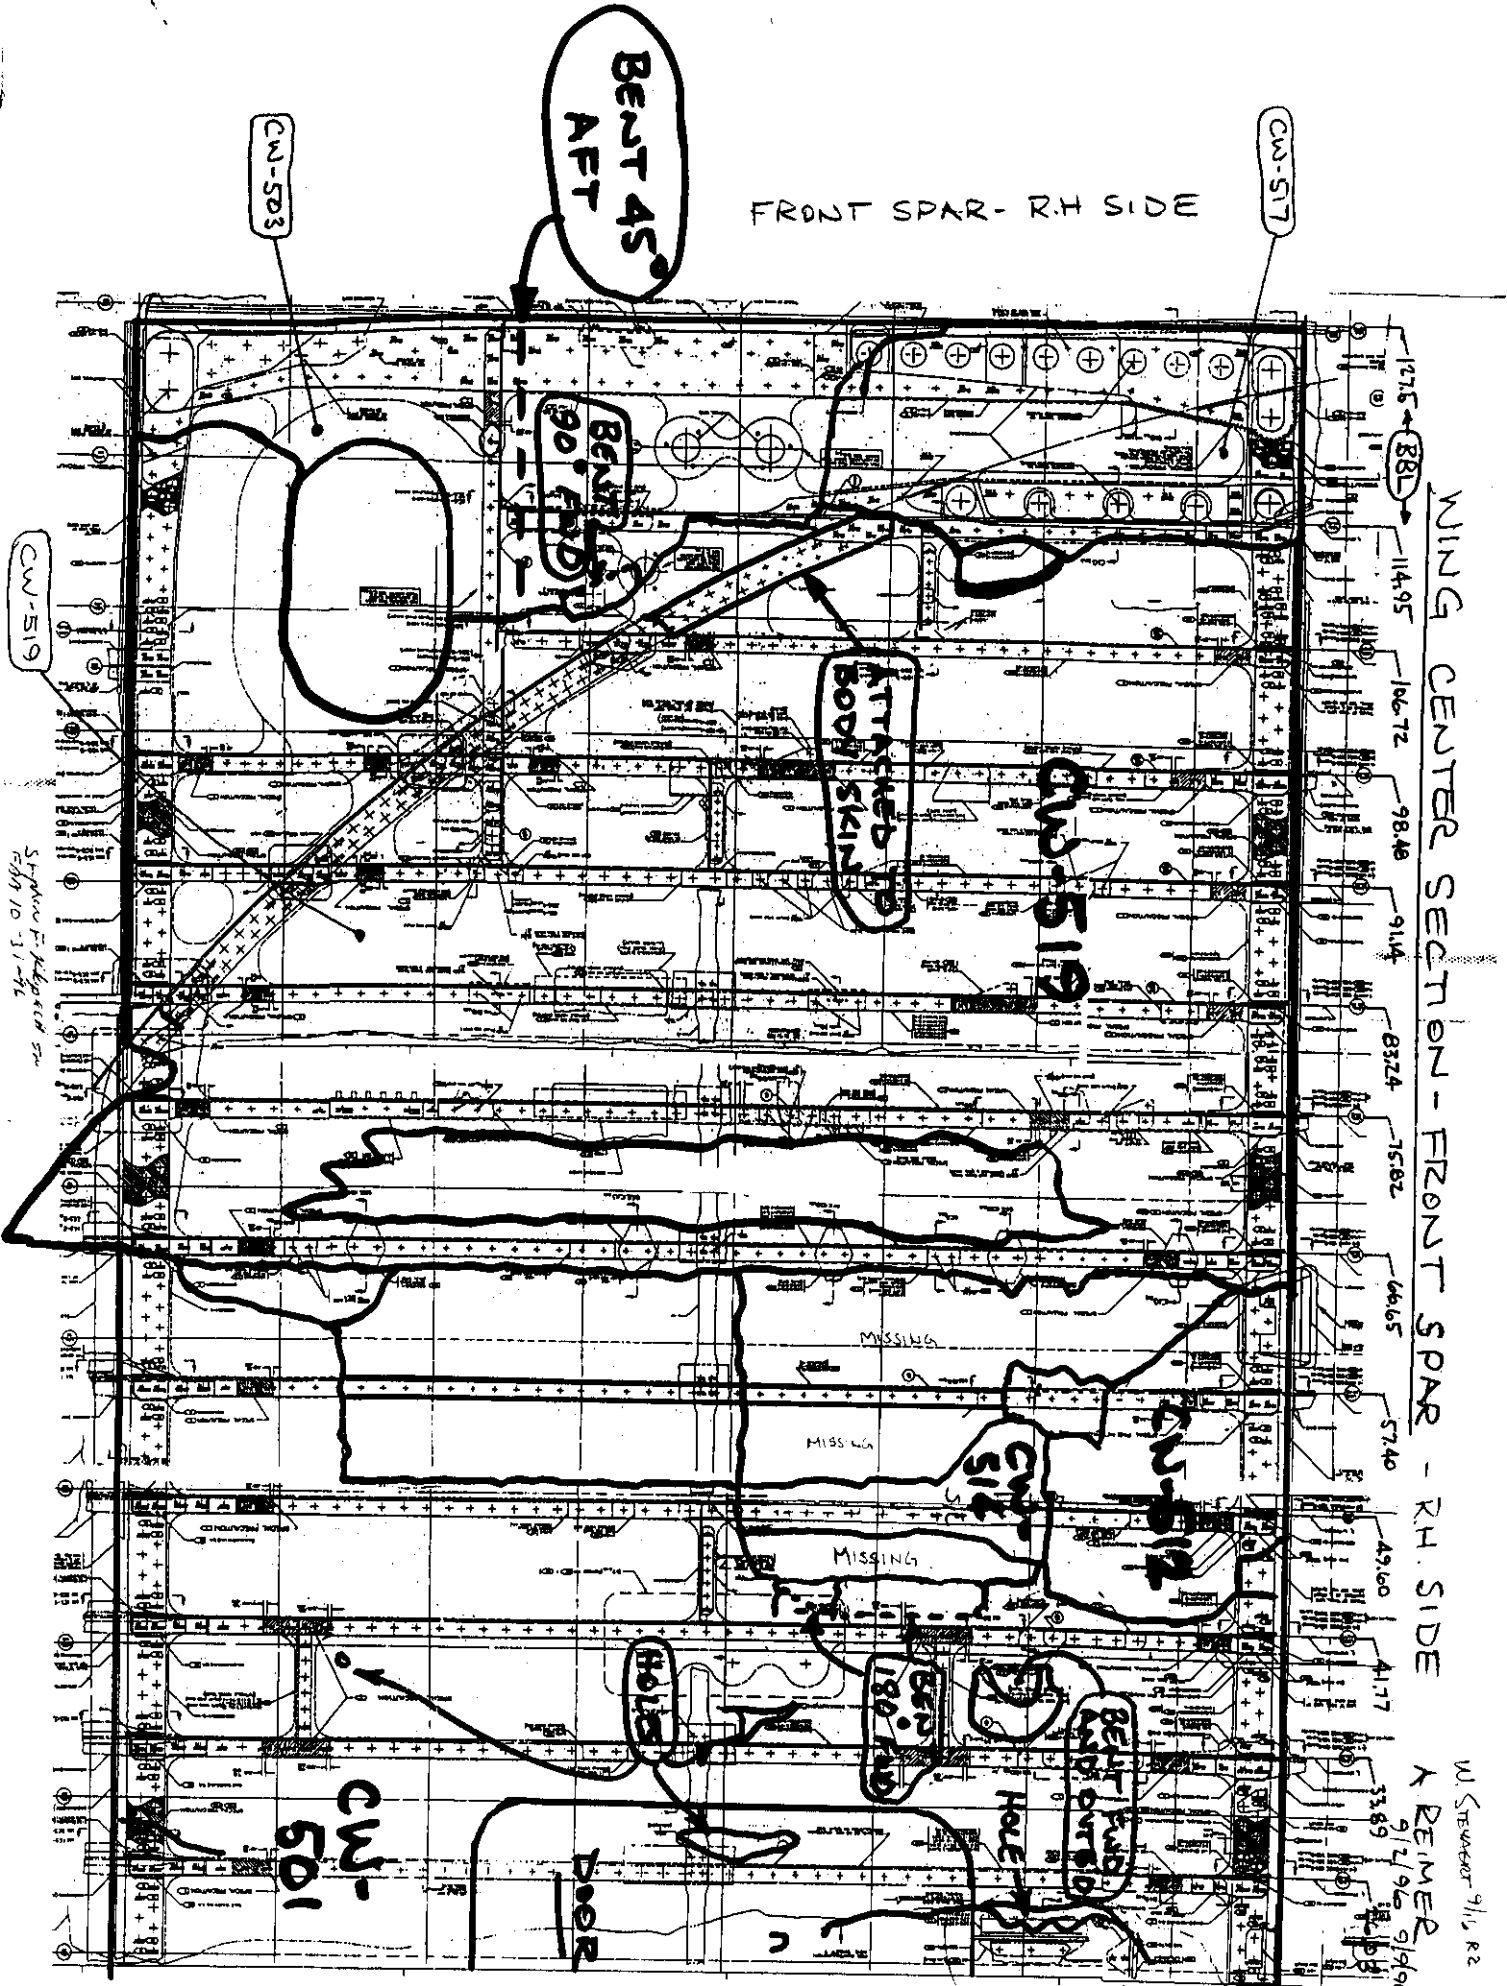
WING CENTER SECTION - FRONT SPAR - R.H. SIDE

ACTUAL
FRACTURE
LINE
NOT
KNOWN

MISSING
PIECE
