SPANWISE BEAM # 3

CW-603

# SPANWISE BEAM N° 3

DEBRIS FIELD # 3

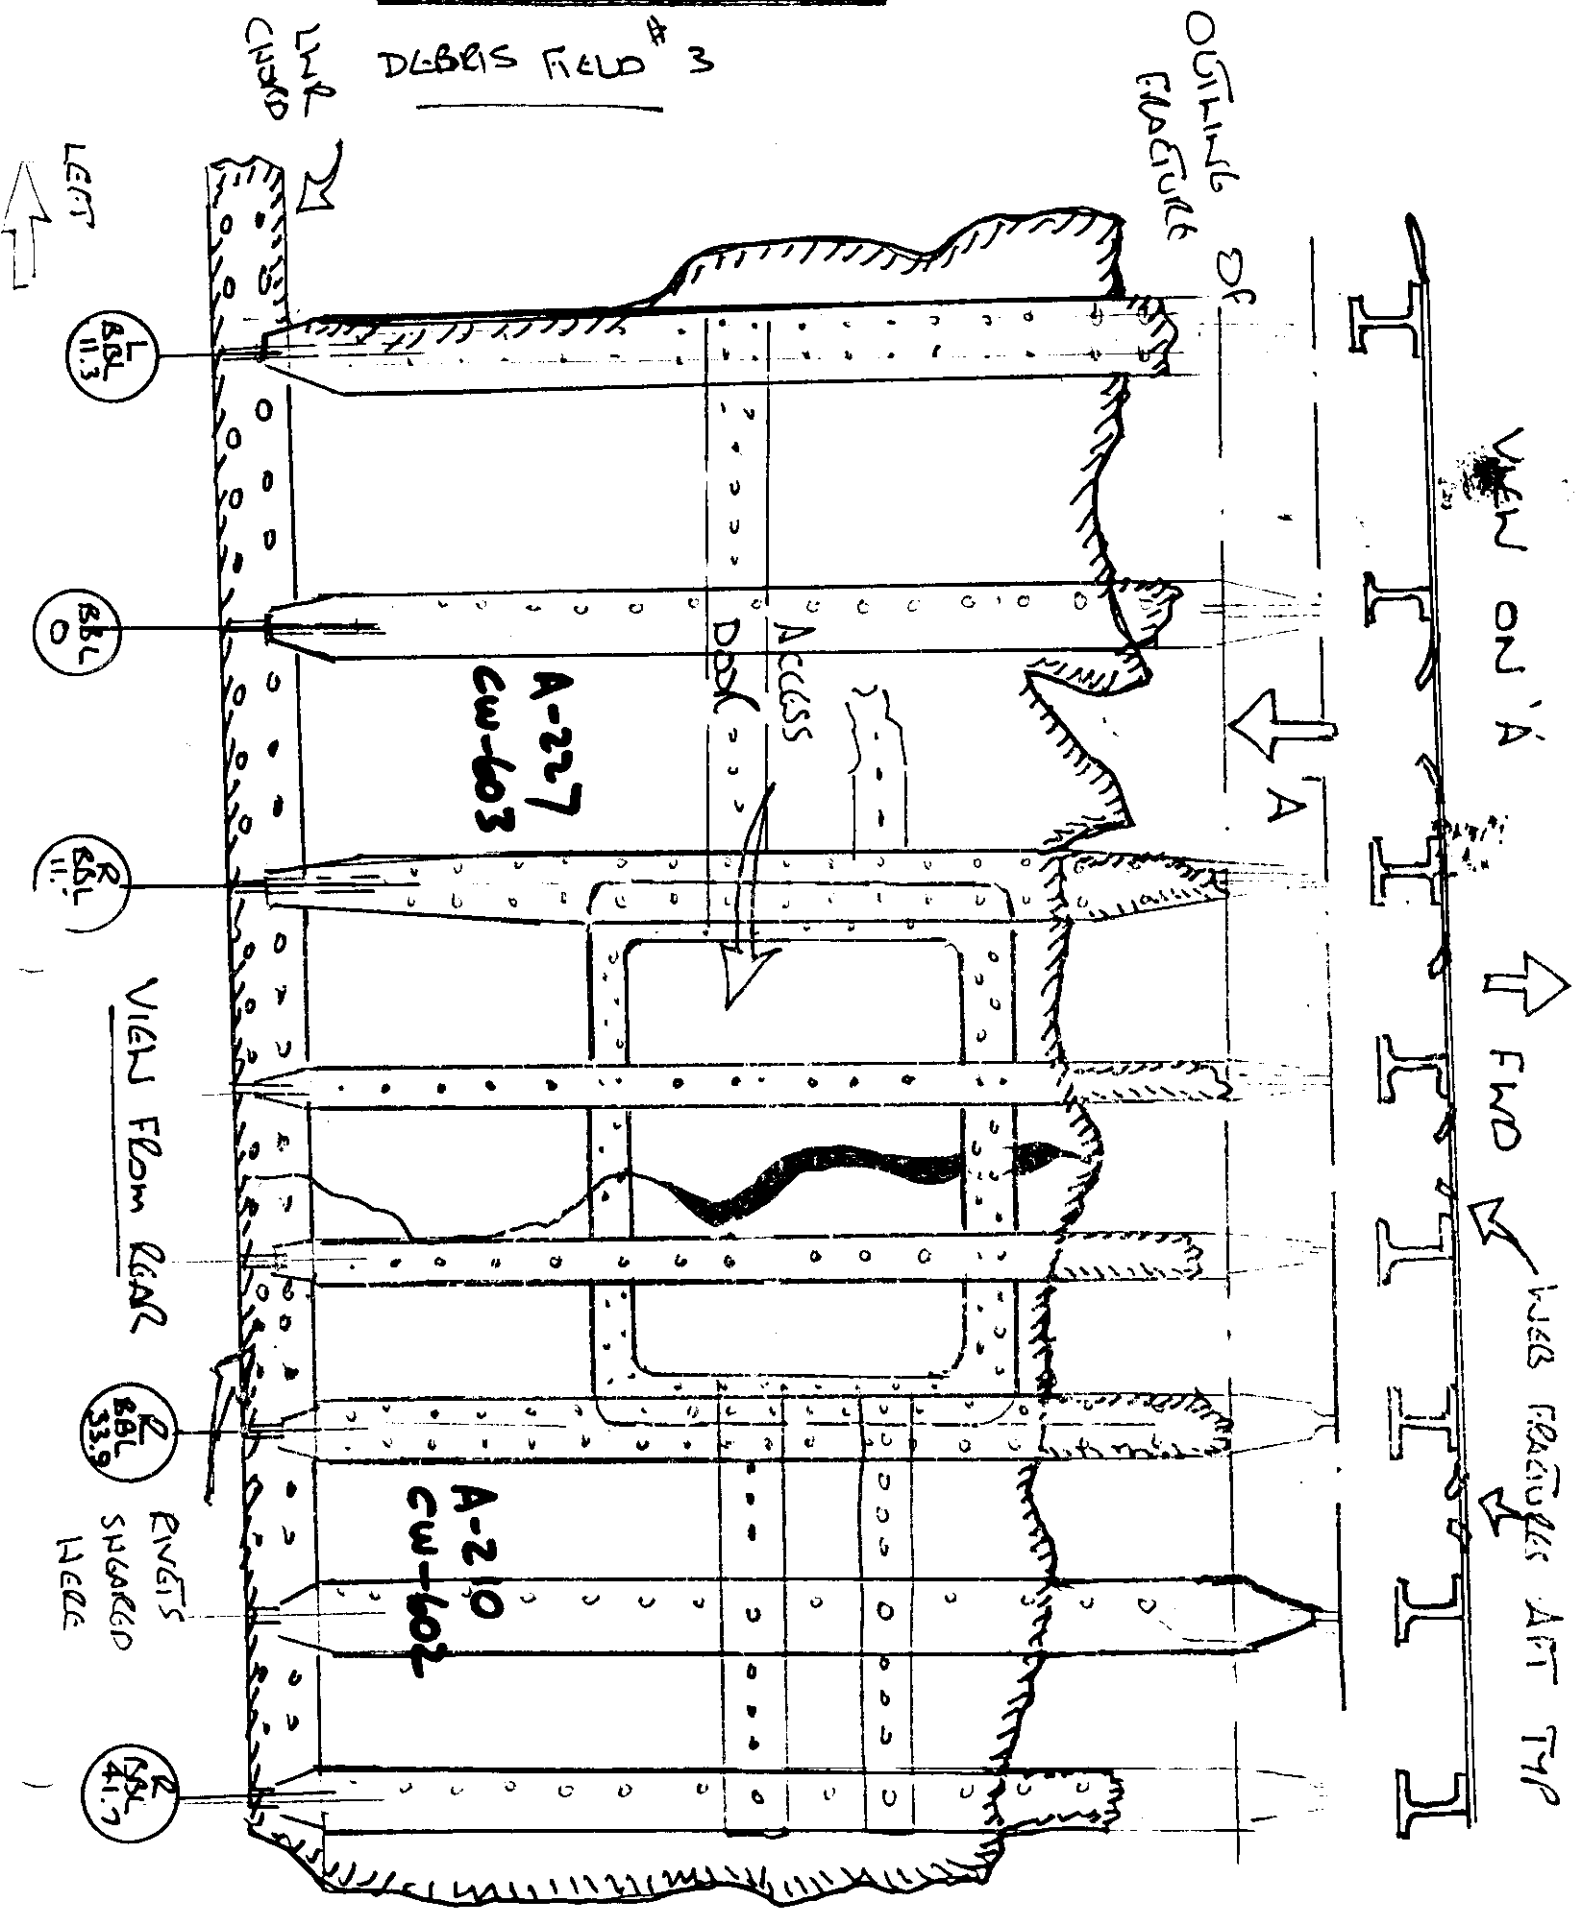
This section extends from RBL ~~17.27~~<sup>23.0</sup> to LBL 17.27 and includes half of the manufacturing access door. This section connects to CW-602 on the right side.

There are four stiffeners that remain attached to the web and all the stiffeners fractured just above the access door. All the shear ties remain attached to the stiffeners at the lower side but the horizontal flange of the shear tie is broken in half at RBL & LBL 11.31. The lower chord separated from the shear ties and is bent slightly forward. The rivet pitch is 1.5".

~~There is no evidence of any fire damage~~ to this section of the beam. There is no evidence of any pre-existing cracking or corrosion to this section of the beam. SEE FIRE AND EXPLOSION FIELD Notes. TCA.

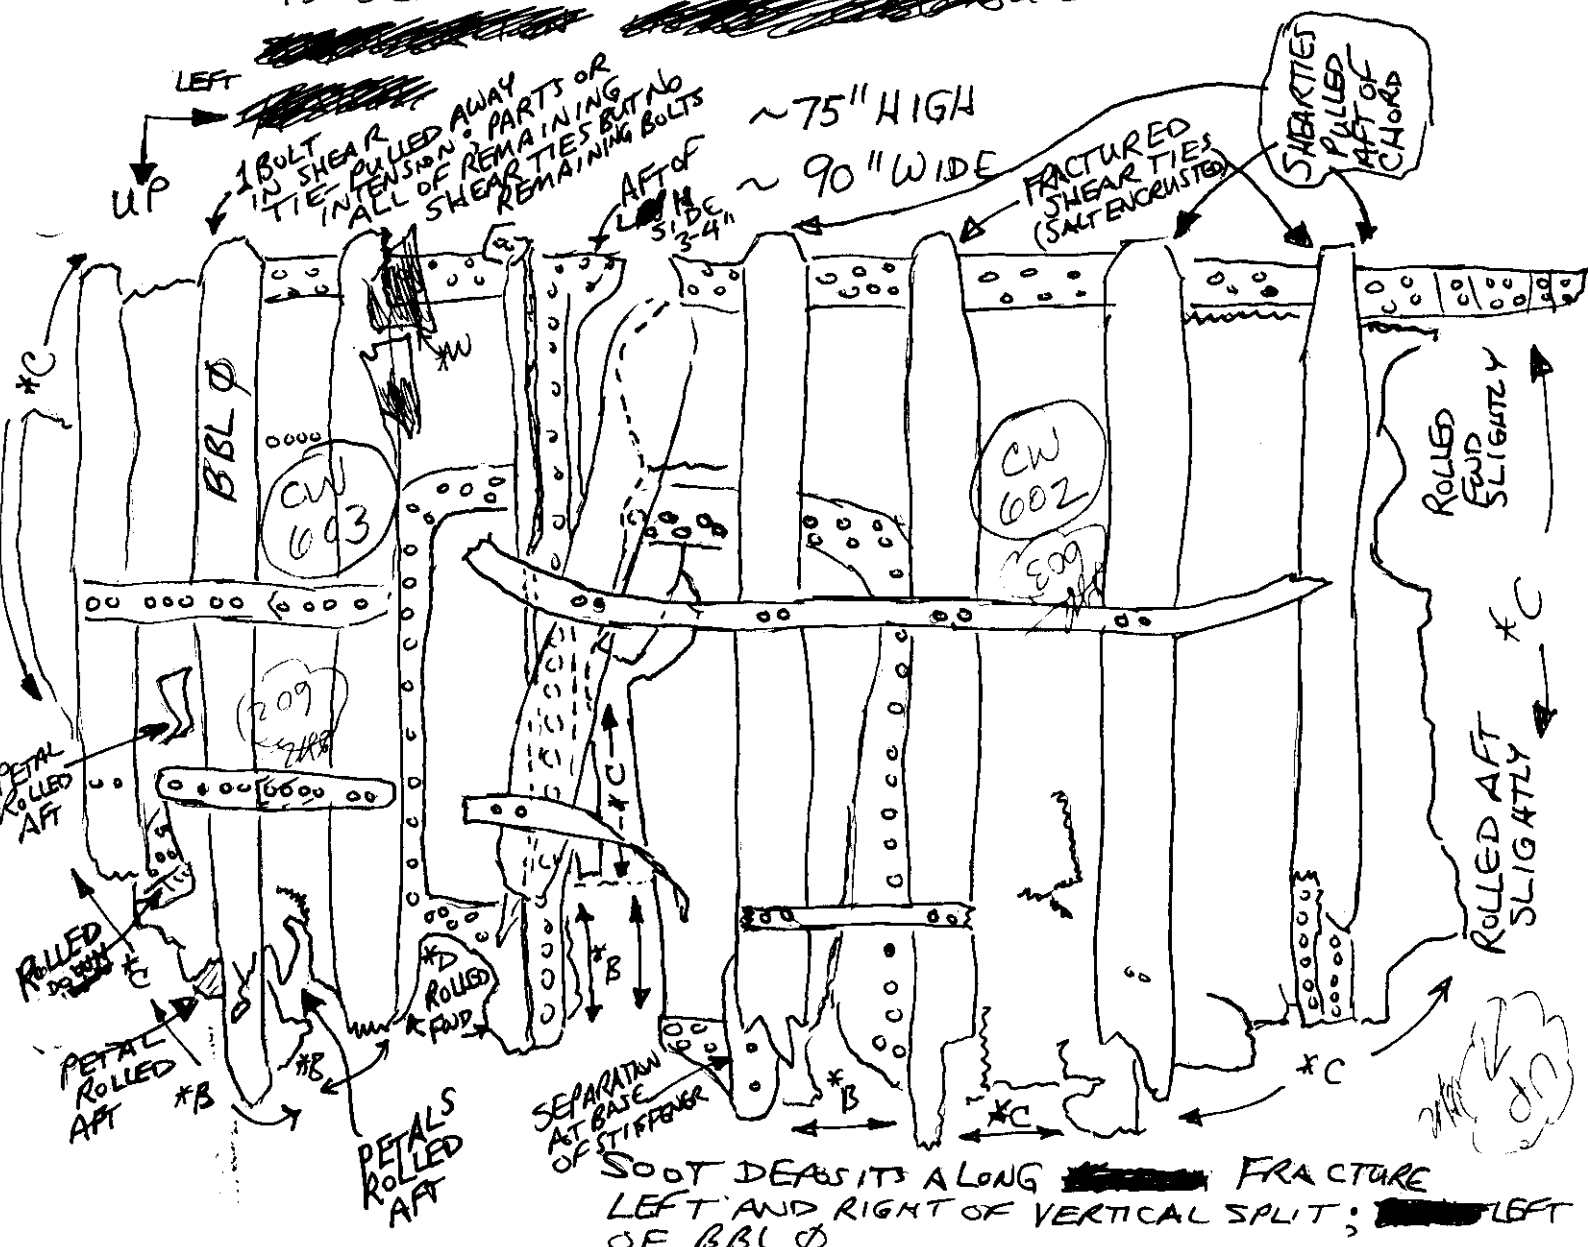
SPANWISE BEAM #3

FRACTURED THROUGH SEALED PRODUCTION  
ACCESS HATCH. FOUR STIFFENERS WIDE  
EACH SIDE OF VERTICAL WEB FRACTURE.  
FIRST STIFFENER LEFT OF WEB FRACTURE  
IS SEPARATED FULL LENGTH IN STIFFENER WEB.

SOOT DEPOSITS ALONG ~~FR~~ FRACTURE  
LEFT AND RIGHT OF VERTICAL SPLIT; ~~FR~~ LEFT  
OF BBL Ø
