SPANWISE BEAM # 3

CW-604
A-475
RED

This section is from LBL 17.27 to LBL 75.90 and contains seven stiffeners.

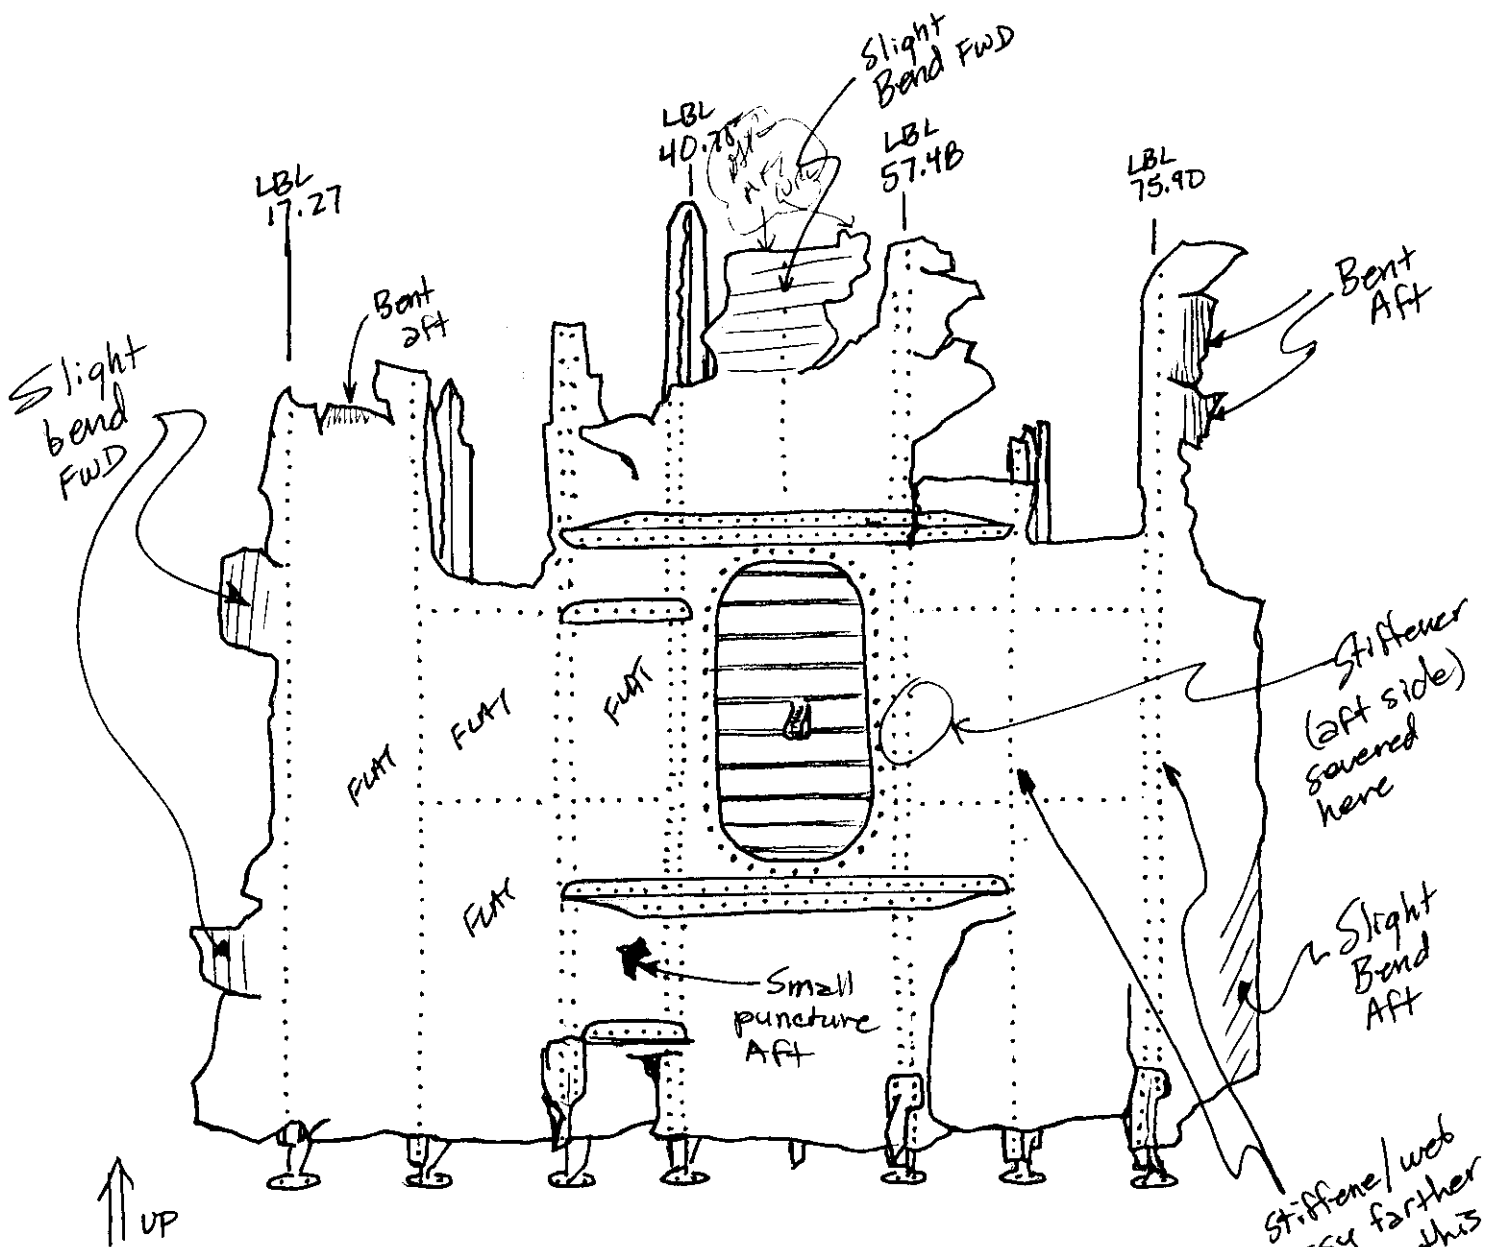
SPANWISE BEAM No. 3 SEGMENT

Both sides of segment are clean
(very very high soot or dirt on FWD face).
No obvious sign of fire damage.

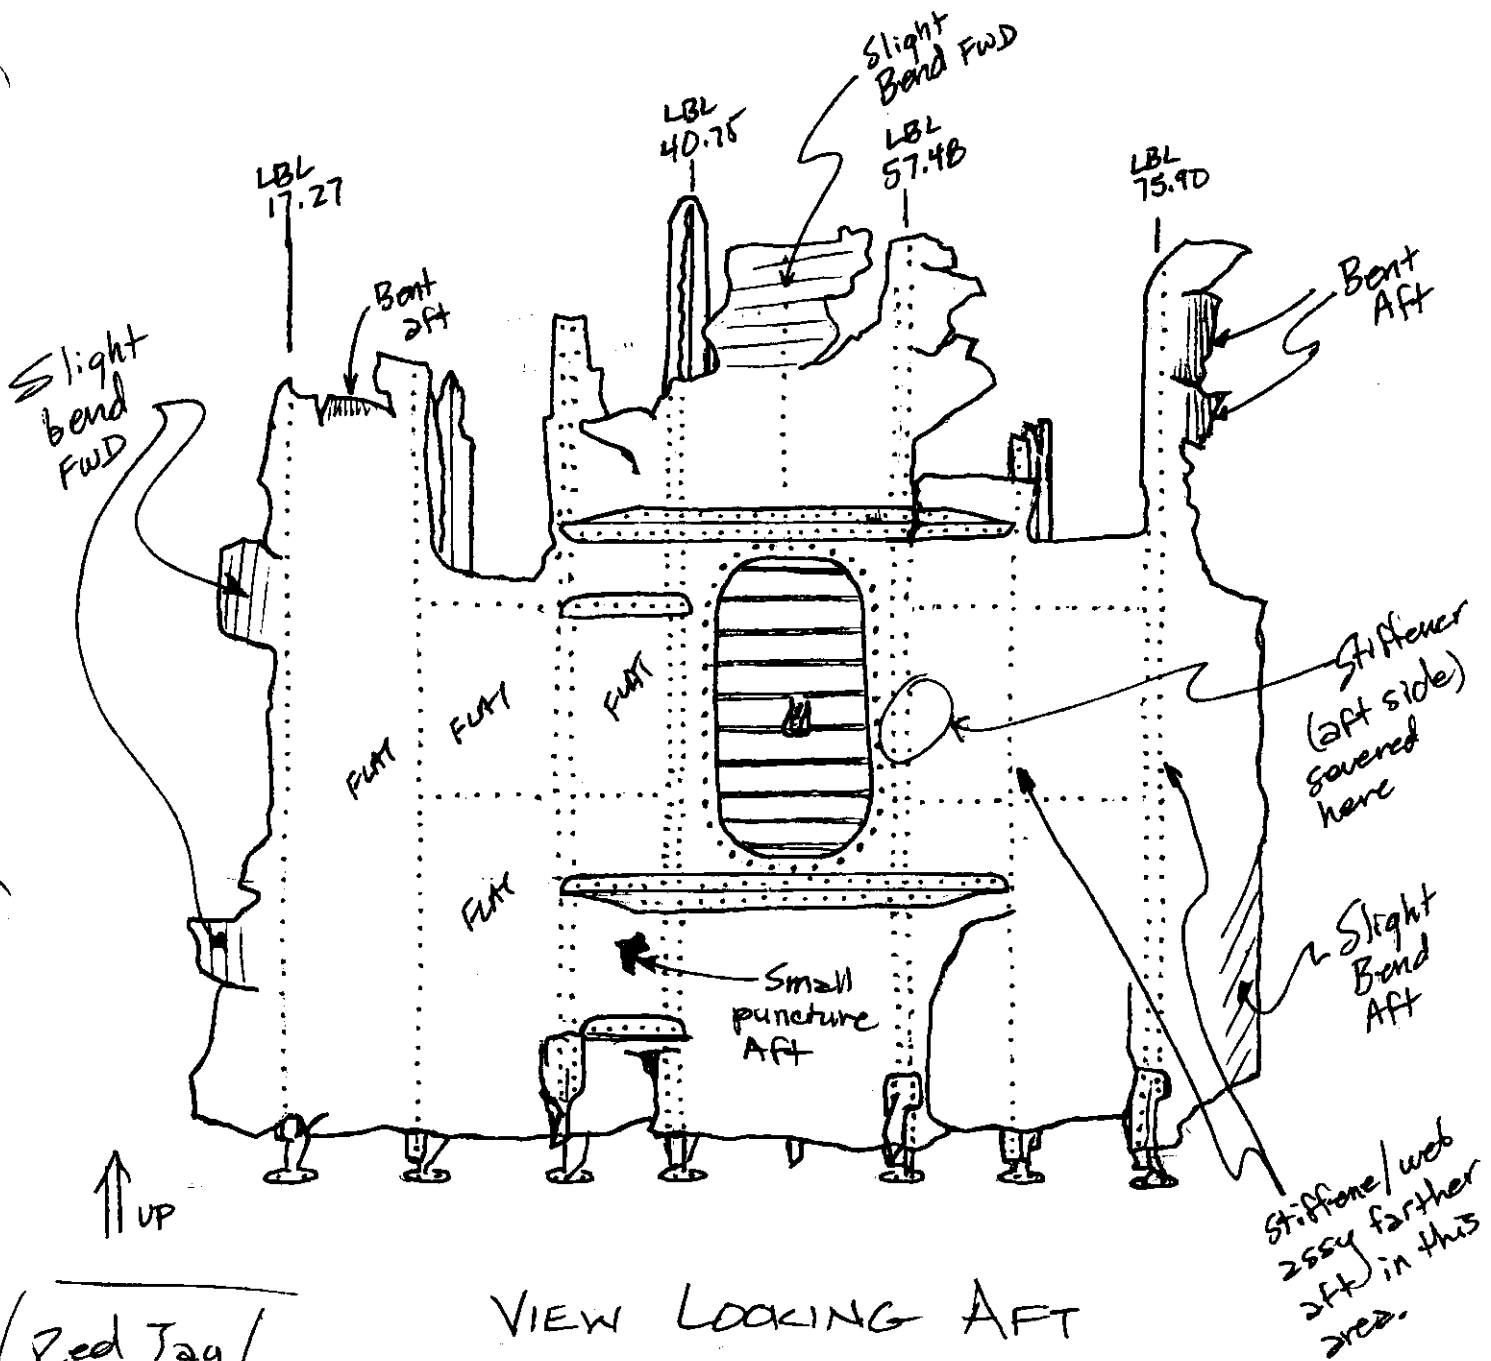
SPANWISE BEAM No. 3 SEGMENT

Both sides of segment are clean
(very very high coat or dirt on FWD face).
No obvious sign of fire damage.
