SPANWISE BEAM # 3

CW-606  
Z-3045  
GREEN

GREEN DEBRIS FIELD

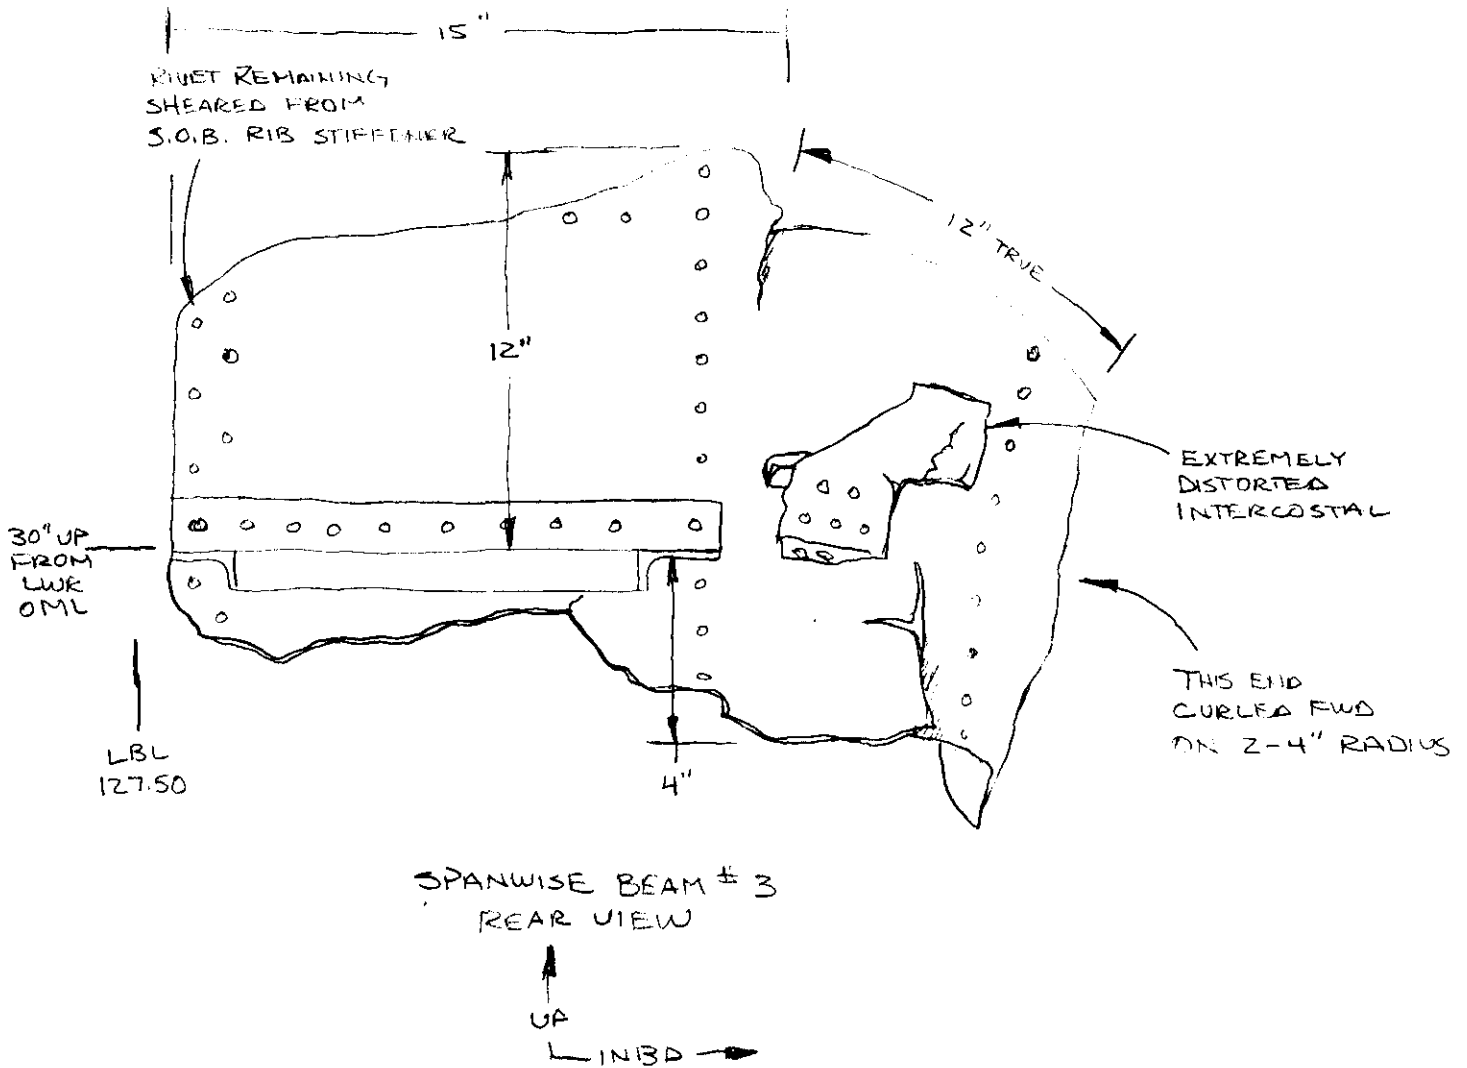
CW-606

This panel extend from LBL 100 to 127.5, and WL 140 to 156. The inboard 10" is bent forward 90 degrees. An intercostal is damaged and a horizontal end panel stiffener is intact.

PART HAS VERY LIGHT SOOT ON FWD AND AFT SIDE. ONLY ONE HORIZONTAL STIFFENER AND MOST OF ONE INTERCOSTAL REMAIN ATTACHED. REMAINDER OF RIVETS COMMON TO S.O.B. RIB STIFFENER AND SPANWISE BEAM ARE SHEARED WITH THE REMAINDER OF THE RIVET IN THE HOLE.

WHEN PART IS MOUNTED IN RECONSTRUCTION, THE INBD END THAT IS CURLED FWD ALIGNS FAIRLY WELL WITH LARGE DISTORTED HOLE IN LEFT LOWER FRONT SPAR
