CW-610 and CW-611

Two Pieces of Spanwise Beam # 3, Left Side. These panels are separated by a single vertical fracture, and are shown in the attached figure. Both panels are generally flat, with soot covering the aft side only. The un-primed aluminum surface has a dark tone. The forward surfaces of both panels are relatively clean, and undamaged.

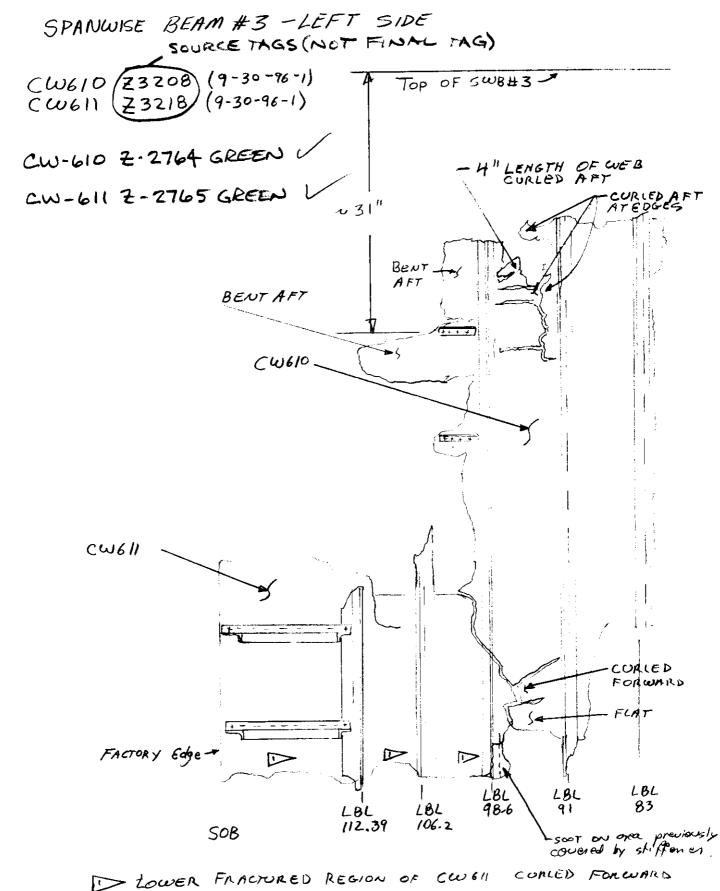
The stringer attachment flanges are intact, with fasteners in place. Upstanding webs are fractured, generally in the middle to upper portion of the web. The vertical stiffener at LBL 98.6 is fractured at the attachment flange base over the upper 50% length of the panel, and is fractured through the upper portion of the upstanding web over the remaining panel length. Two intact stringer intercostal clips are attrached to the web, with small pieces of web torn from the intercostal. The upper portion of the Web between LBL 98.6 and LBL 91 has a very jagged fracture, with some minor curling of the edges, primarily aft (~1/4 in to $-\frac{1}{2}$ in). One web portion of this region is bent aft 4". Remianing fracture surfaces around the panel show no evidence of corrosion or prior fatigue damage.

This panel is approximately 21 high, by 31 inches wide. It contains portions of stringers at LBL 98.6, LBL 106.2, LBL 112.39, with the vertical stiffeners fractured at their bases. A six inch length of the stiffener base at LBL 98.6 is missing, with soot covering the surface once occupied by the stiffener base. The lower edge of the panel is curve forward slightly.
