SPANWISE BEAM # 3

CW-612  
Z-2763  
GREEN

This panel at RBL 83.24 is 12" wide by 31" high.

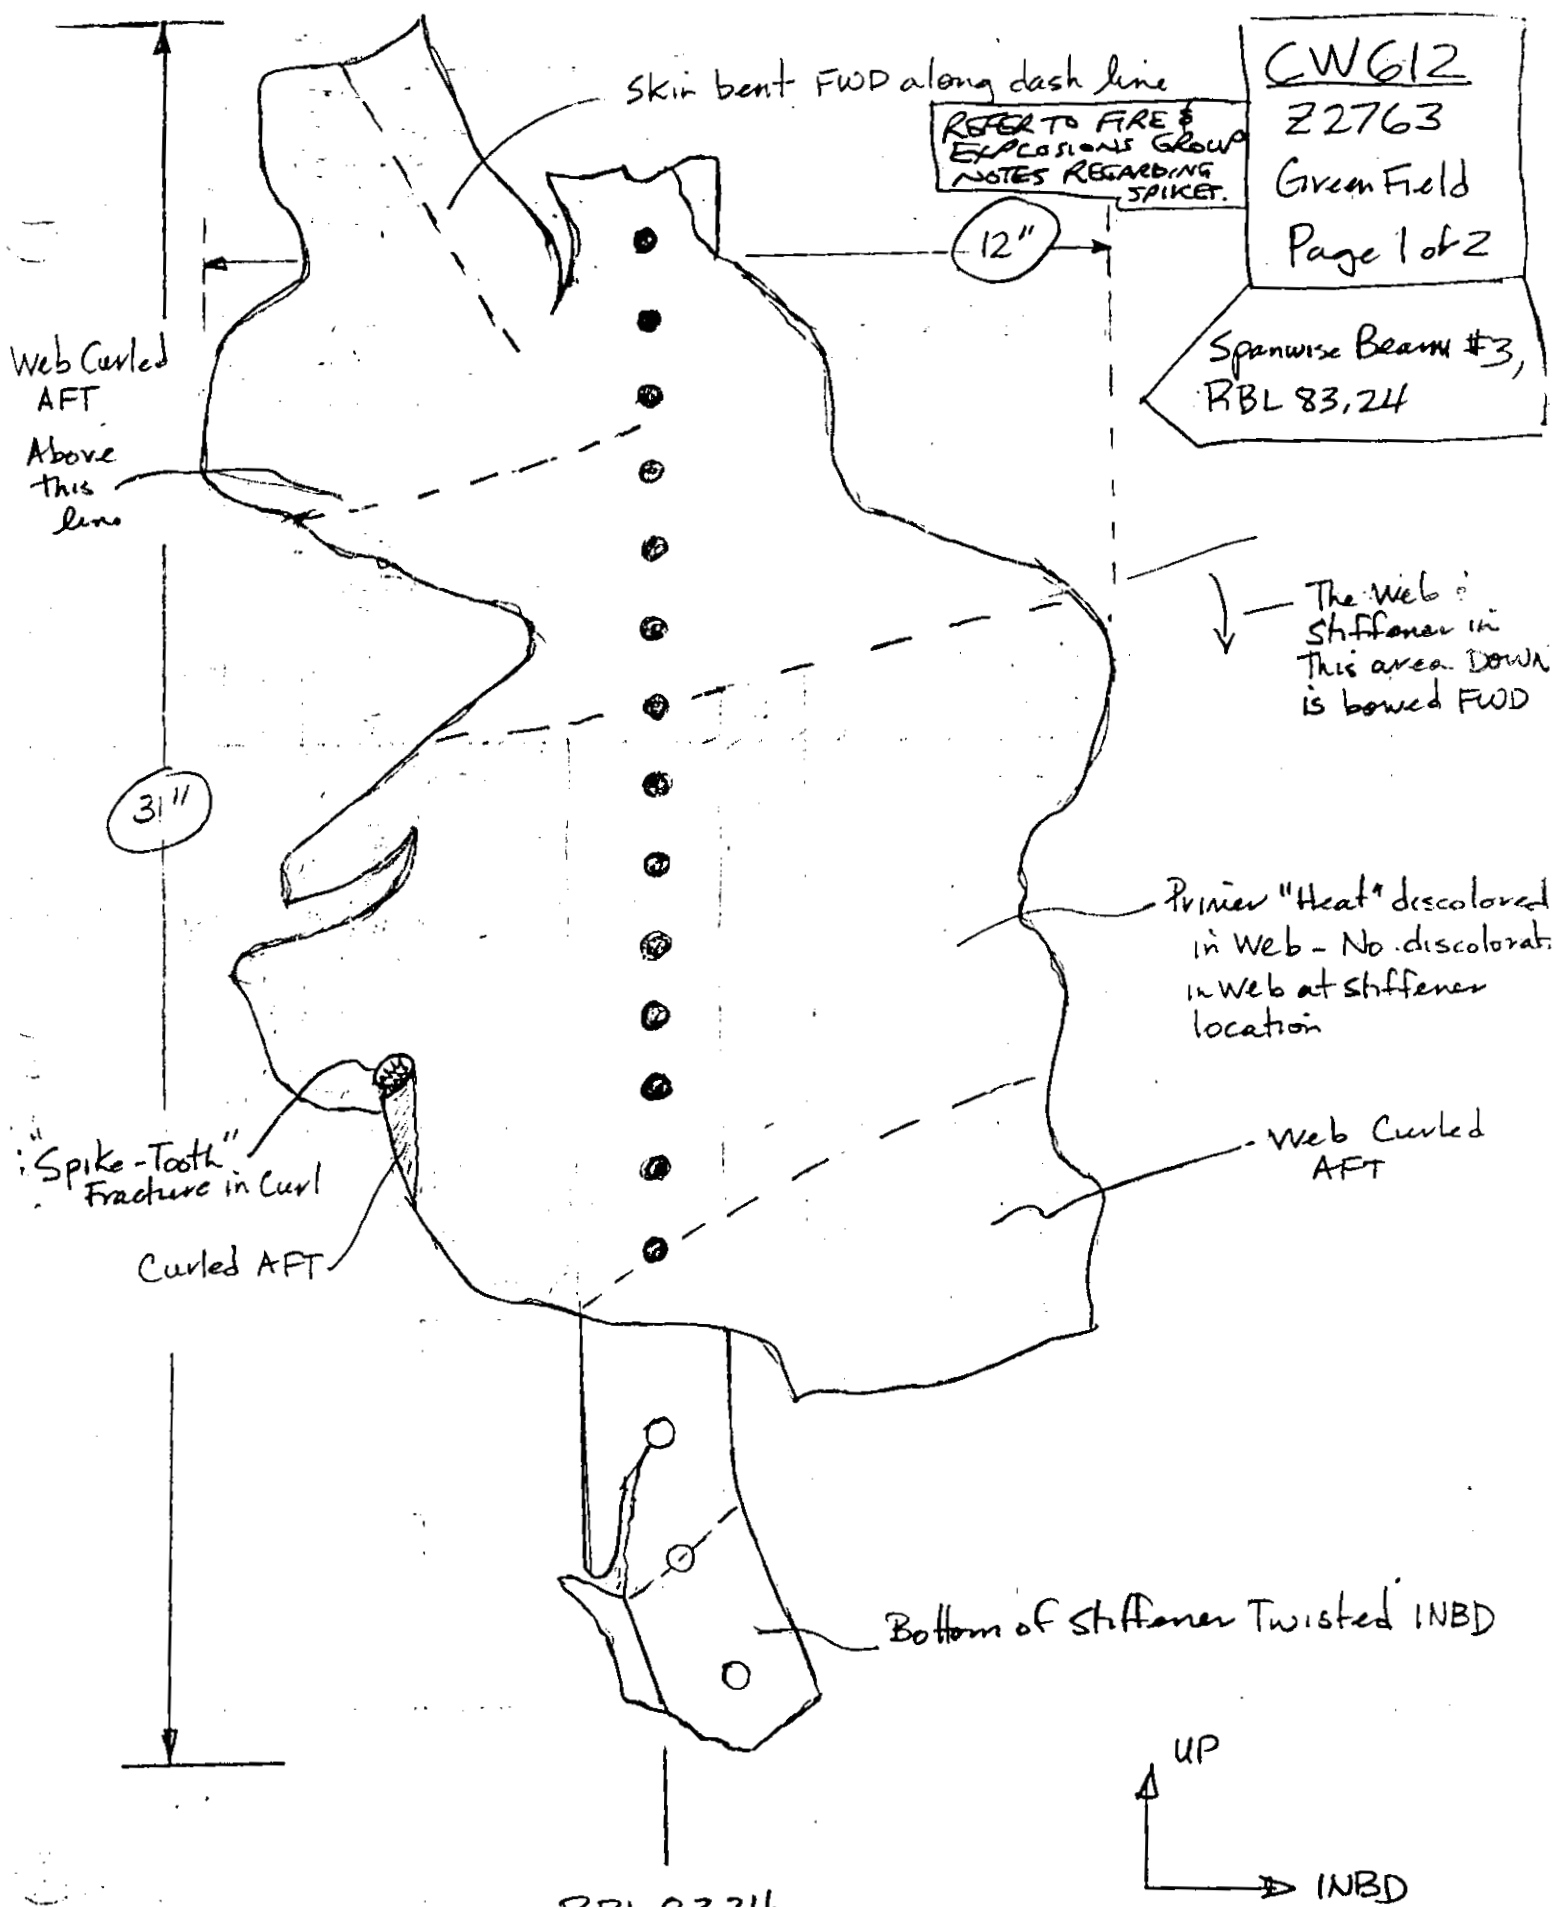
Spanwise Beam #3,  
 RBL 83,24

Skin bent FWD along dash line

Web Curled  
 AFT  
 Above  
 this  
 line

The web of  
 stiffener in  
 this area DOWN  
 is bowed FWD

Primer "Heat" discolored  
 in web - No discoloration  
 in web at stiffener  
 location

"Spike-Tooth"  
 Fracture in Curl  
 Curled AFT

Web Curled  
 AFT

Bottom of Stiffener Twisted INBD
