WING CENTER SECTION - SPANWISE BEAM # 2

CW-702
C-224
GREEN

Sparwise Beam
No. 2

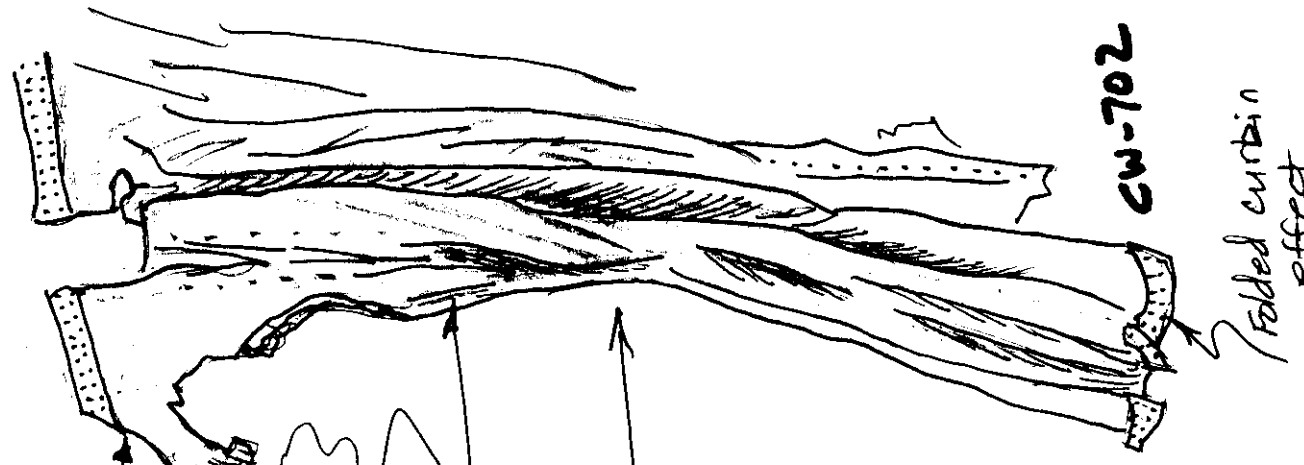
CW-702

Folded curtain effect

Scoted

≈ 60"

CW-701

RTS
S.O.B. Rib
NOT CONNECTED

NOT CONNECTED
RTS CW-701

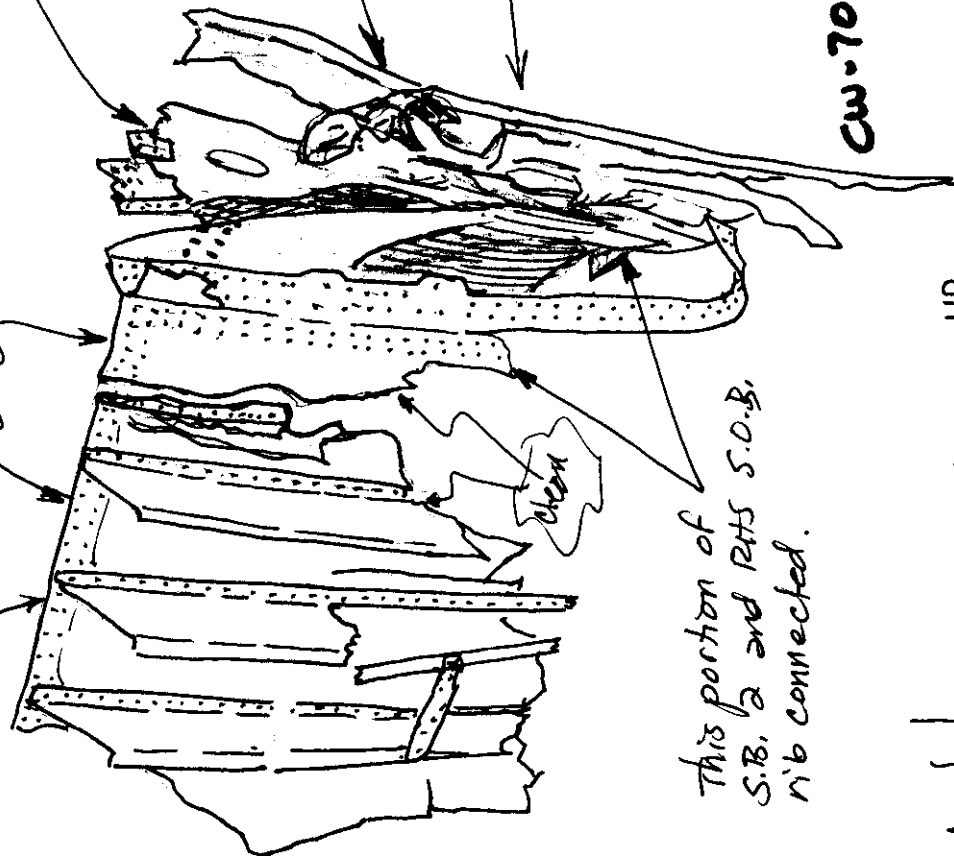
This portion of
S.B. 2 and RTS S.O.B.
rib connected.

clean

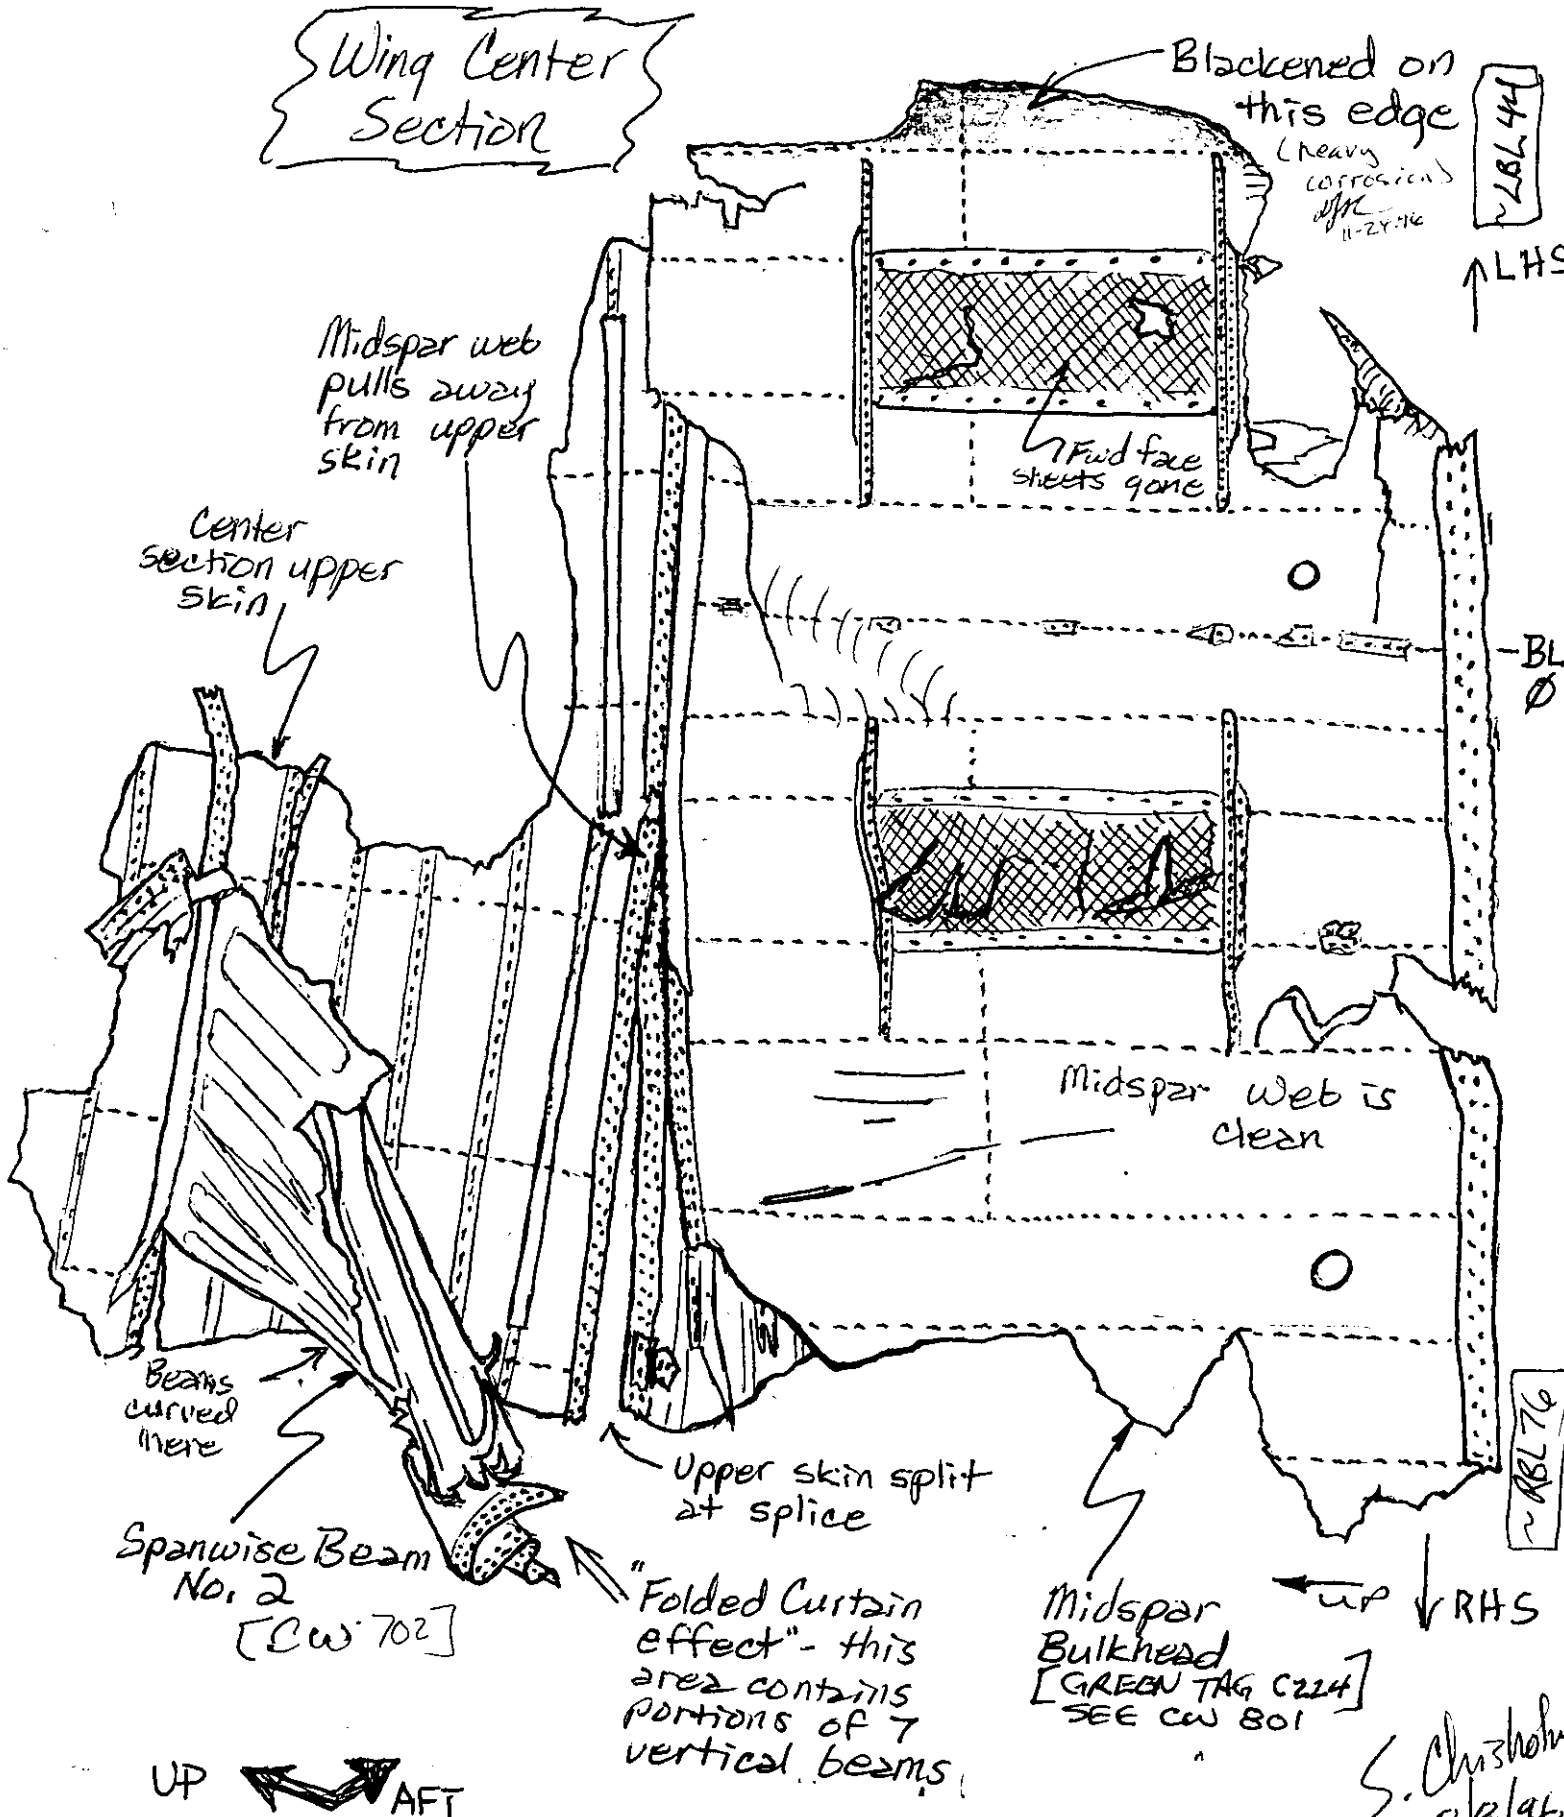
Wing Center Section

VIEW LOOKING AFT
(section resting on RHS edge)
