WING CENTER SECTION - SPANWISE BEAM # 2

CW - 704B-003-4-22866 Green YELLOW 6:22867 Green

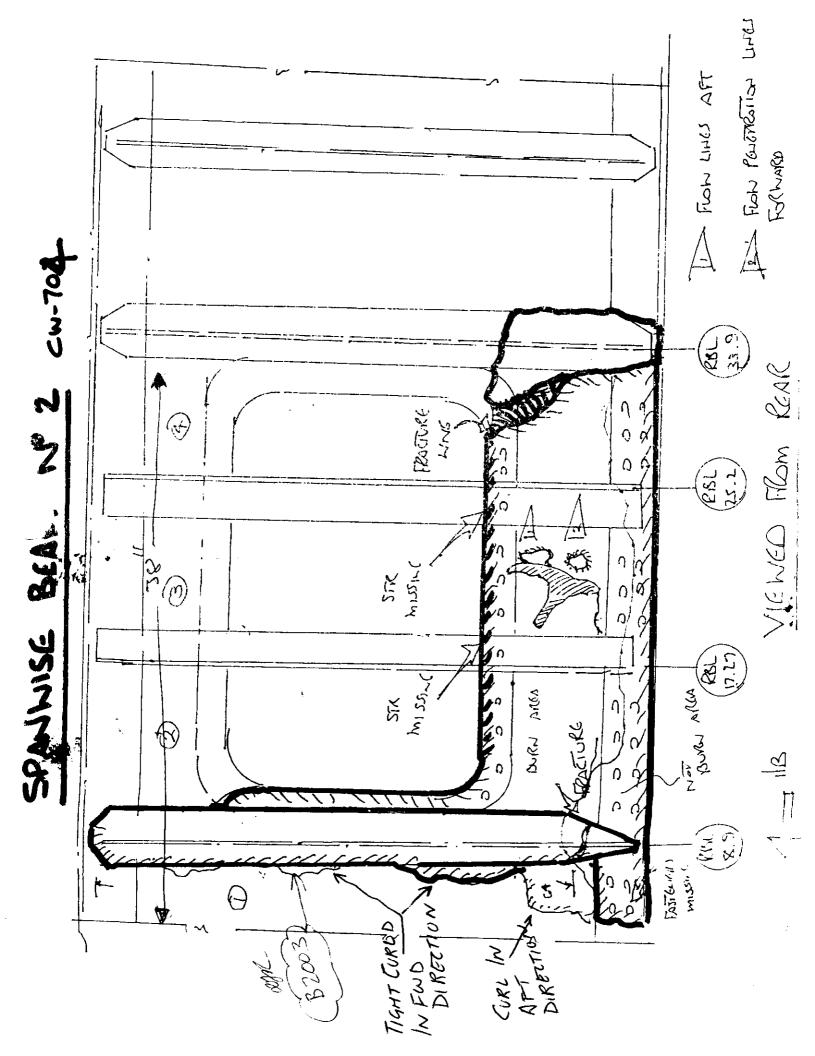
(Boo3)

This section is the lower chord and web from RBL 8 to RBL 34 and includes the vertical stiffener and web at RBL 8.9.

This section was sent to NTSB lab and a metallurgical examination was performed. It returned to the hangar in two pieces and the upper portion was given a number B-2003 (YELLOW).

The lower chord has separated from the skin panel and the remaining chord to skin fasteners have failed in tension. One remaining fastener in the lower chord just outbd of the RBL 9 lower tension fitting exhibits aft bending. The RBL 9 tension fitting common to the keel beam remains attached to the lower chord. The hole thru the lower chord and fitting for the tension bolt shows elongation on the lower surface of the chord on the aft side of the hole. The nut remains buried in the tank sealant on the top surface of the hole. There are numerous small penetrations in the web and the web is bent in multiple directions. The web inbd of the RBL 9 stiffener (B2003) has numerous horizontal fractures and is curled tightly fwd. The web just outbd of the stiffener and directly below the door is bent 180 degrees aft. The web inbd and outbd of RBL 25 (B003) has multiple penetrations with very jagged features around the edge of the hole.

This part has spike-tooth fractures that are documented in the metallurgical report.
