WING CENTER SECTION - SPANWISE BEAM # 2

CW-705
C-2170
GREEN

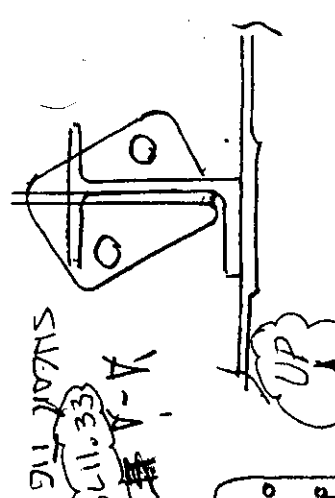
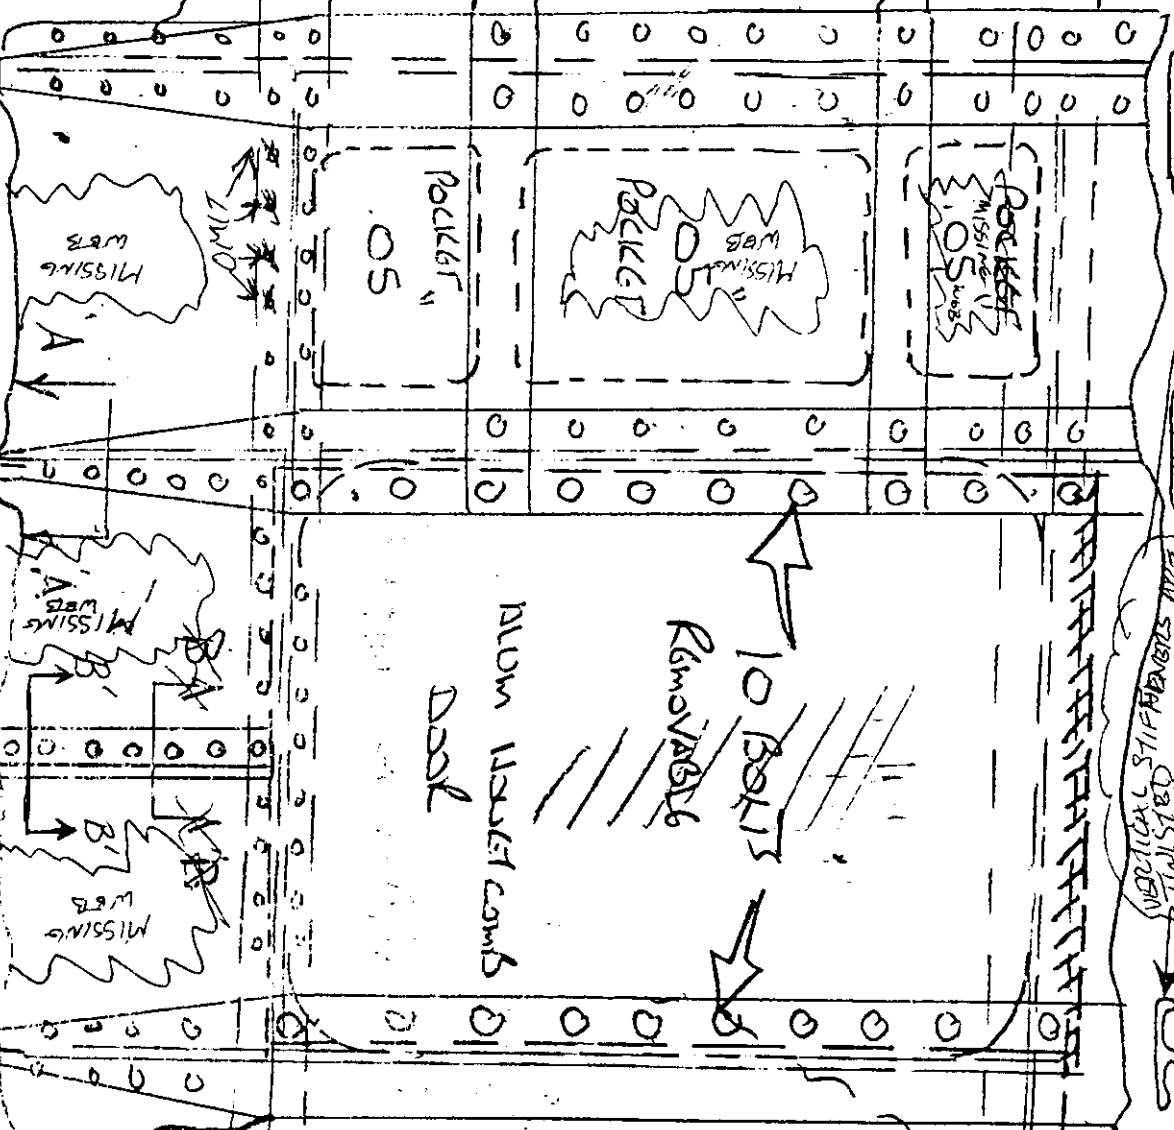
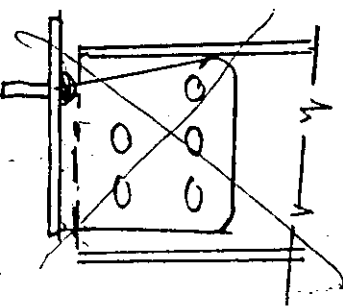
CW-705

This section is from LBL 11.00 to LBL 33.00 and from near the upper chord to just below the honeycomb access door. Three stiffeners remain attached to the web and honeycomb access door.

This section is bowed forward at the honeycomb access door area and the stiffeners, web, and the door exhibit forward bending. In between the stiffeners that are above the access door, there is a 4" x 14" section of web that is missing in each stiffener bay. The edges of the remaining web around these holes have a very large quantity of horizontal fractures radiating from the web edge. These web edges are also predominately bent aft with local regions that are bent fwd. The honeycomb door remains attached to the vertical stiffeners on either side of the door but the middle 8" of the door from the top to bottom is missing and the remaining honeycomb is shredded fwd ^{more than} ~~and~~ att. _{all}

There is heavy fire damage and soot accumulations. See the fire and explosion group notes for complete documentation.
