MID SPAR - WING CENTER TANK

CW-801
C-224
GREEN

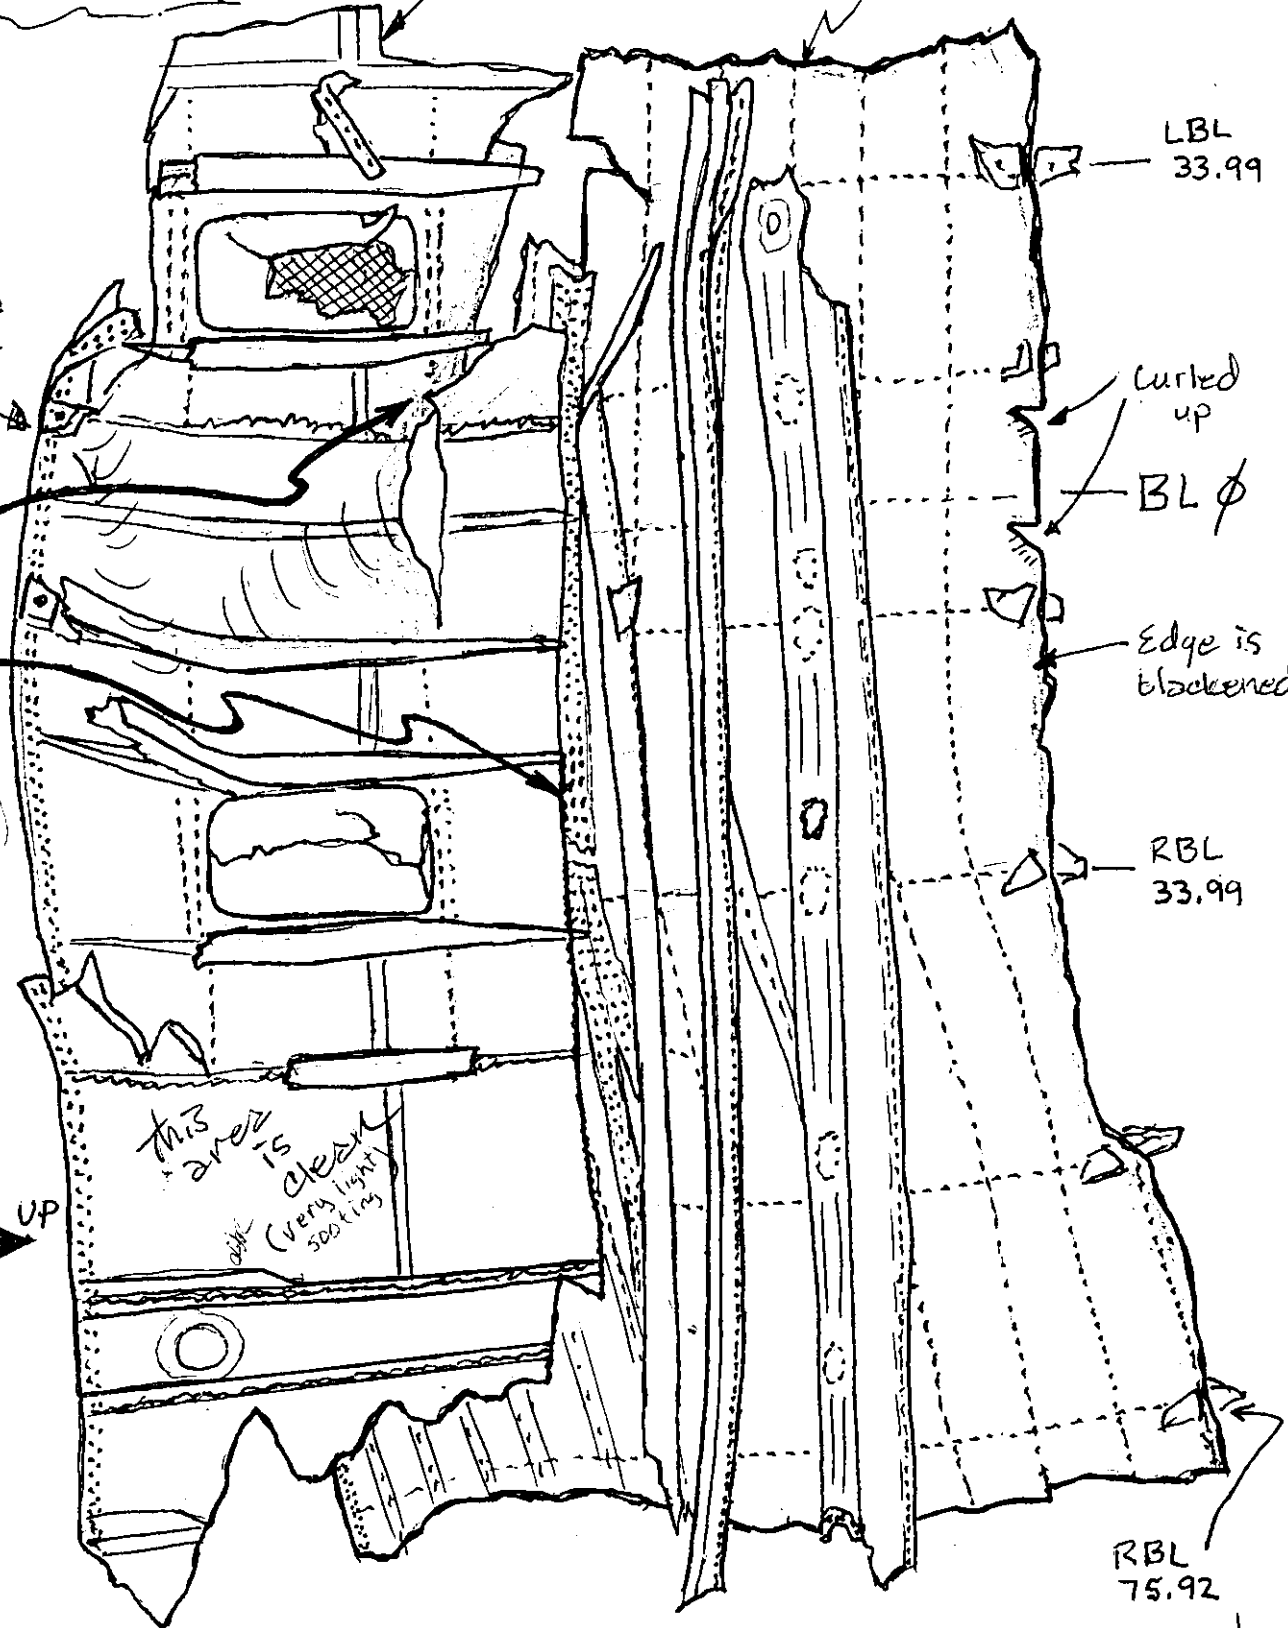
CW-801 GREEN TAG #C-224

This area bent aft

Blackened Area

Curled up

Edge is blackened

Midspar web pulls away from upper skin (running right)

this area is clean (very light soot)
