SPANWISE BEAM #1 - WING CENTER TANK

CW-901 C - 970GREEN

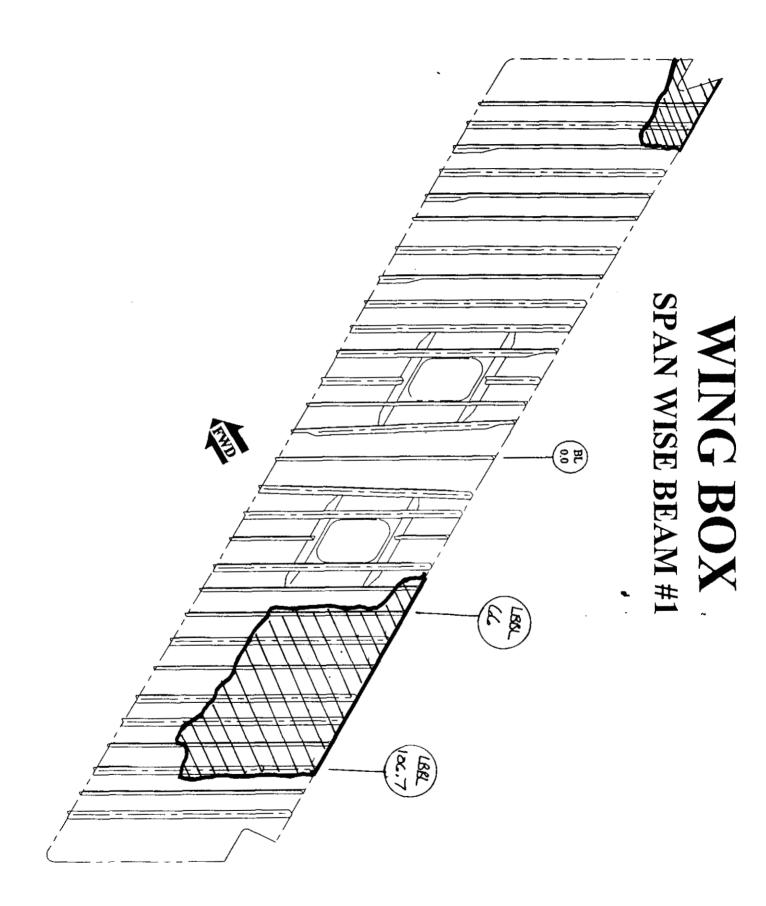
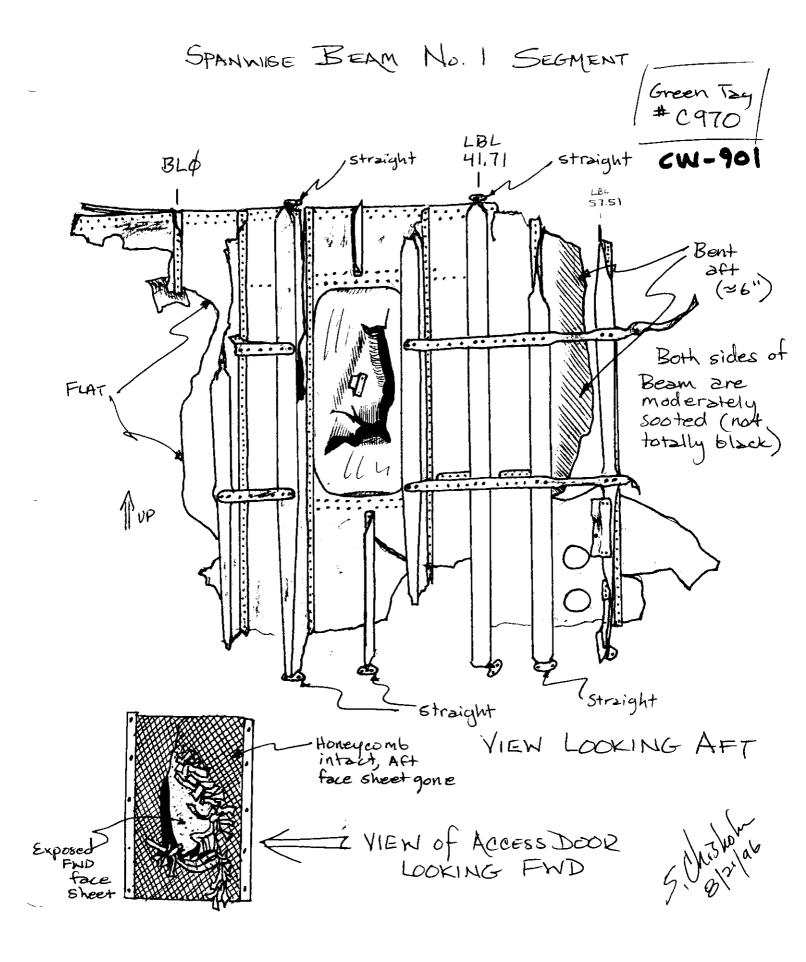
This section extends from the stiffener at LBL 57.51 to approx BL 0 and includes the upper chord, the web, one access door, stiffeners at LBL 11 through LBL 57.51, and stabilization straps. It does not includes the lower chord or the lower portion of the web.

The upper 34" of the stiffener at LBL 57.51 is not attached to the web and shows a shear failure of the rivets that would be common to the web on CW-902. All of the rest of the stiffeners have remained attached to the web. The upper shear ties and the upper portion of the stiffener are broken off at LBL 11.00, 34.00 49.60, and 57.51. The upper shear tie remained attached at LBL 41.77 and 17.27. The lower shear ties were intact at LBL 17.27, 25.26, 41.77, 49.6 and 57.51. The shear tie and lower portion of stiffener is missing at LBL 11.00 and LBL 34.00. The majority of the stiffener's free flange (which is on fwd side in this beam) remains attached except at LBL 11.00 and LBL 49.60. The stiffeners do not exhibit any bending in the fore/aft direction. The web exhibits tearing and jagged fractures and is bent aft between LBL 49.6 and LBL 57.5.

The access door remains attached to the adjacent vertical stiffeners and web. The honeycomb face sheet is missing on the aft side and the forward face sheet is torn both vertically and horizontally. The tear is 16" long and 9" wide. The ribbon from the honeycomb core is shredded in the aft direction leaving a 4" x 13" hole in the core.
