SPANWISE BEAM #1 - WING CENTER TANK

CW-906
Z-3272
GREEN

SPAN WISE BEAM #1

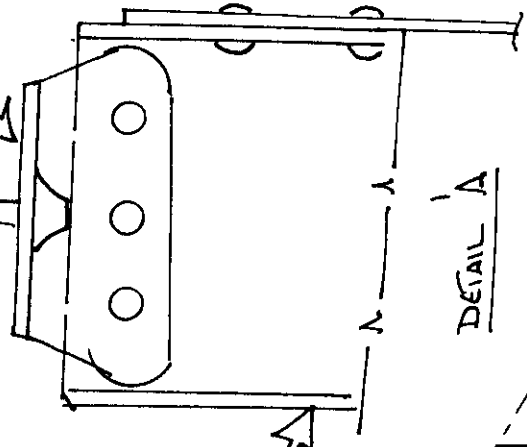
DETAIL A

The stiffener at BL0 extends from 15" above from the lower chord to 42" above the lower chord. The fasteners common to the BL0 rib are missing and the flange remains in tact. The stiffener at RBL 9 is intact except the shear ties at the upper and lower chord are broken off. The upper 14" of the stiffener at RBL 17 has a fracture at the web of the stiffener but the upper shear tie remained attached. Fasteners through the upper shear tie common to the upper skin remained attached and exhibit tensile failure. The lower shear tie at RBL 17 is broken off at the lower end of the stiffener. The RBL 17 stiffener and most of the web above the access door is missing. The stiffener below the door remains attached except the lower shear tie is missing. Only 40" of stiffener at RBL 34.00 remains and both the upper and lower shear ties are missing. The stiffener at RBL 42.00 extends from the lower chord to 52" above the lower chord and the lower shear tie remains attached with no fasteners. The stiffener at RBL 49.6 is missing both upper and lower shear ties and the stiffener free flange.

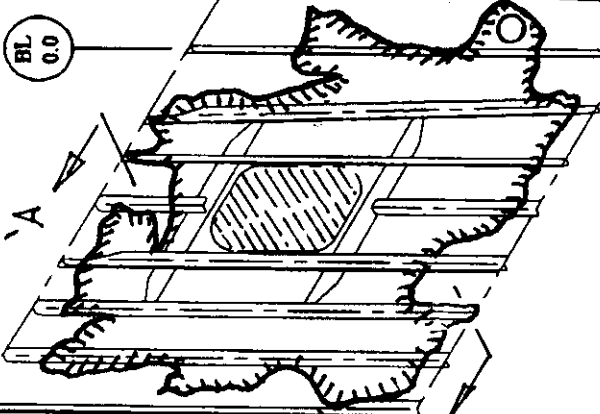
FRACTURE
OUTLINE

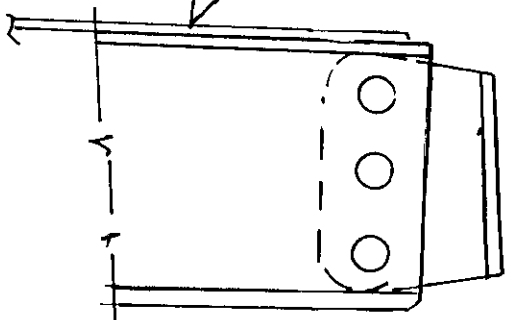
DETAIL B

The fwd side of the access door remains intact and the aft face sheet is missing with very little damage to the honeycomb core.

NOTE
AFT FACE SHEET OF DOOR
MISSING. OTHERWISE CORE IN PLACE
