SPANWISE BEAM #1 - WING CENTER TANK

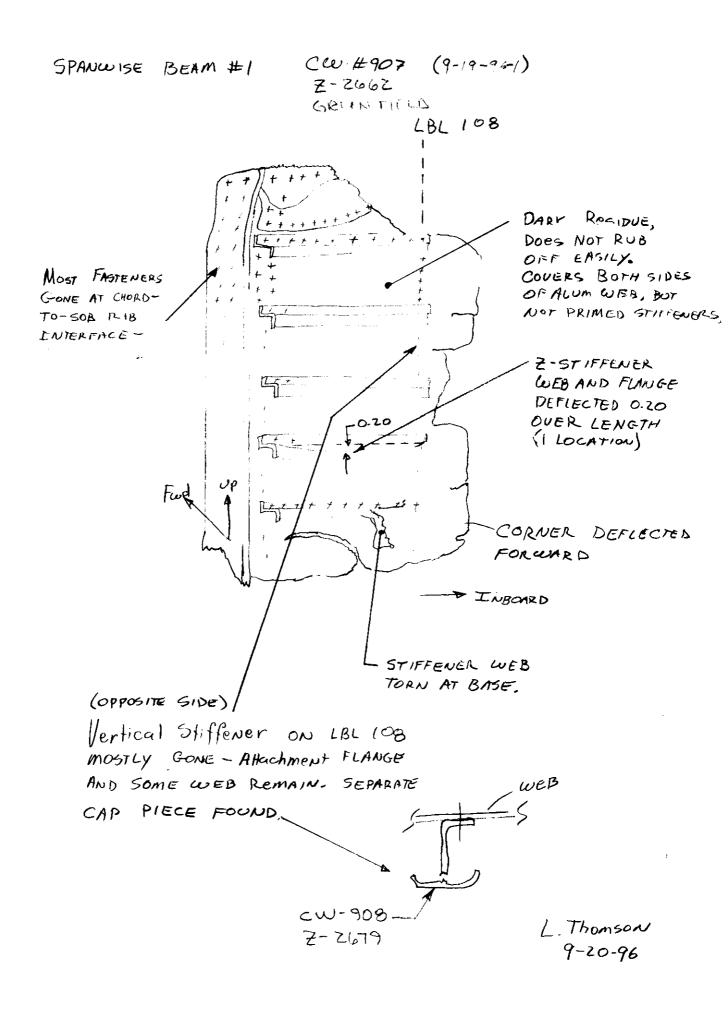
This section is from the left SOB rib to LBL 107 and is 40" tall. It starts 10" above the lower chord and extends to the mating fracture with CW-904. The stiffener common to SOB rib remains intact.

Three fasteners common to SOB rib web and the outboard stiffener on the forward side remain. These 3 fasteners exhibit no bending and failed in tension. The aft lower six fasteners common to the stiffener and LSOB rib are sheared forward and down and remain in outboard stiffener. Eight of the nine forward fastener holes are elongated forward and down. The lower eight inches of stiffener flange is bent aft approximatley ten degrees and twisted counterclockwise when viewed looking down. The upper fastener holes in the outboard stiffener are elongated upward. The remainder of the fastener holes do not exhibit obvious elongation. The stiffener at LBL 112 suffered severe impact damage and most of the stiffener web and free flange is separated. CW-908 is designated as this stiffener free flange with portion of stiffener stabilization strap. All the horizontal stiffeners (qty of 5) at the aft side except for the lowest stiffener are intact. The lowest stiffener has part of the inbd end bent down. The lower section of the web is bent fwd slightly.

Some sooting is exhibited on the forward and aft sides. See fire and explosion group notes for documentation.
