SPANWISE BEAM #1 - WING CENTER TANK

CW-909
Z-2741
GREEN

CW-909 (9-22-96-1) (ZZ741)

SPAN-WISE BEAM #1

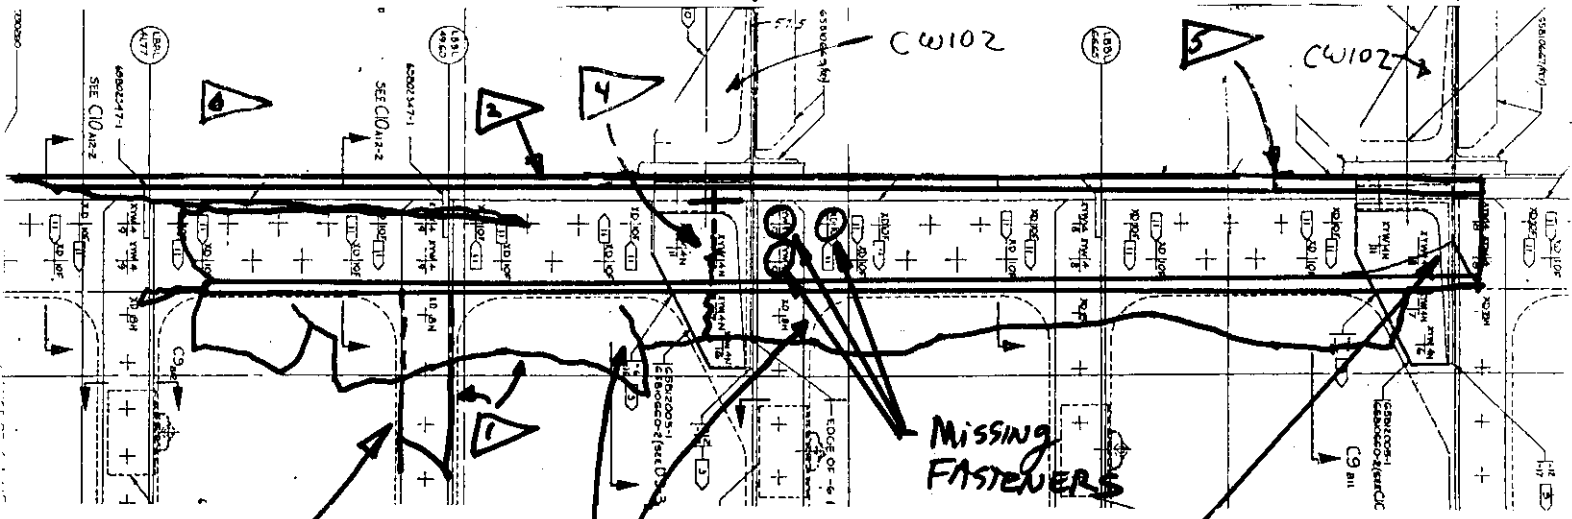
UPPER PORTION OF STIFFENER ATTACHED

END OF CHORD FLANGE BENT UP

- 1. WEB and stiffener DARK BROWN COLOR
- 2. GREEN PRIMER ON STIFFENER COVERED WITH SOOT.
- 3. PORTION OF WEB BENT FORWARD
- 4. WEB FRACTURED
- 5. LOCAL CAP FRACTURE
- 6. Fracture IN CHORD WEB

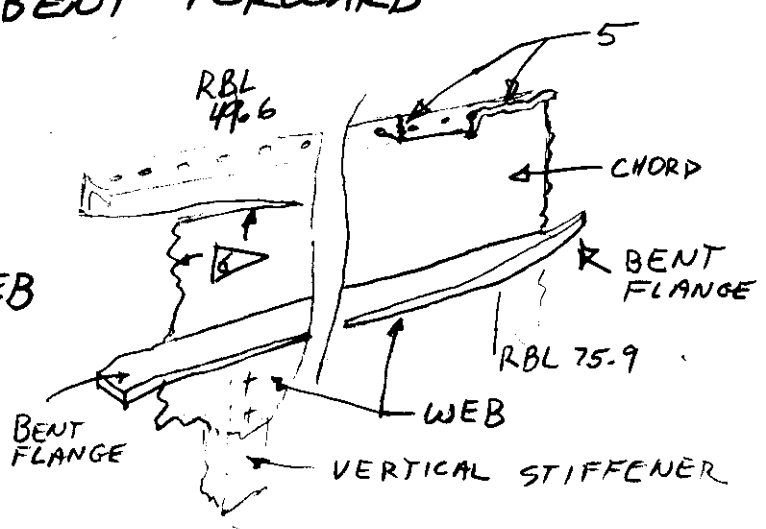
The web to chord fasteners remain intact and 15 out of 25 fasteners common to the upper skin remained in the chord. Five exhibit tension type failure, five exhibit shear failure, and five fasteners common to the skin still have the countersunk head intact. These fasteners with the csk intact are at locations that the skin panel failed thru the fastener line. The free flange of the chord at the outboard end is bent up. The lower web edge at RBL 60 has a portion of the web bent fwd and the portion remaining straight down exhibits spike tooth fractures. Only the bulkhead web flange of LBL 49.6 stiffener remains and is bent fwd. ~~Severe corrosion on forward and aft sides of bulkhead web.~~ *dkk*

There is sooting on the skin flange and web of the upper chord at the aft side. There is some sooting on the fwd side of the web. See fire and explosion group notes for documentation.
