SPANWISE BEAM #1 - WING CENTER TANK

CW-910
Z-2724
GREEN

CENTER SECTION
SPANWISE BEAM # 1
CW-910
Z-2724

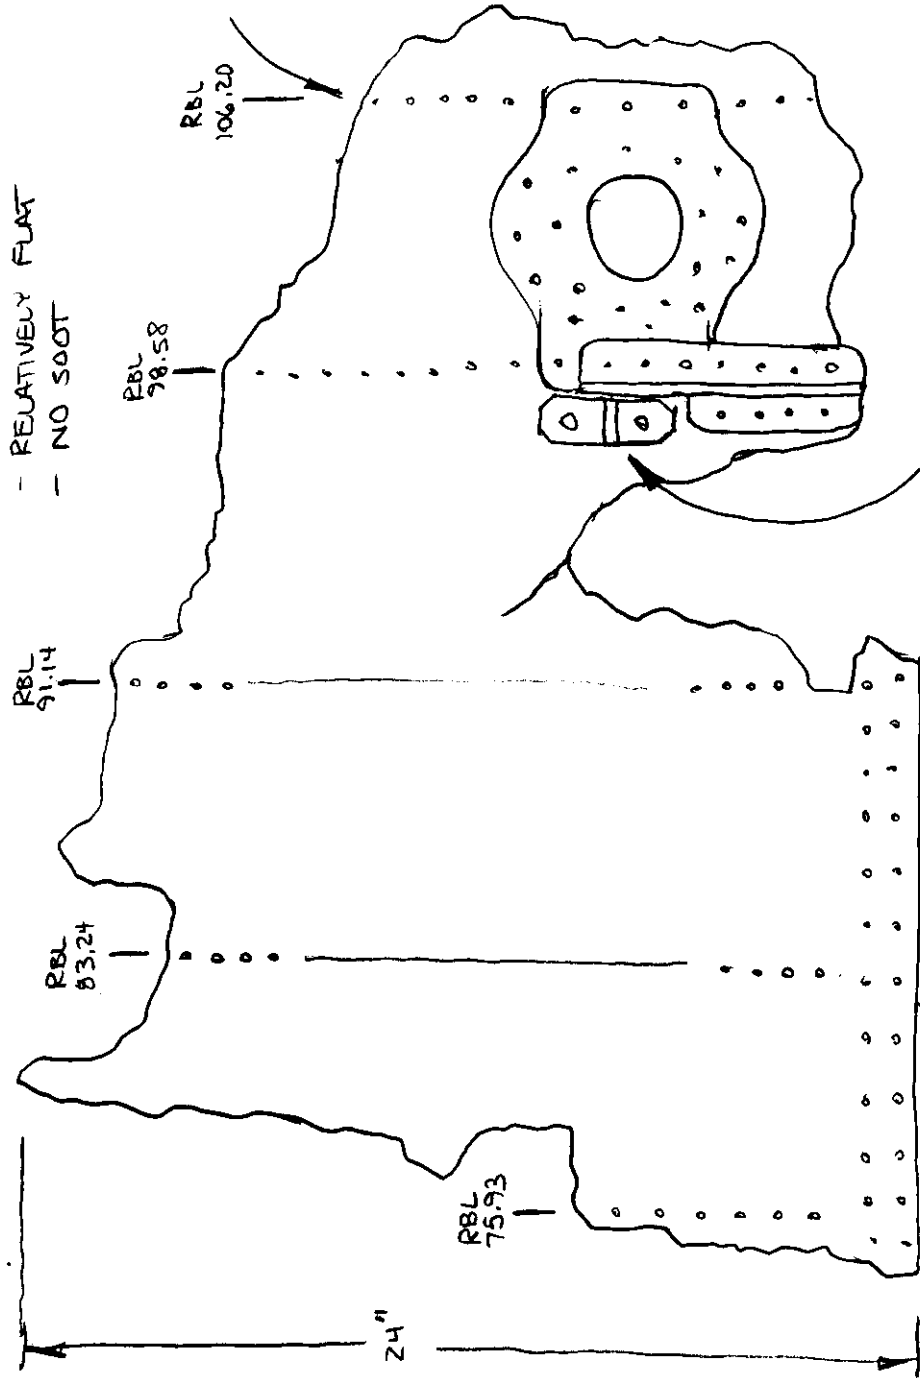
This is a section from RBL 76 to 107 and from the lower chord up 22". Only the bulkhead web flange of the stiffener at RBL 98.6 remains attached. The doubler on the aft side around the system's penetration remains attached.

All other fastener holes that would have been common to stiffeners or the lower chord are open. The web has a portion missing from RBL 91 to 97 extending 10" above the lower chord.

There is soot accumulation in local area on the doubler aft side. See fire and explosion group notes for documentation.

NO STIFFENERS ATTACHED
EXCEPT SKIN FLANGE
AT THIS LOCATION
ONLY ON FWD SIDE

FWD AND AFT FLANGES OF TENSION
FITTING COMMON TO LOWER
INTERCOSTAL ARE BROKEN OFF
