NATIONAL TRANSPORTATION SAFETY BOARD

WING CENTER SECTION SHEAR TIE FACTUAL SUMMARY

ACCIDENT : DCA96MA070
Location : East Moriches, New York
Date : July 17, 1996
Time : 2031 Eastern Daylight Time
Airplane : Boeing 747-131, N93119
Operated as Trans World Airlines (TWA) Flight
800

SHEAR TIE STUDY FACTUAL SUMMARY

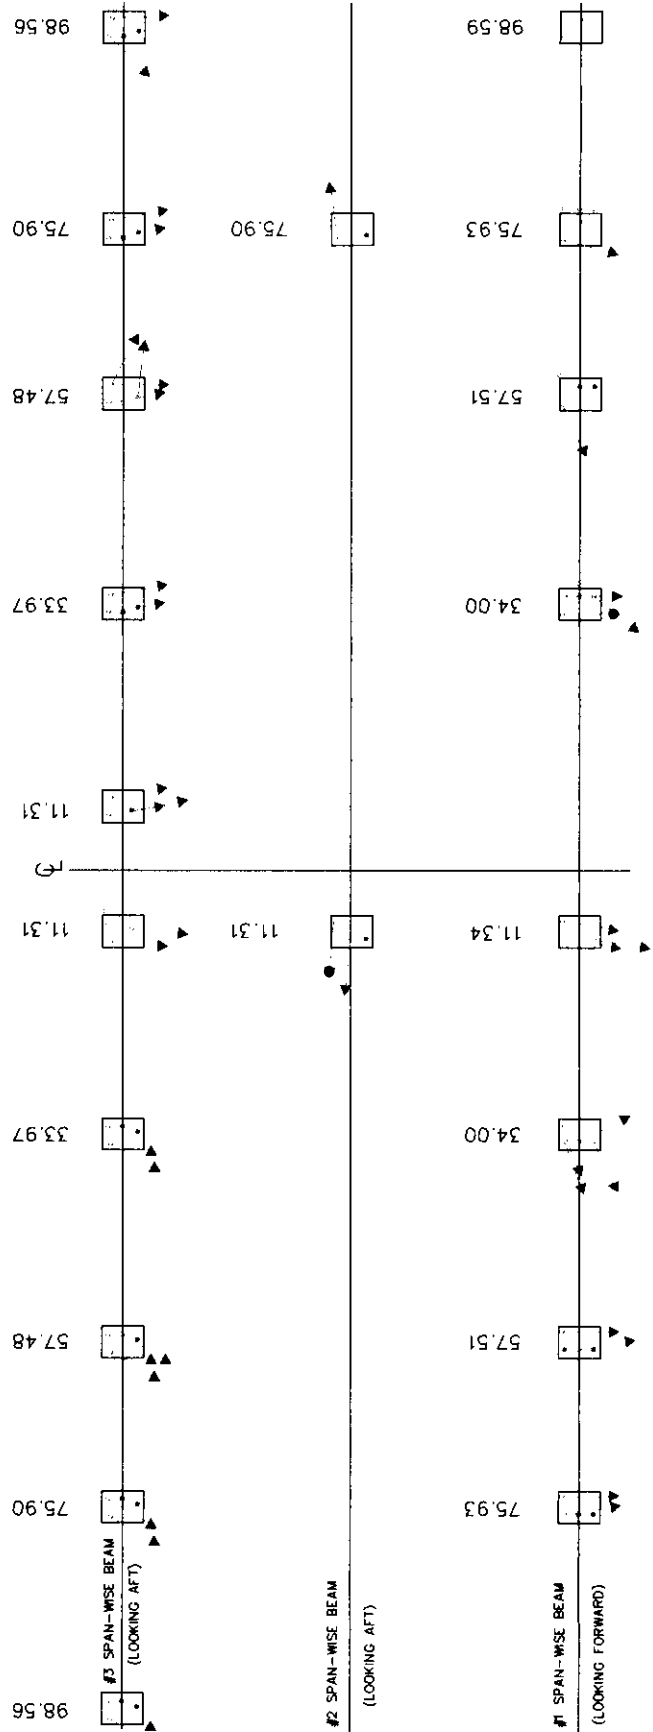
Center Fuel Tank Area
Shear Tie Separation Patterns
Tension Fitting Vertical Face

The vertical faces of the tension fittings associated with spanwise beams 3 and 1 were evaluated for deformation. The tension fittings are only installed on the upper skin at locations common to the floor beams. The bolt holes exhibited deformation which was consistent with vertical and/or lateral loads applied simultaneously with the longitudinal loads which resulted in the bolts withdrawing from the shear ties. The vertical face of the tension fittings on spanwise beam #3 face forward to mate with the web; thus the bolt withdraw occurred as the beam web moved forward. The vertical face of the tension fittings on spanwise beam #1 face aft to mate with the web; thus the bolt withdraw occurred as the beam moved aft.

Generally, the bolt holes on the vertical faces of those fittings recovered from spanwise beam #1 exhibit downward deformation with somewhat random lateral deformation. The holes on the vertical faces of the fittings recovered from spanwise beam #3 exhibit downward deformation with no lateral component at BL 0, and an outboard component to the downward deformation which becomes more pronounced with distance from BL 0 (except for RBL and LBL 98).

NOTE: ARROWS INDICATE DIRECTION OF HOLE OR BOLT DEFORMATION ON TENSION FITTING VERTICAL FACE.

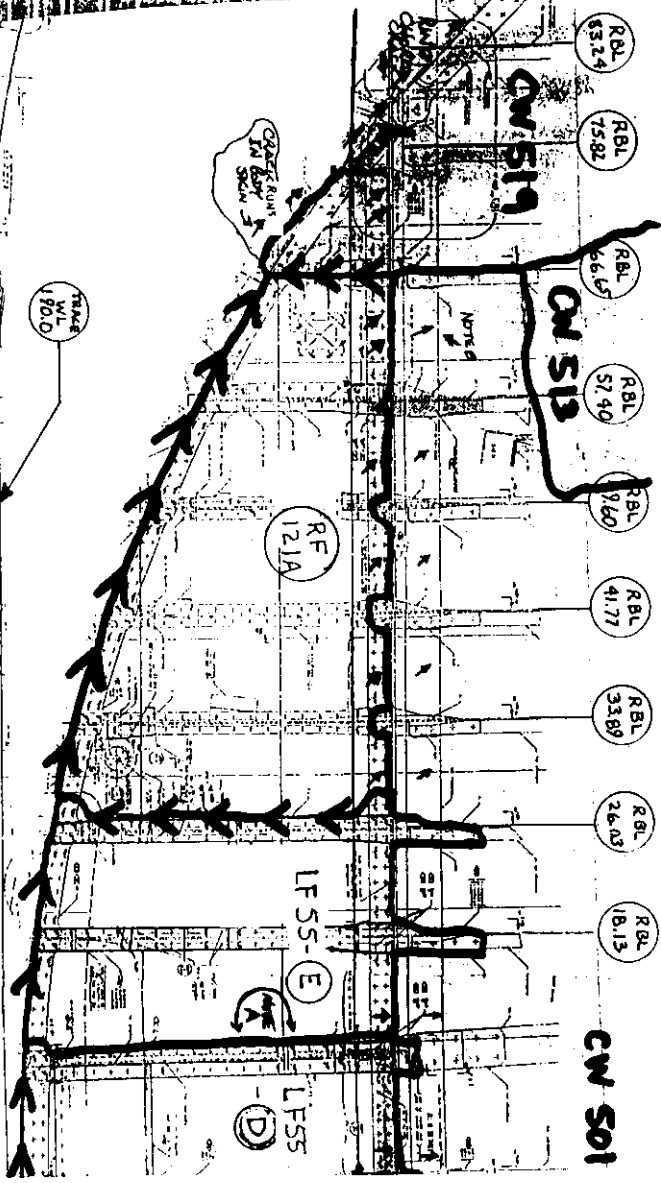
NOTE A: LFSS E MOVED FORWARD RELATIVE TO LFSS D, RESULTING IN A VERTICAL
 SHEAR SEPARATION IN THE WEB.

NOTE B: FRONT SPAR WHERE WING BULKHEAD WEB IS LAPPED OVER FRONT SPAR
 WEB. ARROWS INDICATE DIRECTION OF MOTION OF FRONT SPAR
 WEB AS RIVETS ARE SHEARED

NOTE C: RING CHORD IS BENT AT ENDS OF LFSS A
 DOWN AND OUTWARD

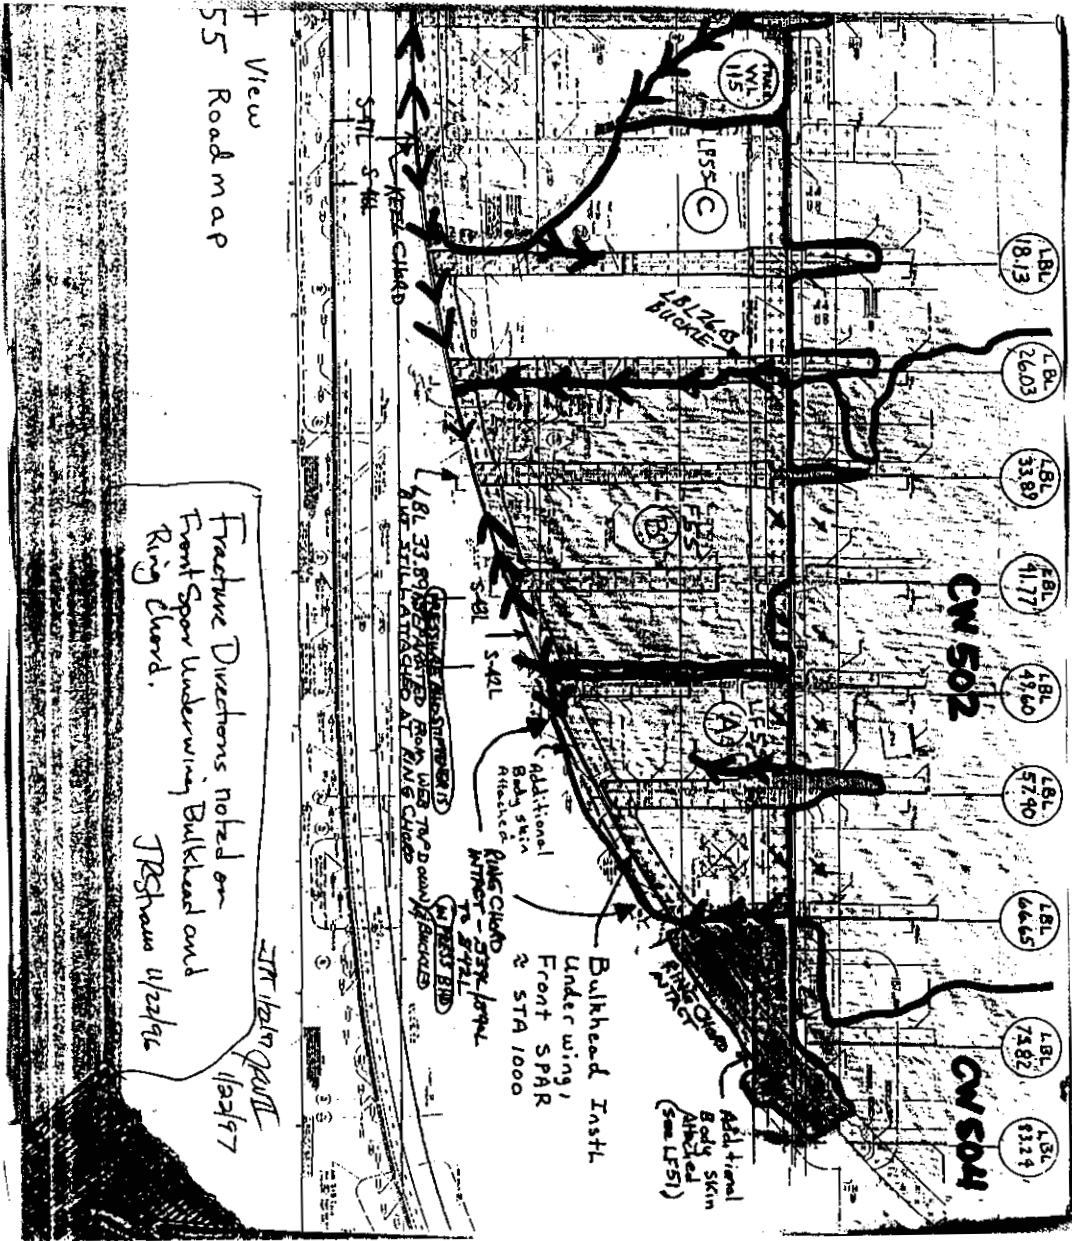
View
55 Road map

Fracture Directions noted on
Front Spar Underwing Bulkhead and
Ring Clamd.
JRS/has 1/23/94

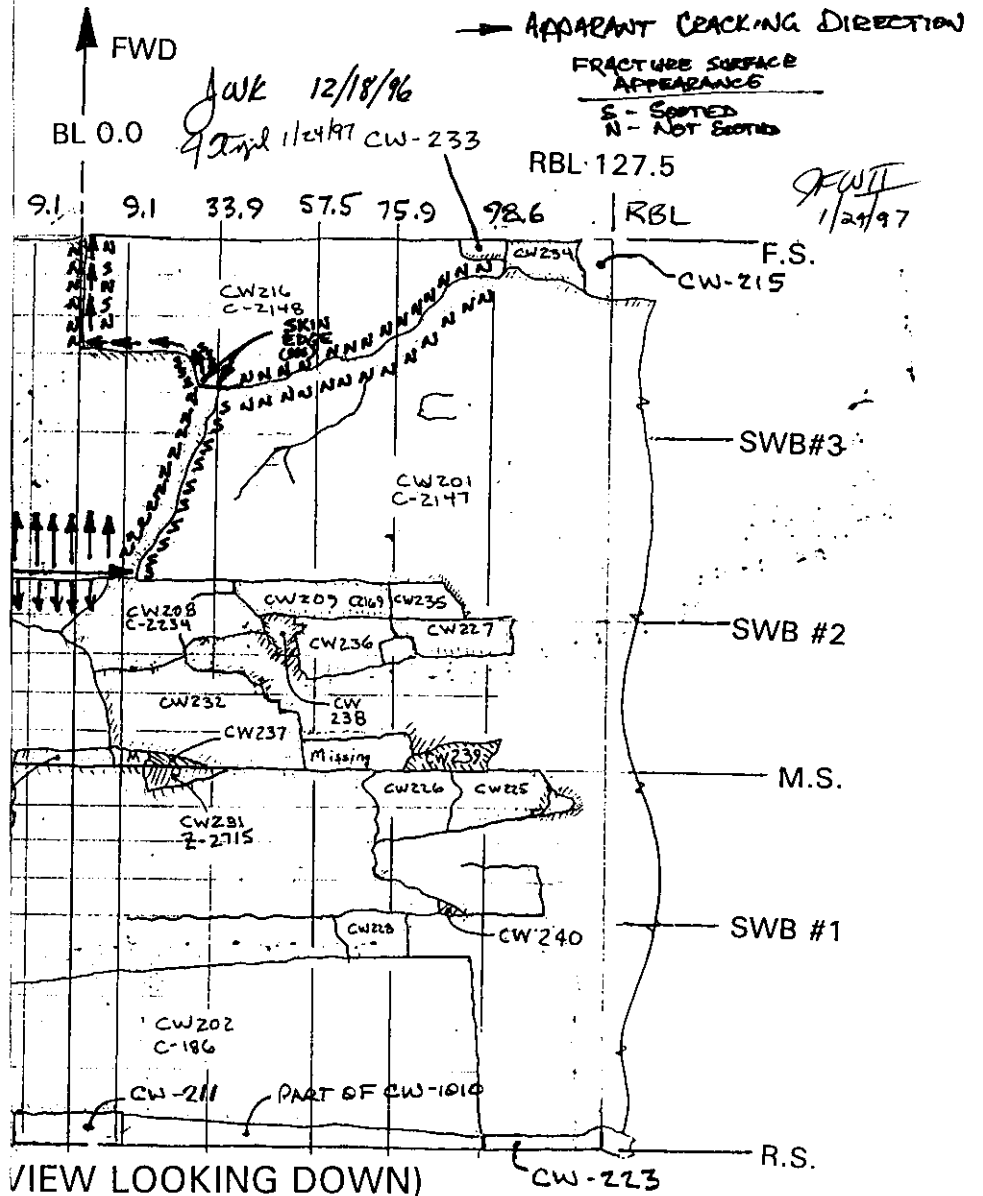
→ APPARANT CRACKING DIRECTION
 ↪ PURE COMPRESSION SEPARATION CENTER

LBL 127.5
 LBL 98.6 75.9 57.5
 FRACTURE SURFACE APPEARANCE
 S - SMOOTH
 N - NOT SMOOTH

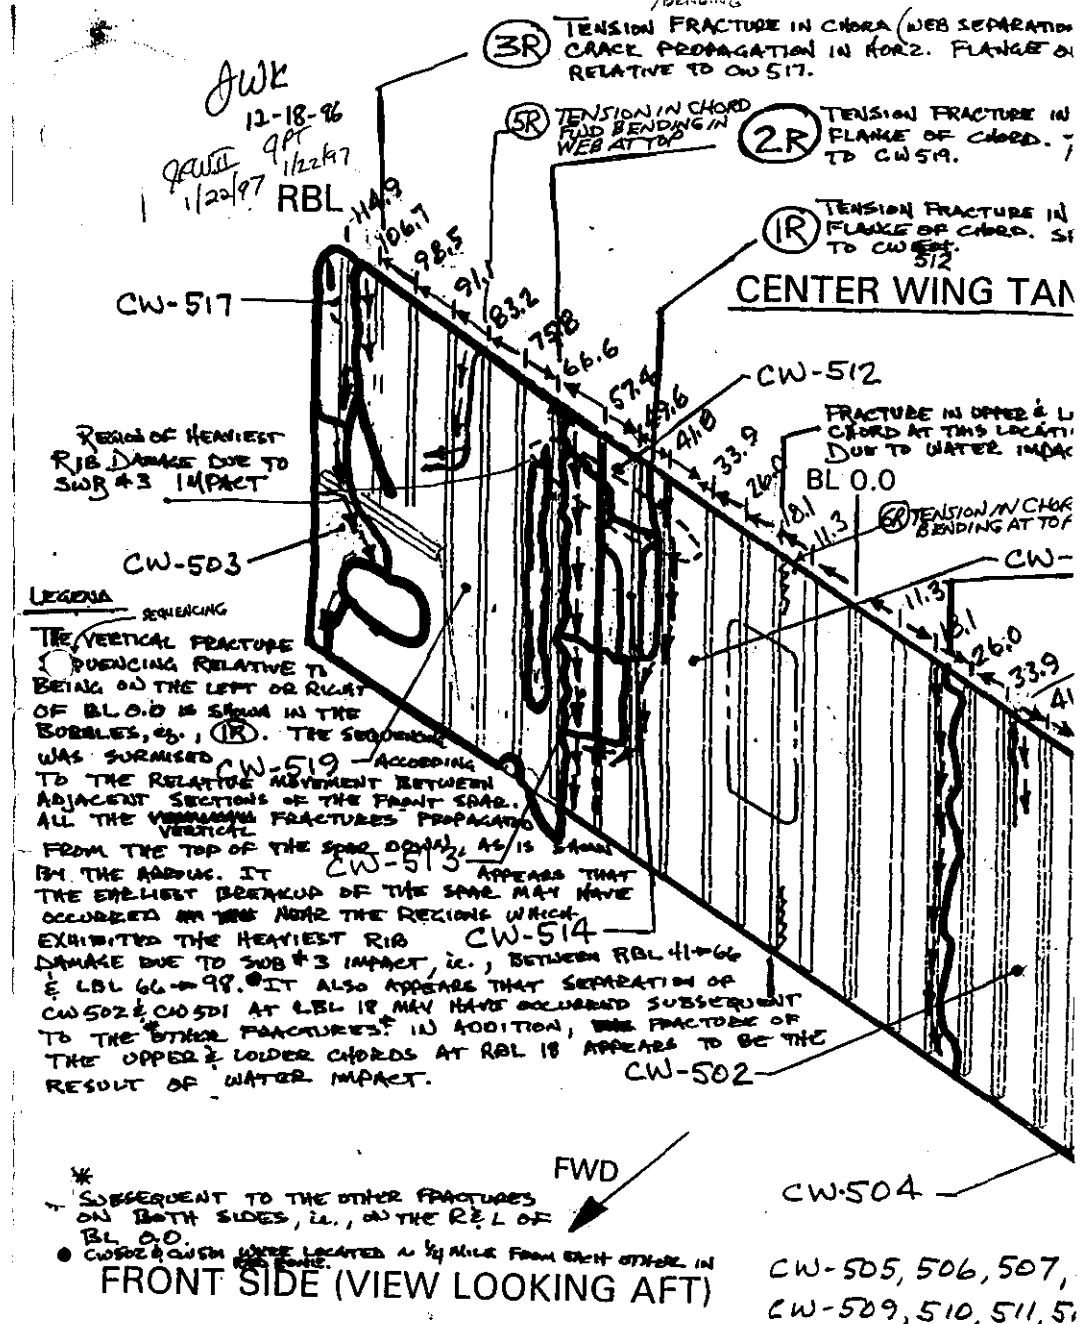
FIGURE B-3

(3R) TENSION FRACTURE IN CHORD (WEB SEPARATION) CRACK PROPAGATION IN ROR2. FLANGE OF RELATIVE TO CW 517.
(5R) TENSION IN CHORD AND BENDING IN WEB AT TOP
(2R) TENSION FRACTURE IN FLANGE OF CHORD. 7 TO CW 519.
(1R) TENSION FRACTURE IN FLANGE OF CHORD. 51 TO CW 512

REGION OF HEAVIEST RIB DAMAGE DUE TO SUB #3 IMPACT

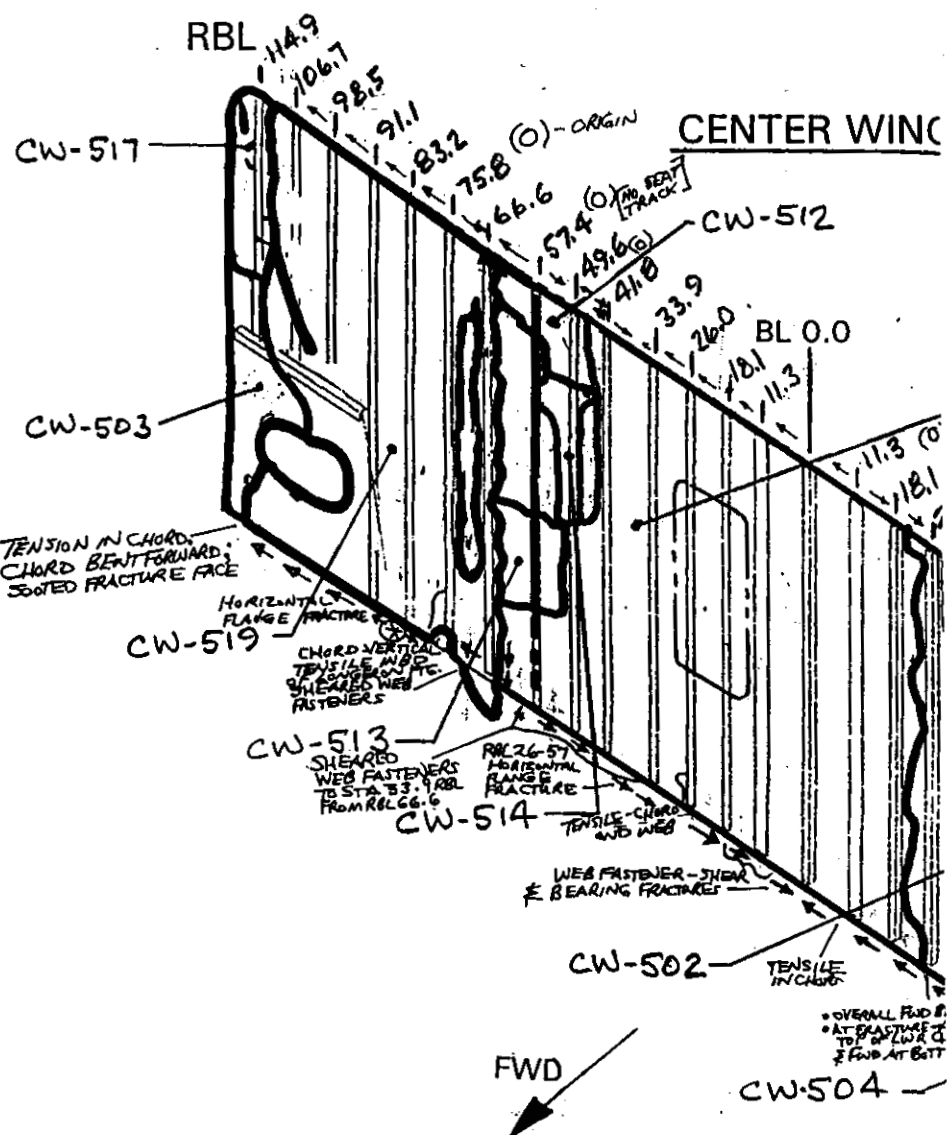
FRONT SIDE (VIEW LOOKING AFT)
 FIGURE B-13

WAS ~~NOT~~ BETWEEN RBL 106 & 114). FRACTURE WAS EXTENSION OF L→R CRACK PROPAGATION IN CHORD. SHEARING IN ADJACENT WEB MAT'L INDICATES CW519 MOVING FWD AND BENDING AT TOP OF

CHORD. FRACTURE WAS EXTENSION OF R→L CRACK PROPAGATION IN CHORD. SHEARING IN ADJACENT WEB MAT'L INDICATES CW512 MOVING FWD RELATIVE TO BENDING AT TOP OF WEB

AND WEB AT TOP. WEB IS PULLED DOWN WITH VERTICAL SHEAR OF CHORD FASTENERS. CHORD FRACTURE WAS EXTENSION OF R→L CRACK PROPAGATION IN CHORD. SHEARING IN ADJACENT WEB MAT'L INDICATES CW512 MOVING FWD RELATIVE TO

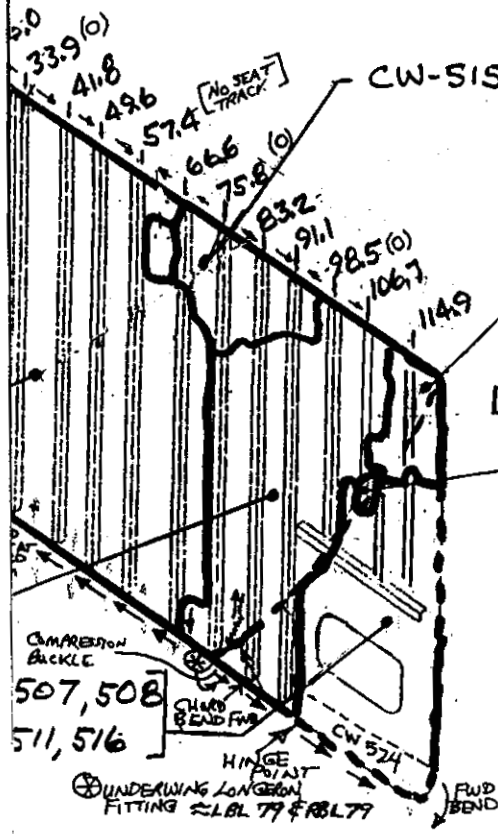
CW-501

SLIGHT BOWING, FLUID NOTED
 (OF VERT. FLANGE OF FRONT SPAR UPPER CHORD)
 AT ORIGIN SITES ASSOCIATED WITH FLOOR BEAMS AT RBL 98, RBL 75, RBL 57, LBL 11, LBL 33, LBL 57, LBL 75 AND LBL 98. INITIATION SITES IN UPPER CHORD CO-LOCATED AT FLOOR BEAM AT RBL 75, RBL 57, LBL 11, LBL 33, LBL 75, AND LBL 98. ONE ADD'L INITIATION SITE BETWEEN RBL 41 AND RBL 49 WAS ASSOCIATED WITH WHERE THE FRACTURE DOVE DOWN INTO THE VERTICAL FLANGE.

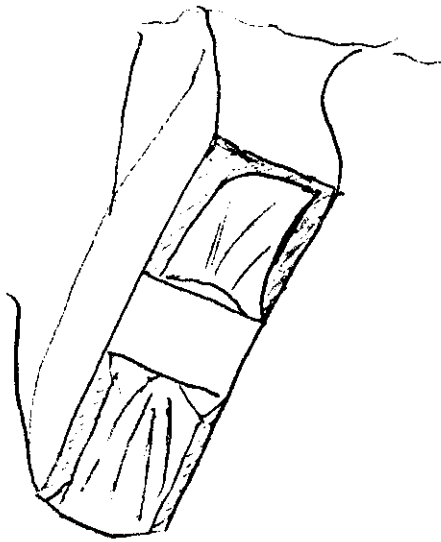
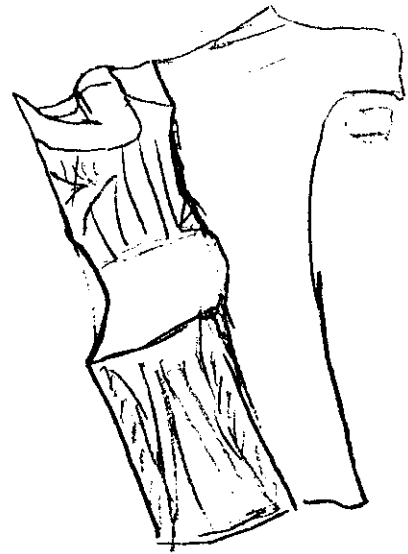
RL 79
CW 216

SAME;
BUT
DIFFERENT
VIEWS

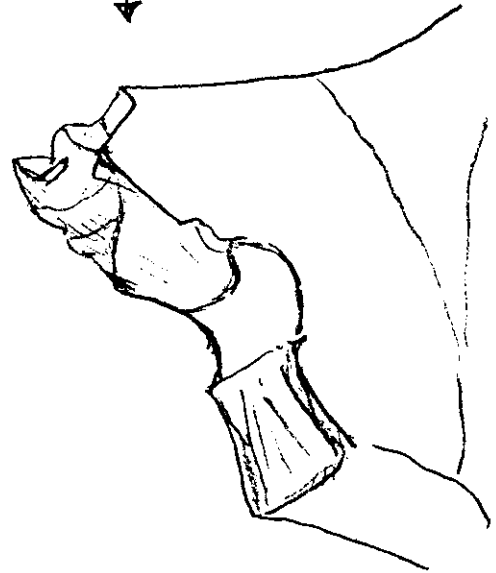
DRAG SPLICE FITTING FRACTURE FACES
(SEE ALSO RF95 AND LFS1)

THE DRAG SPLICE BETWEEN THE FUSELAGE AND THE LOWER SKIN OF THE CWT WAS BROKEN AT THE FIRST ATTACHMENT BOLT IN THE FUSELAGE FITTING ON BOTH SIDES OF THE AIRPLANE. ON BOTH SPLICES, THE FRACTURE INITIATED FROM THE UPPER AND LOWER EDGES OF THE BOLT HOLE. OVERSTRESS FRACTURE WAS TYPICAL OF TENSION ~~AND~~ PERHAPS WITH SOME BENDING. DRAG SPLICE IS CROSS HATCHED IN DRAWING BELOW (BORROWED FROM FATIGUE SECTION OF METALLURGY BOOK).

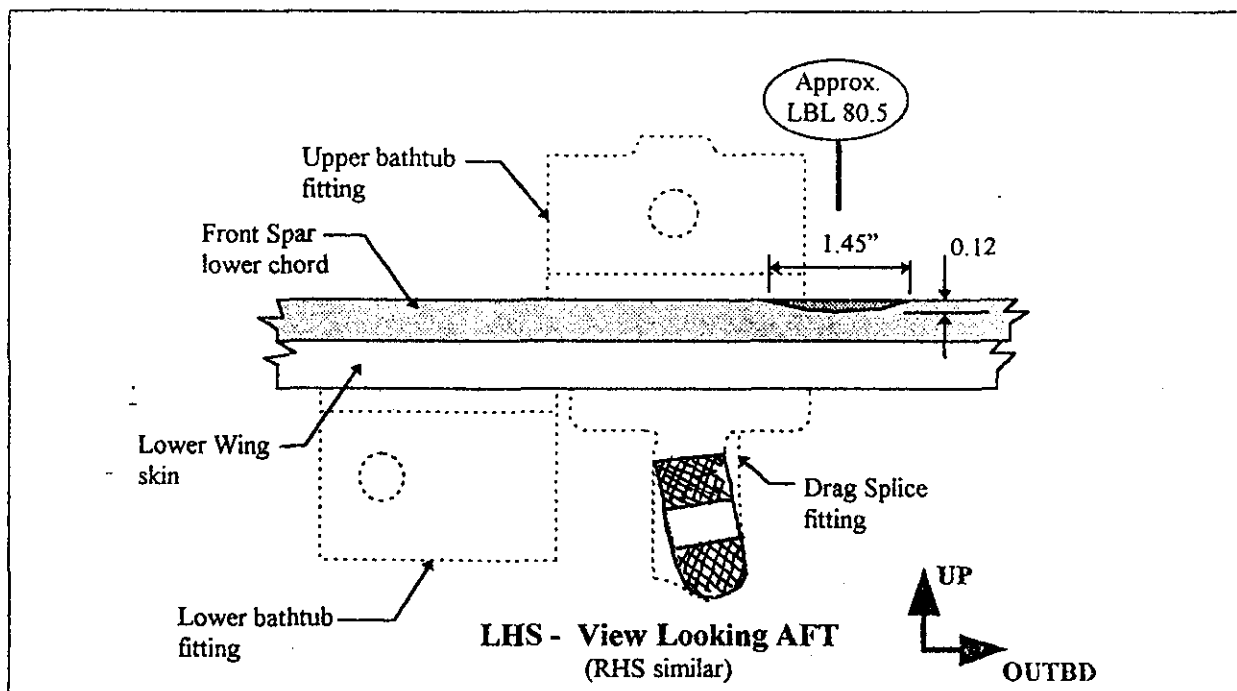
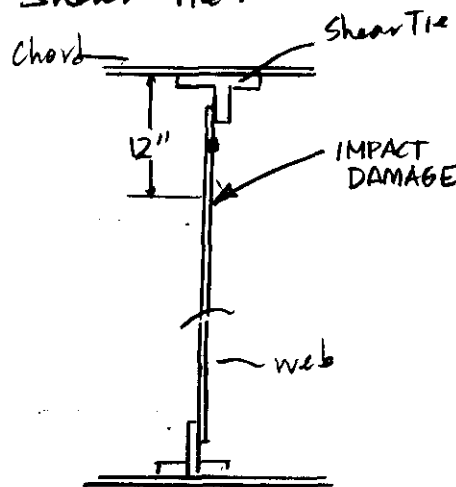
FS/SWB#3 Impact Damage Study

- Made observations of impact damage noted on AFT surface of Front Spar Stiffeners and on the Front Surface of SWB#3, (see table attached). Noted dimension of impact damage, and missing structure on SWB #3, on FS: SWB#3

- Graphically depicted what the ^{FWD} movement of the SWB#3 would do to the FS stiffeners (impact damage). Assumed the top was free to move and bottom was fixed and rotated about the lower shear tie.
- Top shear tie would impact FS at 12" from top of upper base of upper shear tie.

- Then calculated where the predicted damage ^{range} would occur based on the missing portion of the SWB#3. Based on a few examples it was determined that the upper fractured ends of SWB#3 may have ^{easily} caused the impact damage noted on the aft FS stiffeners. If the lower end of SWB#3 shifts AFT then the damage to the FS Stiffeners will be lower (see enclosed example).

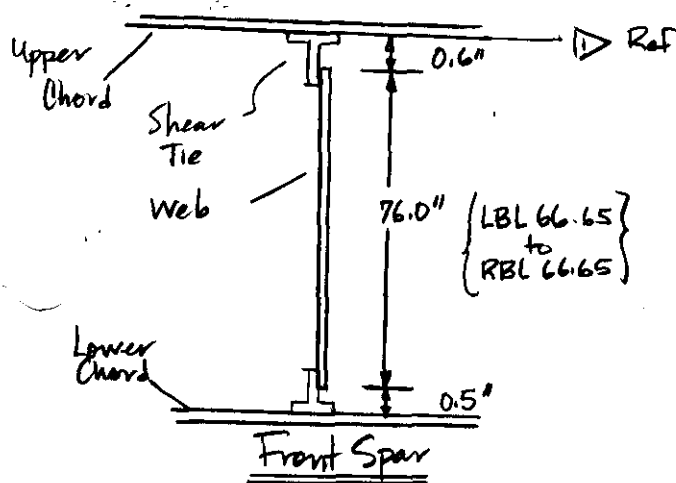
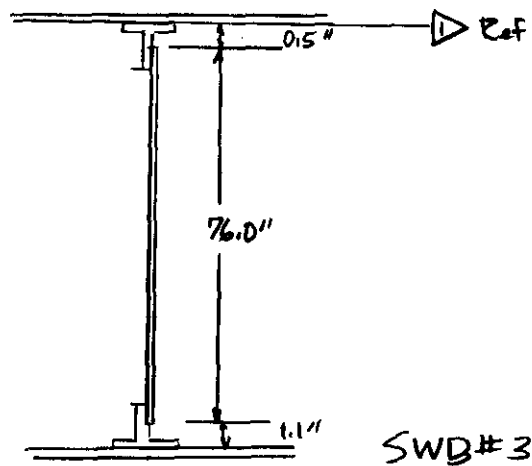
Front Spar	Spanwise Beam #3	
Stiffener Location	Impact Damage on Stiffeners (back-side)	Remaining Structure	Impact Marks on front surface of Beam
LBL 106.72	No Damage		
LBL 98.48	From 16"-24"	LBL 98.48	Below 22"
LBL 91.14	" 12"-19"	LBL 91.14	" 18"
LBL 83.24	* " 13"-36" 12"-40"	LBL 83.24	" 17"
LBL 75.82	" 13-26"	LBL 75.82	" 4"
LBL 66.65	" 10-21"	LBL 66.65	" 20"
LBL 57.40	* " 10-20" 12-17"	LBL 57.48	" 4"
LBL 49.66	* " 12-16" 12-20"	49.32	" 6"
LBL 41.77	* " 10-31" 12-35"	41.77	" 15"
LBL 33.89	* " 12-34" 12-24"	33.97	" 9"
LBL 26.03	* " 12.5-37" 12-31"	25.26	" 16"
LBL 18.13	" 11-39"	17.27	" 17"
LBL 11.07	" 12-15"	11.31	" 30"
BL 0	" 11-17.5"	BL 0	" 23"
RBL 11.07	" 11-30"	RBL 11.31	" 28"
RBL 18.13	" 11-18	RBL 17.27	" 20"
RBL 26.03	" 11-15.5"	RBL 25.26	" 15"
RBL 33.89	" 11-19"	RBL 33.97	" 10"
RBL 41.77	" 10.5-17"	RBL 41.77	" 8"
RBL 49.66	" 13-26"	RBL 49.60	" 19"
RBL 57.40	" 12-16"		
RBL 66.65	" 11-19"		
RBL 75.82	" 7-19"

RBL 83.24	" 4-15"		
RBL 91.14	" 12.5-27"		
RBL 98.48	" 12.5-31"		
RBL 106.72	" 14-22"
