CENTER WING

Metallurgy Group Notes - Wing Center Section Study

October 8, 1996

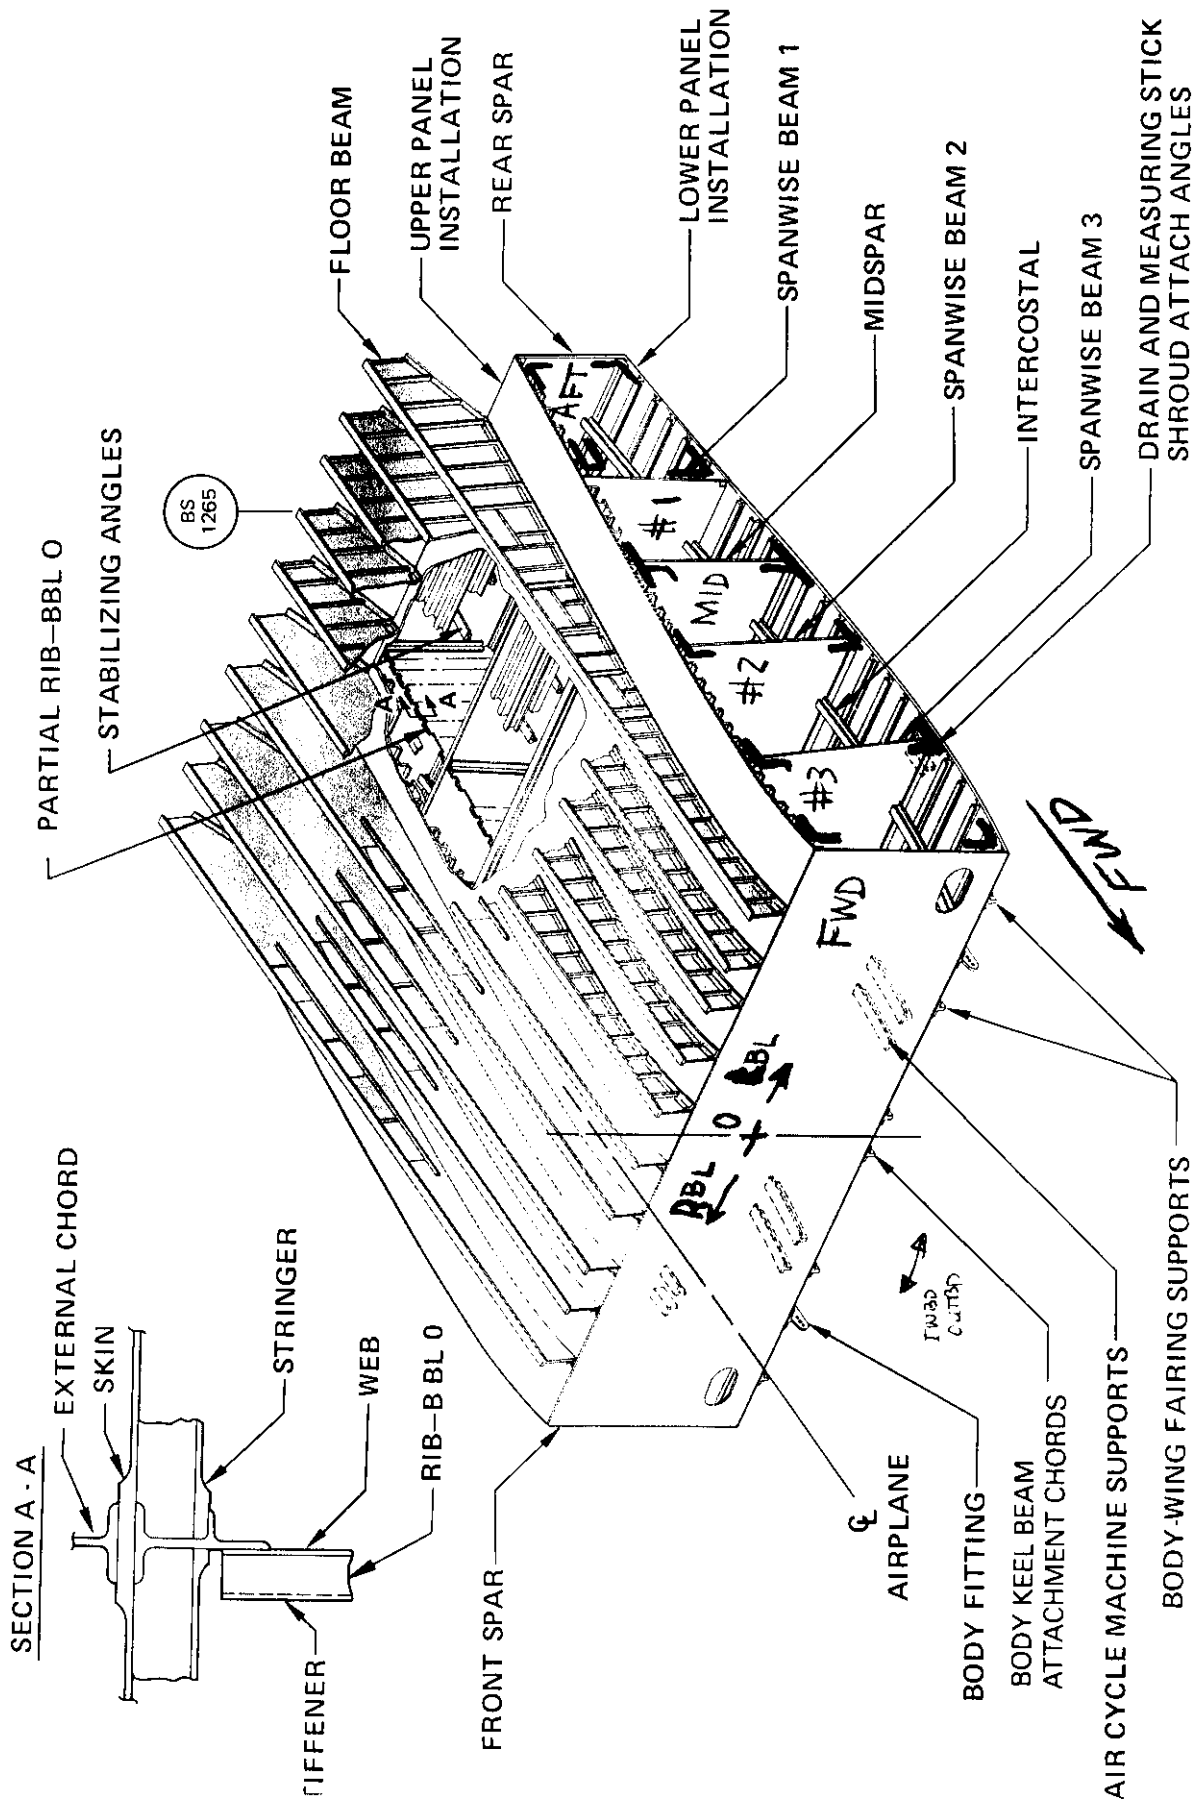
FIGURE 1

Figure 1 shows a sketch of the wing center section. Each of these structures contain numerous vertical members called stiffeners that are situated parallel to each other and provide support for the upper and lower skin and the spanwise web. The stiffeners and web are attached to a upper and lower spanwise chord to fabricate a beam. The chords attach directly to the skin. The vertical stiffeners attach to the chords by shear ties. The chord for the front, midspar and spanwise beam No. 3 are forward of the shear ties, whereas, the chord for spanwise beam No. 1 is AFT of the shear ties. (see figure 1).

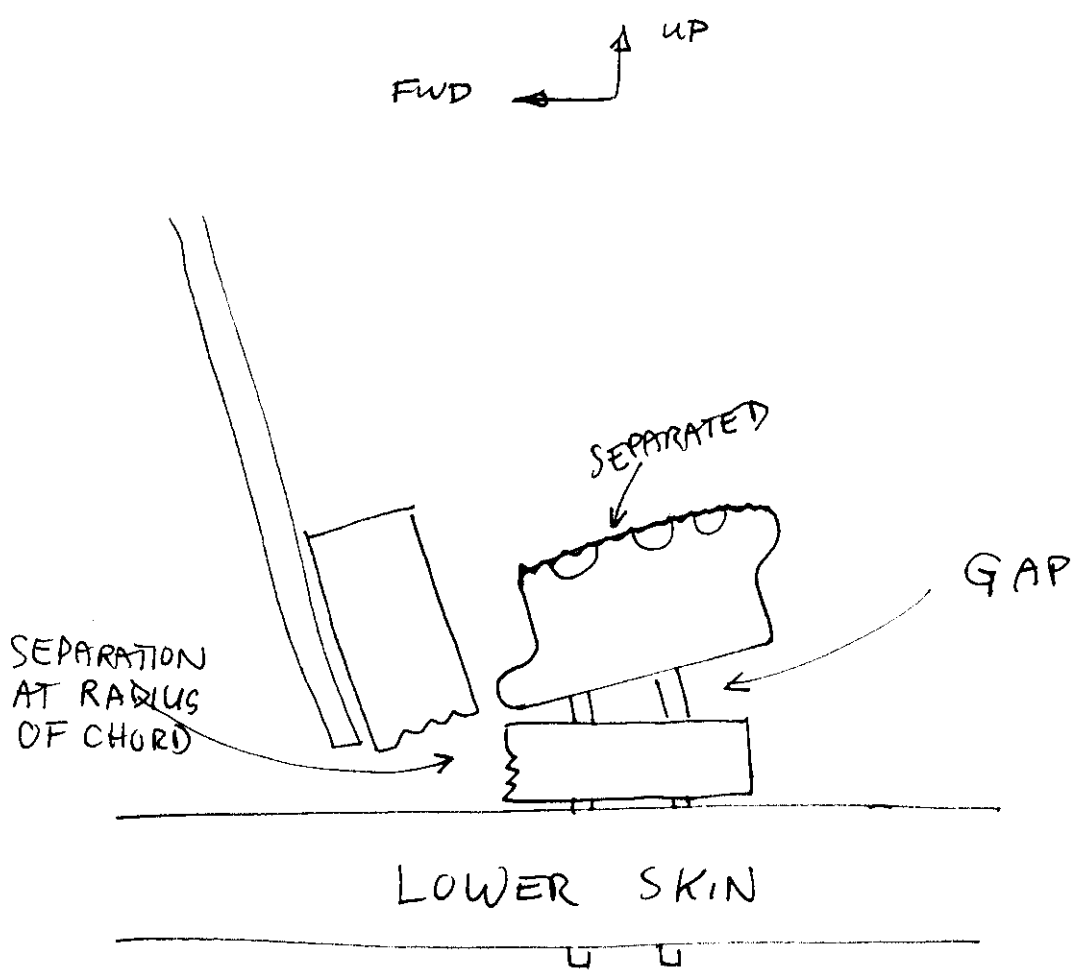
FIGURE 2.

Examination of the wing center section revealed that the front spar moved forward relative to the upper and lower skin. The chords for this spar separated spanwise along the radius (see figure 2). A major portion of the shear ties for the lower skin and attachment bolts were found attached to the chord, whereas, less than half of the shear ties for the upper skin were found attached to the chord. The AFT side of the attached shear ties contained a gap on the AFT end between the shear tie and the chord (see figure 2). The shear tie for the front spar is attached to the chord by four bolts. In the remaining areas where the shear ties and attachment bolts separated from the chord, bolts were found protruding out of the chord and several holes were found with no bolts. Typically, the two forward bolt holes on the chord contained deformation or gouge marks on the forward side indicating that a bolt attached to a shear tie departed in the forward direction. Several holes which correspond to the AFT holes of the shear ties contained similar gouge marks on the forward side. Several bolt holes exhibited no deformation indicating that the shear tie bolts were pulled straight out of the hole. Where bolts were found attached to the lower chord, these bolts were vertically oriented or deformed slightly forward indicating that the departing shear tie was moving forward.

FORWARD SPAR

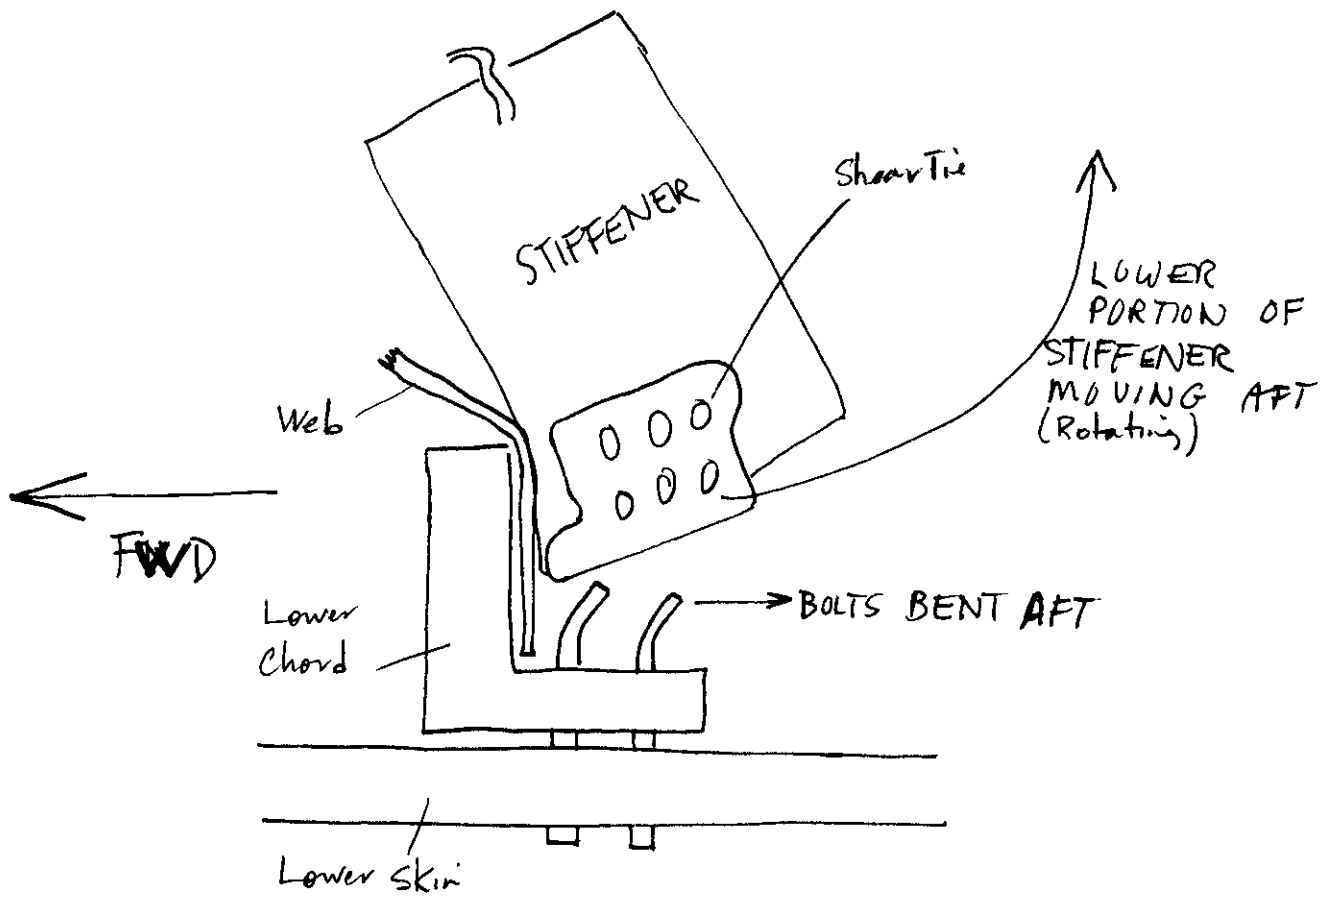
FIGURE 3

by one bolt, revealed the associated stiffeners separated approximately 6 inches below the inside surface of the upper skin. The upper portion of the stiffeners contained diagonal fractures in a direction which would suggest forward movement relative to the skin. In the remaining areas where the shear ties and two attachment bolts separated from the upper chord, the bolt holes on the inboard side of the chord contained gouge marks on the forward side. At the lower skin, the chord and portion of the web from LBL 114 to 26 and RBL 34 to 49 remained attached to the lower skin. The chord and web were deformed in the forward direction. In these areas, the majority of the shear ties were found separated from the chord. The inboard face of these chords contained a combination of bolt holes with gouge marks on the aft side and bolts protruding out of the chord that were deformed in the aft direction, as if the lower portion of the stiffener rotated AFT about the chord (see Figure 3). The bolt holes on the lower chord from LBL 18 to RBL 26 exhibited tensile pullout (no lateral deformation) and the chord for the upper skin in this area exhibited bolt holes with gouge marks on the forward side. Using the same observations, the upper portion of this spanwise beam in the range RBL 58 to 106 was found to have moved forward and the lower portion in the same area moved AFT.

SPANWISE BEAM # 3
LOWER PORTION

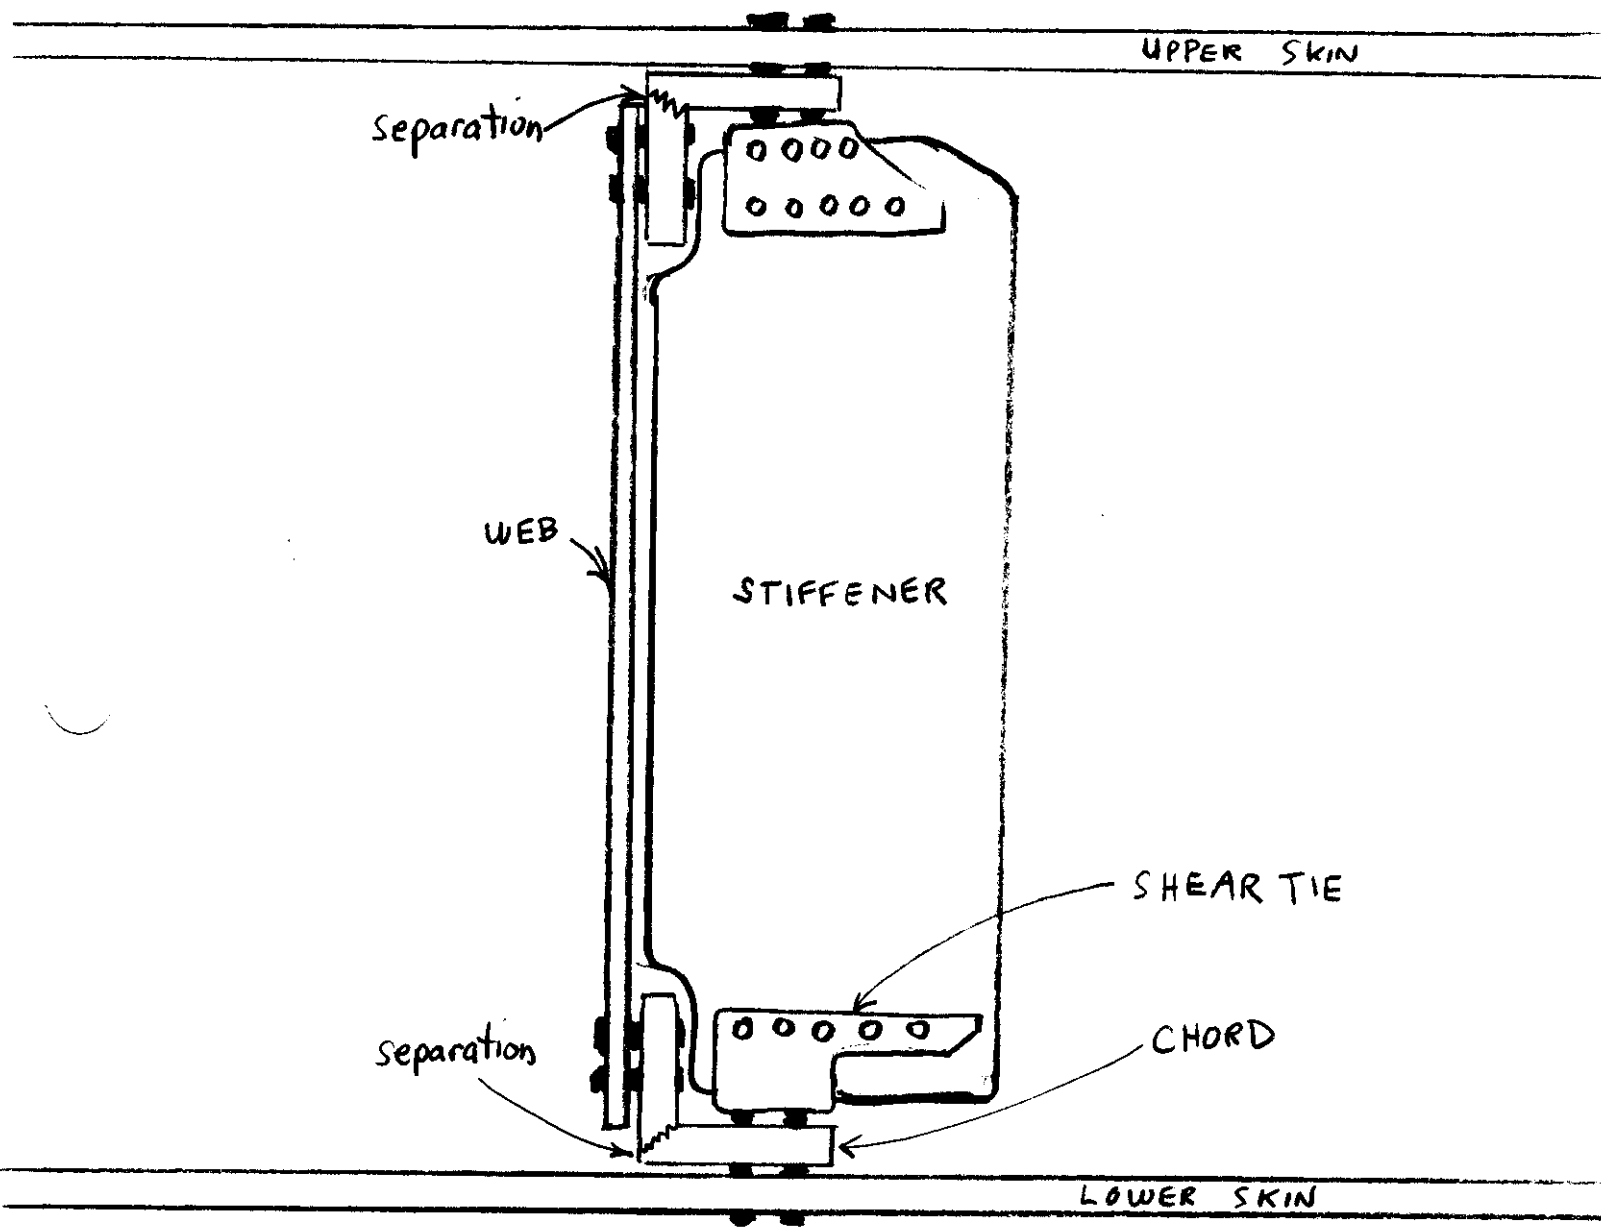
FORWARD SPAR
(SIDE VIEW)

The AFT faces of the stiffeners for the front spar exhibited impact damage between 4 and 39 inches from the shear ties for the upper skin. Between 4 and 30 inches of the upper portion of spanwise beam No. 3 were missing along its length as well. This corresponding damage to the AFT faces of the front spar stiffeners and top portion of spanwise beam No. 3 is consistent with the top of spanwise beam No. 3 striking the stiffeners of the front spar.

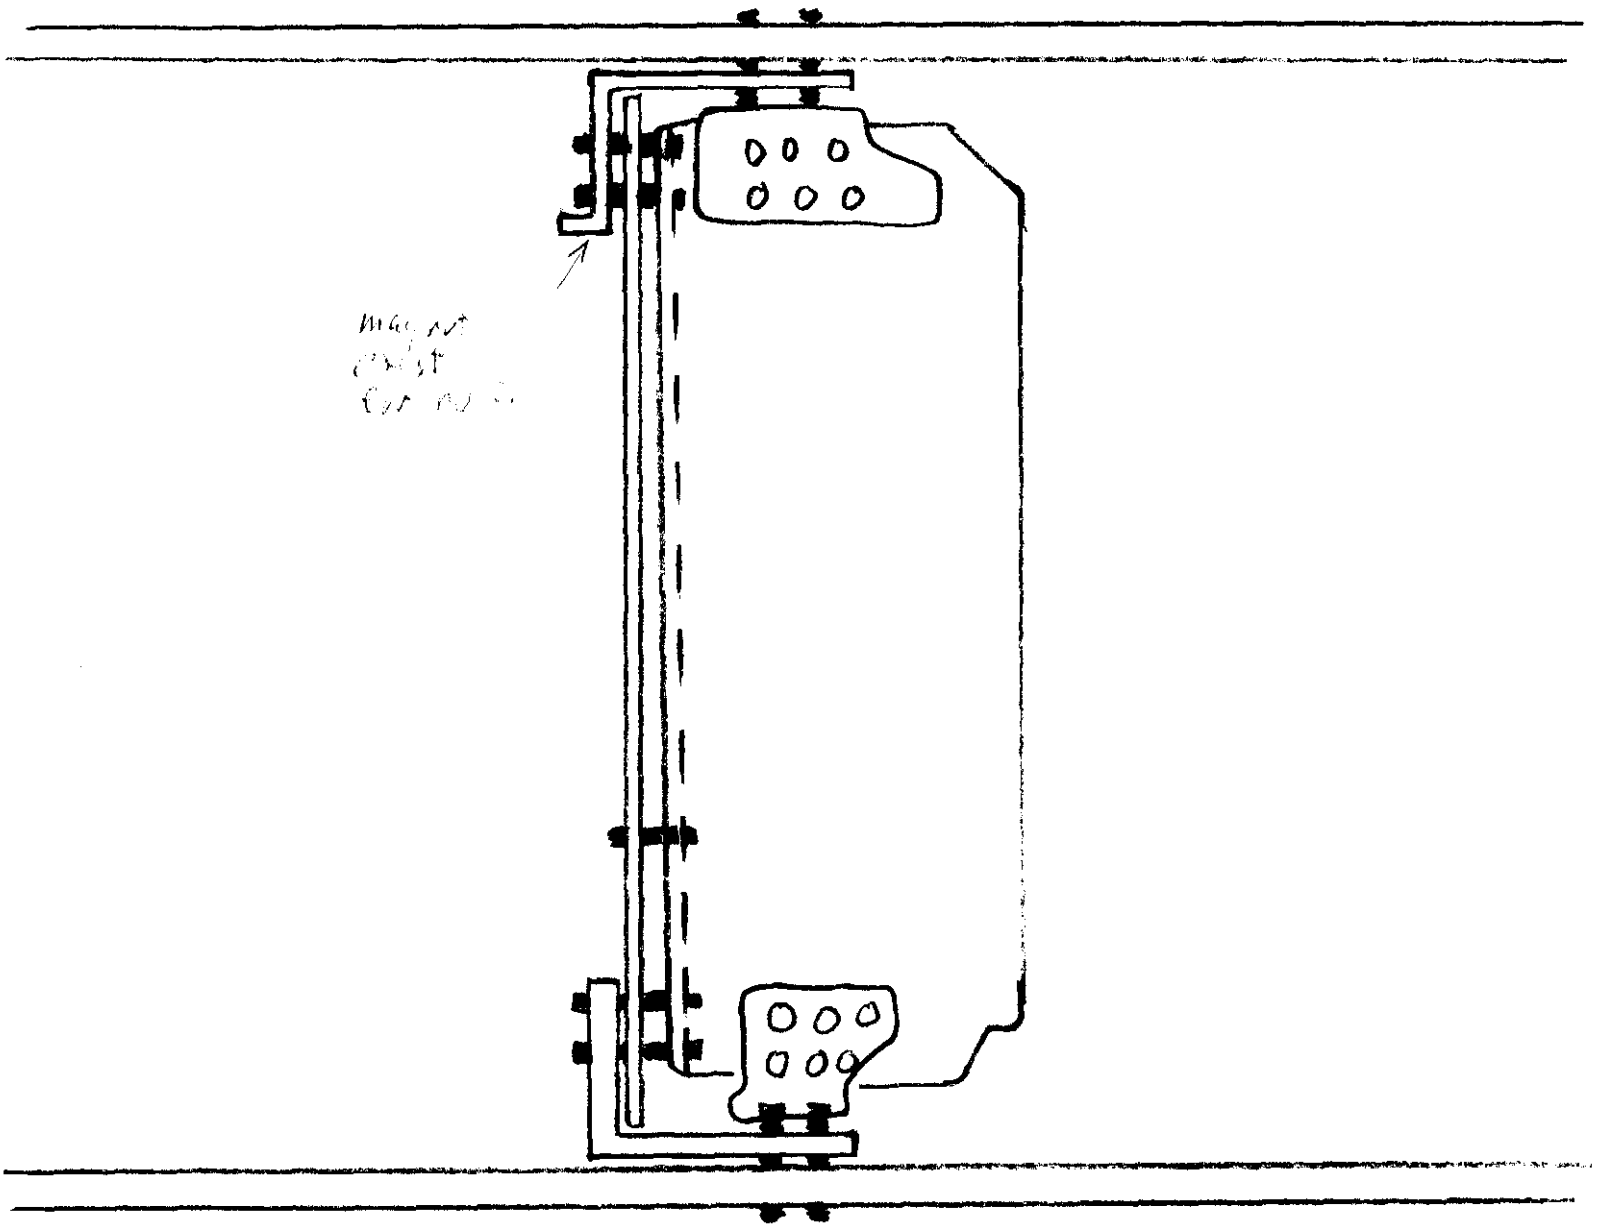
SPANWISE BEAM # 3 (S-19)

Spanwise beam No. 3 was found to have moved in the forward direction. In this beam, shear ties are attached to the chords by two bolts, with the exception that on the upper skin along the passenger floor beam locations one larger diameter bolt is used to attach the shear tie to the chord. Examination of the upper skin where the shear ties were attached to the upper spanwise chord

Mag. pot
exist
for no. 3

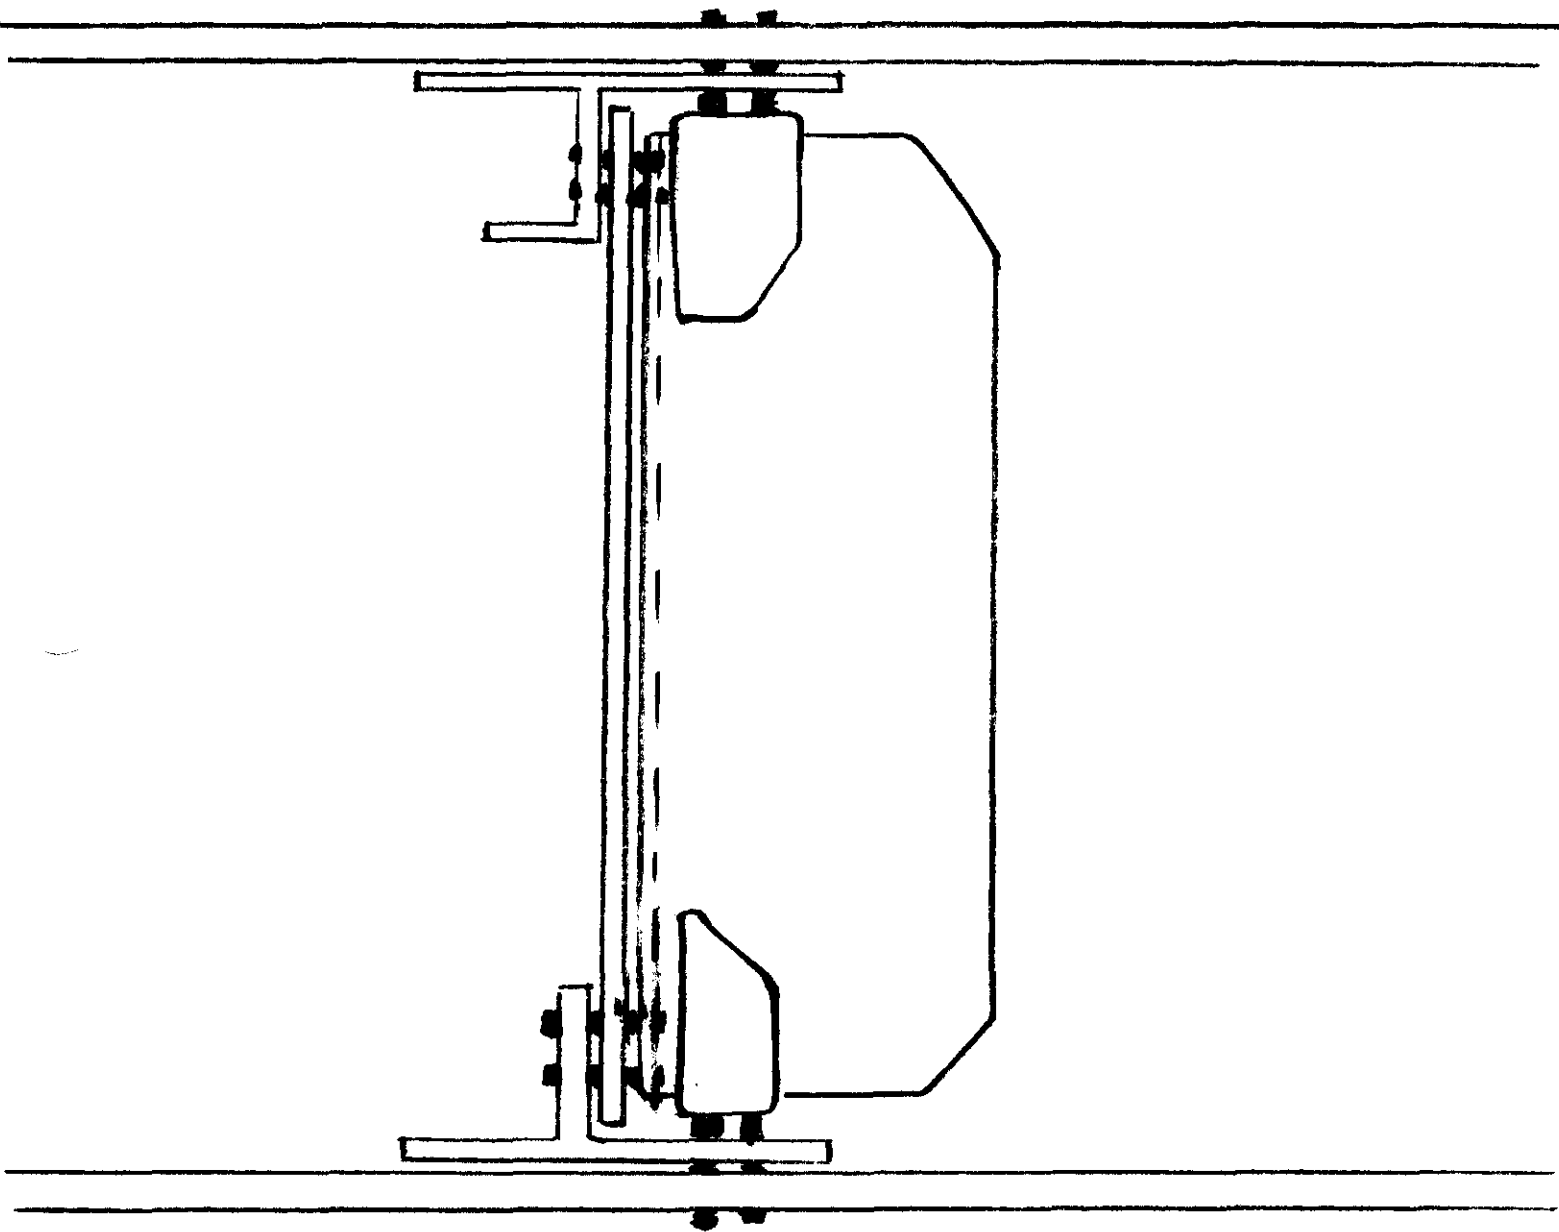
MID SPAR

Spanwise beam No. 2 and the mid spar did not exhibit consistent deformation patterns in any of the common fastener holes or bolt holes to indicate which direction these items traveled with respect to the skin. *see additional comments*
SPC, 11-03-96

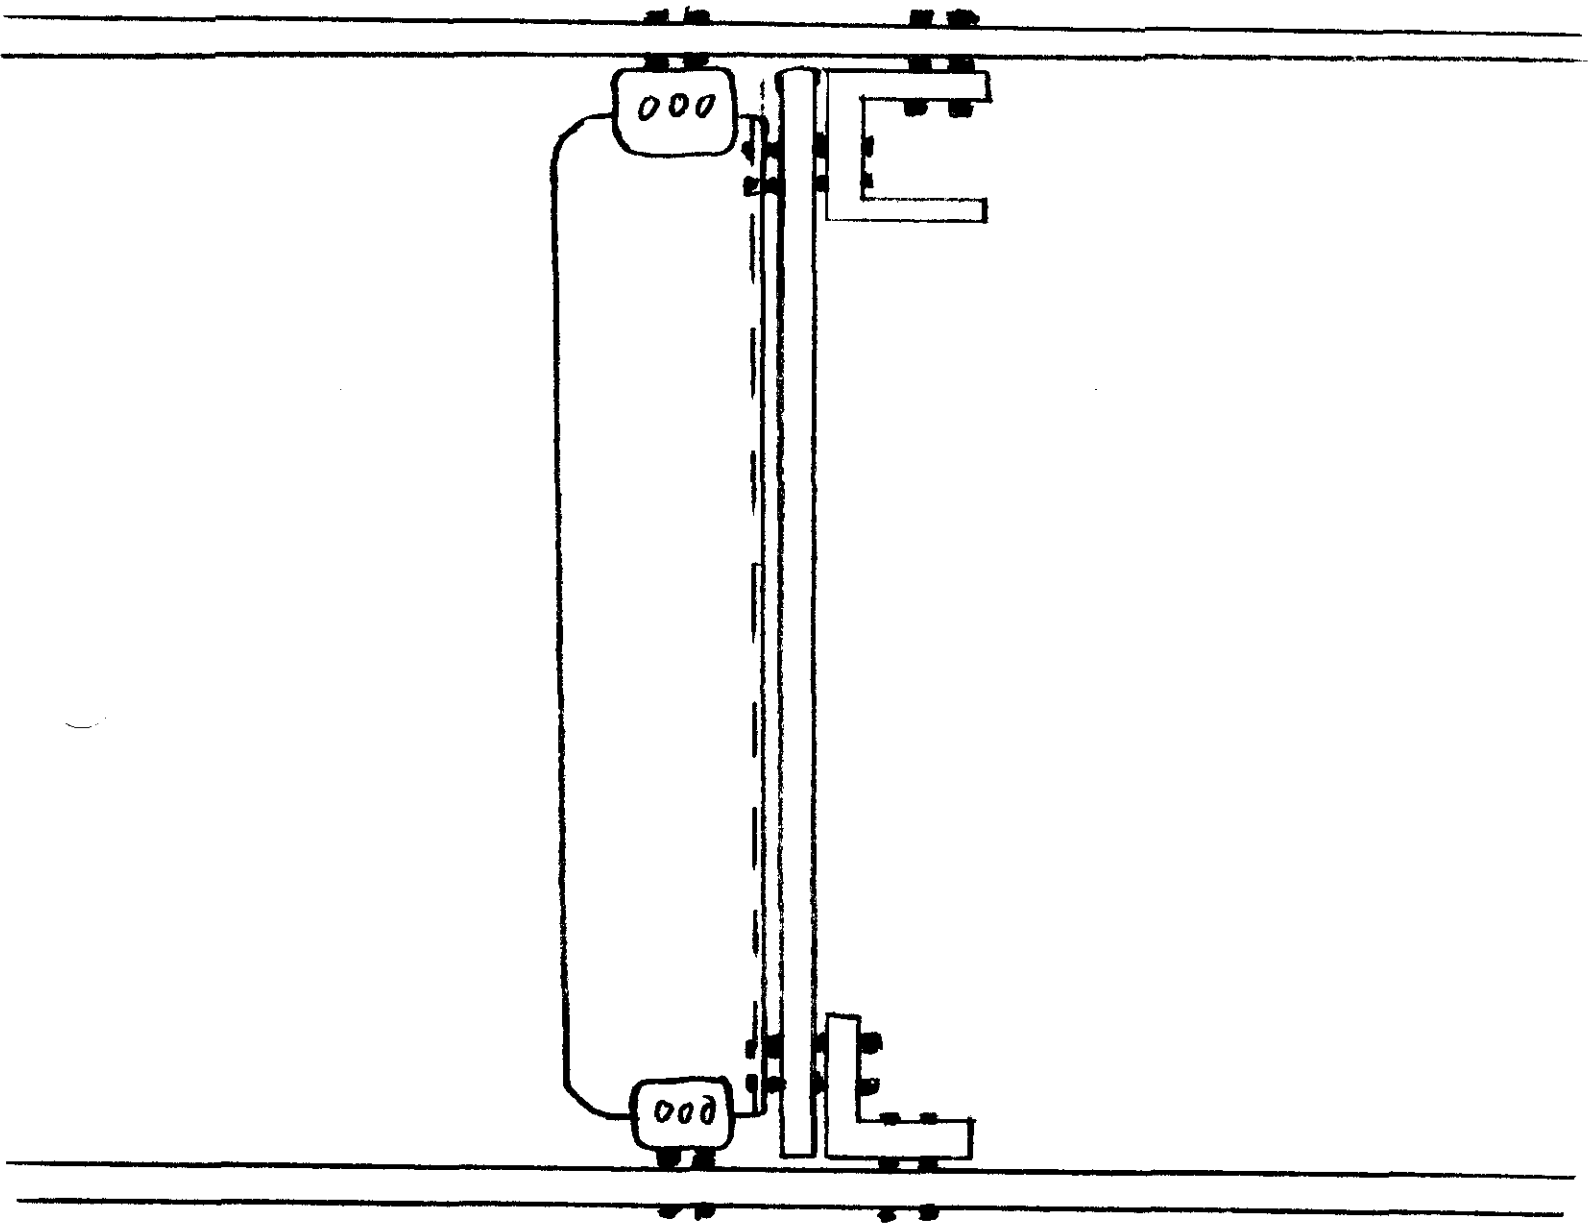
SPANWISE BEAM #1

Spanwise beam no. 1 was found to have traveled in the AFT direction. The lower portion of this spanwise beam from LBL 114 to RBL 41 was found to have rotated FWD about the chord of the lower skin and the upper portion in the same area moved AFT. The upper portion of the stiffeners LBL 11, LBL 34 through 98, and RBL 11 through 41 were found with diagonal fractures in a direction further supporting the spanwise beam in these areas moved in the AFT direction.
