**NATIONAL TRANSPORTATION SAFETY BOARD
Office of Aviation Safety
Washington, DC 20594**

STRUCTURES GROUP - EMPENNAGE FACTUAL SUMMARY

ACCIDENT : DCA96MA070
Location : East Moriches, New York
Date : July 17, 1996
Time : 2031 Eastern Daylight Time
Airplane : Boeing 747-131, N93119
Operated as Trans World Airlines (TWA) Flight 800

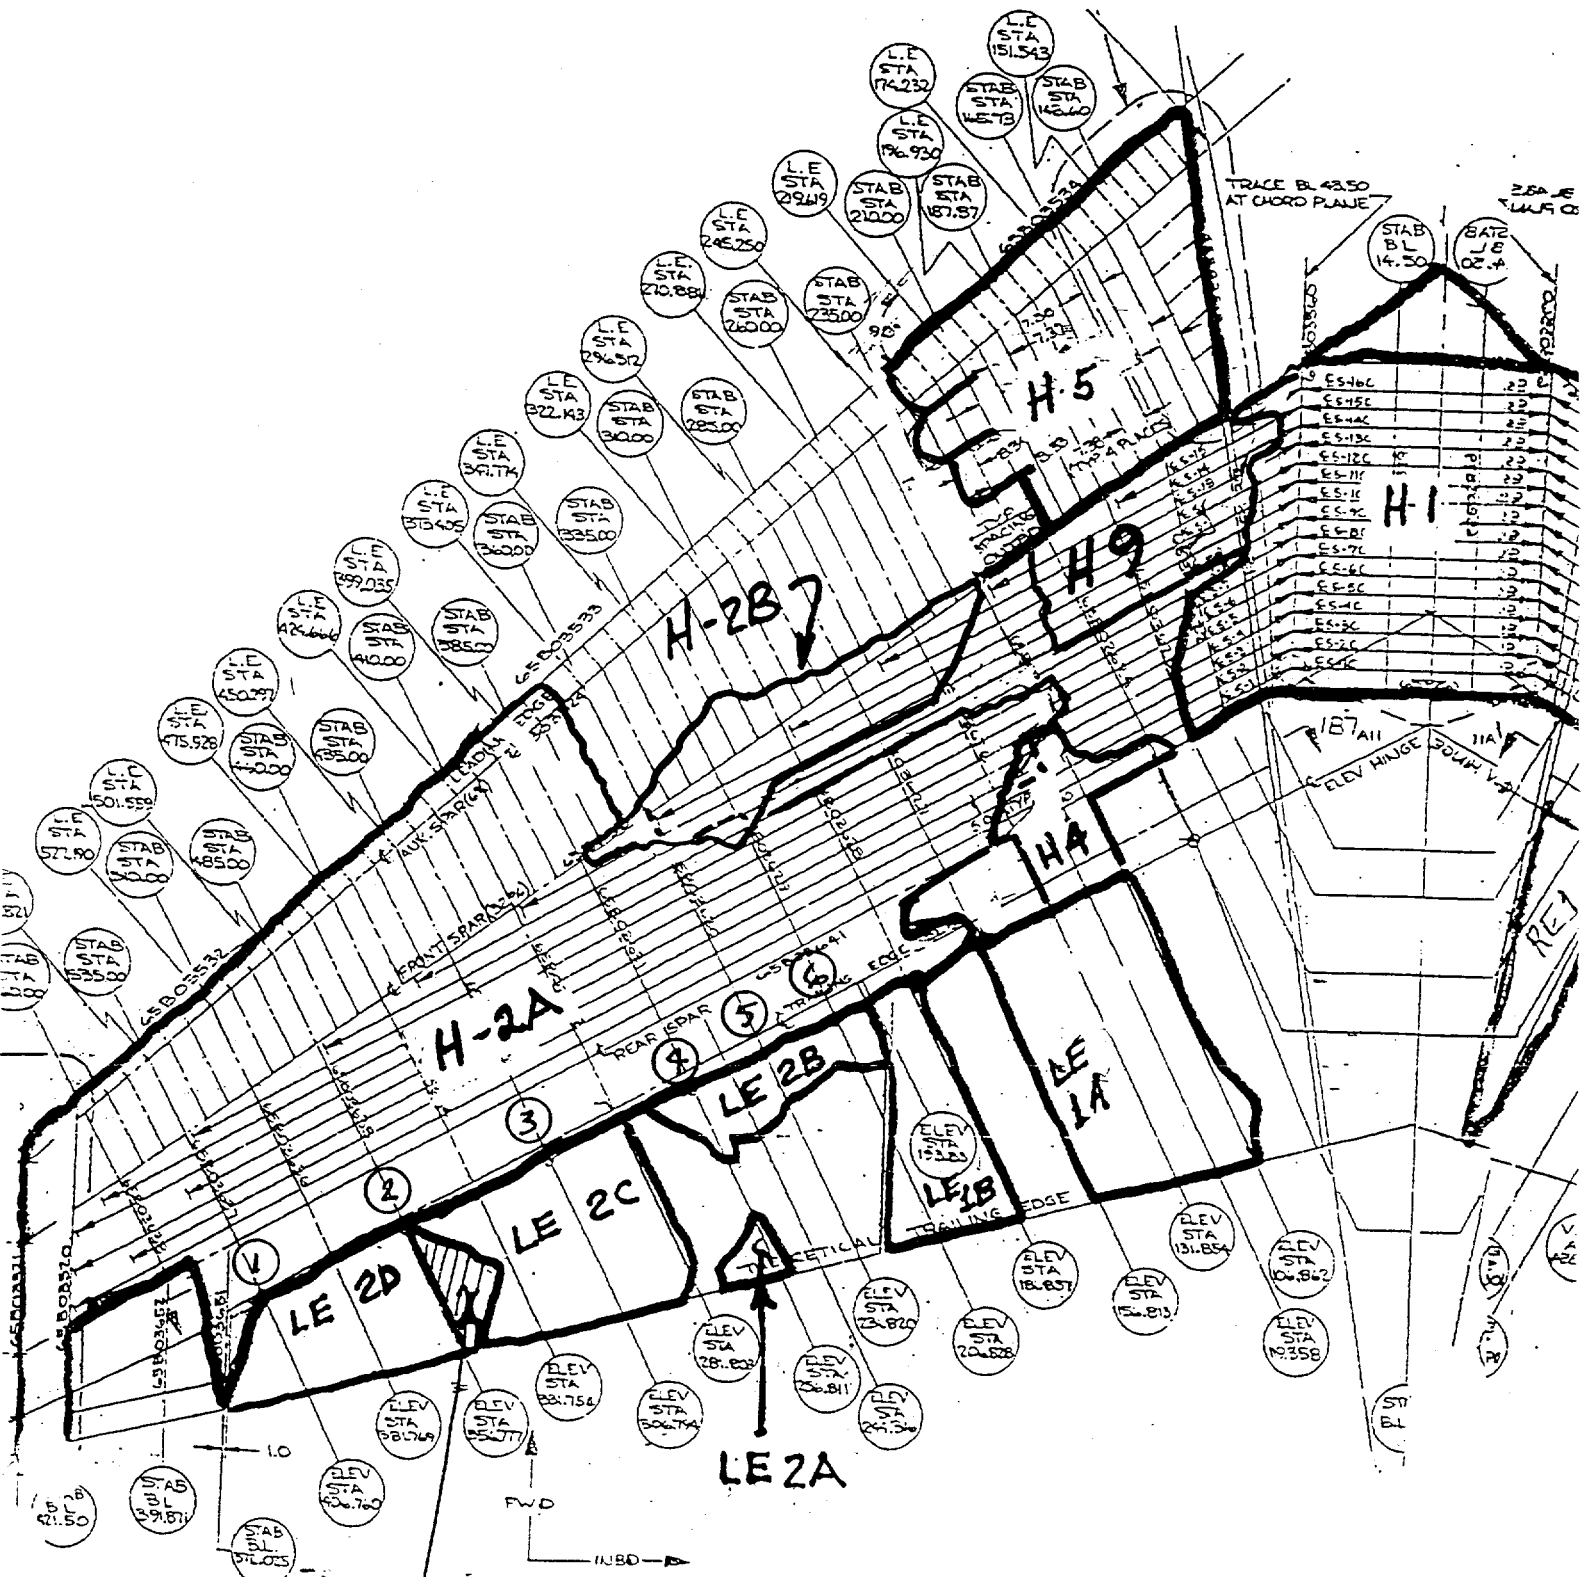
HORIZONTAL STABILIZER LEFT HAND SIDE

The left Horizontal Stabilizer fractured into three large sections and numerous smaller sections. These sections were found in the Green debris area.

The aft portion of the left Horizontal Stabilizer from the torque box left side to Stab STA 187 (approx.) remained attached to the torque box. This section comprised the upper and lower skins and a 3-foot section of the rear spar. The upper and lower skins were bent up. The stringers from the lower skin were bent up and aft. The upper skin stringers remained attached to the skin and were bent up. The rear spar section remained attached to the torque box and was bent aft. There are local soot deposits on the exterior and interior surfaces of the upper stringers and skin.

A large inboard section of the leading edge of the horizontal stabilizer (H-5) included a section of the front spar from Stab STA 143.60 to leading edge STA 233 (approximately). The front spar web was bent slightly aft at the lower corner near the root; no deformation of the outboard end was observed. Just forward of the front spar, outboard end, the upper skin was torn and two pieces were bent up approximately 60 and 180 degrees, respectively.

Another section of inboard left Horizontal Stabilizer (H-4) comprised an area from Stab STA

198 to 271 and included a 5-foot section of rear spar, a small section of the upper skin, and a section of left elevator (LE-1A). The inboard portion of the rear spar section, from Stab STA 235 to 37 inches inboard, was bent aft approximately 20 degrees from the spar reference line. The outboard portion of the rear spar, from Stab STA 260 to 11 inches outboard, was curled aft approximately 45 degrees.

The outboard portion of the left Horizontal Stabilizer comprised the area from Stab STA 230 to the stabilizer tip. The upper and lower skins remained attached to the front and rear spar on (H-2A). The lower skin and the stringers at the inboard end are bent up at Stab STA 230 to 285. The corresponding upper stringers near the rear spar are bent forwards. The rear spar remained intact from the tip to Stab STA 275. The front spar remained intact from the tip to Stab STA 347 and exhibit slight aft bending at the bottom of the spar web. The leading edge remained attached to the front spar from Stab STA 372 to stabilizer tip. The outboard and inboard ends of the leading edge upper surface from Stab STA 372 to 390 and from STA 460 to tip were torn in numerous locations and directions. The leading edge bull nose was crushed aft from STA 525 to 560 and the inboard end exhibited evidence of witness marks in the lateral direction. There were numerous punctures on the upper skin surface.

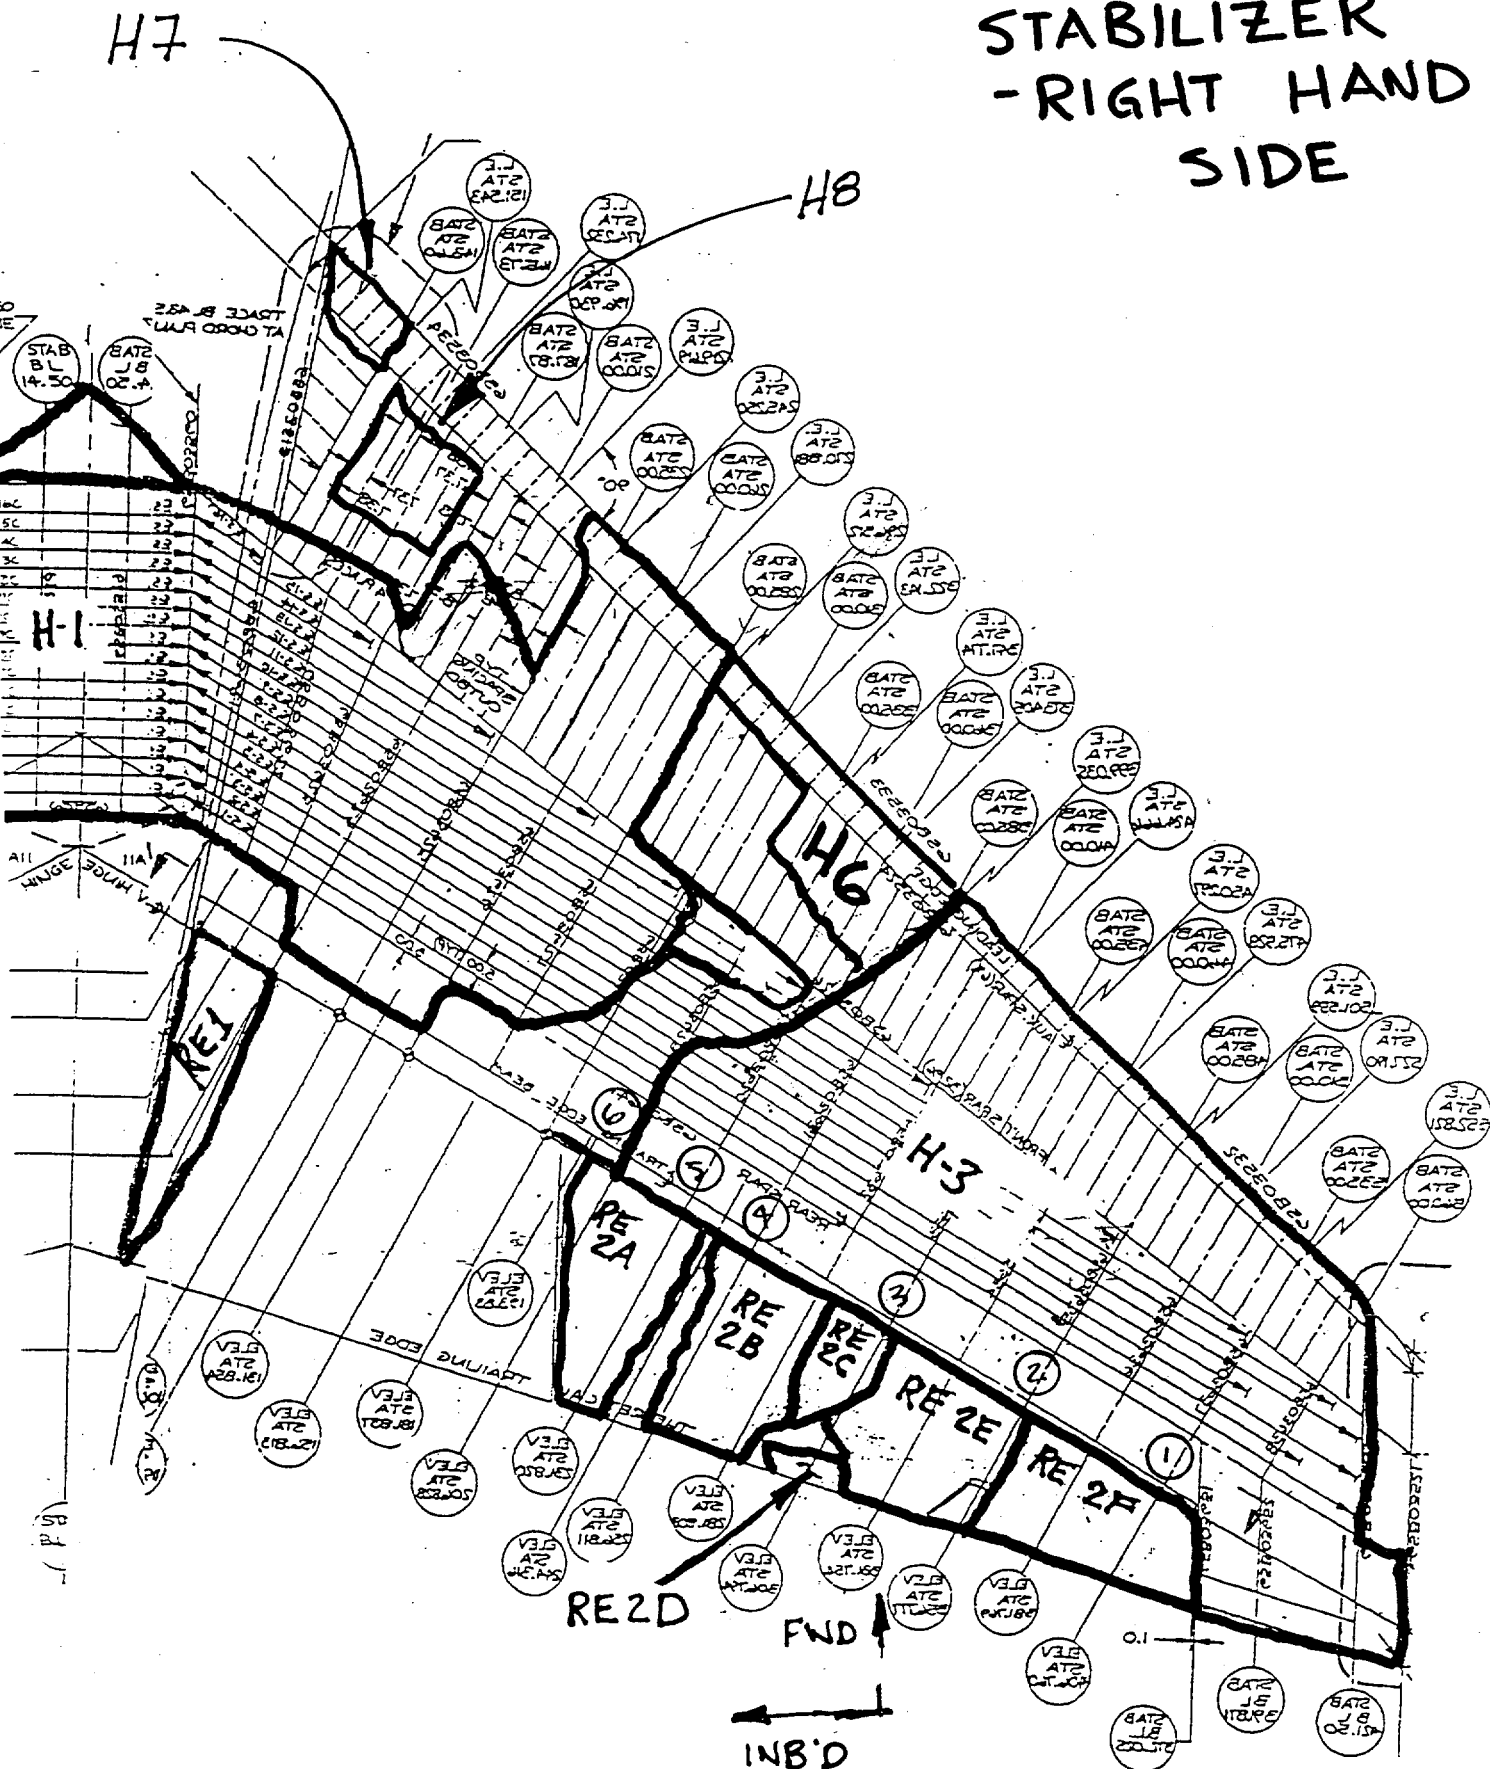
HORIZONTAL STABILIZER - RIGHT HAND SIDE

The right horizontal stabilizer inboard section remained attached to the horizontal stabilizer center torque box (H-1). The outboard fracture of this section was located near Stabilizer Station (Stab STA) 360, approximately. The upper skin in this area exhibited evidence of slight buckling. A few of the lower skin stiffeners are bent in the forward direction. The rear spar remained attached to this section from the torque box to Stab STA 285 and exhibited bending in aft direction at STA 285. The leading edge from the inboard end to Stab STA 235 was damaged. The remaining leading edge ribs inboard of Stab STA 153 are bent inboard and the leading edge ribs between Stab STA 196 to 235 approximately are bent outboard. About 50 inches of the leading edge outboard of Stabilizer STA 235 remained attached.

The outboard section of the right Horizontal Stabilizer (H-3), from Stab STA 310 to the tip, remained in one section. The rear spar at the inboard end was bent aft. The front spar just inboard of the Stab STA 385 was bent forward. The leading edge from the tip to Stab STA 385 remained attached to this section. The leading edge exhibited numerous dents along its length and was crushed aft at the inboard end for about 8 inches in length. The outboard-most 12 inches of the leading edge was crushed aft and outboard. This area exhibited black rub marks on the leading edge skin in the lateral direction. An engine turbine blade penetrated the upper honeycomb surface near the outboard trailing edge.

The leading edge section (H-6) between H-1 and H-3 is comprised of leading edge skin and ribs. The ribs fractured and separated from the front spar. In general, the aft ends of the rib webs were bent slightly outboard. The bull nose skin was dented along its length.

The inboard nose section (H-7) of the right Horizontal Stabilizer included the leading edge to the auxiliary spar. The lower skin surface was torn and bent down and forward.

A section of the structure outboard of H-7 exhibited evidence of red paint transfer marks on the upper skin (H-8); only the remnants of the shattered logo light window remain in the window frame.

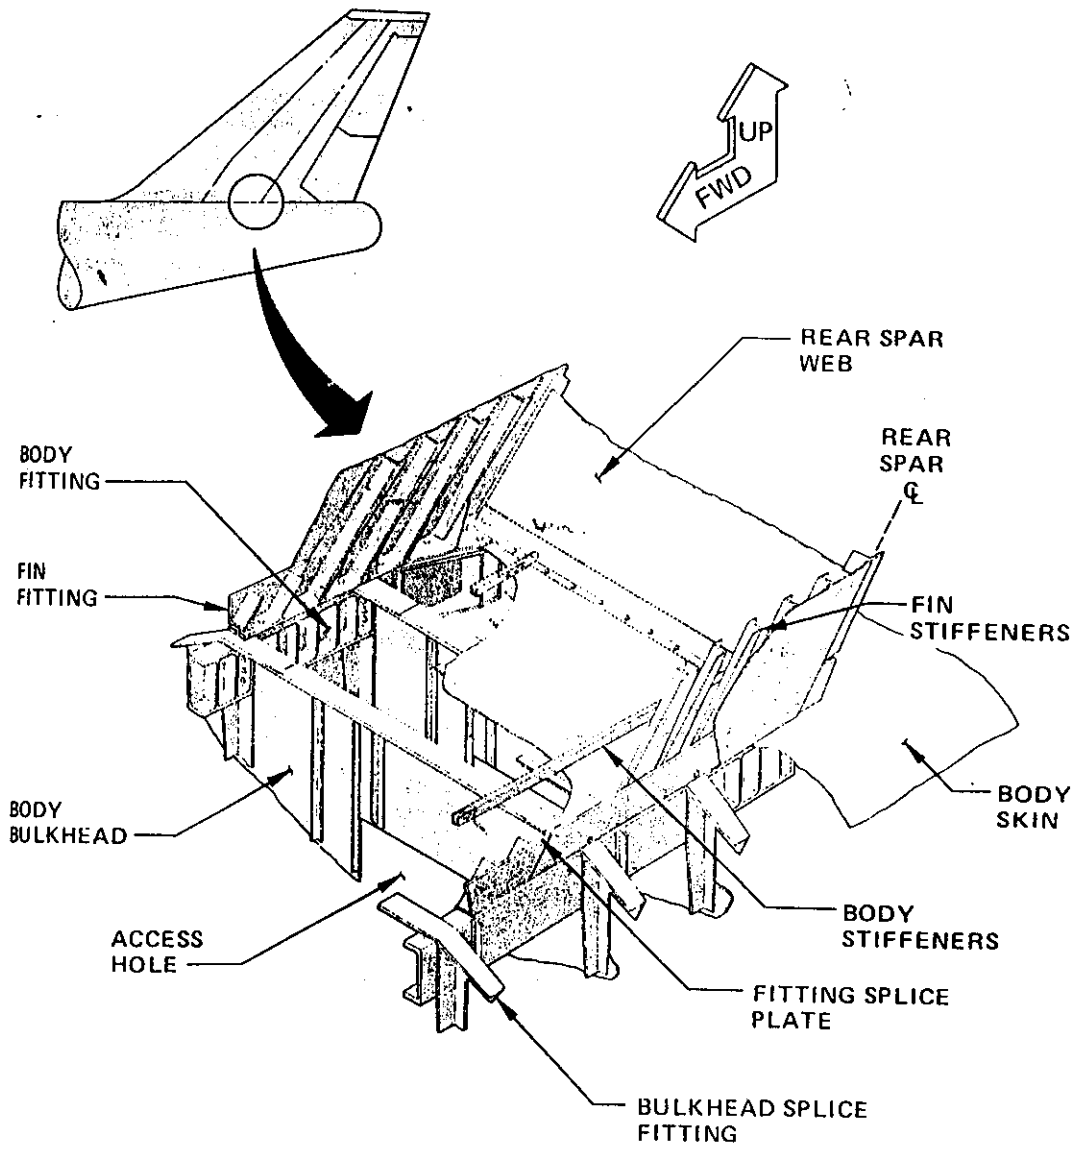
Fin/Body Attachment

The vertical stabilizer structure between the front and rear spars fractured into numerous sections. The right body fittings from the rear spar to stringer 9 of the vertical fin, separated with the right skin and stringers remaining attached (V-9). The right skin was bent outboard at the upper ends. Remnants of the body bulkheads were still attached below the body fittings and were bent aft. Vertical skin panel V-8, which mates with V-9, was relatively flat except for slight bending outboard of the upper 10 inches of the panel. The left body fitting for the vertical fin separated, with the left skin and stringers remaining (V-6). The left skin and stringer panel (V-5), which mates with V-6, is relatively flat. The V-4 part consists of the upper vertical fin left skin panel and stringers between the front and rear spars from Fin STA 370 to 520. The lower panels (V-5, V-6, V-8, and V-9) exhibit an outward deformation at the lower fractured end, relative to the vertical fin surface.
