**NATIONAL TRANSPORTATION SAFETY BOARD  
Office of Aviation Safety  
Washington, DC 20594**

**STRUCTURES GROUP - ENGINE STRUT SUMMARY**

**ACCIDENT : DCA96MA070**  
**Location : East Moriches, New York**  
**Date : July 17, 1996**  
**Time : 2031 Eastern Daylight Time**  
**Airplane : Boeing 747-131, N93119**  
**Operated as Trans World Airlines (TWA) Flight**  
**800**

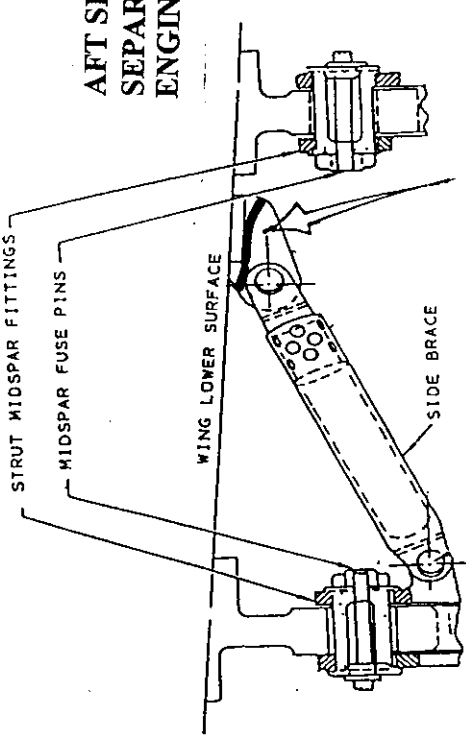
STRUT TO-WING CONNECTIONS STRUT NO.1

**SIDE BRACE ATTACHMENT  
 SEPARATED AT WING CONNECT  
 (DUCTILE FRACTURE)**

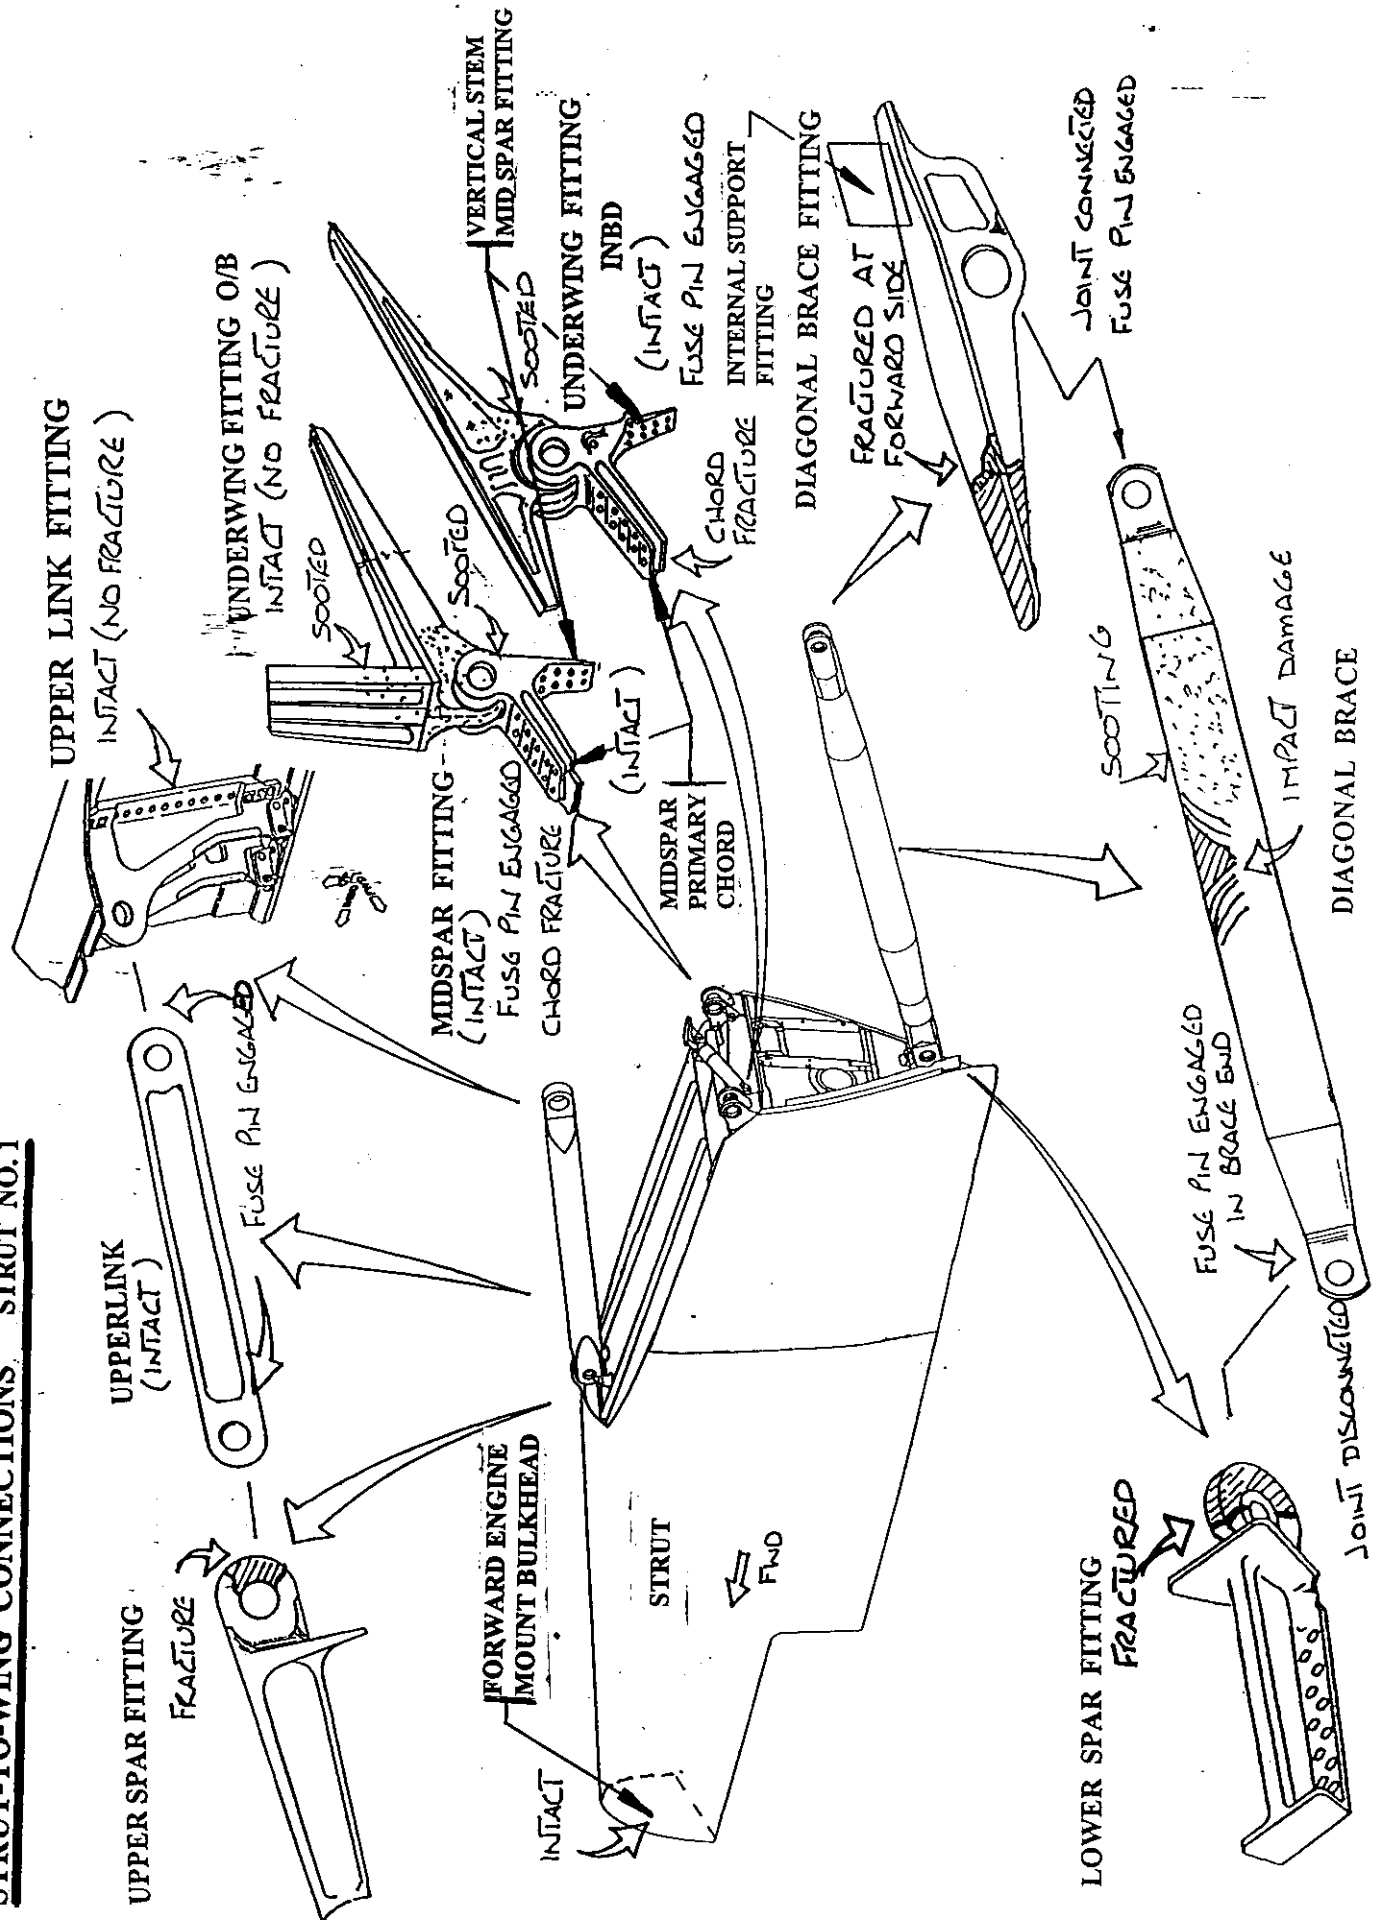
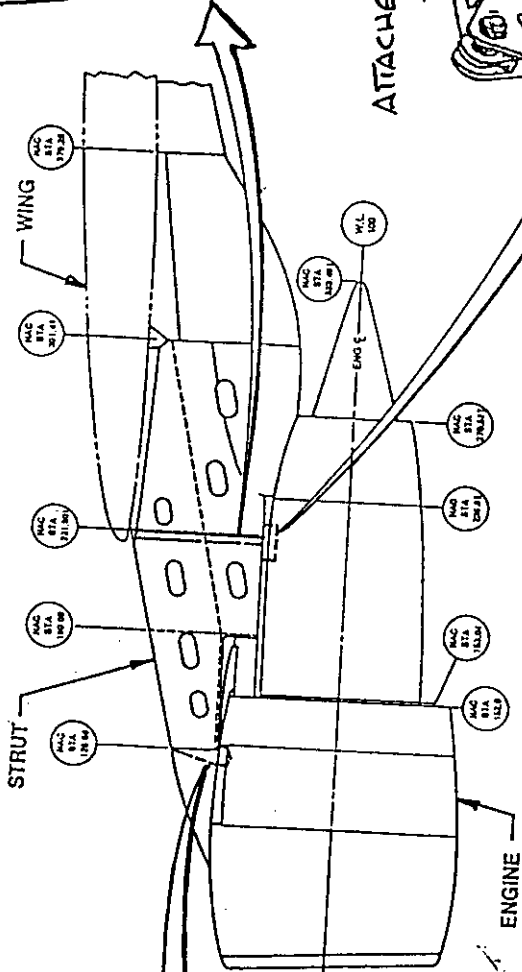
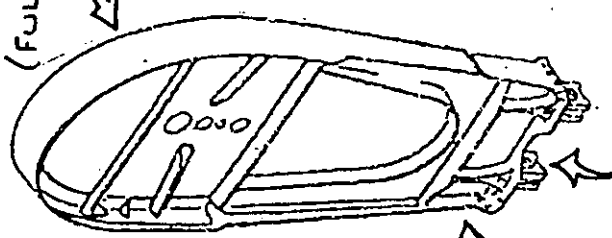
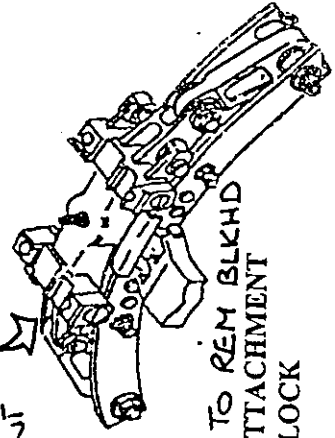
STRUT NO. 1

FORWARD ENGINE MOUNT BULKHEAD (INTACT)

FULLY ATTACHED TO STRUT BOX

CONE BOLT (INTACT)

FAN CASE ATTACHED

FORWARD ENGINE MOUNT ATTACHMENT (INTACT)

REAR ENGINE MOUNT BULKHEAD

(FULLY INTACT)

(INTACT) CONNECTED TO REM BLKHD TANGENTIAL LINK ATTACHMENT TO LOWER MOUNT BLOCK

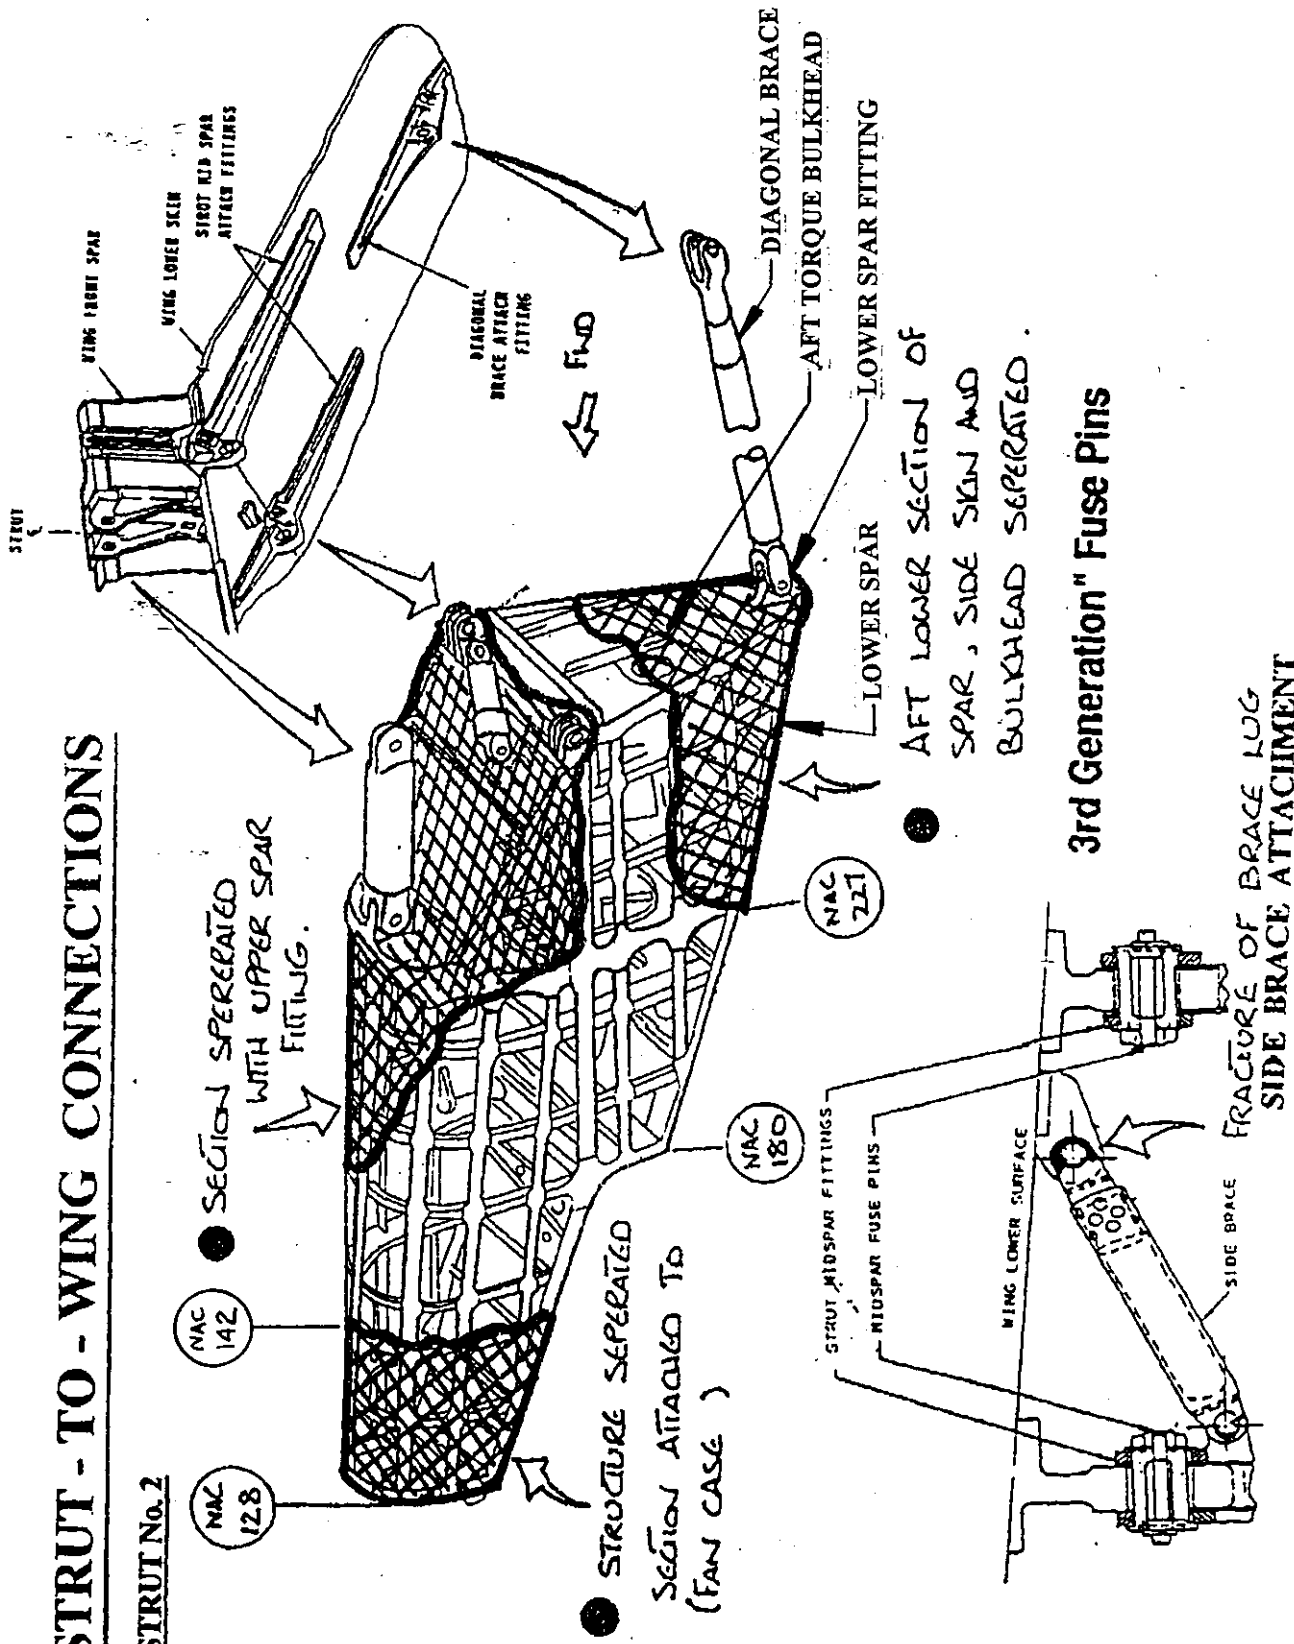
STRUT No. 2

● AFT LOWER SECTION OF SPAR, SIDE SKIN AND BULKHEAD SEPERATED.

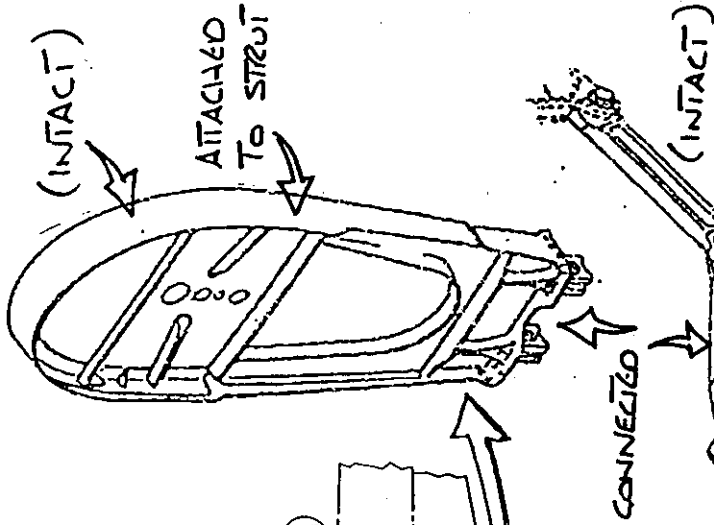
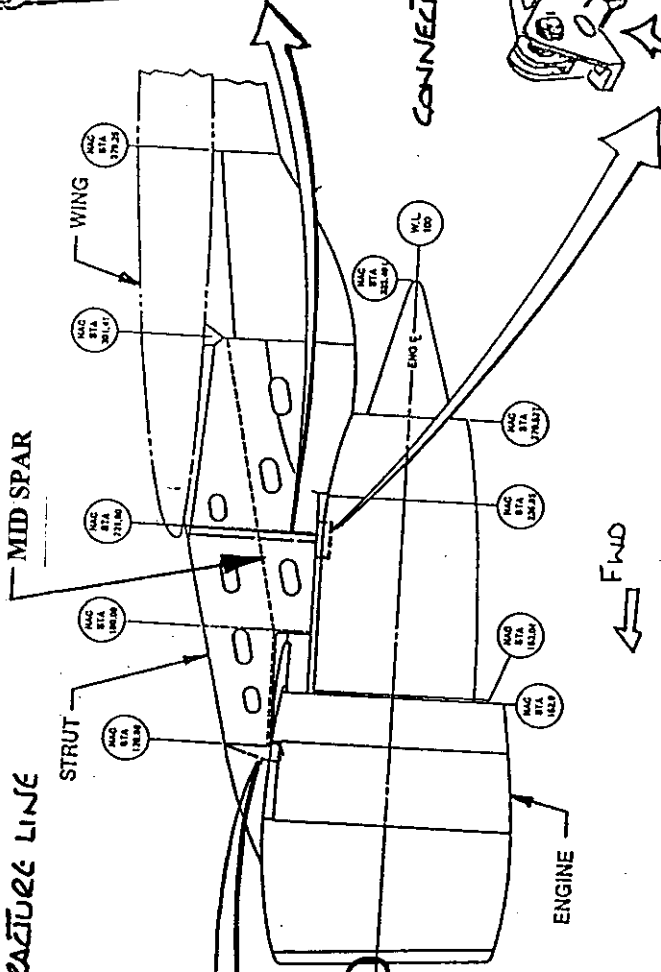
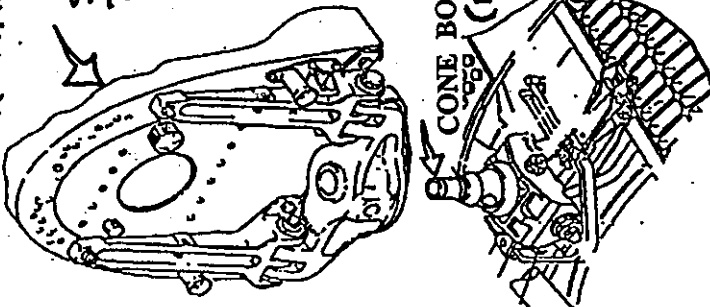
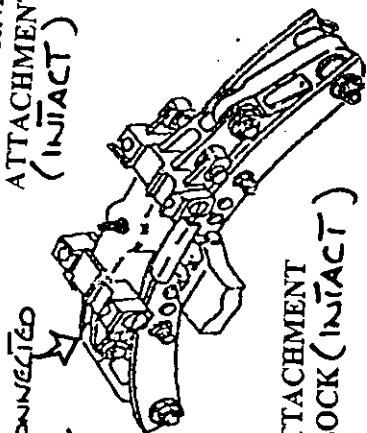
STRUT NO. 3

FORWARD ENGINE MOUNT BULKHEAD (INTACT)

SEPERATED ALONG THIS FRACTURE LINE

FRONT CONE BOLT (INTACT)

FORWARD ENGINE MOUNT ATTACHMENT (TO FAN CASE) ENGINE MOUNT SEPERATED WITH AND CONNECTED TO FAN CASE

THRUST LINK ATTACHMENT (INTACT)

REAR ENGINE MOUNT SEPERATED WITH AND TO TURBINE EXHAUST CASE.

TANGENTIAL LINK ATTACHMENT TO LOWER MOUNT BLOCK (INTACT)

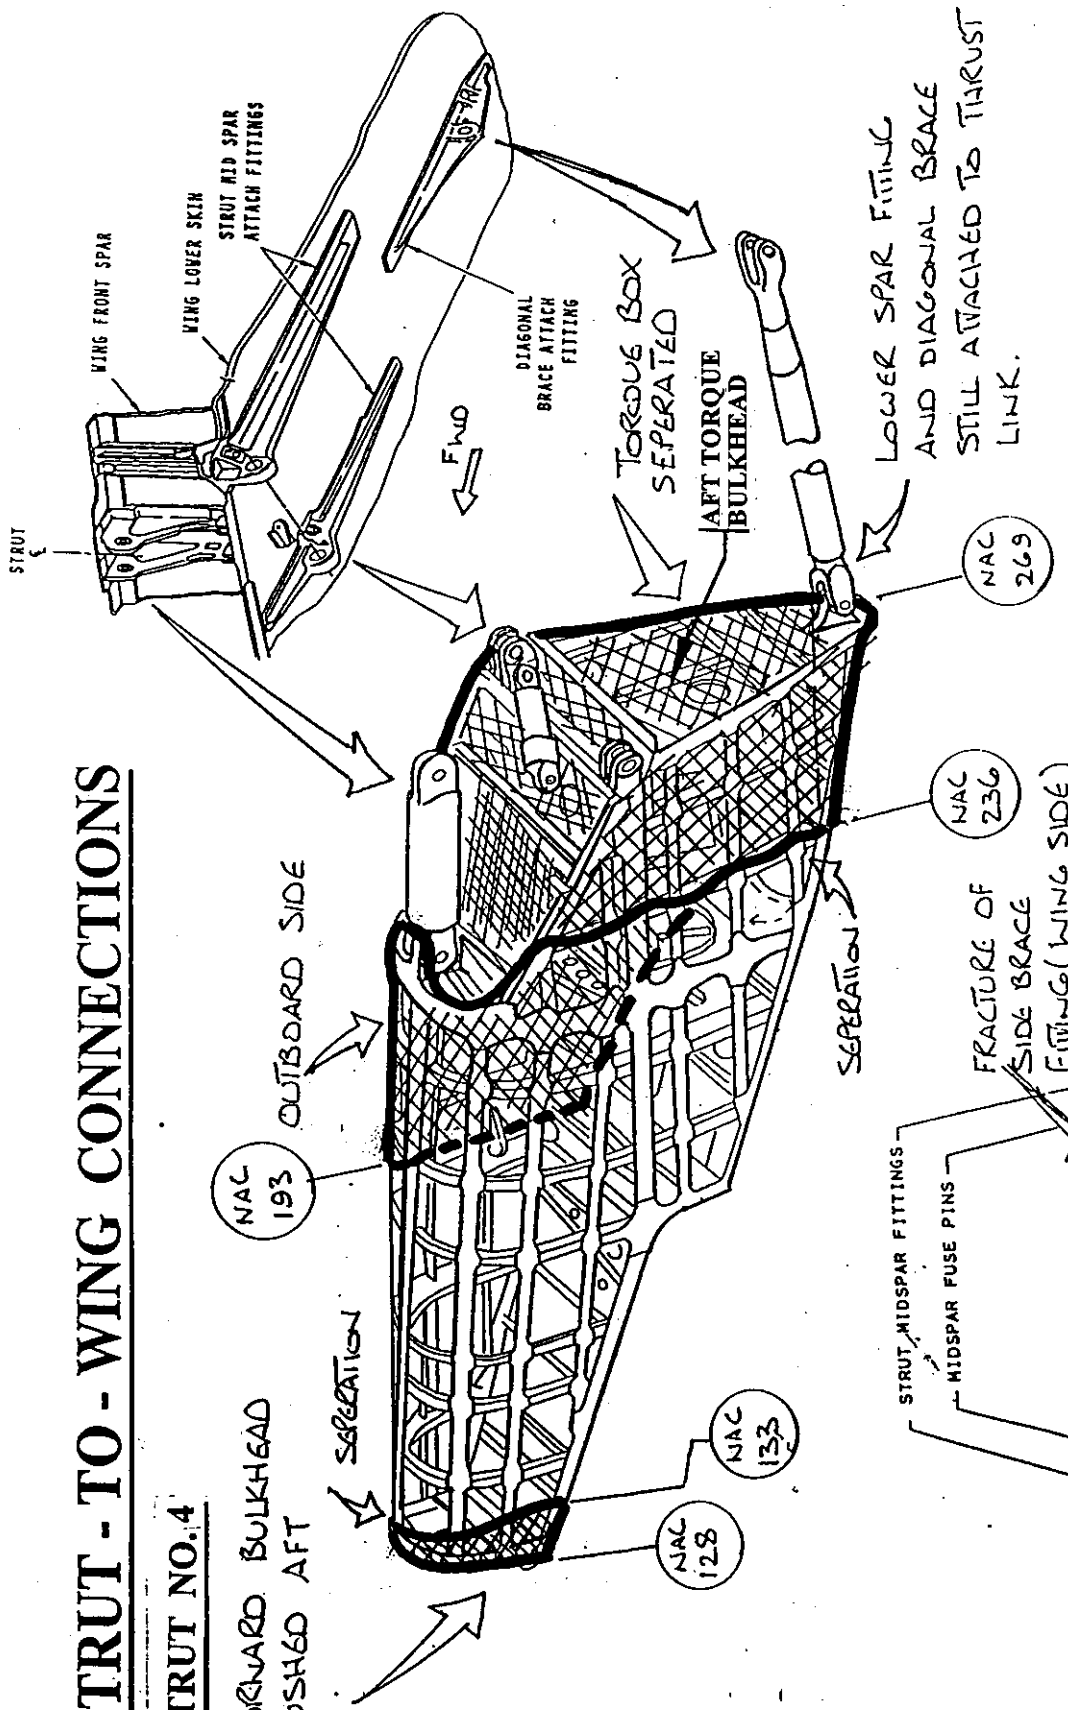
## STRUT NO. 4

FORWARD BULKHEAD  
PUSHED AFT

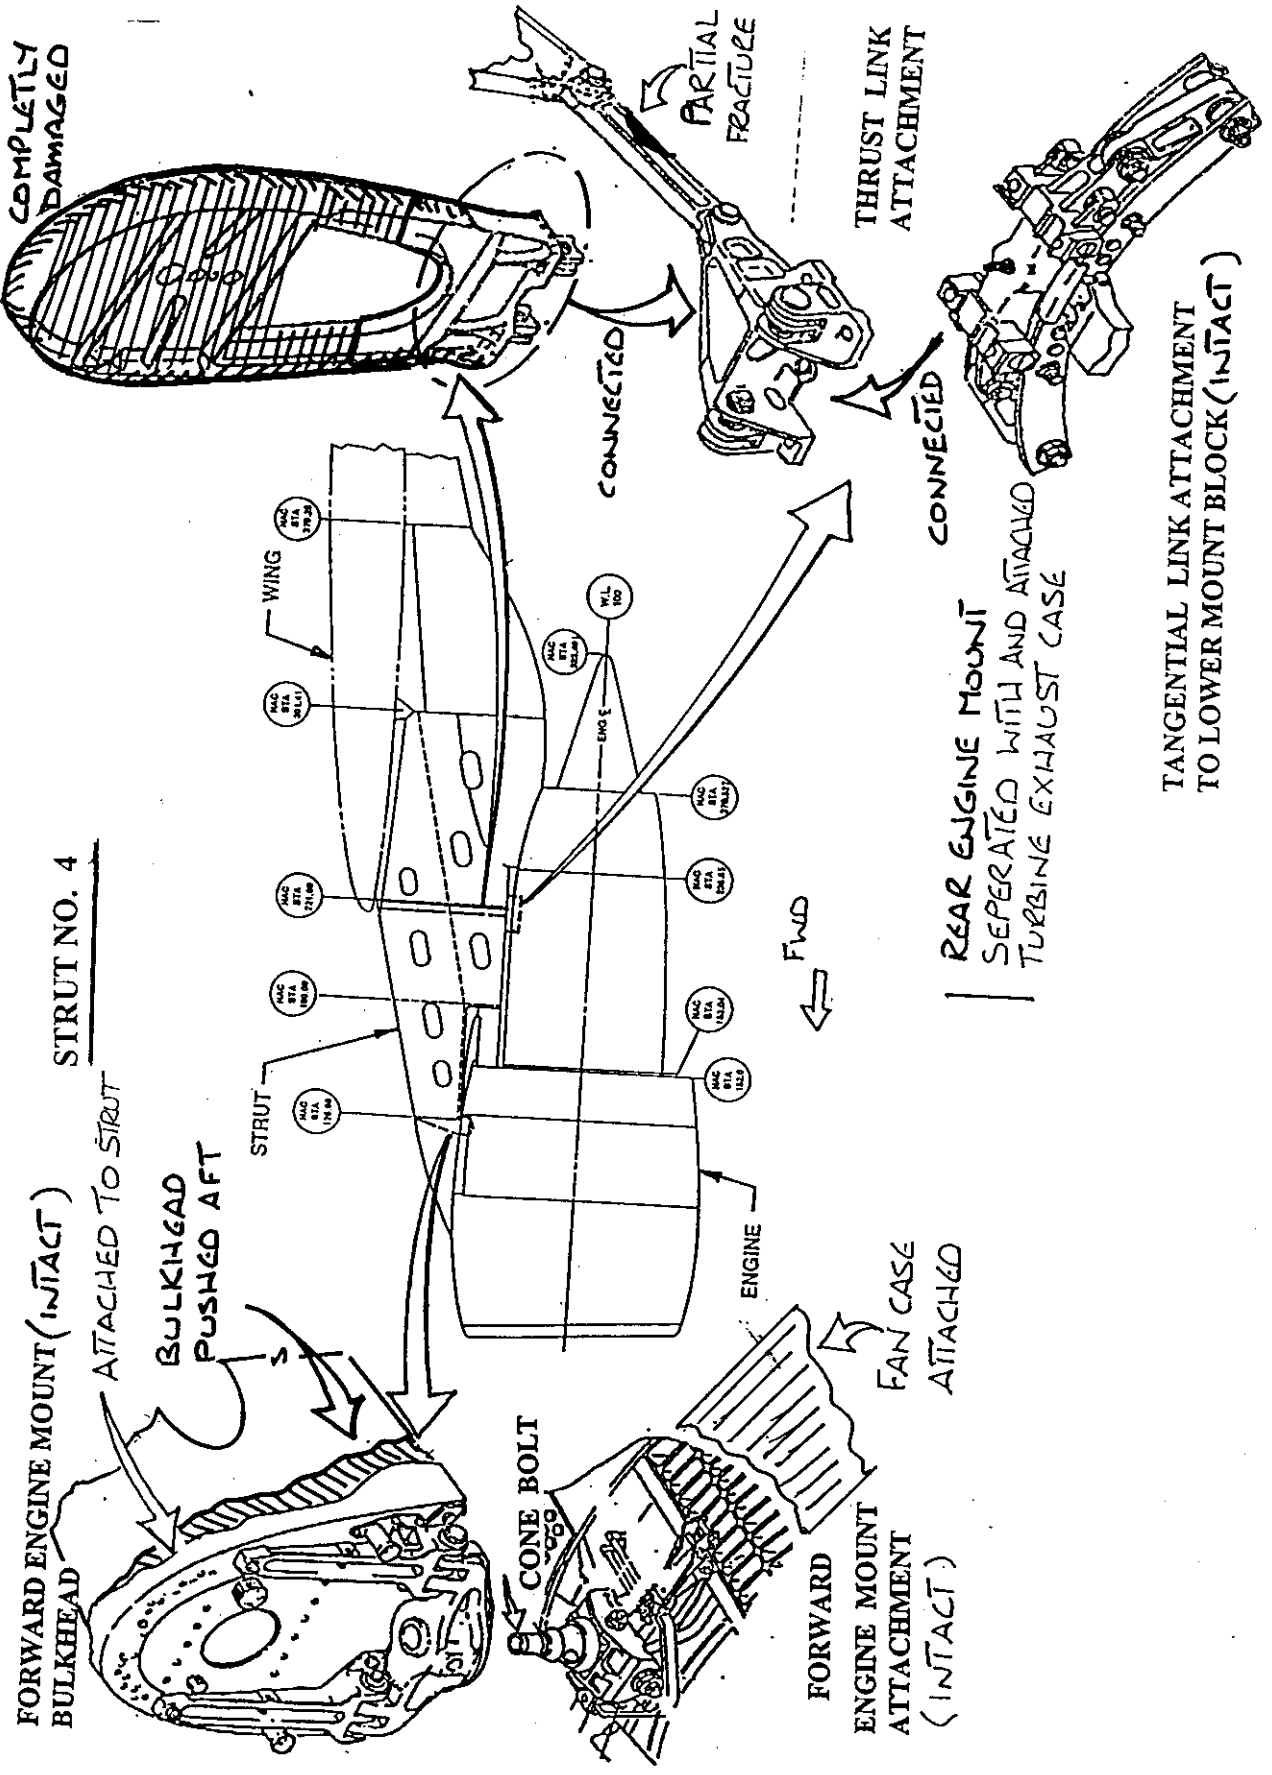
FORWARD ENGINE MOUNT (INTACT)  
BULKHEAD

ATTACHED TO STRUT

BULKHEAD  
PUSHED AFT

PARTIAL  
FRACTURE

REAR ENGINE MOUNT  
SEPERATED WITH AND ATTACHED  
TURBINE EXHAUST CASE

TANGENTIAL LINK ATTACHMENT  
TO LOWER MOUNT BLOCK (INTACT)

COMPLETELY  
DAMAGED
