**DOCKET NO. SA-517**  
**EXHIBIT NO. 7A**

**STRUCTURES GROUP CHAIRMAN'S FACTUAL REPORT**

**A. ACCIDENT DCA-97-MA-058**

Location: Agana, Guam  
Date: August 6, 1997  
Time: 0142 Guam Local Time  
Aircraft: Boeing 747-300, HL-7468, Korean Air, Flight No. 801

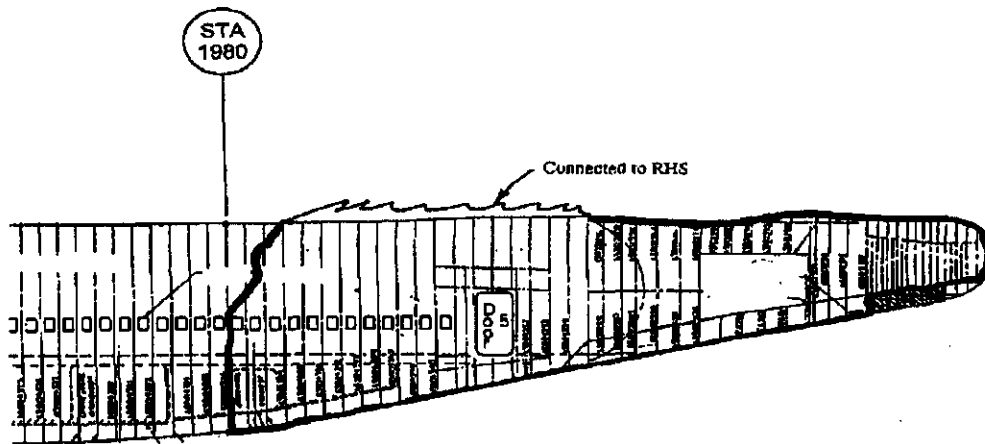
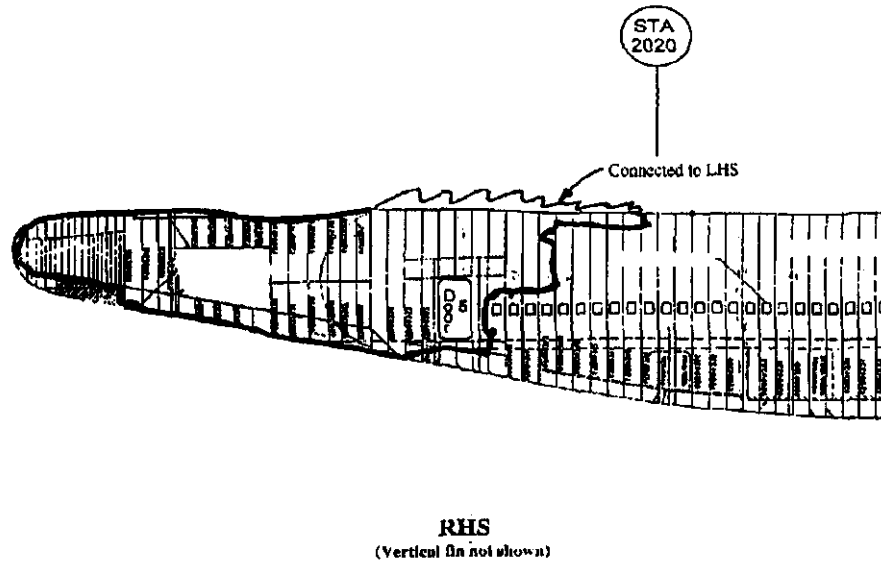
The empennage structure and the aft portion of the section 46 fuselage structure remained attached and essentially intact forward to approximately STA 1980. The RHS and LHS horizontal stabilizer components (including elevators) and the vertical fin were still intact and attached. This entire section was in an upright position and tilted slightly to the LHS. See [Figure 1] and [Figure 2] for a definition of this section.

The exterior surface was lightly sooted on the LHS with heavy fire damage on the forward portion which rested on the RHS wing. The exterior of the RHS had almost no sooting but was burned around the periphery of door 5R and within 3 frame bays of the break line. The interior was fire damaged from the main deck floor level to the belly. The upper portions of the internal structure were not burned significantly. The aft pressure bulkhead was intact and the lower portion was deformed due to impact forces. There was no fire damage to the bulkhead.

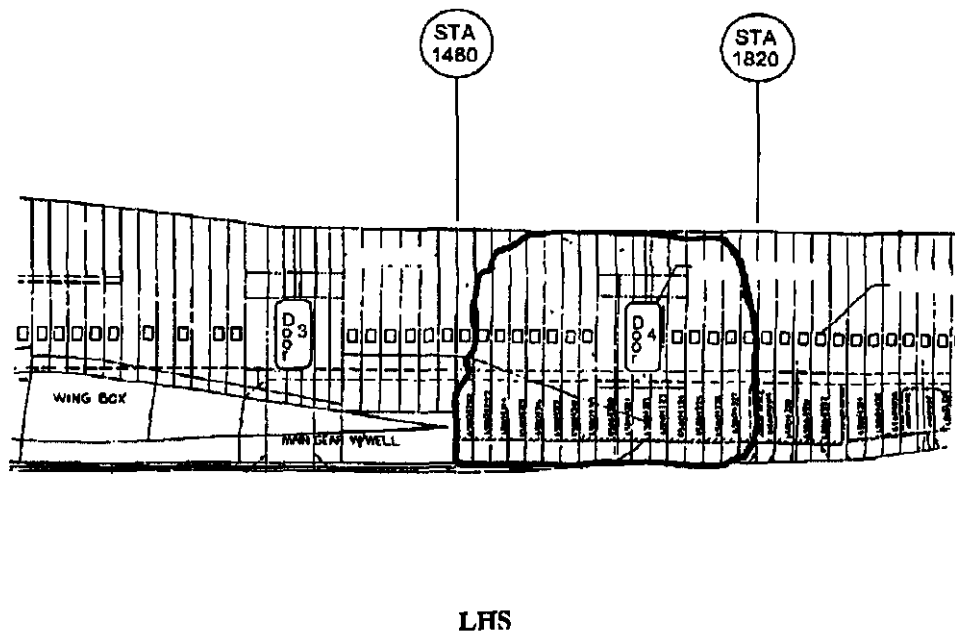
**Figure 3**

A large panel of the section 46 skin rested with the outside surface down and was partially covered by the center section structure. The panel was from the LHS of the fuselage and extended from approximately the crown centerline to the belly centerline, from STA 1480 to STA 1820. The majority of the frame and stringer segments remained attached to the panel. The interior structure was not burned, however, the exterior was heavily sooted. See [Figure 3] for a definition of this segment.

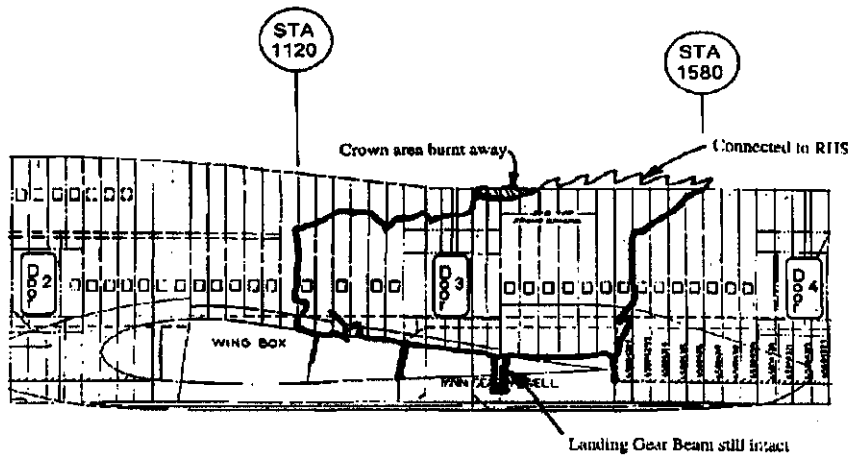
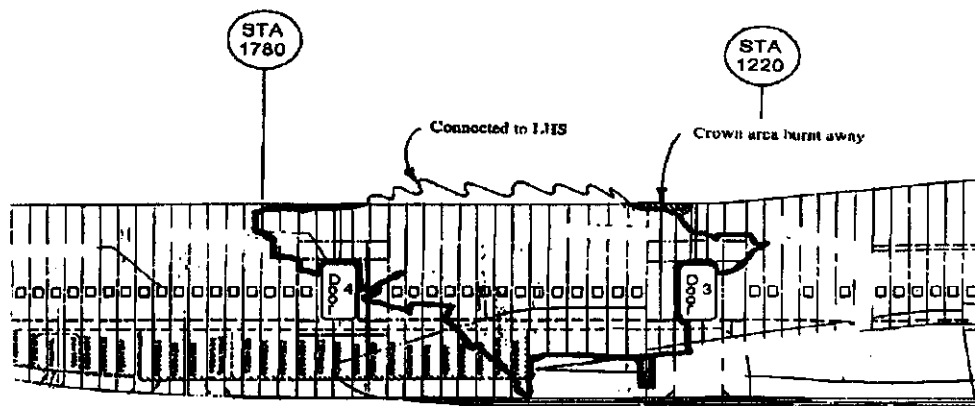
The center portion fuselage structure extended from STA 1120 (LHS) and STA 1240 (RHS) aft to STA 1780. The LHS and RHS skin were still attached across the crown and the section was still attached to the RHS wing by the landing gear beam. The STA 1350 landing gear beam was still attached to the section on both the LHS and RHS. The majority of the rear spar and spanwise beam #1 were still in place, as well as portions of the midspar. The remaining spanwise beams and the front spar were found fragmented. The entire center section was found rotated 180 degrees to the debris path, with the forward end of the section facing the aft body and empennage structure described previously. The interior was extensively fire damaged throughout the section with the crown area forward of STA 1350 burned through. The exterior skin had fire damage primarily adjacent to the break and the exterior of the RHS skin was heavily burned between door 3R and door 4R. See [Figure 4] and [Figure 5] for a definition of this section.

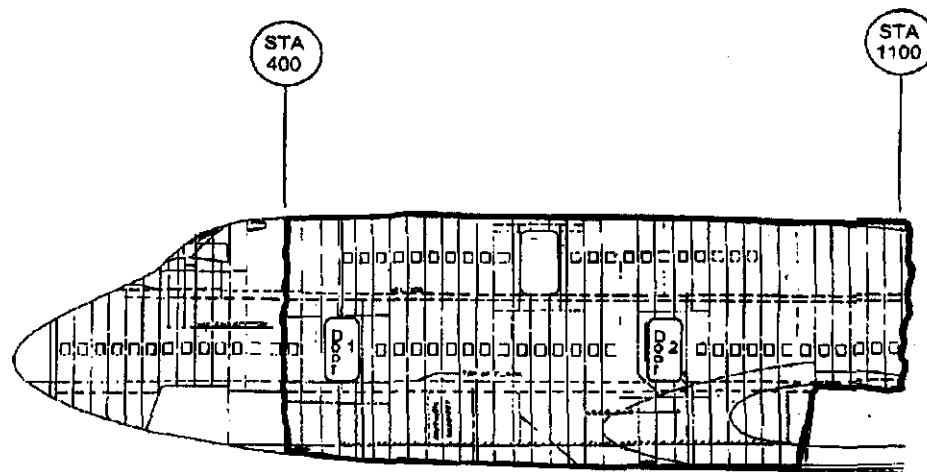
**Figure 6**

The forward fuselage section from approximately STA 1120 to STA 400 was located on a hillside just beyond the center section (toward the runway). The structure was split just above the main deck floor on the RHS and most of the internal structure (frames, stringers, and fractured floor beams) remained attached. There was extensive fire damage to the structure that was on the lower portion of the hillside (LHS structure and crown area). Much of the structure in this lower area was burned through. There was minimal fire damage to the structure at the top of the hillside (LHS main deck structure). See [Figure 6] for a definition of this section.

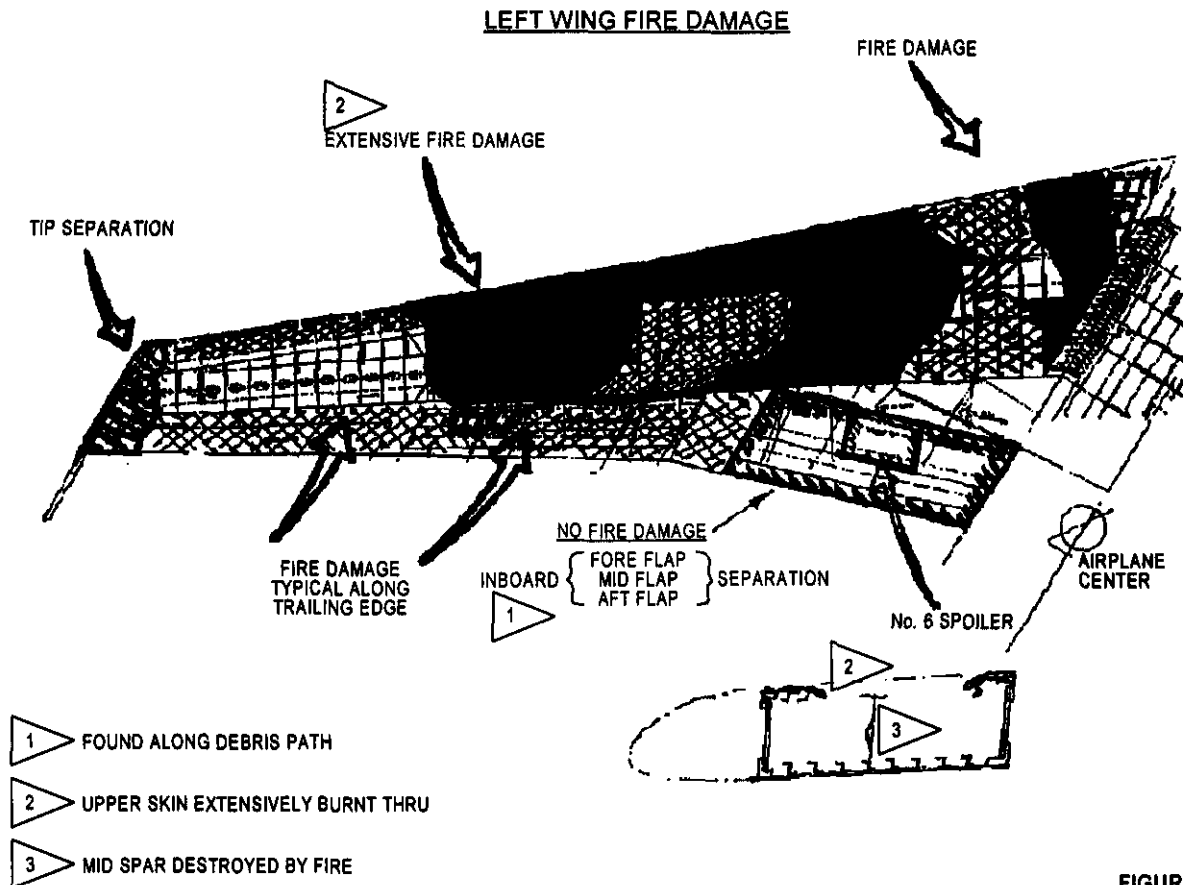
**FIGURE 9**

The LHS wing outboard section was located approximately parallel to the RHS wing section within the main wreckage area. This wing structure was approximately 80% complete. Extensive post impact fire resulted in heavy damage to the wing upper skin and mid spar between wing station (WS) 470 and WS 1200, including the mid-spar web and chord structure. The corresponding lower skin and stringers also had considerable fire damage. Exposure to the post impact fire resulted in various degrees of damage to the remaining wing structure, including the leading edge and trailing edge flap structure. The outboard wing tip, which was comprised of

The trailing edge flaps and control surfaces were found mostly intact with some local fire damage, with the exception of the inboard flap system, #4 flap track, and #6 spoiler, which separated from the wing box during initial impact (The #4 flap track was located in the debris path prior to the main wreckage area. See wreckage plots and data table [Attachment 1] for location of these components). Examination of these components showed that the fractures typical of overload, resulting from impact. Details of the LHS wing damage are shown in [Figure 9] and [Figure 11].

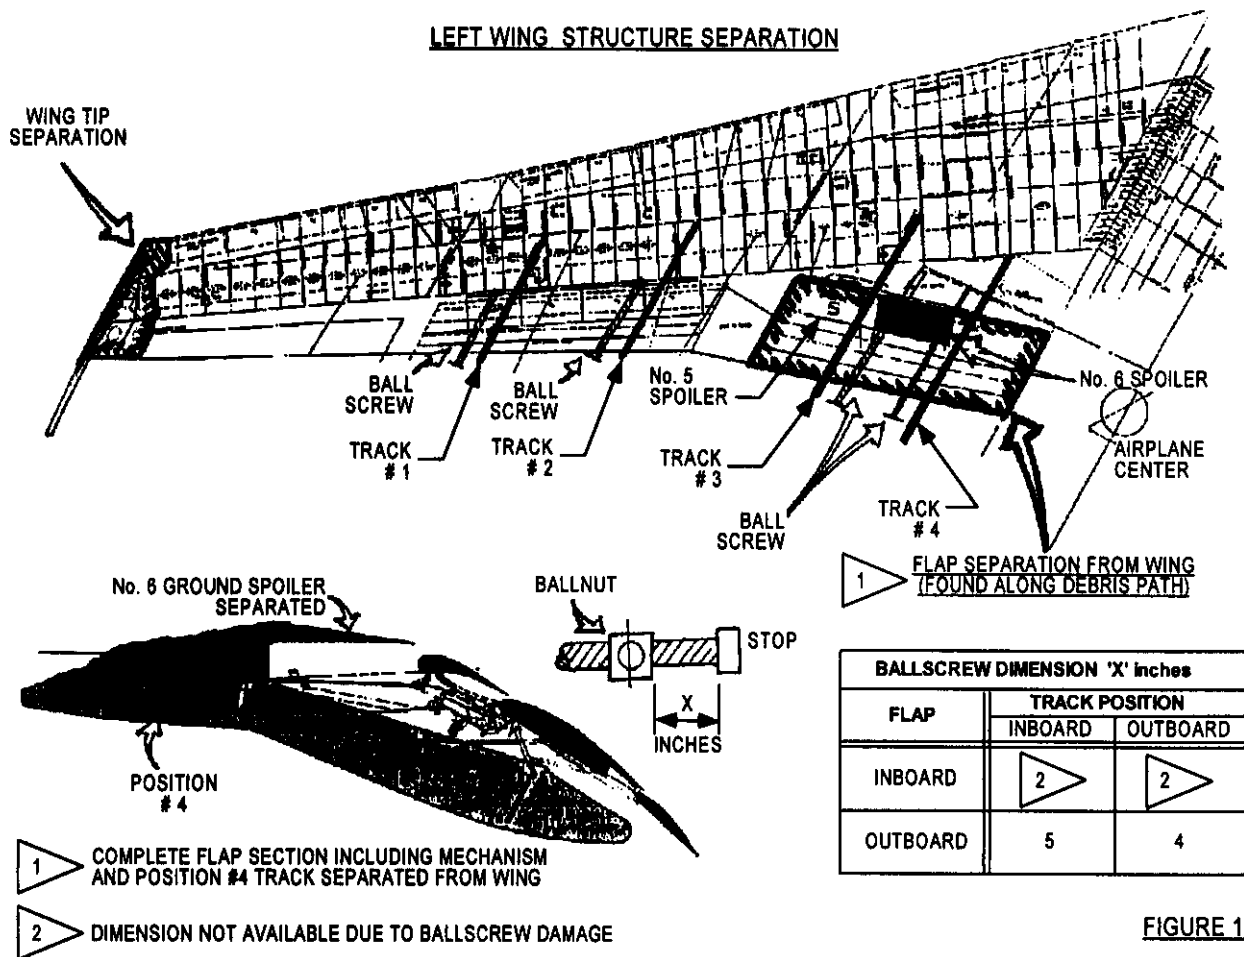
**FIGURE 11**

The full combination of outboard flap and support structure was found in place on the wing box with a detent extension representative of approximately 25 degrees, as indicated by the measured ball screw position (see Figure 11). The flap structure had heavy fire damage.

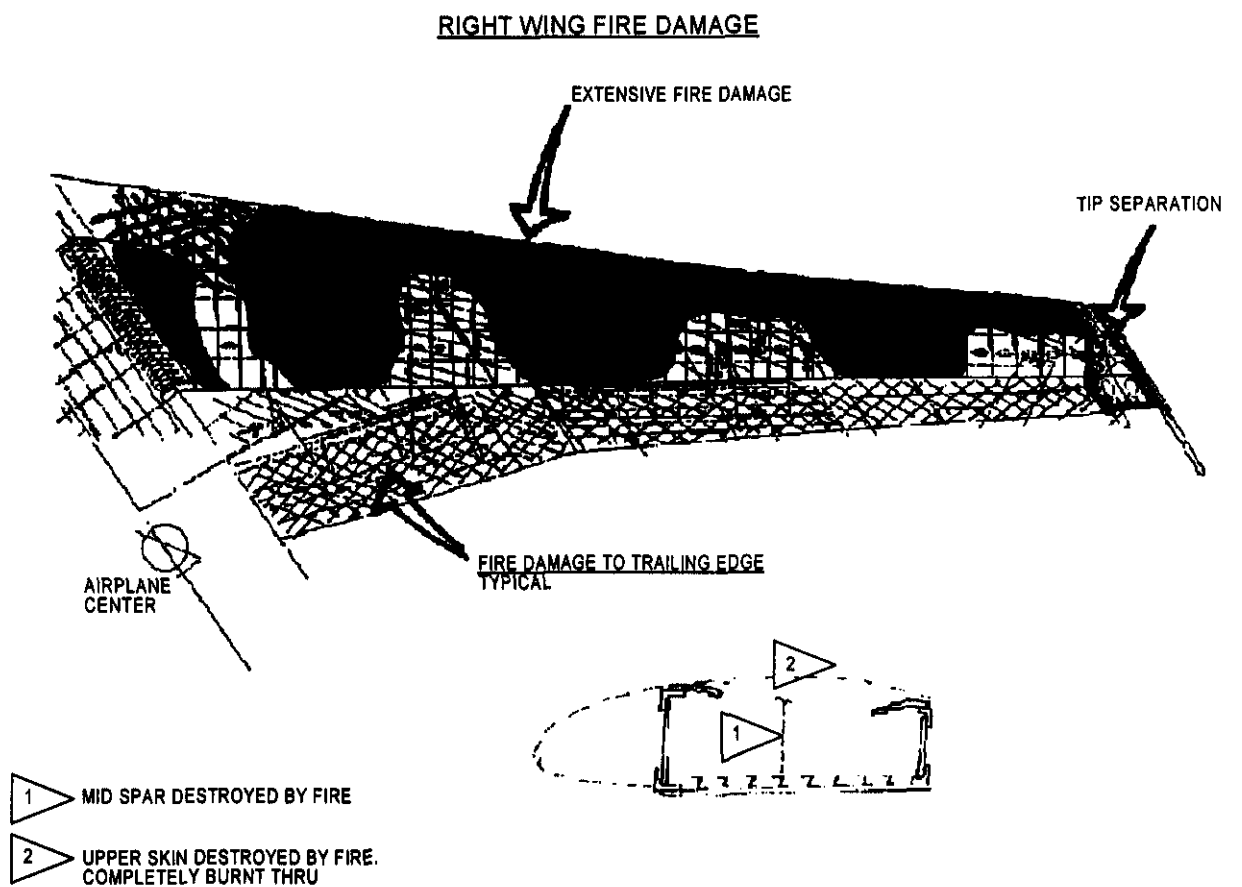
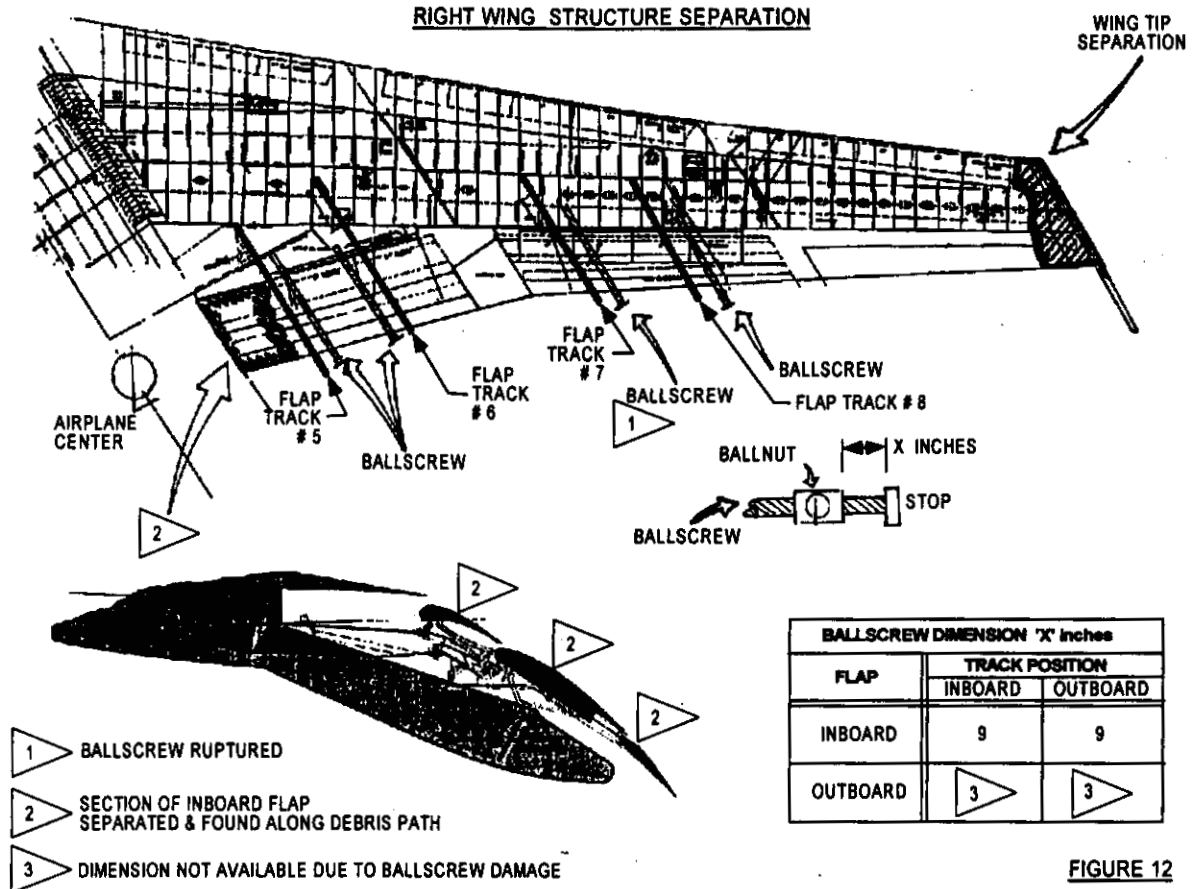
The RHS outboard wing section was located alongside the LHS wing within the main wreckage area, with similar damage to the wing box structure as a result of impact forces and post impact fire damage. The wing structure was approximately 75% complete with extensive fire damage between of the upper skin and related mid-spar web structure between WS 500 and WS 1400. The outboard wing tip was separated at the surge tank end rib in a similar manner to the LHS wing structure and was free of fire damage.

The full compliment of flight control surfaces and trailing edge flaps remained with the wing box, with the exception of approximately six feet of the inboard end of the fore, mid, and aft flap structure (These components were found in the vicinity of the initial impact. See wreckage plots and data table [Attachment 1] for location of these components). The fractures are typical of overload, resultant from impact forces. This section was free of fire damage. Details of the RHS wing damage are shown in [Figure 10] and [Figure 12].

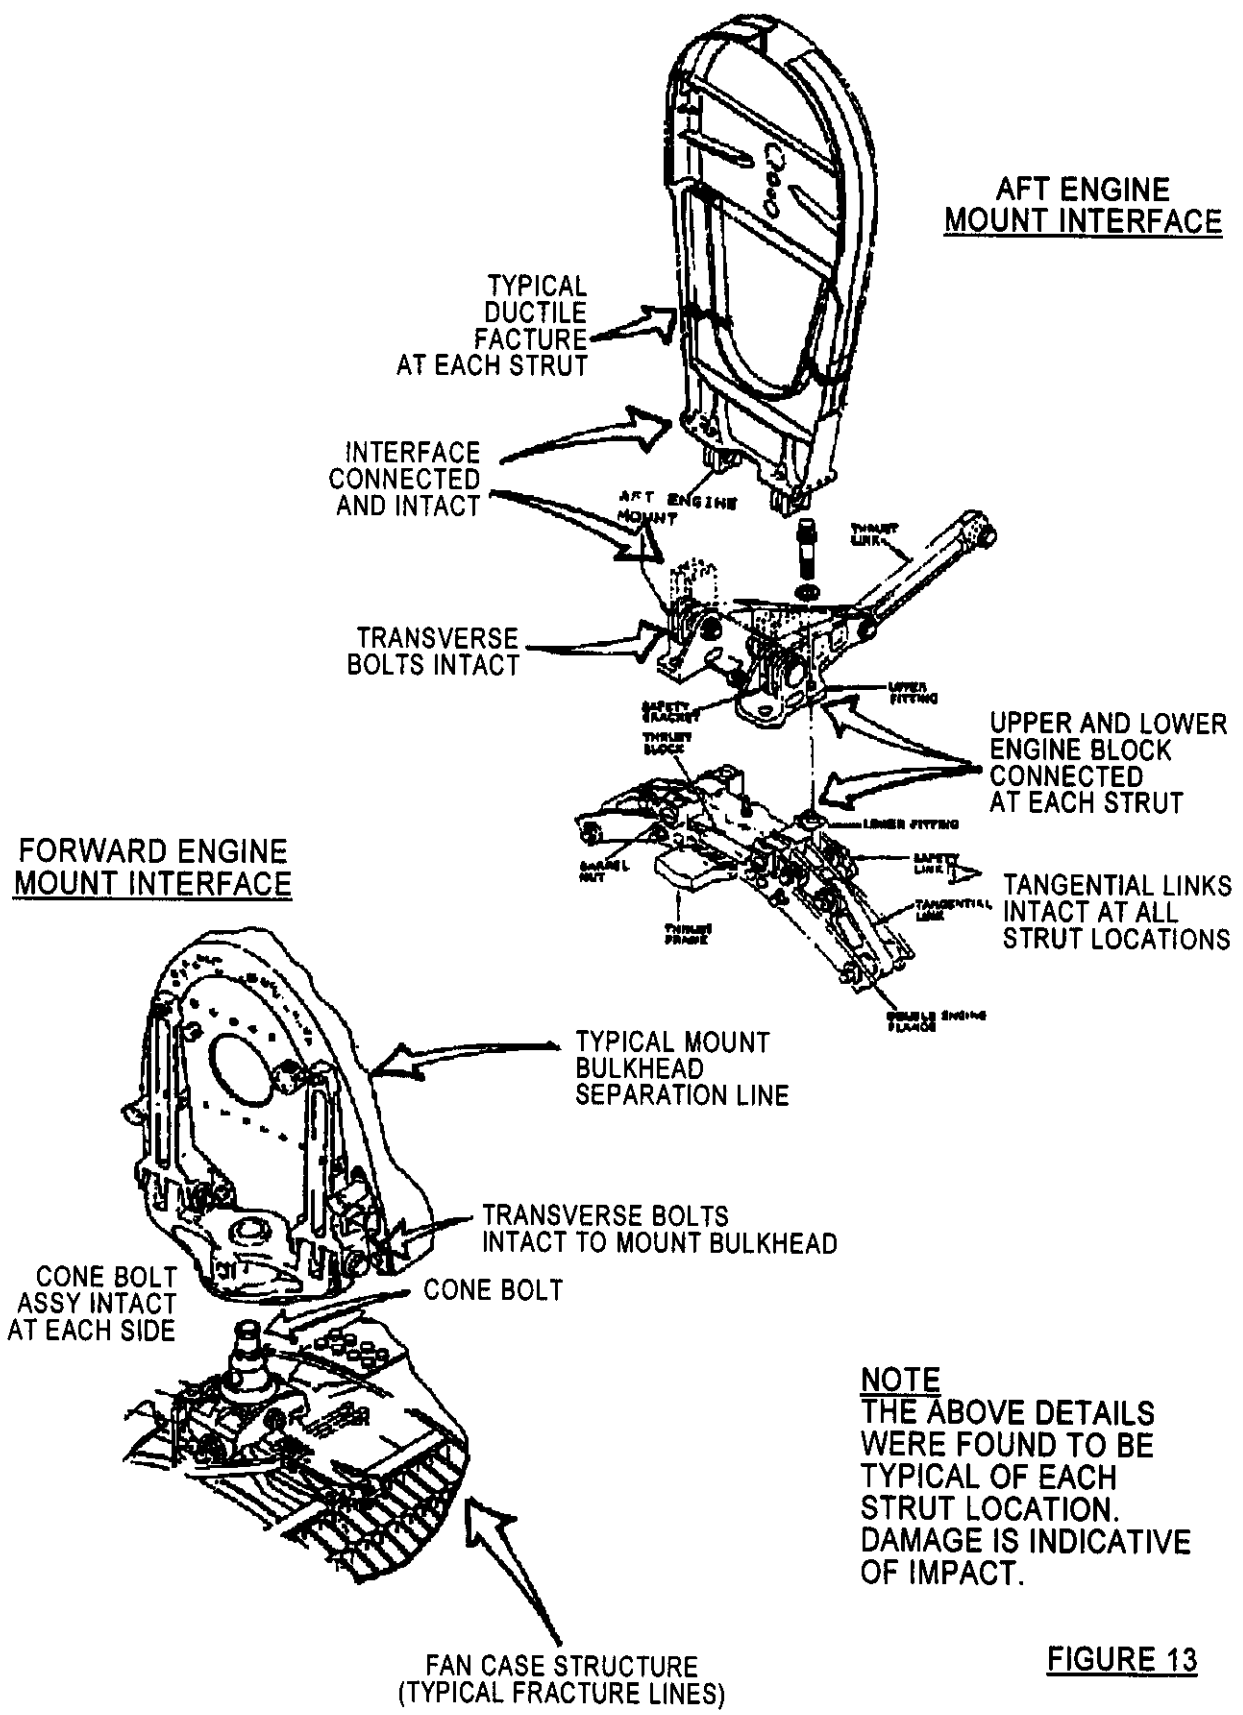
**FIGURE 13**

All four P&W JT9D-7R4G2 engines were found detached from the aircraft. Engines #2, #3, and #4 were located in the main wreckage area. The #1 engine was located close to the initial impact area as shown in [Attachment 1]. Typical engine mount separation is shown in [Figure 13].

Each forward and aft engine mount assembly was located and included the strut forward bulkhead, the cone bolt assembly, and the strut rear engine mount and tangential link assembly. Each of these components were found intact and connected to a section of the fan case and "S" frame segments respectively.

Although the strut and engine frame had extensive impact damage, the primary interface assemblies for both the cone bolt and tangential link assembly of each engine remained intact.
