**NATIONAL TRANSPORTATION SAFETY BOARD  
WASHINGTON, D.C.**

**STRUCTURES/SYSTEMS GROUP CHAIRMAN'S  
FACTUAL REPORT**

STRUCTURES/SYSTEMS GROUP CHAIRMAN'S FACTUAL REPORT

DCA-96-MA-068

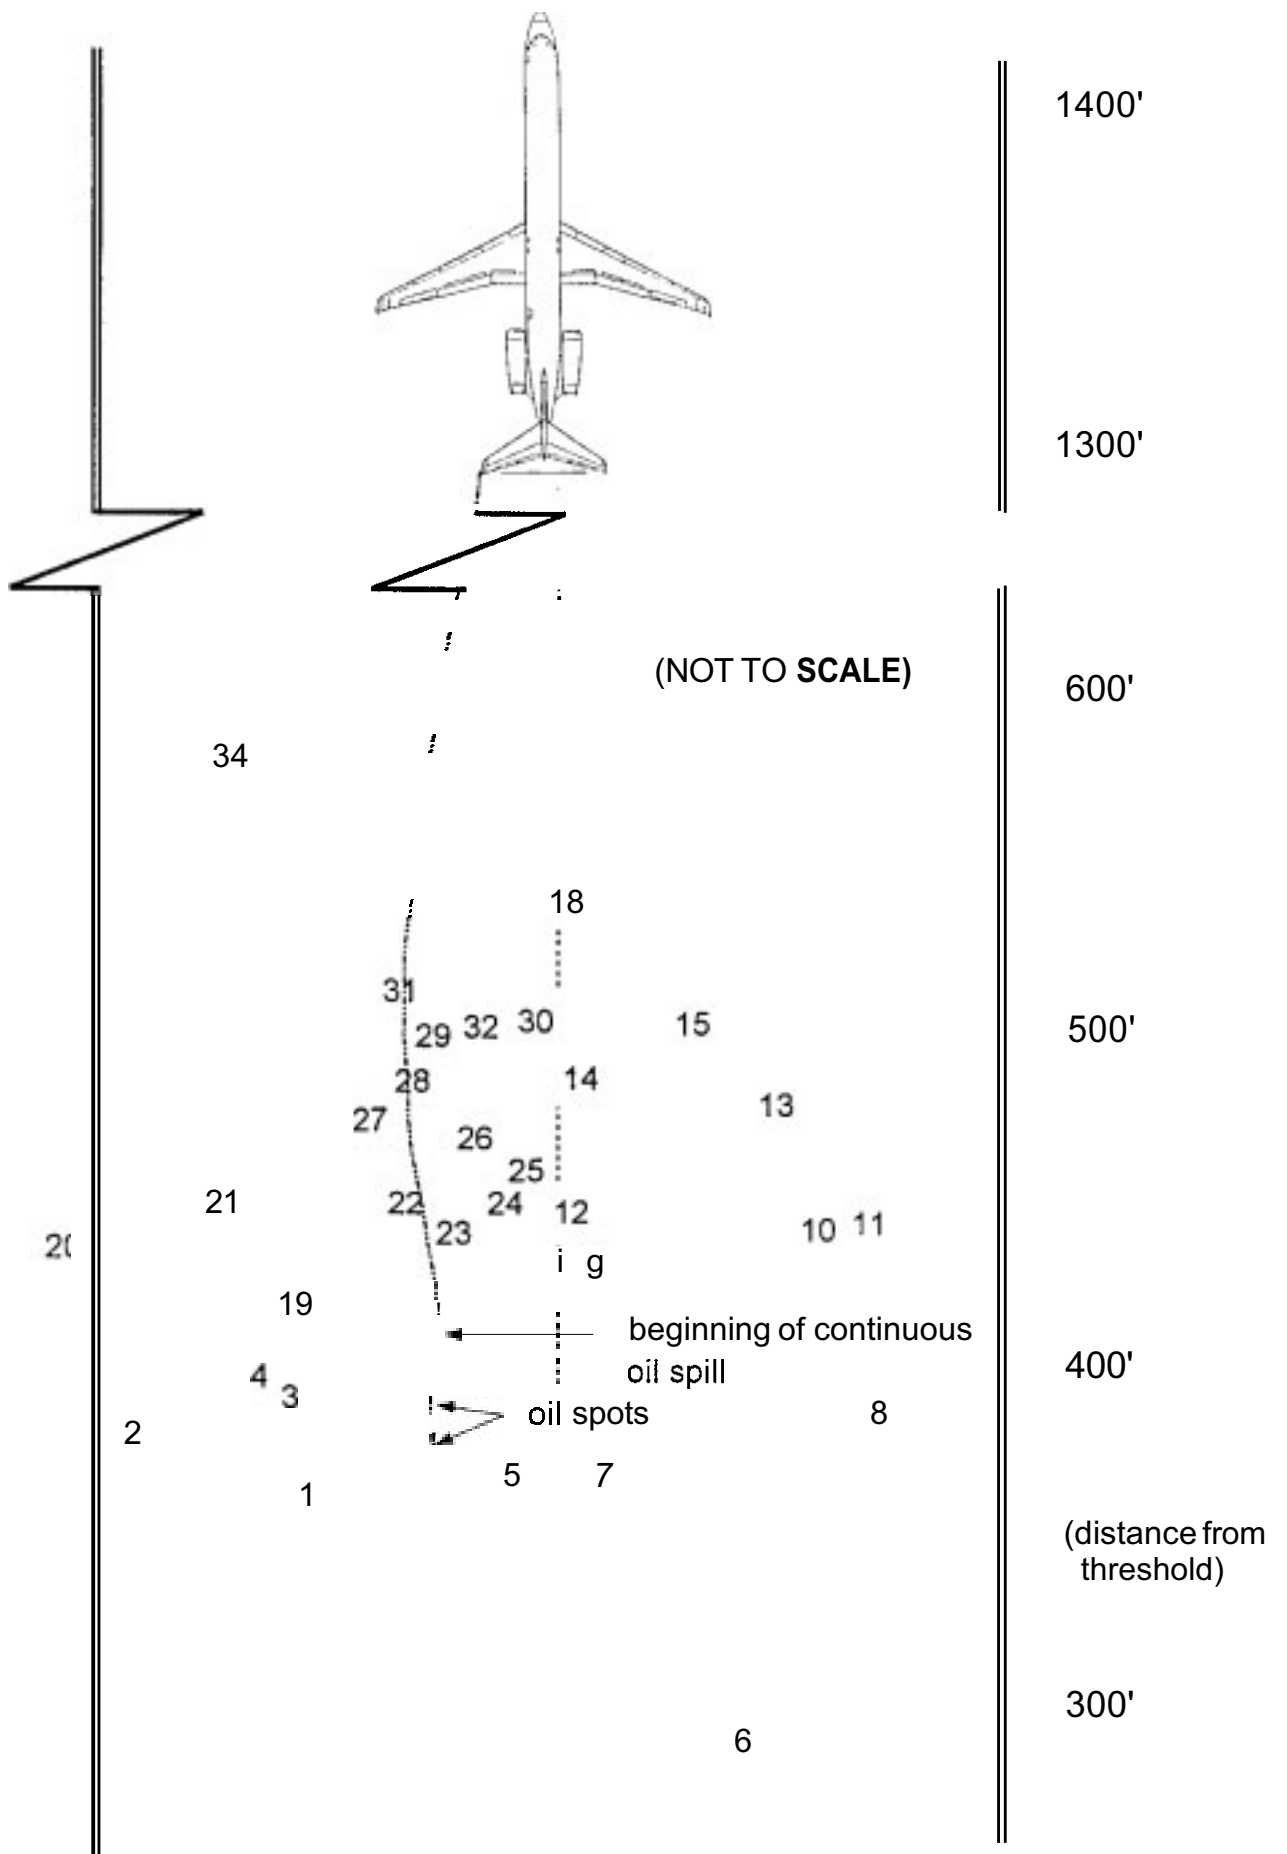
Figure 2. Runway 17 Debris Locations

Locations of airplane/engine debris are provided in figure 2. Locations of the gouges in the runway surface are provided in figure 3.

<u>Item #</u>	<u>Distance from Threshold (ft)</u>	<u>Distance (L/R) from Centerline (ft)</u>	<u>Item Description</u>
1	360	39L	25"x15" fiberglass skin piece
2	379	68L	fan blade outer portion
3	396	43L	runway gouge #10 (9"L x 3"W x 2" deep)
4	398	45L	runway gouge #11 (set of 4; 36"L x 5"W x 1" deep)
5	370	7L	30" fan cowl support
6	291	36R	fan blade outer portion
7	370	12R	fan blade outer portion
8	386	56R	fan blade outer portion
9	428	9R	1st stage stator section
10	438	48R	4"x10" aluminum cowl section
11	441	61R	7"x14" engine case wall piece
12	440	3R	1st stage stator vane
13	475	39R	fan blade portion from root to below shroud
14	484	6R	fan blade mid-span portion
15	500	24R	fan blade mid-span portion
16	540	20R	#1 bearing outer race section
17	557	45R	#1 scavenge pump gear
18	532	4R	2"x2" hub pc. & blade root pc.
19	416	39L	8"x8" cowl section
20	433	77L	1st stage stator vane
21	445	54L	1st stage stator vane
22	445	24L	1st stage stator vane

23	437	19L	1st stage stator vane
24	445	10L	fan blade
25	457	7L	1st stage stator vane
26	461	15L	1st stage stator vane
27	470	29L	fan blade minus root
28	481	21L	fan blade
29	492	22L	fan blade
30	500	5L	fan blade
31	515	25L	tie rods w/nuts, #1 bearing retention nut
32	497	16L	#1 bearing outer race section
33	563	24L	nose cowl
34	579	56L	bullet nose

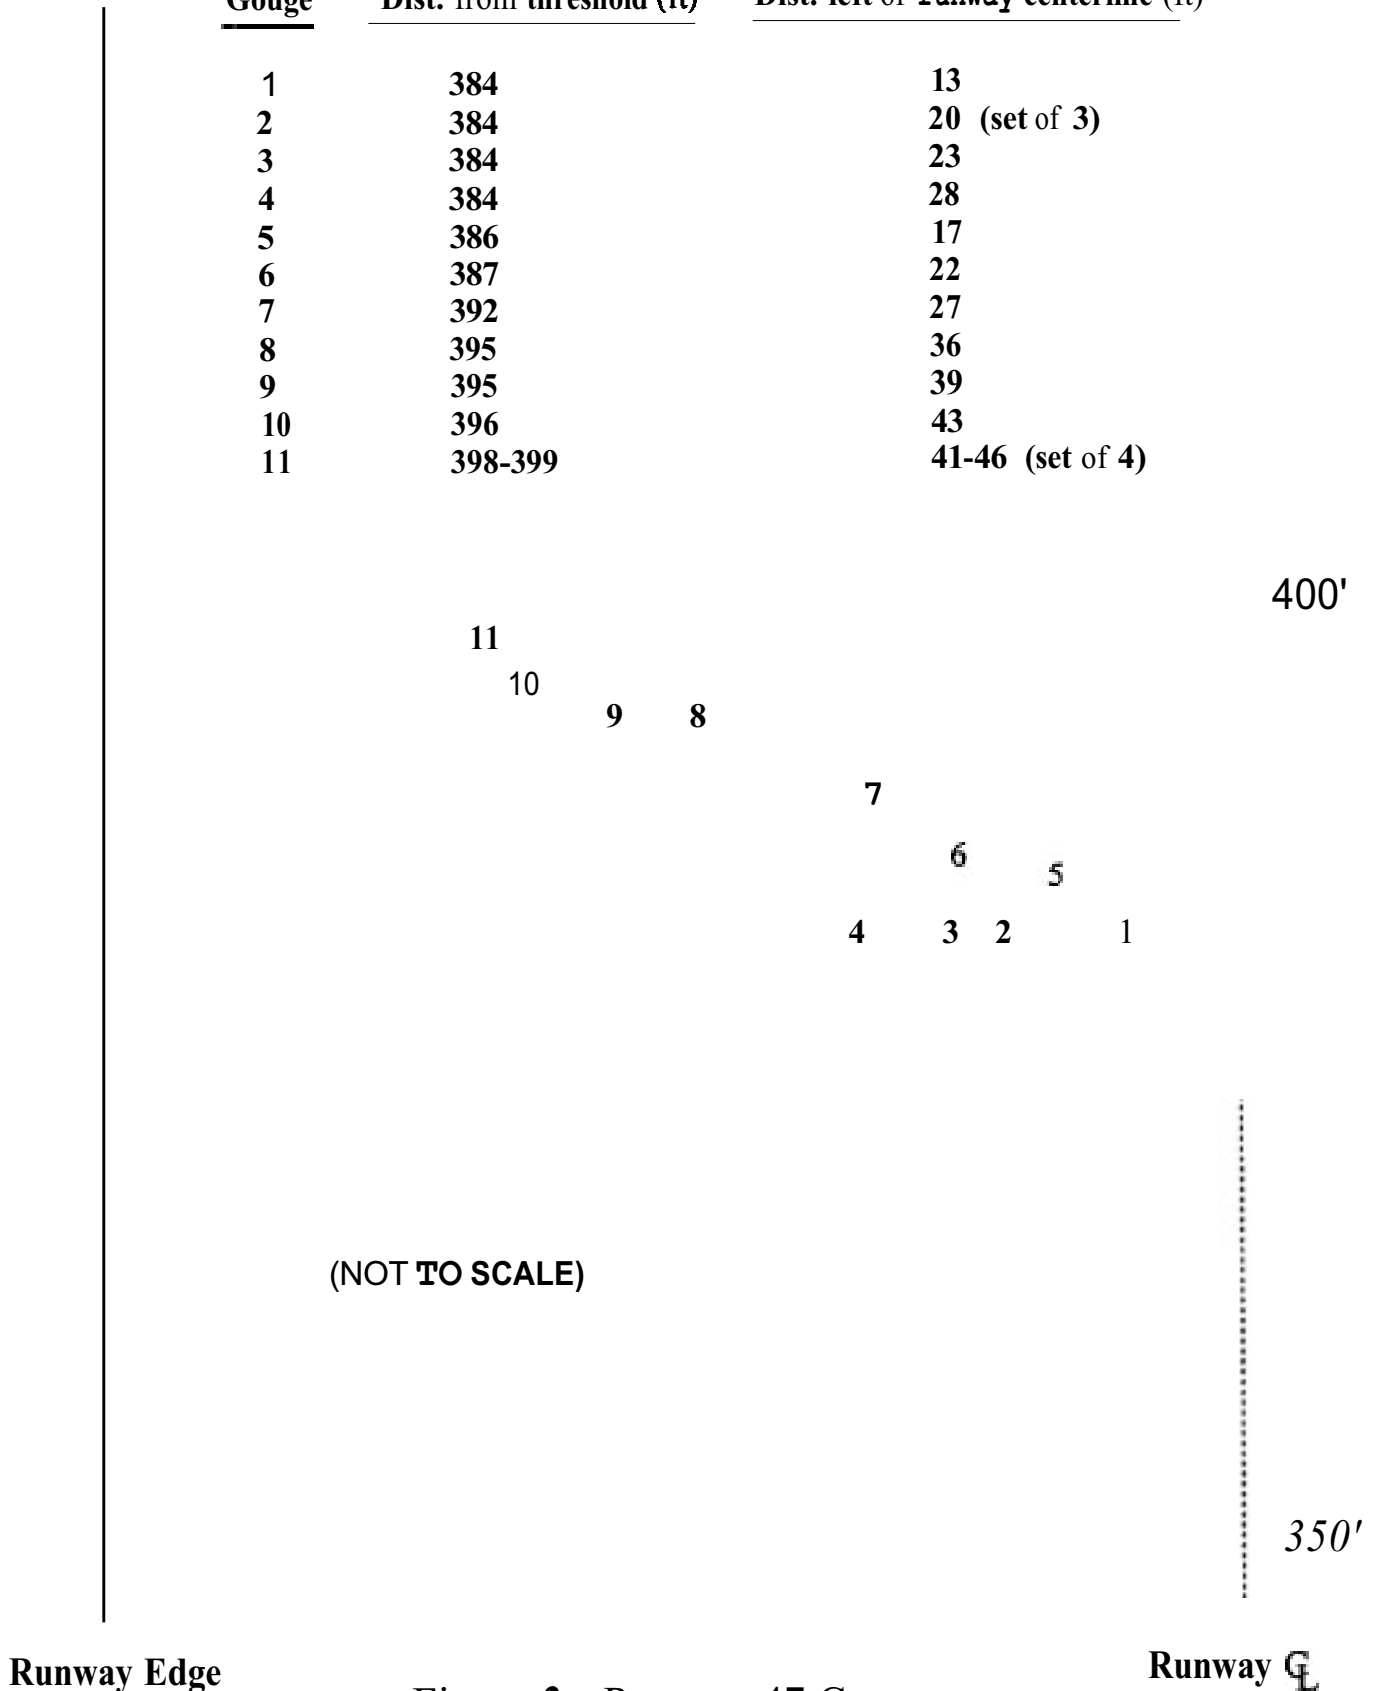
Figure 3. Runway 17 Gouges

Several gouges were documented on the runway left of the centerline. As viewed from the runway 17 centerline, the gouges were oriented along a magnetic heading of approximately 110°. The first gouge was located 384 feet from the threshold and 13 feet left of the centerline. Four ground-impact marks (divots) were noted between the runway gouges and the larger (2/3) hub section, which was located approximately 725 feet from the runway threshold and 715 feet left of the centerline. As viewed from the runway gouges, the locations of the divots and the larger hub section arced slightly to the left. Figure 1 shows the locations of the divots relative to the runway gouges and the hub section. The smaller (1/3) hub section was located approximately 2,400 feet right of runway centerline and approximately 900 feet from the threshold. Various engine debris was found on both sides of the runway.

<u>Gouge</u>	<u>Dist. from threshold (ft)</u>	<u>Dist. left of runway centerline (ft)</u>
1	384	13
2	384	20 (set of 3)
3	384	23
4	384	28
5	386	17
6	387	22
7	392	27
8	395	36
9	395	39
10	396	43
11	398-399	41-46 (set of 4)
