Docket No. SA-520

Exhibit No. 7-Q

NATIONAL TRANSPORTATION SAFETY BOARD

Appendix P
Photographs

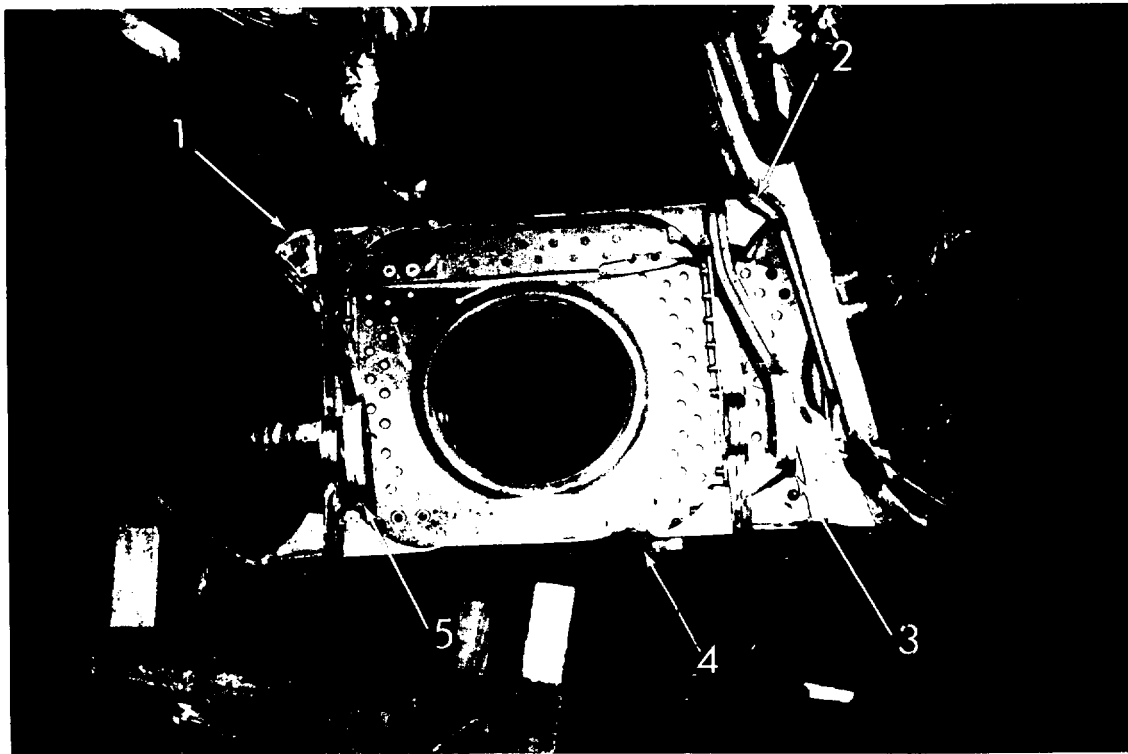
Photograph #14. Horizontal Stabilizer - Close-up of the Center Section. Arrows 1 and 2 point to the mirror image fractures. Arrows 3 and 5 point to the bent side plates. Arrow 4 points to the semi-circular indentation.

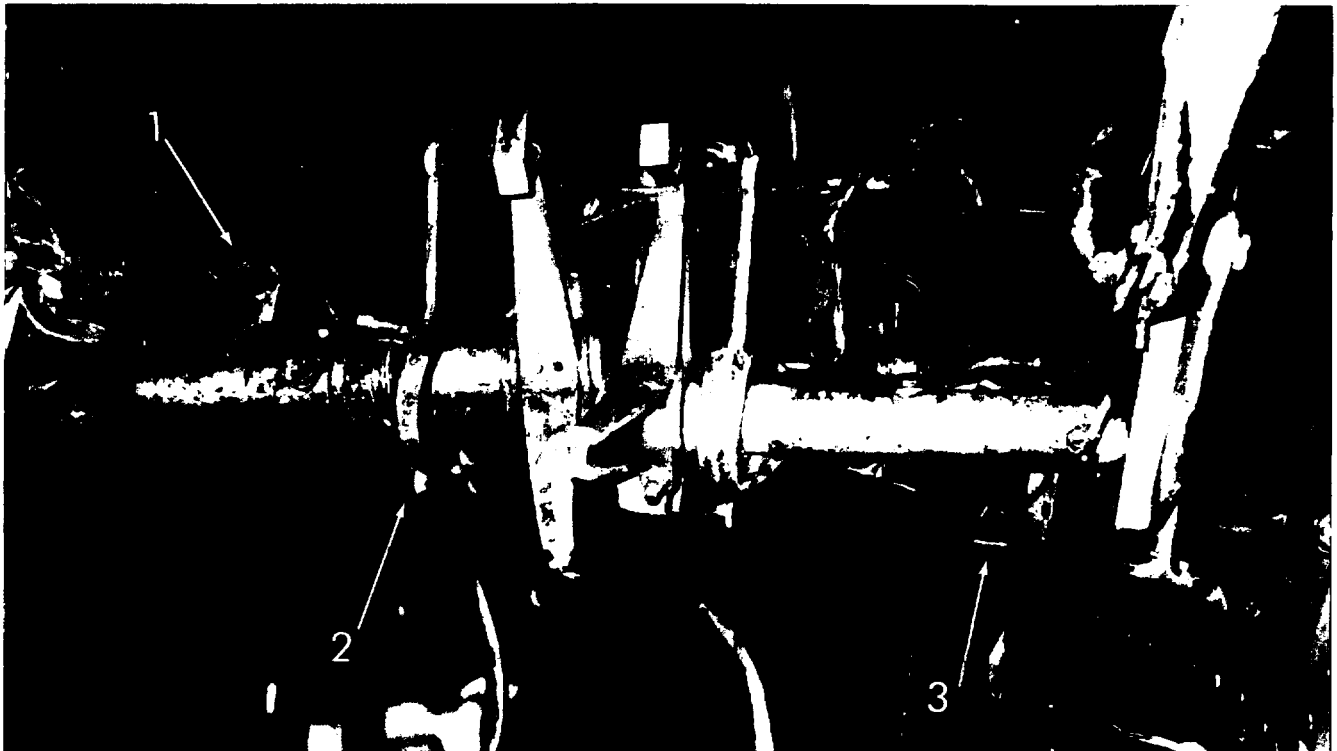
Photograph #19 - Horizontal Stabilizer - Aft Center Section (view looking forward) Arrow 1 points to the left rib's aft production hole which is torn and elongated at the 2 o'clock position. Arrows 2 and 3 point to mirrored damage.

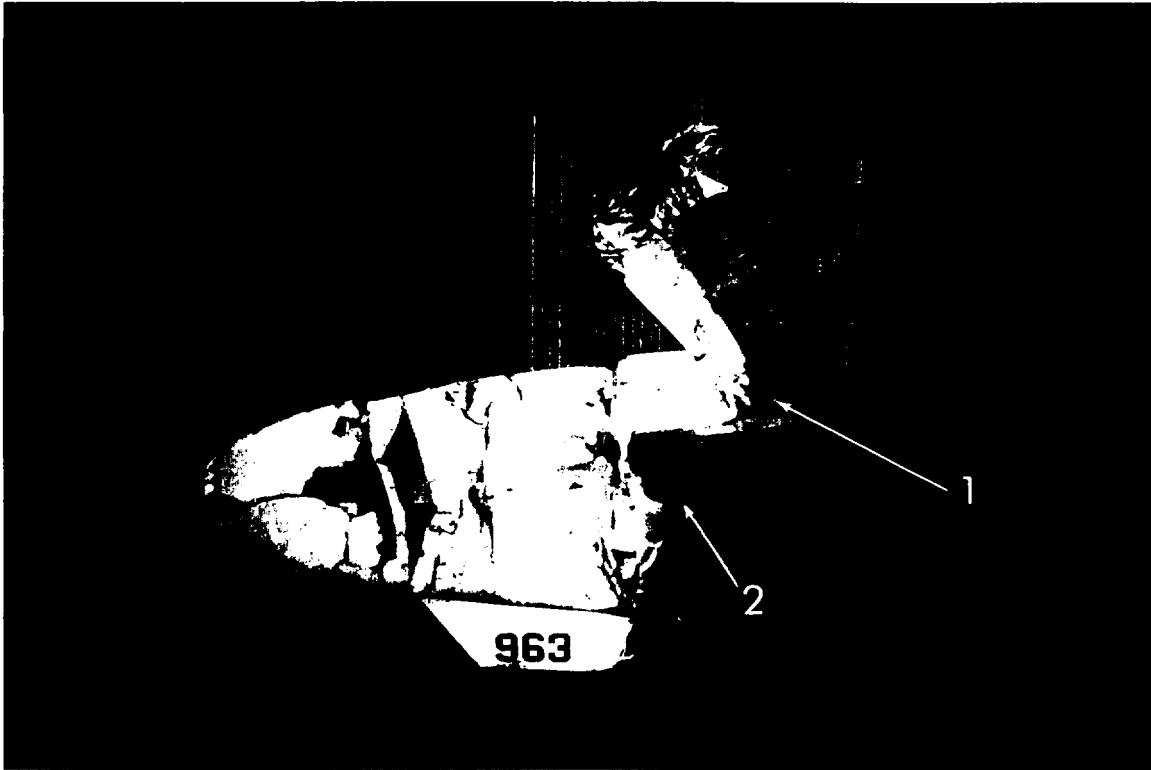
Photograph #20. Vertical Stabilizer Tip Fairing - Right Side. Arrow 1 points to where the mid and aft section of the recovered fairing is mated. Arrow 2 points to where both fairing skins are fractured.

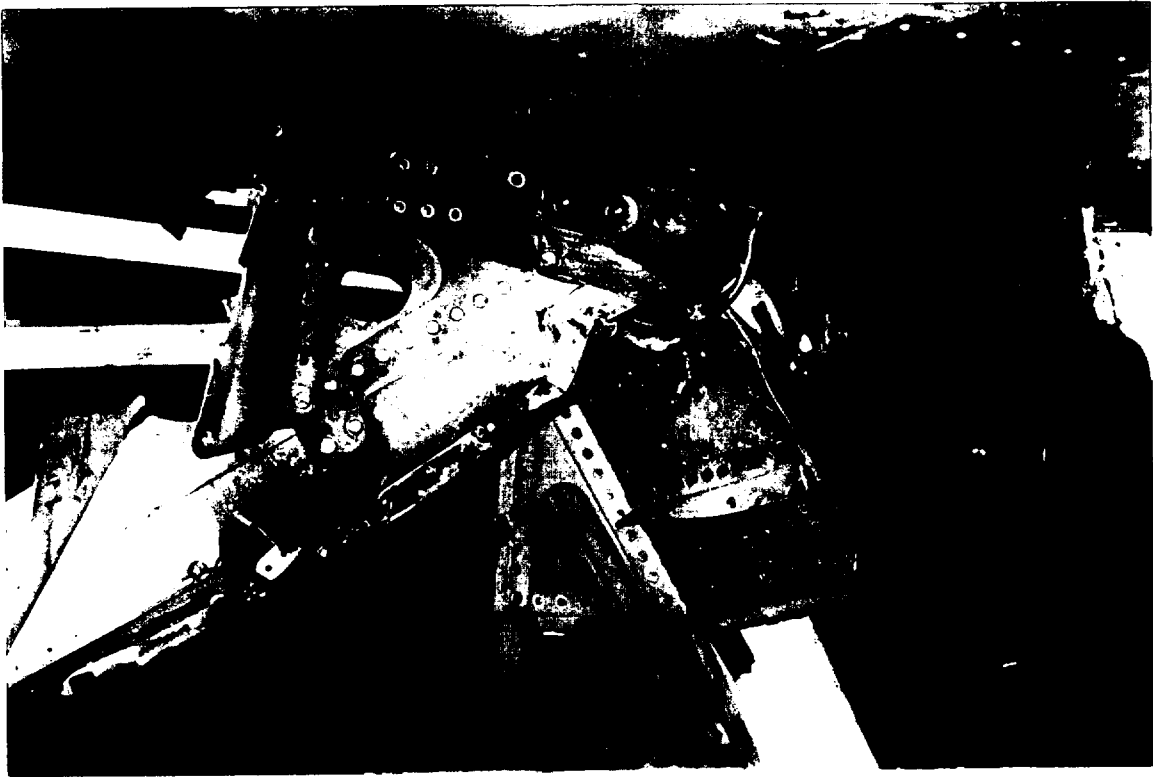
Photograph #22. Horizontal Stabilizer Pivot Point

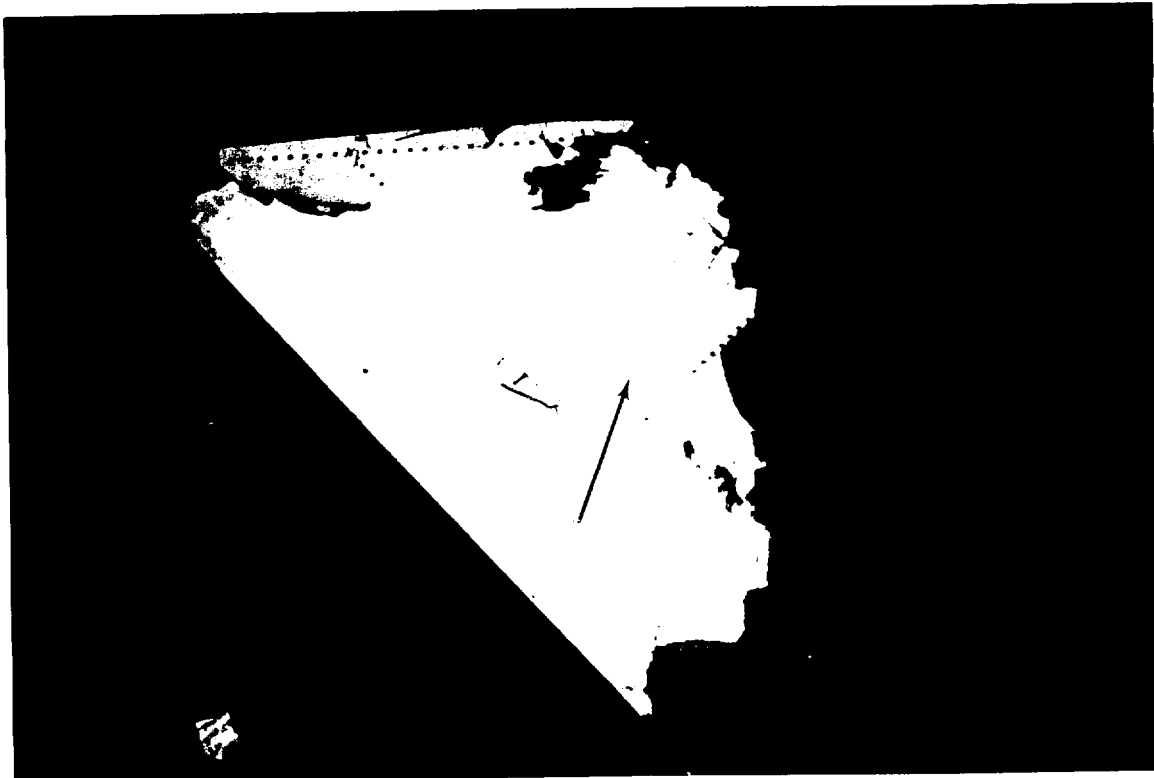
Photograph #24. Rudder - Upper Aft Section (right side). Arrow points to a series of paint abrasions.

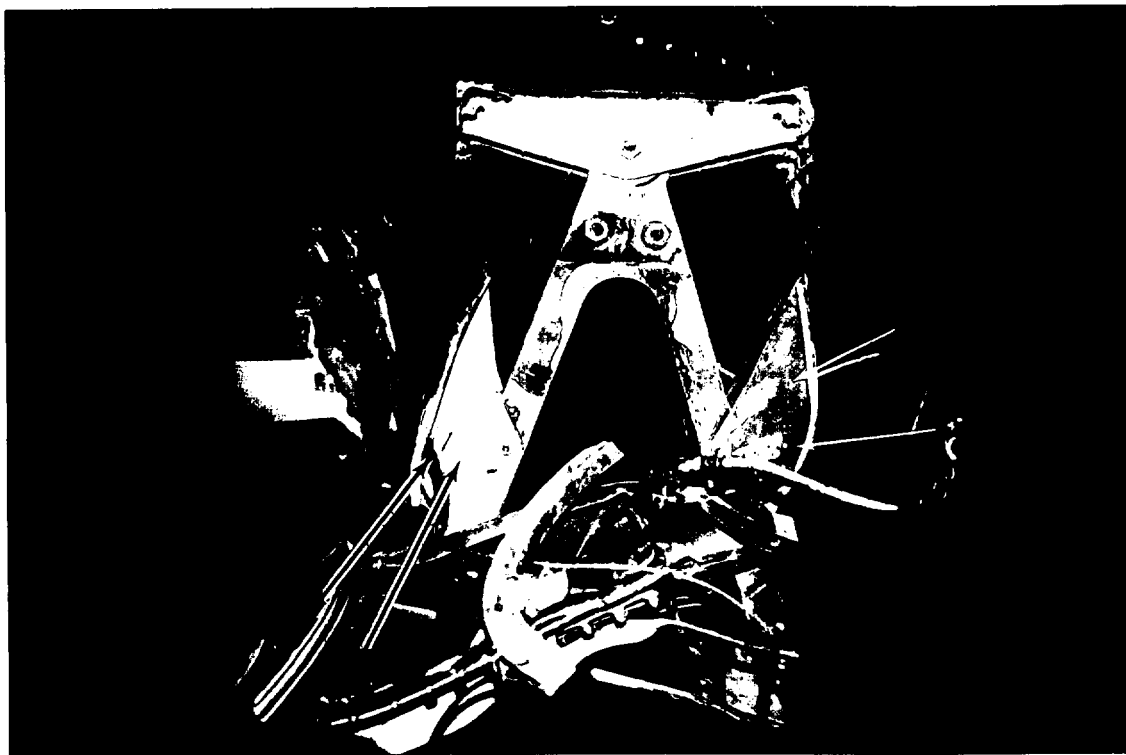
Photograph #25. Vertical Stabilizer Rear Spar Upper Hinge Fitting (view looking down). Arrows point to contact marks.

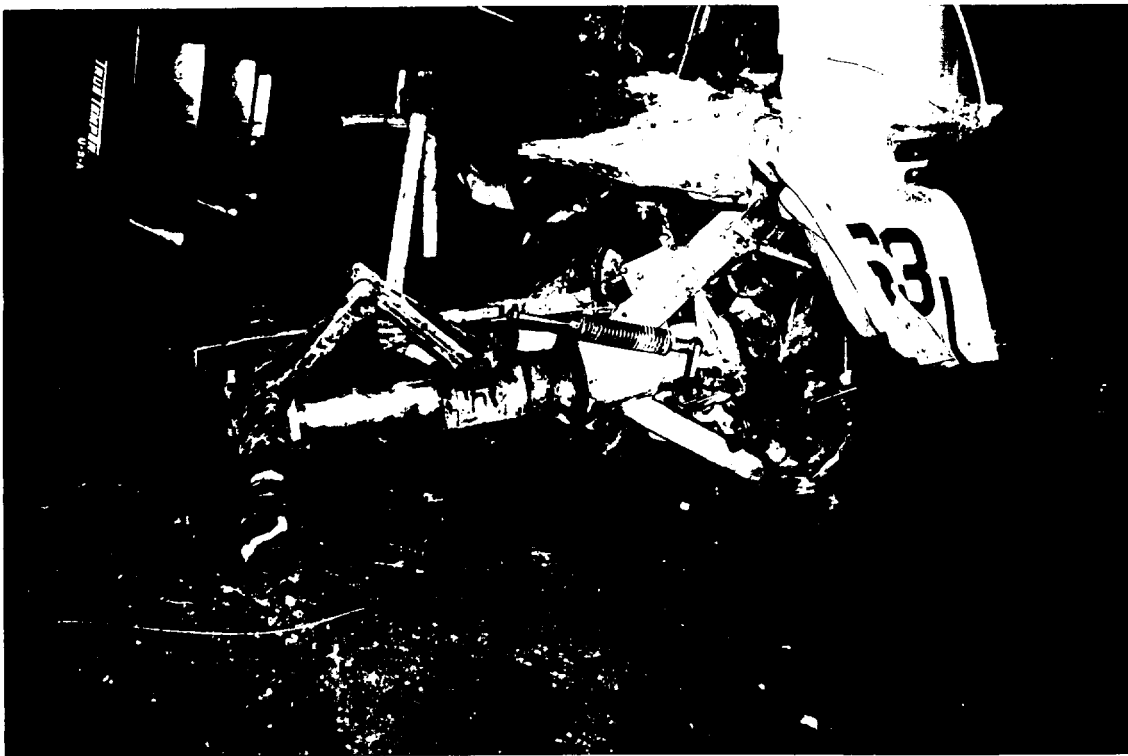
Photograph #26. Landing Gear - Nose

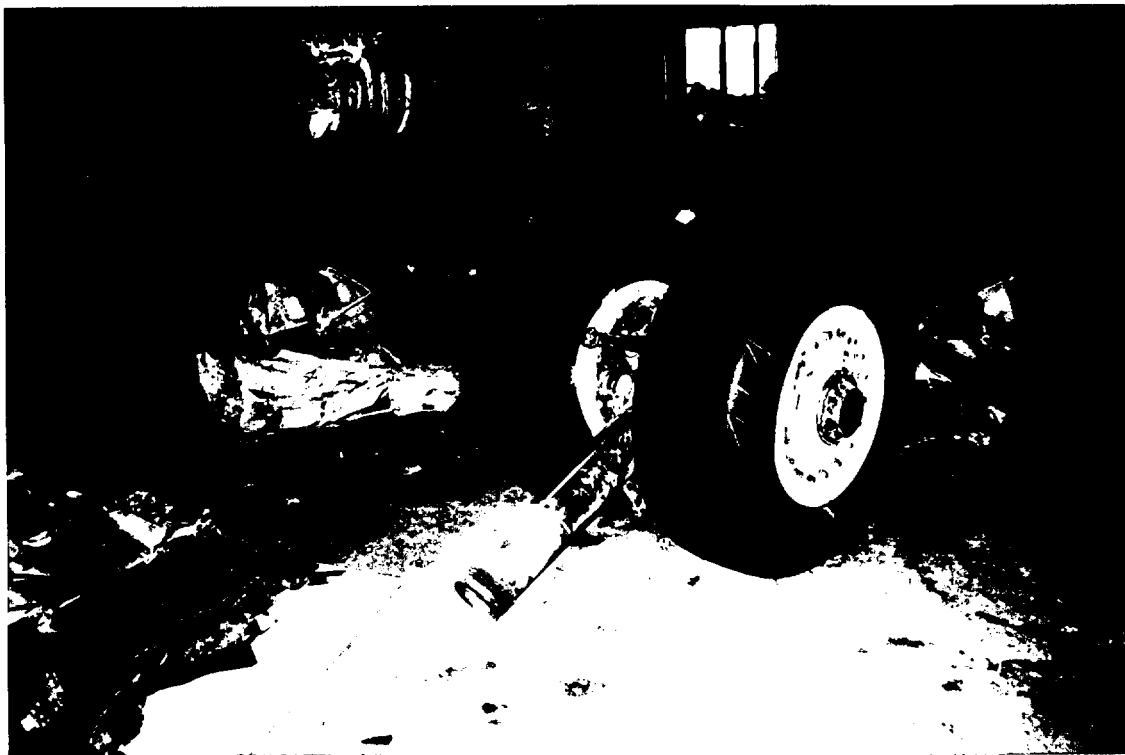
Photograph #27. Landing Gear - Right Main Tire and Wheel Assembly
