LOG # FBM-11

SEAT TRACK SEGMENTS

Handwritten notes:
 TWA 10/17/96
 11A 840-880

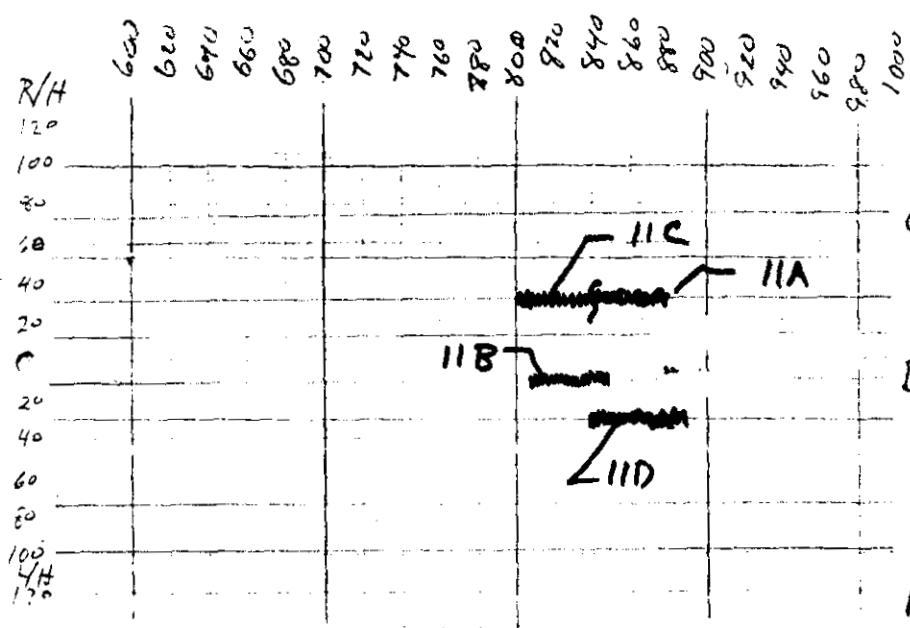
II A RBL 33.99 S/T FROM STA 840 TO 880
 PIECES OF F/B @ STA 860 AND 840 ATTACHED
 (SEE F/B DWG) S/T FAILED @ F/B INTERSECTION
 BOTH FWD & AFT. S/T LIPS ARE ALL
 IN TACT. F/P INSERTS & SCREWS ARE ON BOTH
 FLANGES

II B LBL 11.33 S/T FROM STA 810 TO STA 850
 S/T FRACTURED THRU HUMPS IN LOWER CHORD, PIECE
 OF STA 820 F/B ATTACHED (SEE F/B DWG). NO S/T
 LIPS FAILED F/P INSERTS AND SCREWS STILL
 IN FLANGES

II C ~~RBL~~ RBL 33.99 S/T STA 800 TO 840
 WITH F/B SEGMENT AT STA 820 ATTACHED
 (SEE F/B DWG) TRACK & FRACTURES AND
 DISCRPTION ARE VERY SIMILAR TO II A

II D LBL 33.99 S/T STA 840 TO STA 880 WITH FLOOR
 BEAM SEGMENT AT STA 840 & STA 860. (SEE F/B DWG)
 FEATURES AND FRACTURES ARE SIMILAR TO
 II A. LIPS HAVE CORROSION AND FRACTURES @ STA 10/
 852, 853, 877 & 878
