LOG # FBM-15

FLOOR ASSY FLOOR PANEL, SEAT TRACK AND FLOOR BEAMS

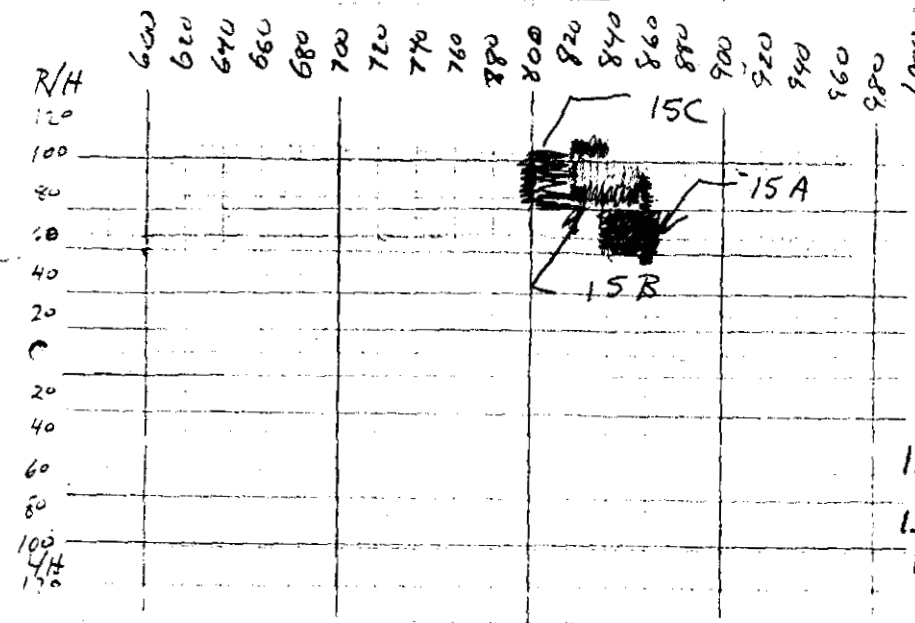
✓ 15A: STA 840 TO 870, RBL 50 TO RBL 90. F/B 840

RBL 52 TO RBL 60, UPPER FLANGE FRACTURED @ RADIUS 15 GONE, STA 860 RBL 50 TO RBL 90 WITH WEB, LOWER CHORD IS FBM-13A (SEE F/B DWG). RBL 55 S/T FRACTURED @ 840 AND 869, FLANGE AND LUGS ARE MISSING, STA 840-846 & LUG MISSING @ STA 853. F/P # 101 AND 27". FRACTURE DELAMINATED PANEL LOWER SURFACE FROM 860 TO EOP. INSERTS @ STA 890 HAVE SOME TEAROUT & SOME PULL THRU. ALONG BL 75.92 S/T INSERTS ARE TEAROUT.

✓ 15B STA 820 TO STA 860 RBL 60 TO RBL 112.

STA 840 F/B FROM RBL 60 TO RBL 110 WITH WEB & LOWER CHORD (SEE F/B DWG). RBL 75.92 S/T AND RBL 98.58 S/T ARE ATTACHED BOTH FRACTURED @ F/B CONNECTION. 98.58 S/T FRACTURED LENGTHWISE THRU LIPS FOR MOST OF LENGTH. F/P HAS SEVERAL FRACTURES AND HAS A DEPLOYED INFLIGHT GALLEY CART FITTING @ STA 845, RBL 85 AFT END OF F/P # 95 HAS TEAROUT ON INSERTS

✓ 15C STA 793 TO 820, RBL 75 TO RBL 98 F/P # 95.

REMAINDER OF F/P # 95 FROM FBM-15B AND ≈ 7" OF F/P # 85. BL 75.92 FROM STA 796 TO STA 809 AND STA 800 F/B FROM RBL 70 TO RBL 97. (SEE F/B DWG)
