LOG # FBM-19

FLOOR ASSY STA 780 - STA 840, RBL 3 TO LBL 94

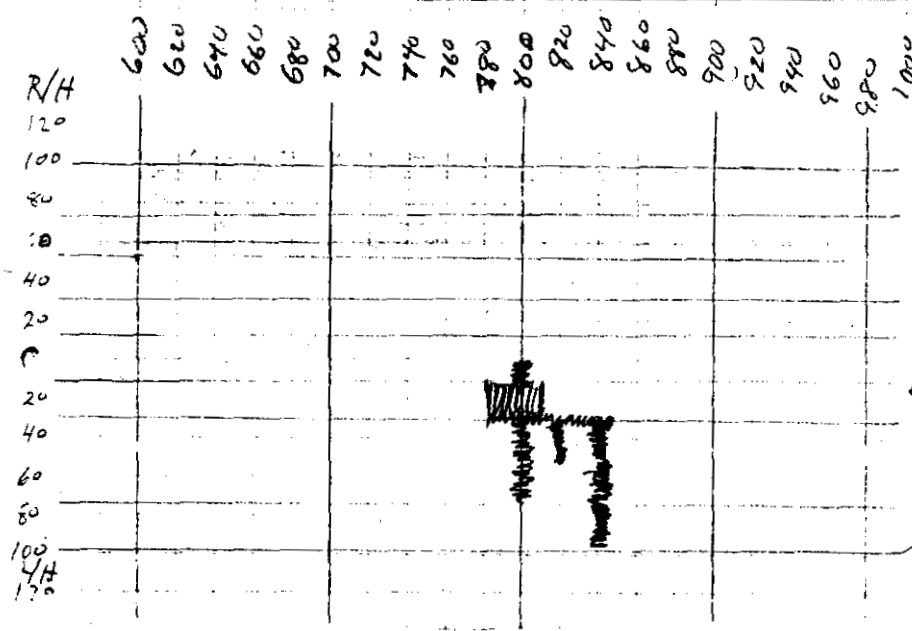
FLOOR PANEL # 93 CONNECTOR TO LBL 1133 S/C FROM STA 790 TO 810; LBL 33.99 S/C FROM STA 780 TO STA 943. STA 800 F/B FROM RBL 3 TO LBL 74, STA 820 F/B UPPER CHORD FROM LBL 33 TO LBL 51 AND STA 840 F/B UPPER CHORD FROM LBL 33 TO LBL 94.

(SEE F/B DWG) 2 OXYGEN MASKS WRAPPED UP @ 840 & BL 33.99 S/C BL 11.33 S/C MATES UP WITH FBM-11B @ STA 810 FRACTURE HAS TWISTING DISTORTION WHERE LOWER FLANGE IS $\approx 45^\circ$ ROTATED WITH INBD SIDE UP. FWD FRACTURE @ 790 HAS SOME TWIST (LESS THAN 15°) IN SAME DIRECTION

BL 33.99 S/C DOESN'T HAVE ANY TORSIONAL DISTORTION, @ STA 810 THE LOWER FLANGE IS BOWED INBD $\approx 1/4"$

STA 800 F/B HAS LOWER CHORD FWD/AFT ROTATION ABOUT BL 33.99 STIFFENER, INBD IS CLOTTED FWD AND OUTBD AFT $\approx 15^\circ$

F/P HAS ONLY FWD AND INBD 10" OF INSERTS WITH TEAR OUT DAMAGE.

1) S/T AT LBL 33.99 IS ACTUALLY CONNECTED
FROM STATION 780 TO STATION 843.
