LOG # FBM-23

DEBRIS FIELD YELLOW

FLOOR ASSY STA 740 TO STA 800  
 LBL 11.33 TO RBL 11.33

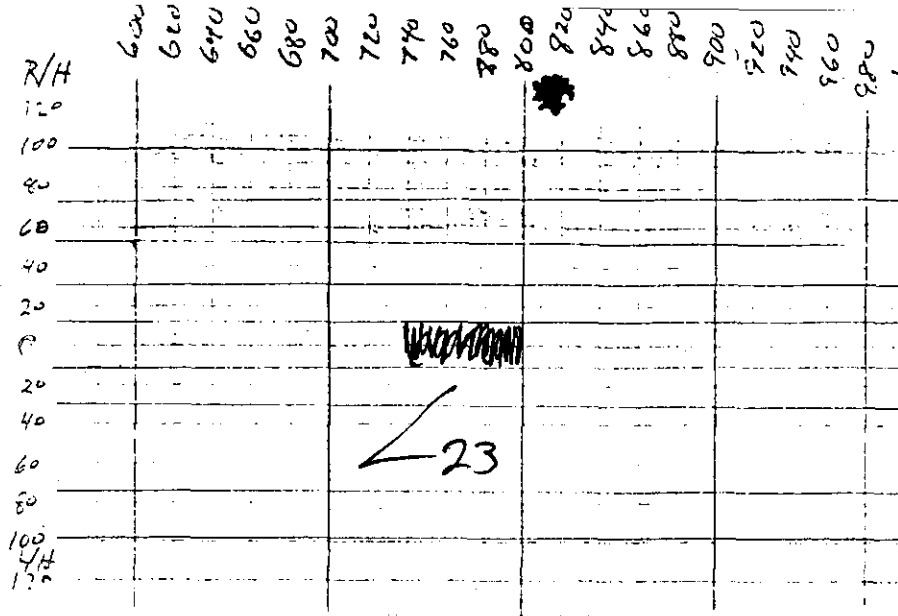
F/P # 82 AND FWD 20" OF #92. AFT FRACTURE IS @ STA 800 WITH ANOTHER FRACTURE IN UPPER FACE <sup>PLY</sup> RUNNING DIAGONALLY FROM STA 800, RBL 11 TO STA 790, LBL 11.

S/T @ LBL 11.33 FROM STA 740 TO 790, BOTH FRACTURES, FWD & AFT HAVE NOT LEFT PERMANENT DEFORMATIONS TO REMAINING MTL.

S/T @ RBL 11.33 FROM STA 720 TO STA 800 WITH AN ADDITIONAL FRACTURE @ STA 797. F/B @ 740 & 760 ARE BENT 45° KEEPING S/T ANGLED DOWN & INBD ON FWD END. WEB & LOWER FLANGE FRACTURED OFF S/T FROM STA 780 TO STA 800.

- F/B STA 740 FROM RBL 12 TO LBL 9 (SEE F/B DWG)
- F/B STA 760 FROM RBL 12 TO LBL 12 "
- F/B STA 780 FROM RBL 12 TO LBL 12 "
- F/B STA 800 FROM RBL 12 TO RBL 2 "

1) THIS SECTION OF FLOORING<sup>ASSY.</sup> ACTUALLY EXTENDS FORWARD TO STATION 720 THE PART THAT EXTENDS FORWARD IS RBL 11.33 SAT ONLY. THIS FACT IS ACTUALLY BROUGHT UP LATER IN THE NOTES.
