LOG # FBM-5
 TARGET # _____
 COORD: LAT _____
 LONG _____

STA 960 FLOOR BEAM PIECES

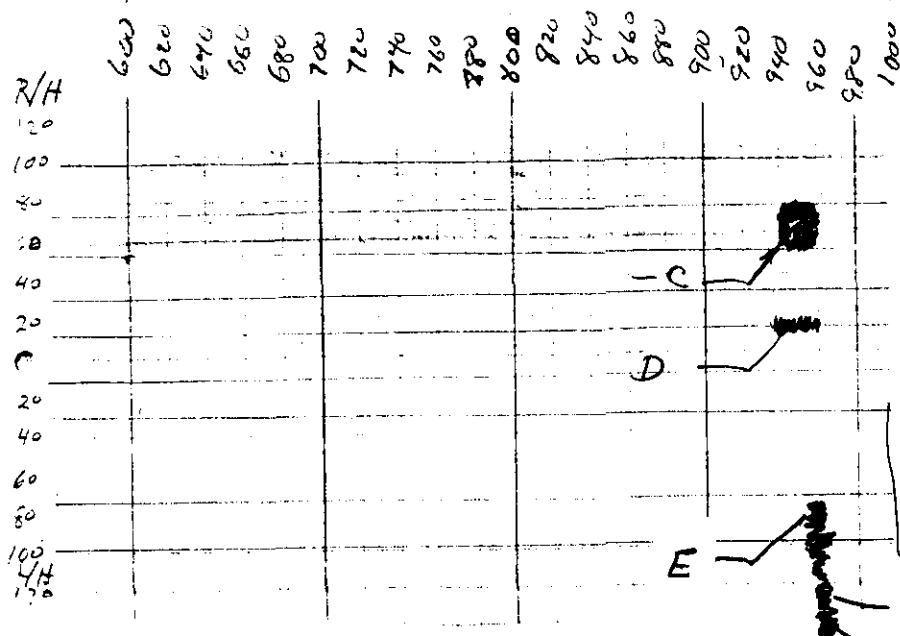
DEBRIS FIELD RED
 5A - TAG A144 RED
 5B - RED NO TAG
 5C - NO TAG FLOATING
 5D - SOURCE TAG A423
 5E - NO TAG (NO DATE)
 -B
 -A

✓ -5A 3 FLOOR BEAM AND FRAME INTERSECTION LBL 110 TO SOB, FRAME \$ 25 & FRACTURE THRU FASTENERS IN FRAME CLIP \$ 29 FRACTURED 1" BELOW STRINGER &

✓ -5B; 15" LONG UPPER CHORD & 2 1/2" STRIP & WEB. FOR MATING TO -A FRACTURE, -B WOULD ANGLE UP ≈ 45°. INBD END FRACTURE ANGLES UP ≈ 20°

✓ -5C: 14" LONG UPPER CHORD, RBL 65 TO RBL 79 WITH PIECE OF F/P # 115, STA 940 TO 960, RBL 55 TO RBL 76 INBD & FWD INSERTS HAVE TEAR OUT FRACTURE OUTBD HAS S/T ATTACHED STA 940 TO STA 960

✓ -5D 5 1/2 LONG UPPER FLANGE, RBL 8,5 TO RBL 14 WITH S/T FROM STA 941 TO STA 960 ATTACHED. FROM 953 TO 959 S/T TAKE ABOUT 30° OF TWIST (AFT IS CCW WITH RESPECT TO FRONT). SEVERAL INCHES OF FLANGE CT F/P IS MISSING.

✓ -5E ✓ UPPER CHORD LBL 78 TO LBL 98 (SEE F/B DWG)
