LOG # FBM-6

DEBRIS FIELD RED

FBM 6
CONTINUED

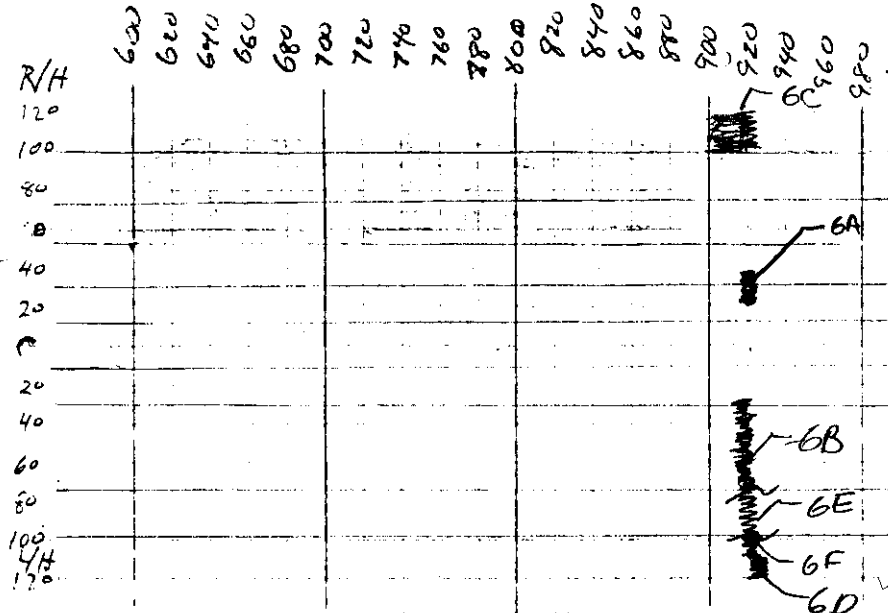
6A: STA 920 F/B UPPER CHORD, RBL 16 TO RBL 37, DOUBLER & STIFFENER FOR S/T CUTOUT @ RBL 33.99, S/T SEGMENT STA 916 TO STA 929 LESS UPPER FLANGE (SEE F/B DWG)

6B: STA 920 F/B LOWER CHORD, LBL 28 TO LBL 71
 SOME BENDING DAMAGE AT BOTH ENDS
 (SEE F/B DWG)

6C STA 920 F/B & FRAME INTERSECTION, RBL 100 TO SOB (SEE F/B DWG) FRAME FRACTURED @ § 25 & FASTENERS AND 1" BELOW F/B. F/P & SOB ANGLE ATTACHED RBL 98.58 S/T SPLIT THRU CENTER OF LUGS, OUTBD HALF FASTENED TO F/P. F/P FRACTURED AT STA 900 (VERY LARGE DELAMINATION), LOWER FACE FRACTURED

① ≈ 910 AND AFT FRACTURE @ STA 922 IS SIMILAR TO FWD FRACTURE. FWD OUTBD 4 INSERTS HAVE EDGE TEAR OUT.

6D STA 920 F/B & FRAME INTERSECTION LBL TO SOB, (SEE F/B DWG), FRAME FRACTURED AT § 25 & AND @ F/B CHORD LOWER RIBS. INBD CHORD & FRAME FRACTURED @ RADIUS WITH WEB INBD WEB OF F/B FRACTURED FLUSH TO STIFFENER EDGE BTWN UPPER & LOWER CHORDS

16E STA 920 F/B UPPER CHORD & WEB
LBL 72 TO LBL 102 (SEE F/B DWG)
WEB HAS SEVERAL BENDS AND TEARS

6F STA 920 1/4" POST WITH F/B WEB AND
CHUNK OF UPPER CHORD ATTACHED. (SEE ~~FB~~
F/B DWG)

LOWER END OF POST FRACTURED
ABOVE FRAME FASTENERS, THRU CARGO LINER
LOWER ANGLE FASTENERS. SOME DEFORMATION
AND VERTICAL TEARING ON INBD & OUTBD
FACES AT RADIUS TANGENT $\approx .5$ & 1.0 LONG.
TWO CARGO LINER NUTPLATES / WASHER & SCREWS
EXHIBIT WASHERS ~~USED~~ COIPPED OVER SCREW HEAD.
