LOG # FBM-7

DEBRIS FIELD  
 7A - NO TAG  
 7B - REO A 143

FBM-7B

RED TAG A 143

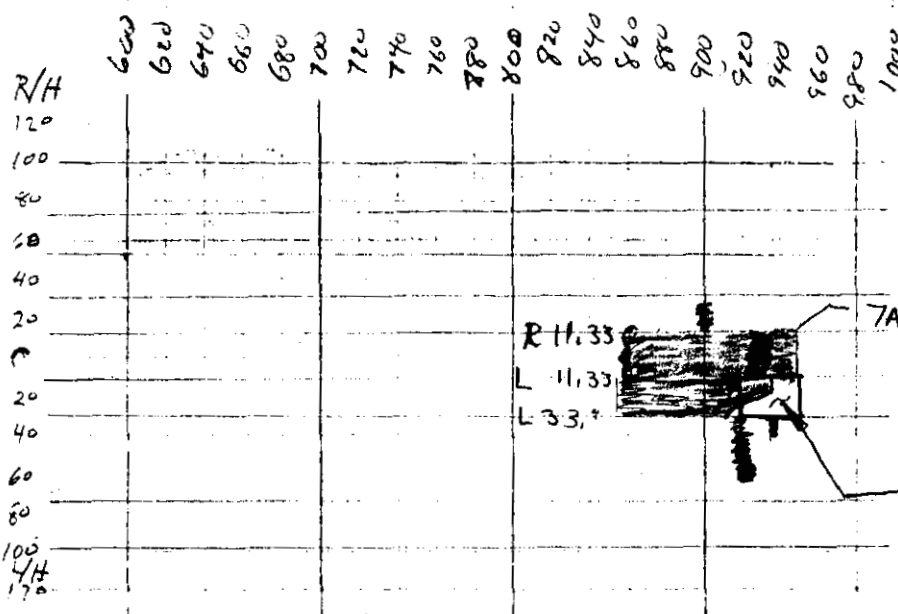
7A STA 860 TO STA 950 FLOOR PANEL WITH S/T & F/B ATTACHED  
 F/P # 113, & 105 AND A PORTION OF #104 FROM STA 860 TO 910  
 AND A PORTION OF # 114 FROM 910 TO 920. <sup>FAILED</sup> INSERTS OF  
 PERIPHERY ARE ALL TEAR OUT.  
 RBL 11,33 S/T FROM 860 TO 940 IS ATTACHED, FRACTURED  
 FWD OF 860 AND AFT OF 940

LBL 11,33 S/T FROM 850 TO 932 IS ATTACHED, FWD  
 FRACTURE IS @ OXYGEN BOTTLE HUMP, THRU NARROW  
 SECTION, AFT FRACTURE BROKE LOWER FLANGE OFF  
 WEB FROM 923 TO END @ RADIUS WITH WEB

FLOOR BEAMS - STA 860, RBL 13 TO LBL 30,  
 STA 880, RBL 13 TO LBL 33, STA 900, RBL 30 TO LBL 25  
 STA 920 RBL 16 TO LBL 26, STA 940 RBL 12 TO  
 LBL 10 (SEE F/B DWGS FOR MORE DETAIL)
