LOG # FBM-9

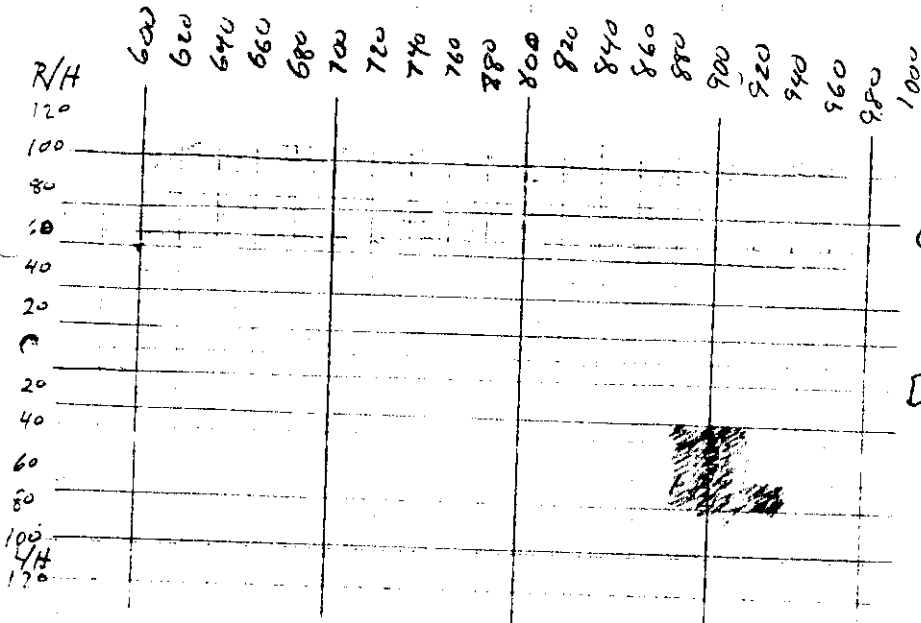
PORTION OF FLOOR PANEL # 110 WITH STA
 880 F/B UPPER CHORD LBL 30 TO LBL 75
 AND STA 900 F/B LBL 25 TO LBL 75
 S/H LBL 33,99 FROM STA 880 TO 900 AND
 S/H LBL 75,92 FROM STA 920 TO STA 940

F/P UPPER FACE PLYS FRACTURED @ STA 900
 AND JUST AFT OF 920. AFT FRACTURE
 IS AT STA 930 FROM LBL 34 TO LBL 60 THEN
 AFT TO STA 940 AND THEN OUT BD TO
 LBL 75. PERIMETER FASTENERS WHICH FAILED
 HAVE TEAROUT WITH MOST FIBER STILL
 THERE, JUST FRACTURED.
