### **Fractographic Analysis of Evidentiary Pawl**

**NTSB FACTUAL REPORT OF FLAP  
ACTUATOR EXAMINATION**

FACTUAL REPORT OF FLAP ACTUATOR EXAMINATION

DCA-97-MA-059

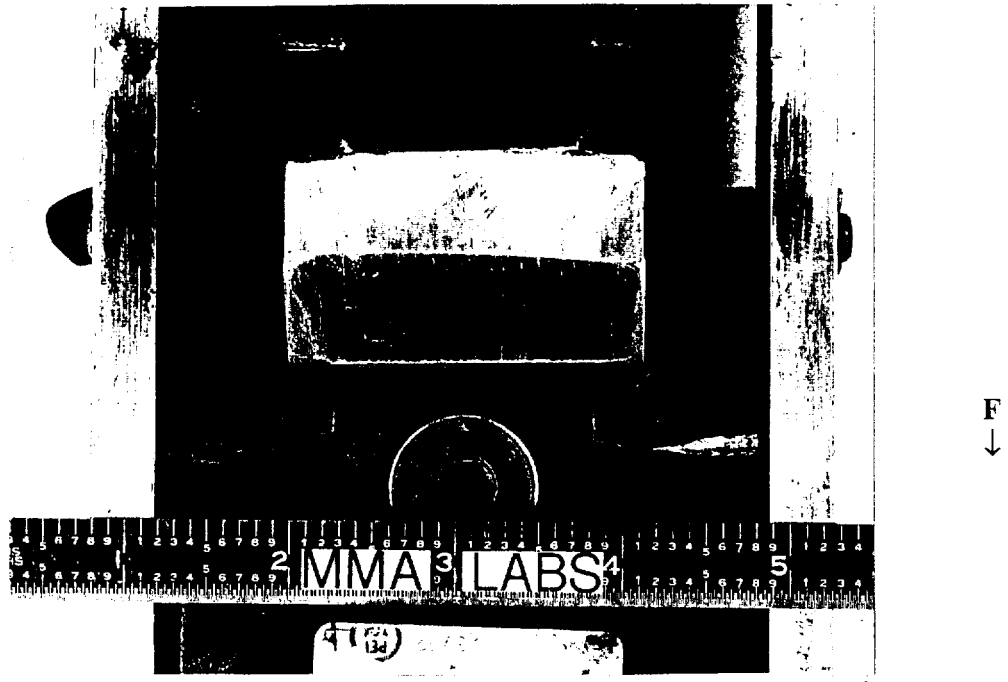
A fractographic analysis was performed on the evidentiary locking assembly's failed locking pawl. The analysis was performed visually and with the use of a scanning electron microscope. The visual and scanning electron microscopic evaluations indicate that the pawl failed due to an impact or overload event. Neither of the fractured surfaces examined exhibited macroscopic features that would be consistent with a fatigue type failure in aluminum. No thumbnails were observed that would suggest a fatigue crack origin(s). No ratchet marks were observed on either of the fractured surfaces. The fractographic features indicate that the failure initiated on the side opposite the witness marks or impact marks identified with arrows in Figure 9a. Figure 10a is made up of two close-up photographs showing the pawl fracture surfaces after disassembly from the unit. Figure 10b is a schematic drawing showing the interpretation of the fractographic features. The radial lines emanating from the pawl corners indicate the general location of the failure origin and direction of crack propagation. Scanning electron microscopy of the fracture surfaces revealed a textured, overload type fracture morphology. The textured or stepped appearance of the fracture surface is attributed to the aluminum microstructure. Figures 11, 12 and 13 are laser reproduced, enlarged scanning electron microscopic micrographs showing the fractographic features observed on the left hand side sample in Figure 5a. The right hand side exhibited similar fractographic features. Metallographic examinations of the failed pawls would be required to verify the directional nature of the grain structure. The fracture surface did not exhibit features that would indicate a fatigue crack mechanism was active.

**Figure 9a: Color Photograph Showing Impact Marks (Identified with Arrows) That were present in the Failed Pawl**

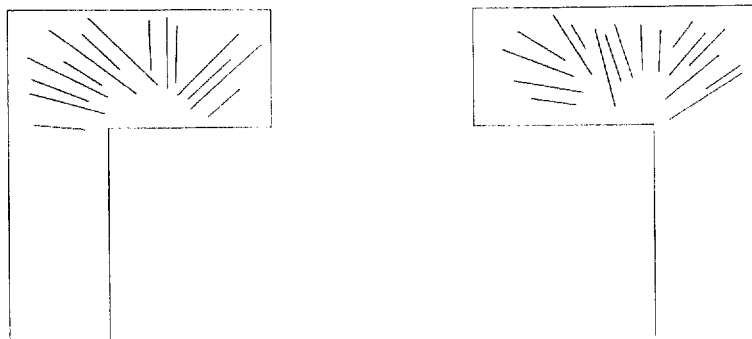
**Figure 10b: Schematic Drawing Showing the Fractographic Features  
Observed in the Failed Pawl.  
The Radial Lines Point Back toward the Crack Origin.**

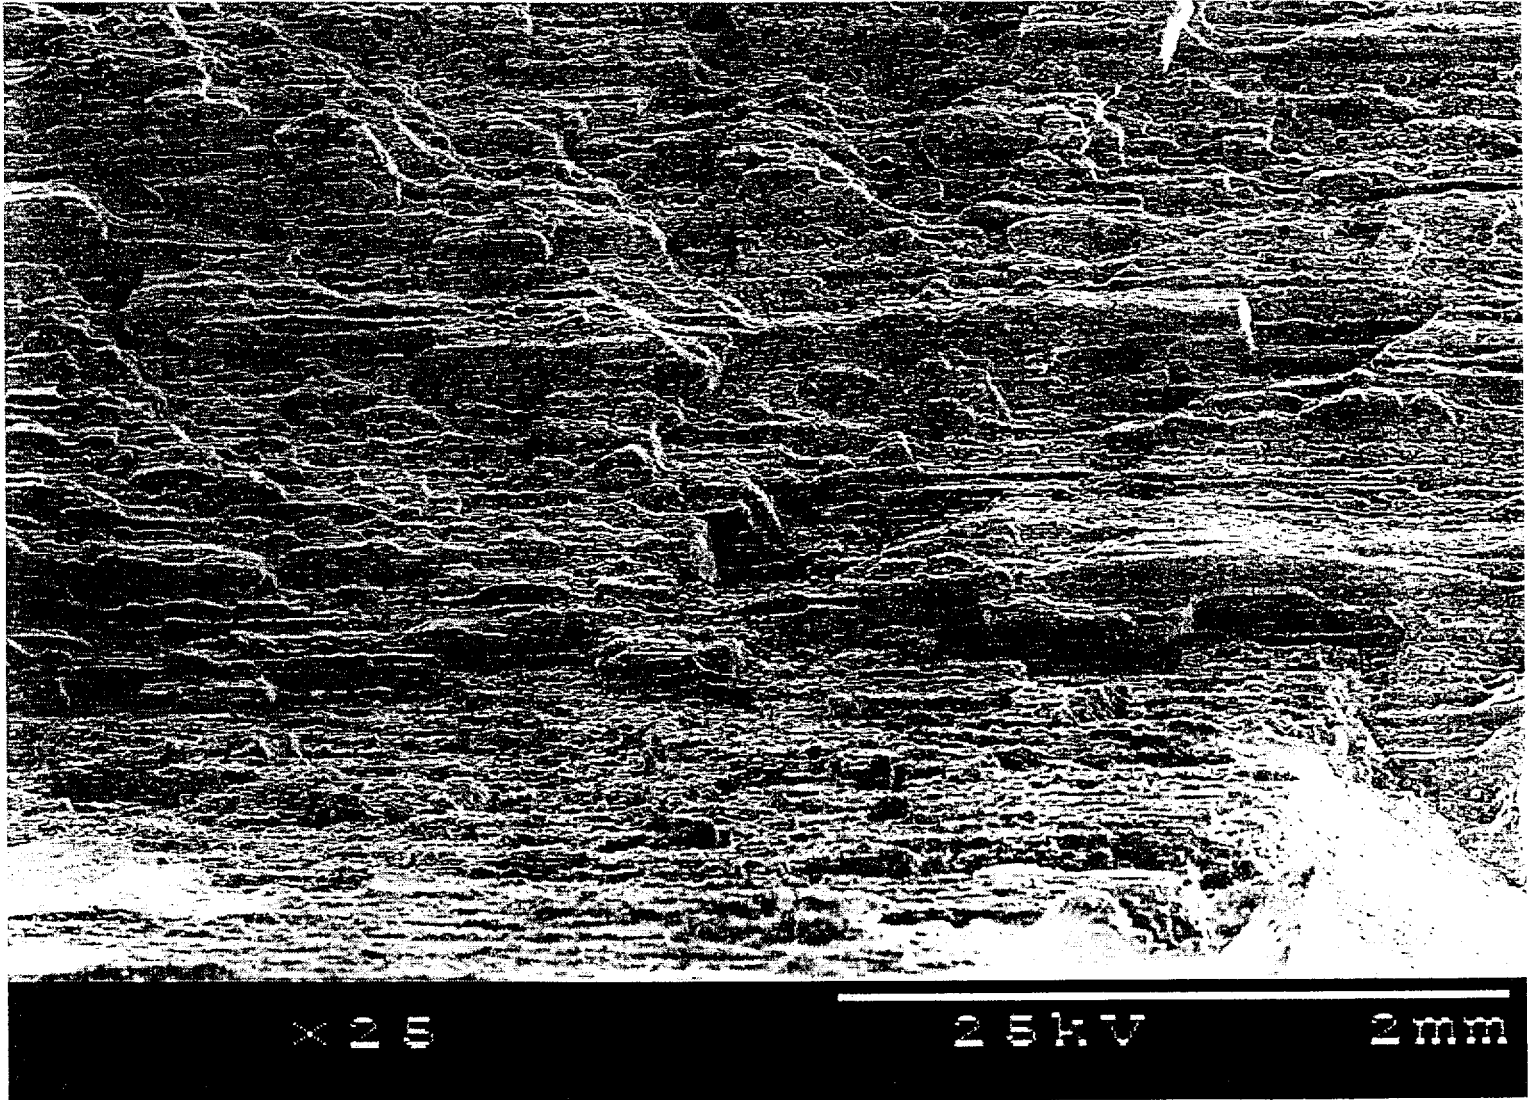
Figure 11: Low Magnification (25X) Laser Reproduced, Enlarged SEM Micrograph Showing the General Vicinity of Fracture Origin.

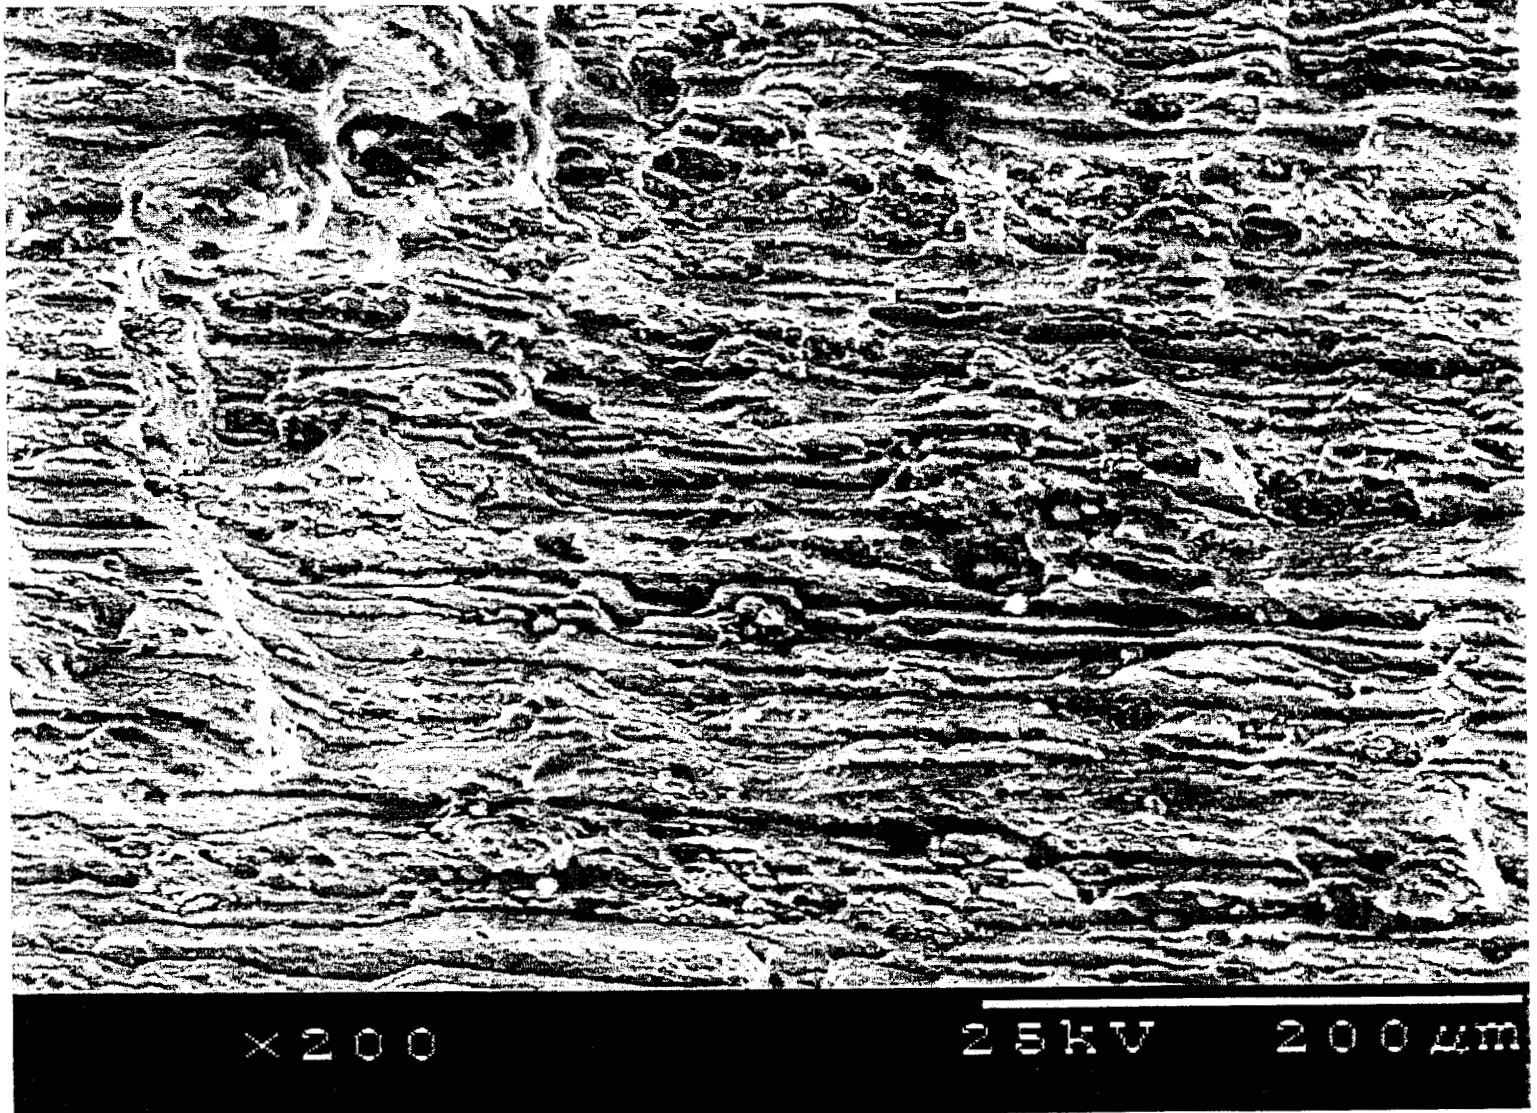
Figure 12: Higher Magnification (200X) Laser Reproduced, Enlarged SEM Micrograph Showing Impact or Overload Fracture Morphology.

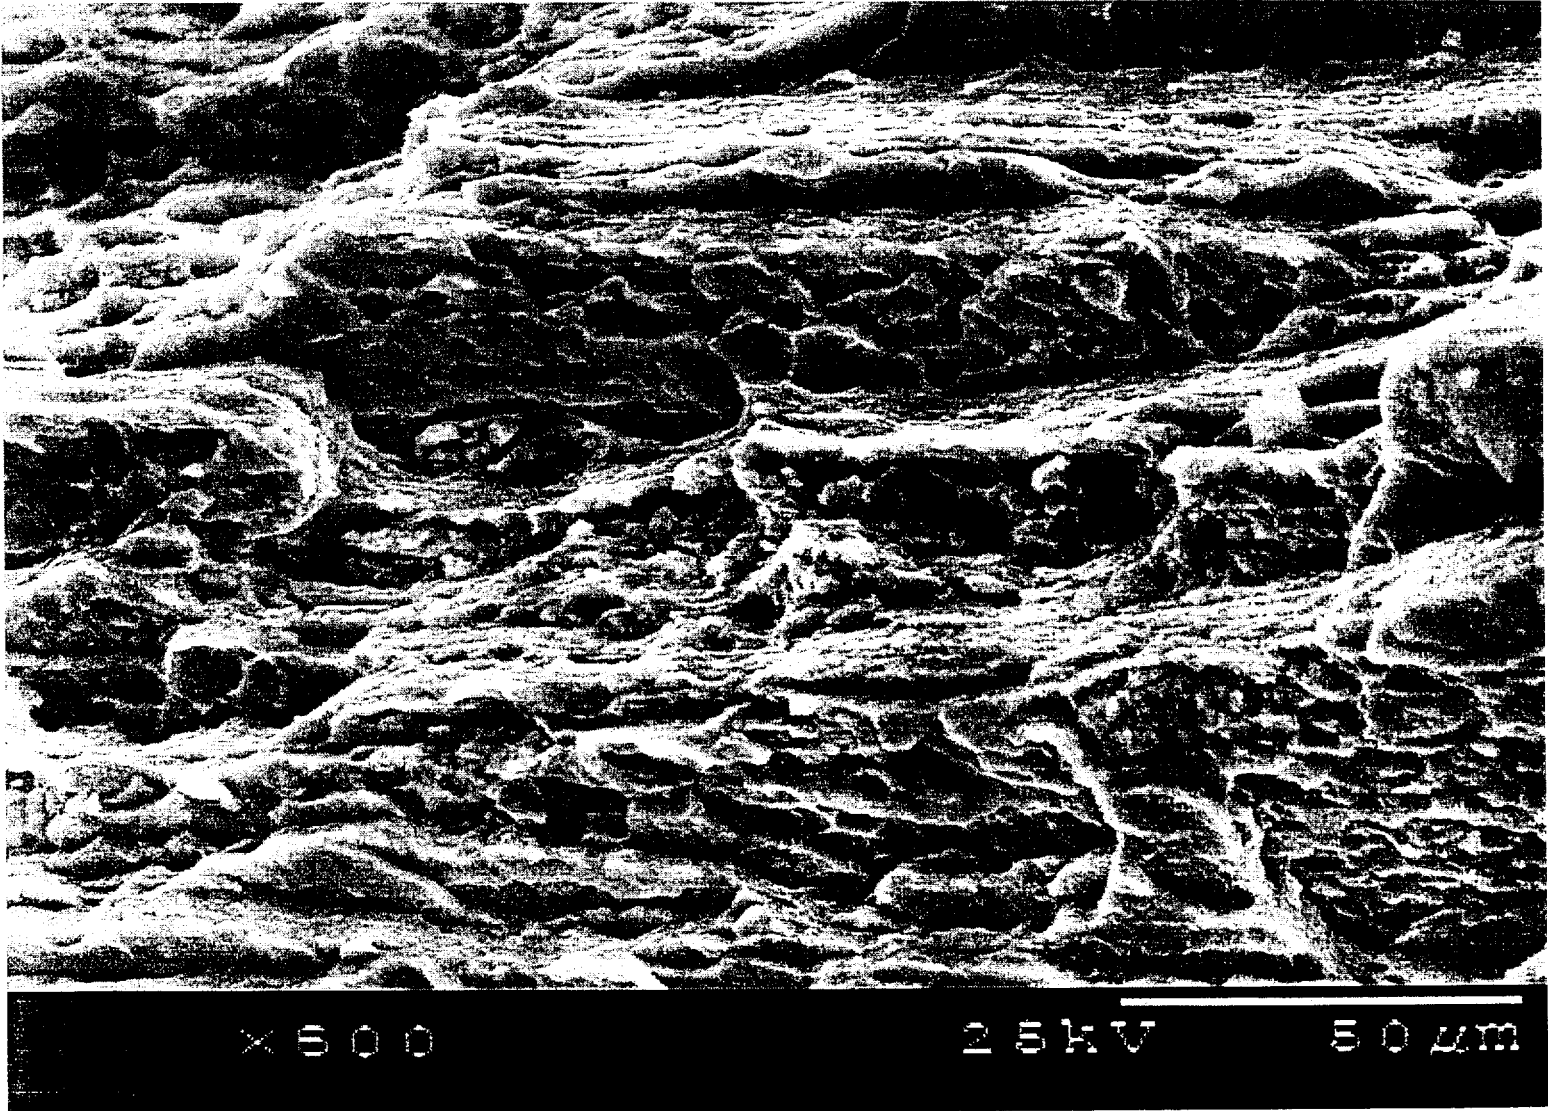
Figure 13: Higher Magnification (600X) Laser Reproduced, Enlarged SEM Micrograph Showing Impact or Overload Fracture Morphology.

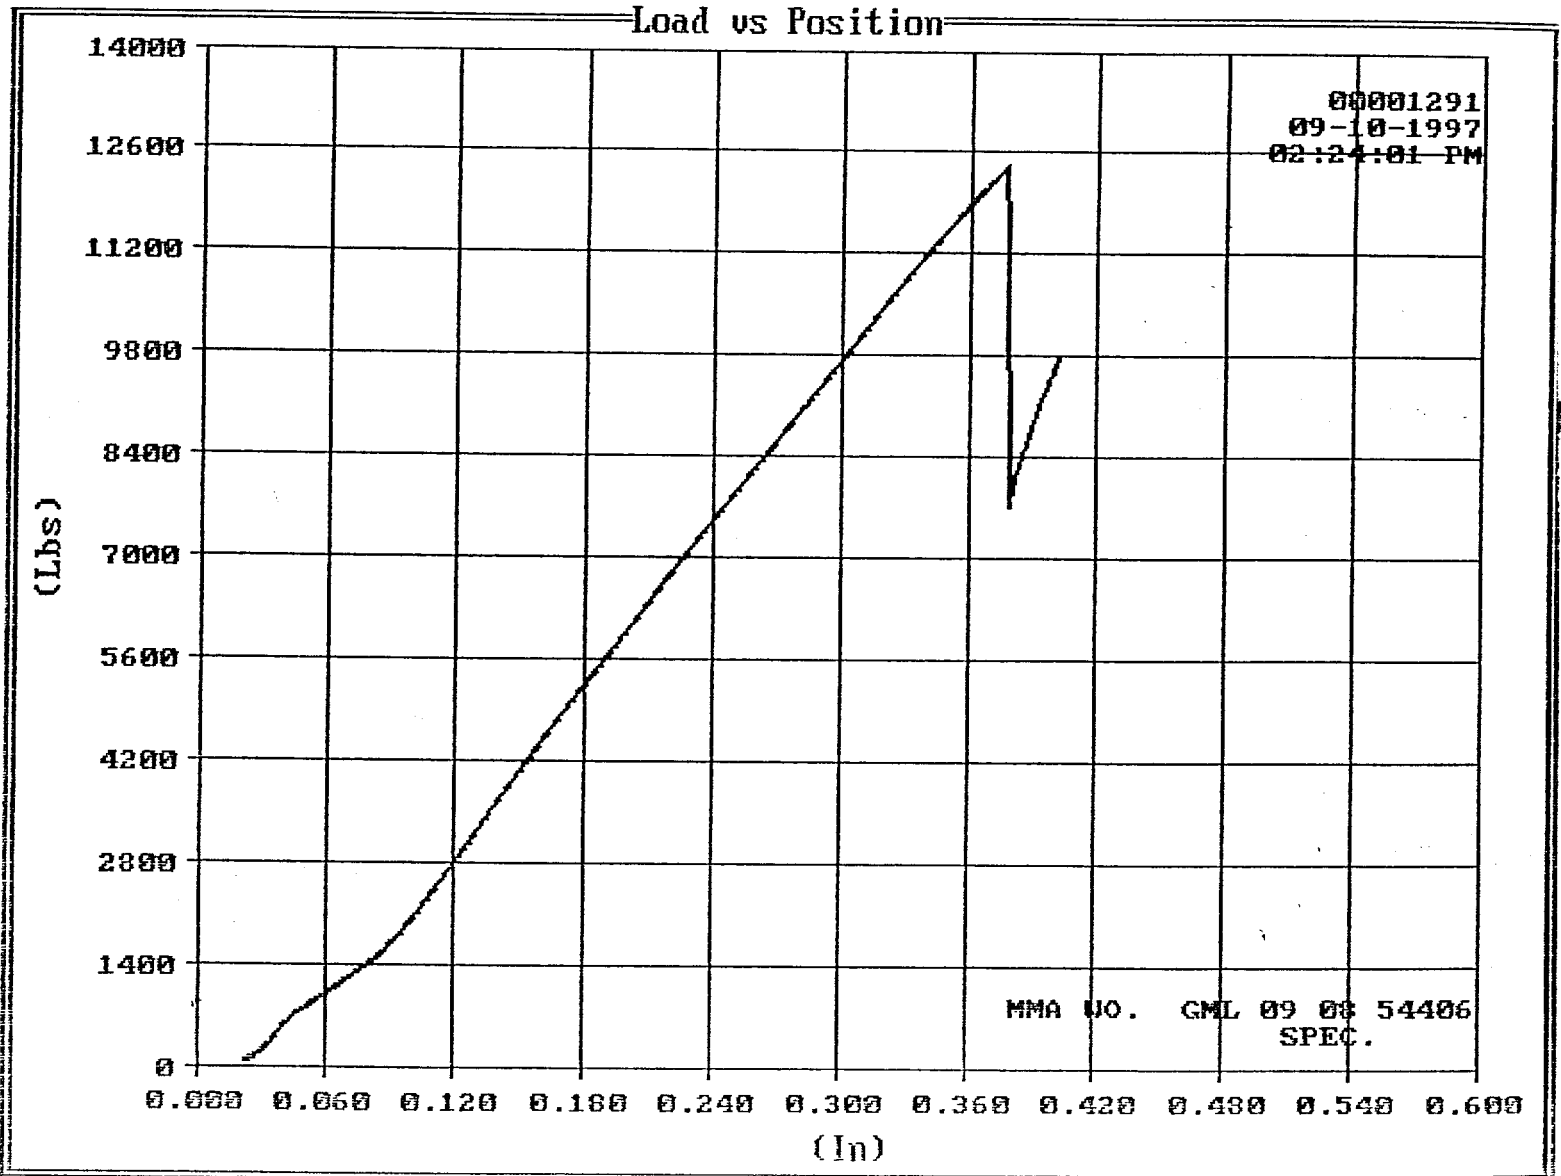
Fully Locked Position Load Test Graph

Load testing was performed to determine if the locking pawls could be sheared or disengaged by a vertical downward load. Testing was performed with the release pawl in the fully locked position and partially locked position. In the fully locked position, the assembly was able to withstand a load of approximately 12,400 lbf with no disengagement or shearing of the locking pawls occurring. During this test, breakage of the lock base occurred with usage of the pallet lock assembly pawls still possible. In the partially locked position, the pallet locking assembly was able to withstand a load of approximately 4,800 lbf. No disengagement or shearing of the locking pawl was observed. Compressive loading was performed to determine if disengagement of the pawls would occur and it did not. MMA was unable to cause in any of the three tests performed pawl disengagement.

Position 0.40330 In Load 12415.0 Lbs  
Stress 24830.0 PSI

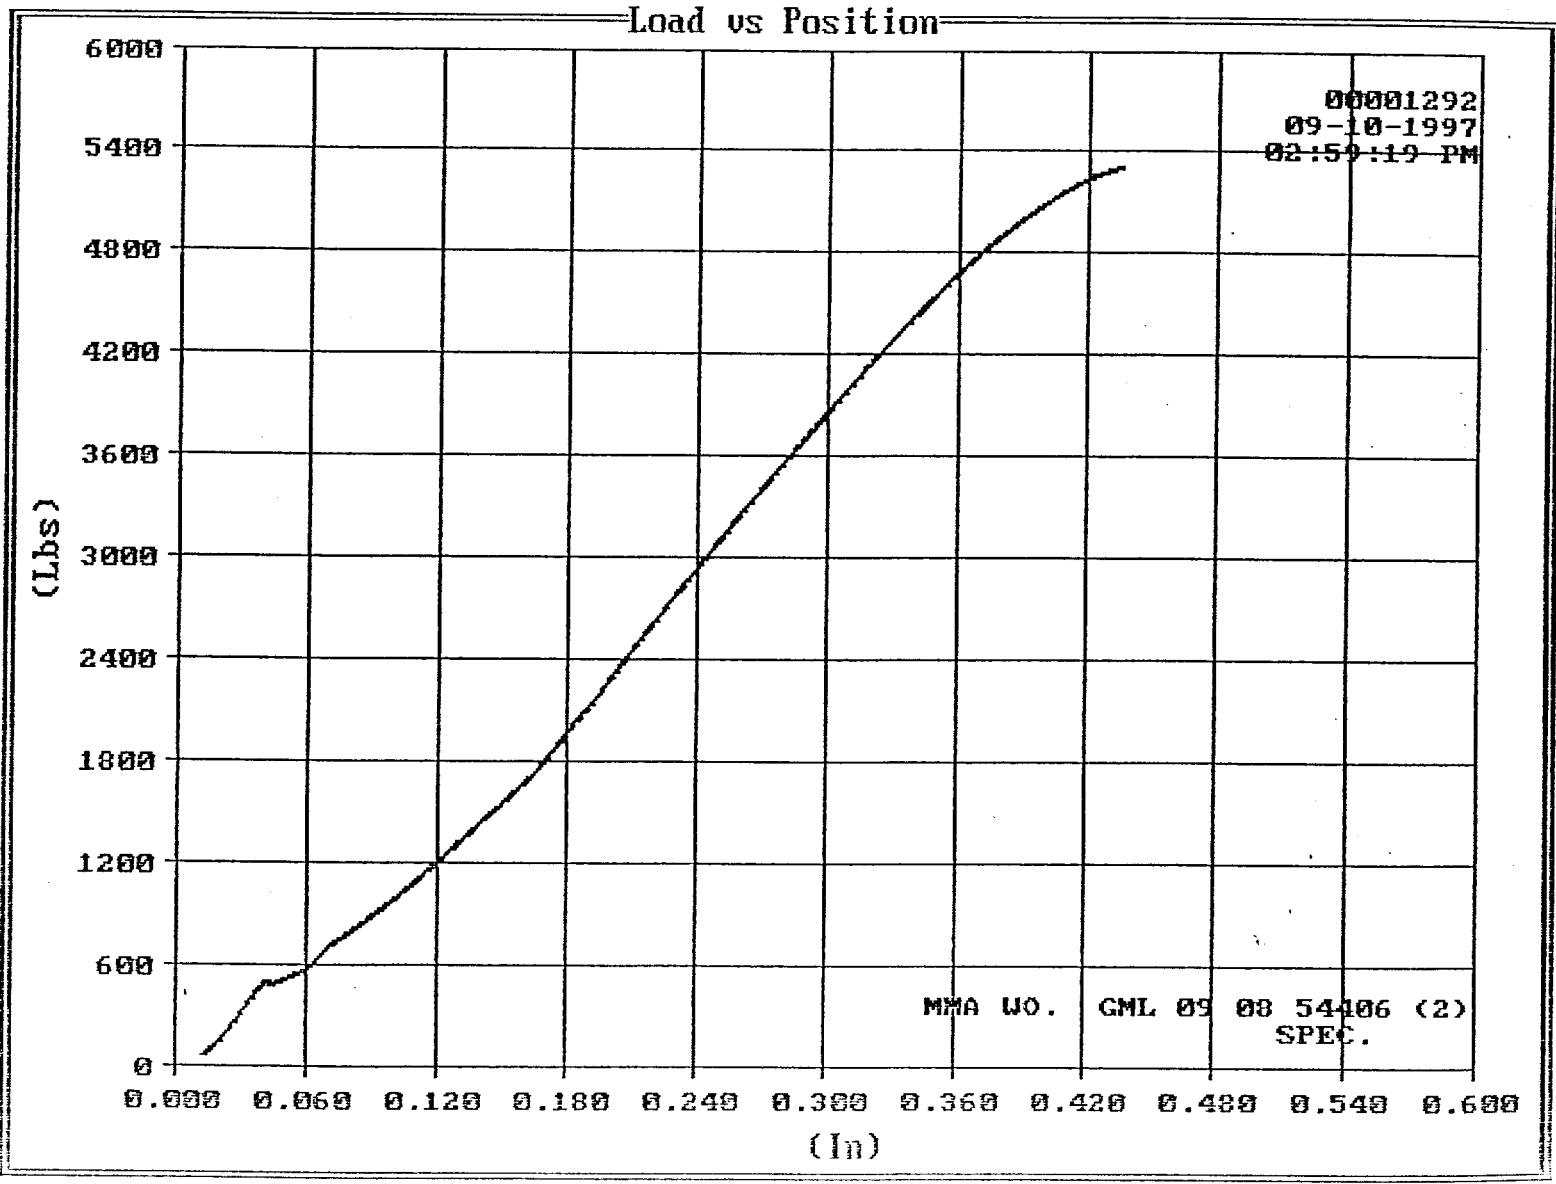
Partially Locked Position Load Test Graph

----- Peaks -----  
Position 0.43650 In Load 5302.5 Lbs  
Stress 10605.0 PSI

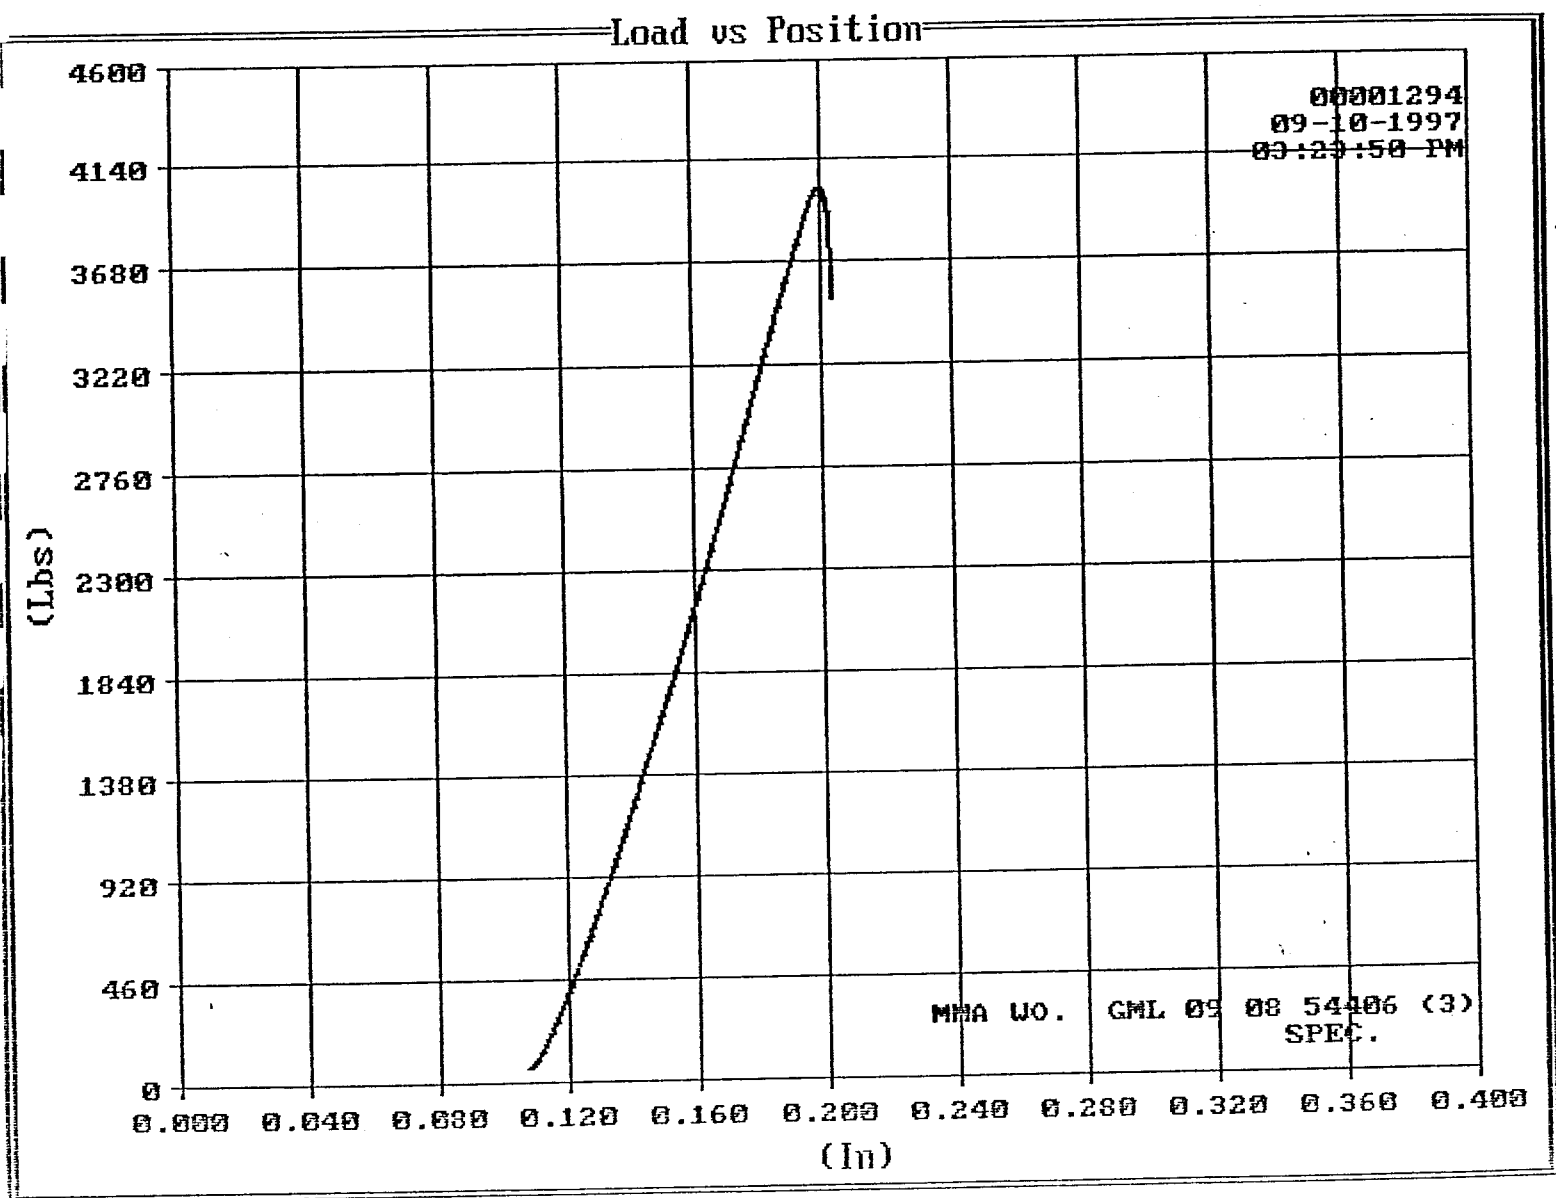
Inverted Compression Load Test Graph

osition 0.20430 In Load 4004.9 Lbs  
ress 8009.8 PSI

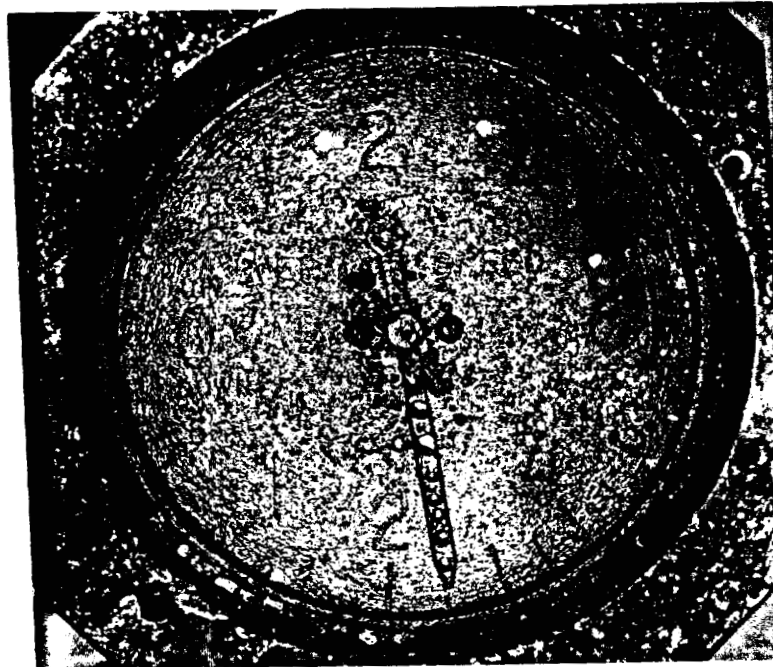
Detail examination of the vertical speed indicator after cleaning revealed that the needle for this indicator was found midway between the numbers 2 and 3 down position as shown in figure 1. The units for this dial plate were not clear because of heavy sooting deposits. The needle could be easily rotated by hand and the soot pattern under the indicator needle was similar in appearance to near by areas.

Figure 1 View of vertical speed indicator showing needle position.

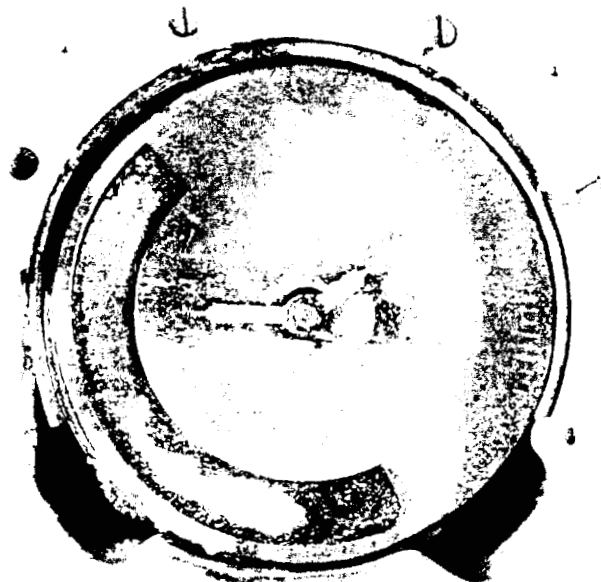
Visual examination of the air speed indicator in figure 2 revealed the max. allowable airspeed indicator needle was pointing to approximately the 330 knots position and the air speed indicator needle was pointing to approximately the 107 knots position. Neither of these indicator needles could be moved easily by hand. Due to the sooting deposits, the mach scale was not legible.

Figure 2 View of the airspeed indicator showing the needle position.
