NATIONAL TRANSPORTATION SAFETY BOARD

STRUCTURES GROUP FACTUAL REPORT

A. ACCIDENT DCA09MA021

Location: Denver, Colorado
Date: December 20, 2008
Time: 1818 Mountain Standard Time (MST)
Aircraft: Continental Airlines Flight 1404, Boeing 737-524, N18611

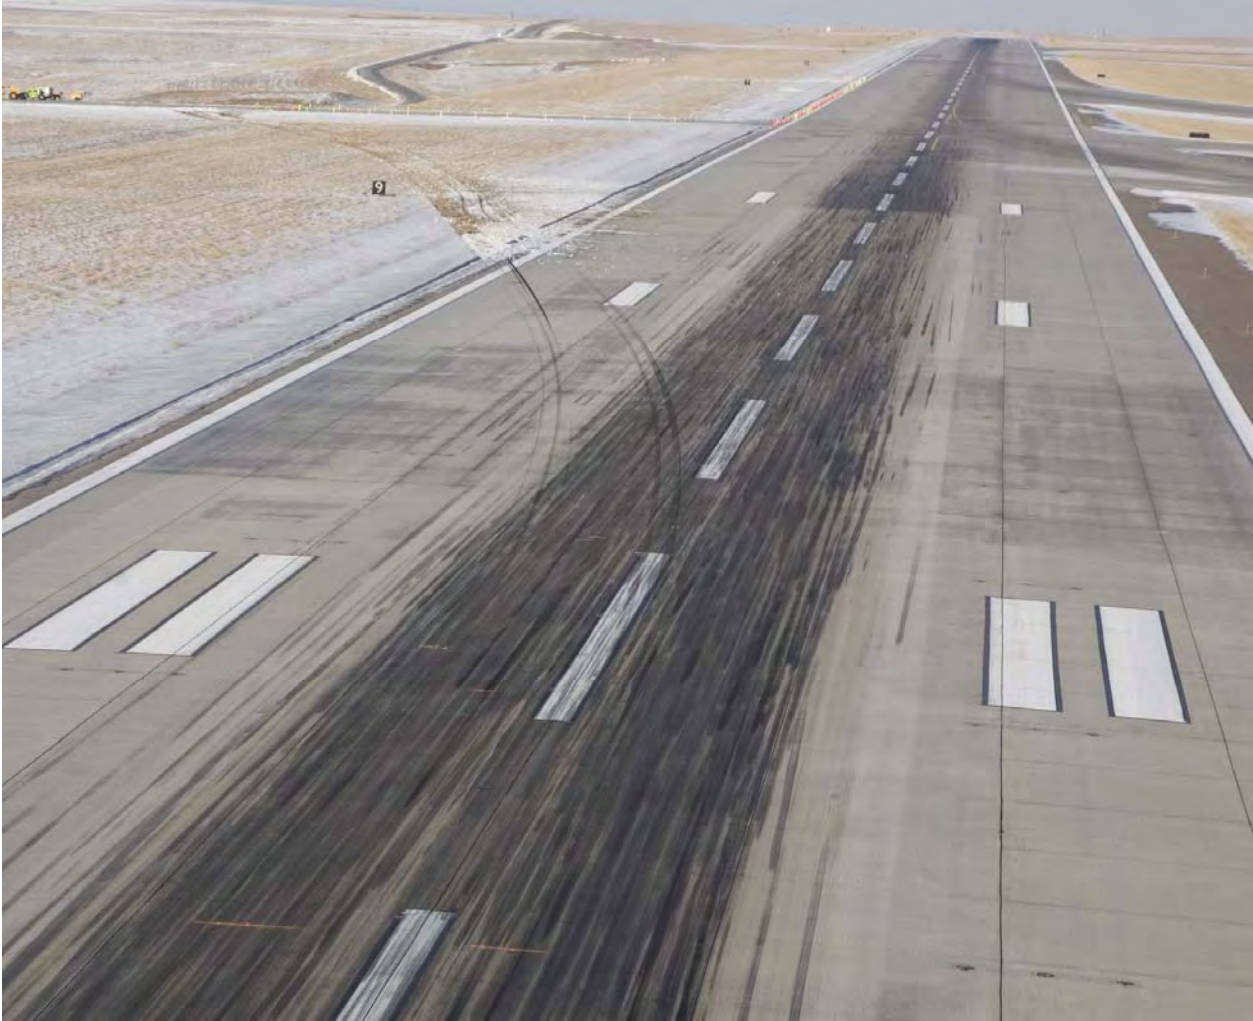
Figure 2 – Aerial View of Runway Skid Marks

Two sets of skid¹ marks initiated about 1,910 feet north of the approach end (threshold) of runway 34R. The skid marks were positioned consistent with the tires from the right and left main landing gear (MLG). The skid marks continued on a straight track for about 60 feet and then began to arc to the left (west). See Figure 2 for an aerial view of the runway skid marks.

The right skid mark set consisted of two parallel skid marks that were positioned 4 feet, 7 inches and 6 feet, 5 inches east of the runway centerline. The width of the individual skid marks varied between 4 and 9 inches. The right set of skid marks started light and increased in intensity to a moderate level. The entire skid mark length measured 837 feet from the point of initiation to the point of departure from the west runway edge. The right skid mark set departed the west edge of the runway about 2,640 feet from the threshold.

varied between 5 and 8 inches. The initiation of the left skid mark set was very light in intensity and transitioned to a light intensity along the skid. The entire skid mark length measured 734 feet from point of initiation to the point of departure from the west runway edge. The left skid mark set departed the west edge of the runway about 2,624 feet from the threshold.

A third skid mark, consistent with the position of the right wheel on the nose landing gear (NLG), initiated about 2,015 feet north of the threshold of runway 34R. Specifically, the skid mark initiated 103 feet, 8 inches north of the right and left skid mark sets and 7 feet, 11 inches west of the runway centerline. This skid mark width measured between 3 and 7.5 inches along the length of the skid mark. About 147 feet from the initiation point, the skid mark began to converge with the left set of MLG skid marks. A second skid mark consistent with the left tire of the NLG became evident about 120 feet from the west runway edge. The two distinct NLG skid marks diverged from the left set of MLG skid marks and remained a distance of about 7 inches from those skid marks for the remainder of the length. At initiation, the NLG right skid mark was very light in intensity and gradually became darker. The last 80 feet of the NLG right skid mark increased to a heavy intensity. The NLG left skid mark was light in intensity at the initiation and increased to a heavy intensity at the runway edge. The two NLG skid marks converged towards each other along the length of the skid. The entire length of the NLG right skid mark was 652 feet from the point of initiation to the point it departed the west edge of the runway.

All three sets of skid marks departed the runway to the left (west) side. Snow and ice was scattered to the right of the departure point back onto the runway. No other debris, ice, or snow was noted or observed on the runway on the night of the accident. No damage was noted to runway signs or lights.

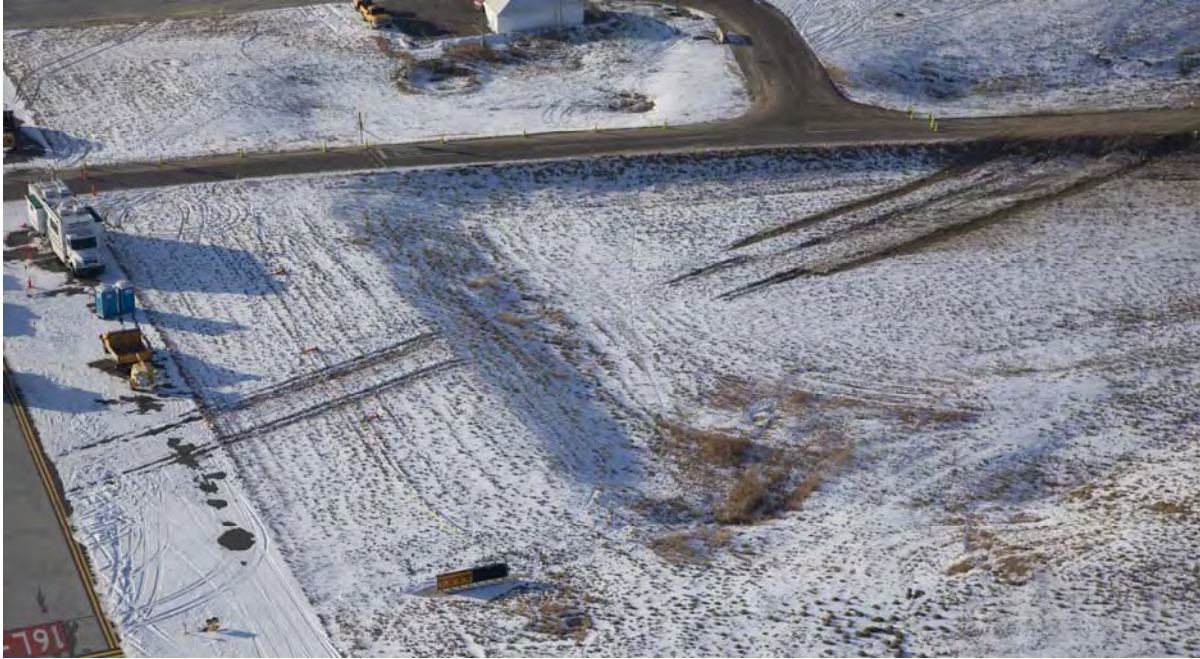
Figure 3 – Aerial View of Ground Scars at Terrain Drop-off

The left and right MLG skid marks changed to ground scars at the edge of the runway when the tires left the paved surface and entered the grass, snow, and dirt. The ground scars continued from the west edge of the runway into the adjacent grass in a north/northwestern direction for about 1,010 feet. The two scars were characterized by ruts formed in the dirt, snow, and grass consistent again with the right and left MLG tires. The left set of ruts appeared wider than the right set of ruts. There was no distinct set of NLG ground scars conclusively identified due to the numerous airport vehicle tracks in this area. The two sets of ruts varied from less than one inch in depth to five inches in depth and a distance of 14 feet was measured between the two sets of ruts. This area of the terrain was snow covered with three to five inches of snow on the night of the accident.

The ground scars transitioned to skid marks as they crossed taxiway WC. The skid marks were very light in intensity and a distance of 14 feet was measured between the right and left MLG skid mark sets on the taxiway. There were no discernable NLG skid marks. The skid marks transitioned back to ground scars as they continued off of the north end of taxiway WC. The right and left ground scars continued for an additional 70 feet and terminated at the edge of a terrain drop off. The left ground scar appeared wider than the right. The terrain abruptly decreased in elevation at this point and was about 13 feet below the taxiway elevation.

Two sets of parallel ruts were formed in the snow and grass 168 feet from the termination of the previous set of ground scars. These ruts were parallel and consistent with the MLG on the aircraft. The right rut measured 33 feet in length and the left rut measured 32 feet in length. The distance between the two ruts measured 16.7 feet. See Figures 3 and 4 for aerial views of the ground scars.

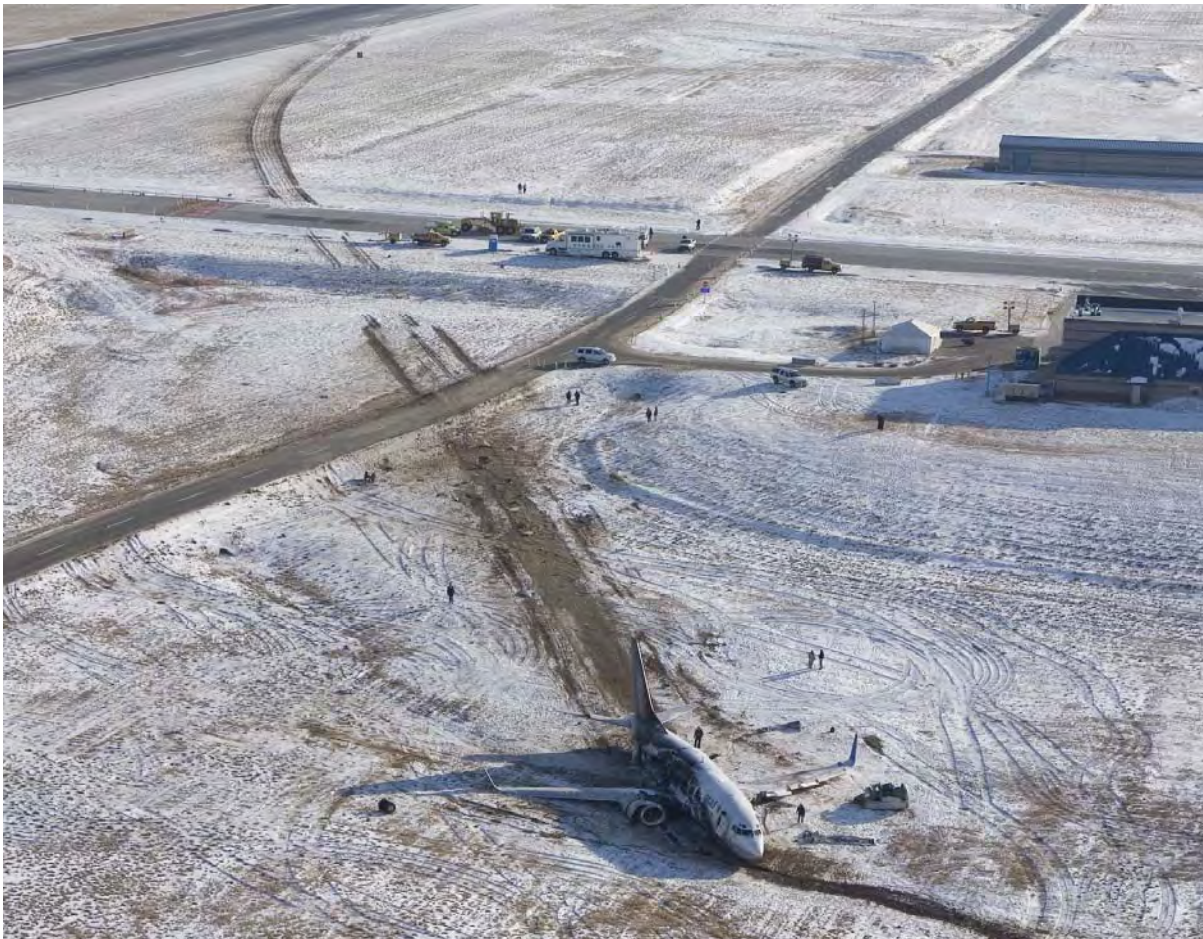
Figure 4 – Aerial View of Ground Scars and Wreckage

Adjacent to the termination of the two parallel skid marks, two additional ground scars initiated, consistent with the right and left engine nacelles. These scars were approximately 29 feet apart, 4.5 feet each at their widest point, and continued from their initiation point for about 90 feet to the airport service road (Kewaunee Street). The initiation of these ground scars was accompanied by the initiation of the debris field. Debris located within the first 90 feet included torn metal, fiberglass, paint chips, and honeycomb material consistent with the engine cowling and nacelles.

Dirt and debris continued up a four foot incline and across Kewaunee Street. Several green reflector polls along the street were bent in the direction of airplane travel. The ground scars continued down a three to four foot slope and transitioned into one wide scar, approximately 20 feet wide at its widest point, for approximately 250 feet to the main wreckage. Debris within this ground scar included torn metal, honeycomb composite material, the right MLG assembly, a portion of the left MLG, and tubing, hoses, and wires consistent with engine components and accessories.

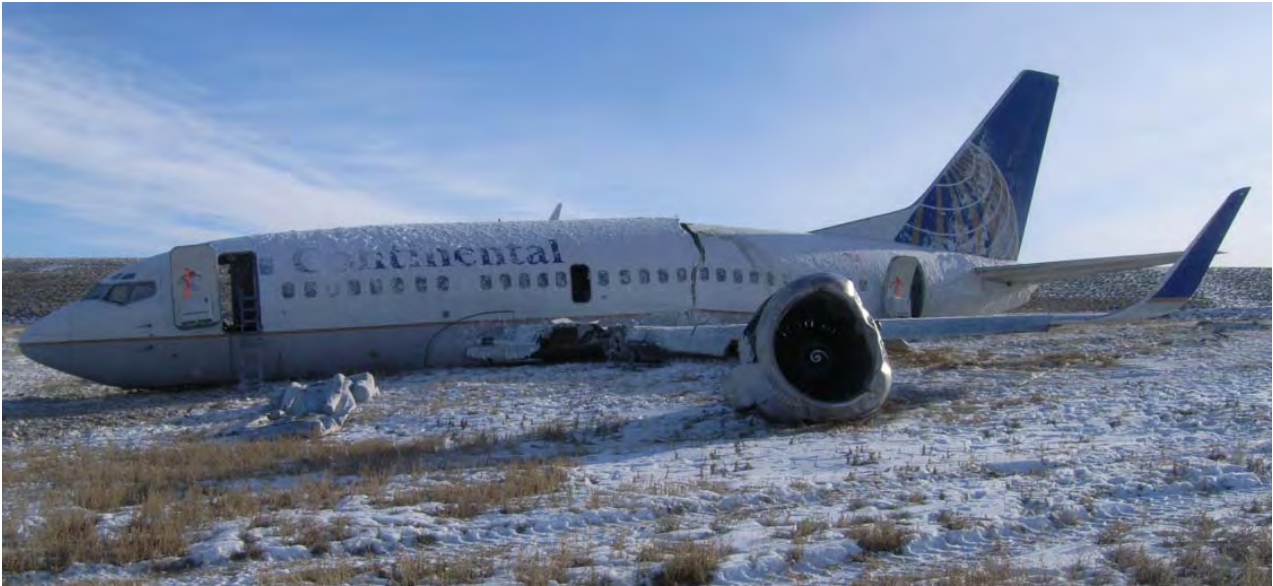
Figure 5 – LH Side of Wreckage

The airplane came to rest in a drainage basin west of runway 34R about 40 feet below the runway elevation. The airplane was on a 315° magnetic heading. Both MLG and the left engine were separated from the airframe. The NLG remained attached to the airplane and was collapsed aft into the NLG wheel well and Electronic Equipment bay aft of the wheel well. There was a post crash fire on the right side of the airplane. See Figures 5 and 6 for photos of the left (LH) and right (RH) side of the wreckage, respectively.

The left wing was intact and attached to the fuselage. The trailing edge flaps, leading edge slats, leading edge Krueger flaps, 5 spoilers, aileron and winglet remained attached to the left wing. The center and inboard leading edge slats and both Krueger flaps exhibited crushing, denting, and buckling damage and deformation in the area around where the engine was installed. The inboard trailing edge flap and inboard ground spoiler were bent and

buckled aft of the area where the left MLG is normally installed. The left engine pylon area was crushed, buckled, and torn in the vicinity of nacelle station (NAC STA) 196.840. The section of the pylon above approximately NAC waterline (WL) 132.15 remained attached to the lower surface of the wing. The left wing forward spar at the pylon attachment location exhibited very little damage. The front spar clevis fitting, inboard lobe, which holds the fuse pin to the upper link assembly, was sheared off.

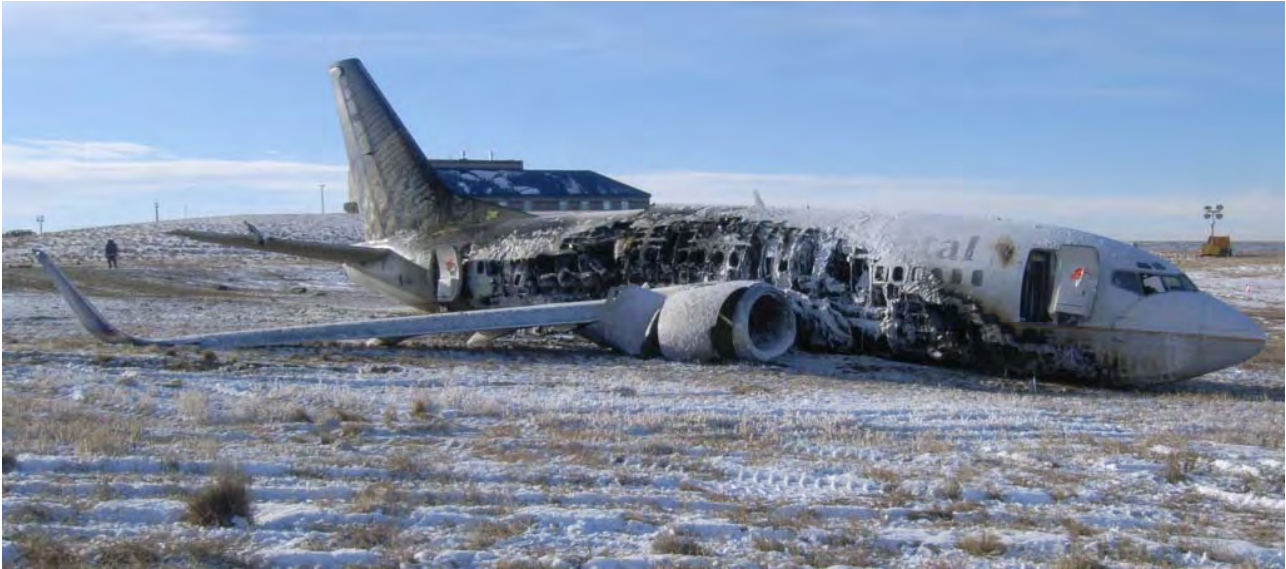
Figure 6 – RH Side of Wreckage

The right wing was intact and attached to the fuselage. The right wing was deformed downward about 20° between the pylon and fuselage. The outboard trailing edge flaps, leading edge slats, 3 outboard spoilers, aileron, and winglet remained attached to the right wing. The Krueger flaps, upper wing skin inboard of the pylon, inboard flaps, and 2 inboard spoilers were consumed by fire. The inboard half of the outboard trailing edge flaps and the lower wing skin inboard of the pylon exhibited moderate to heavy fire damage. The engine and pylon remained attached to the wing with moderate buckling and tearing damage.

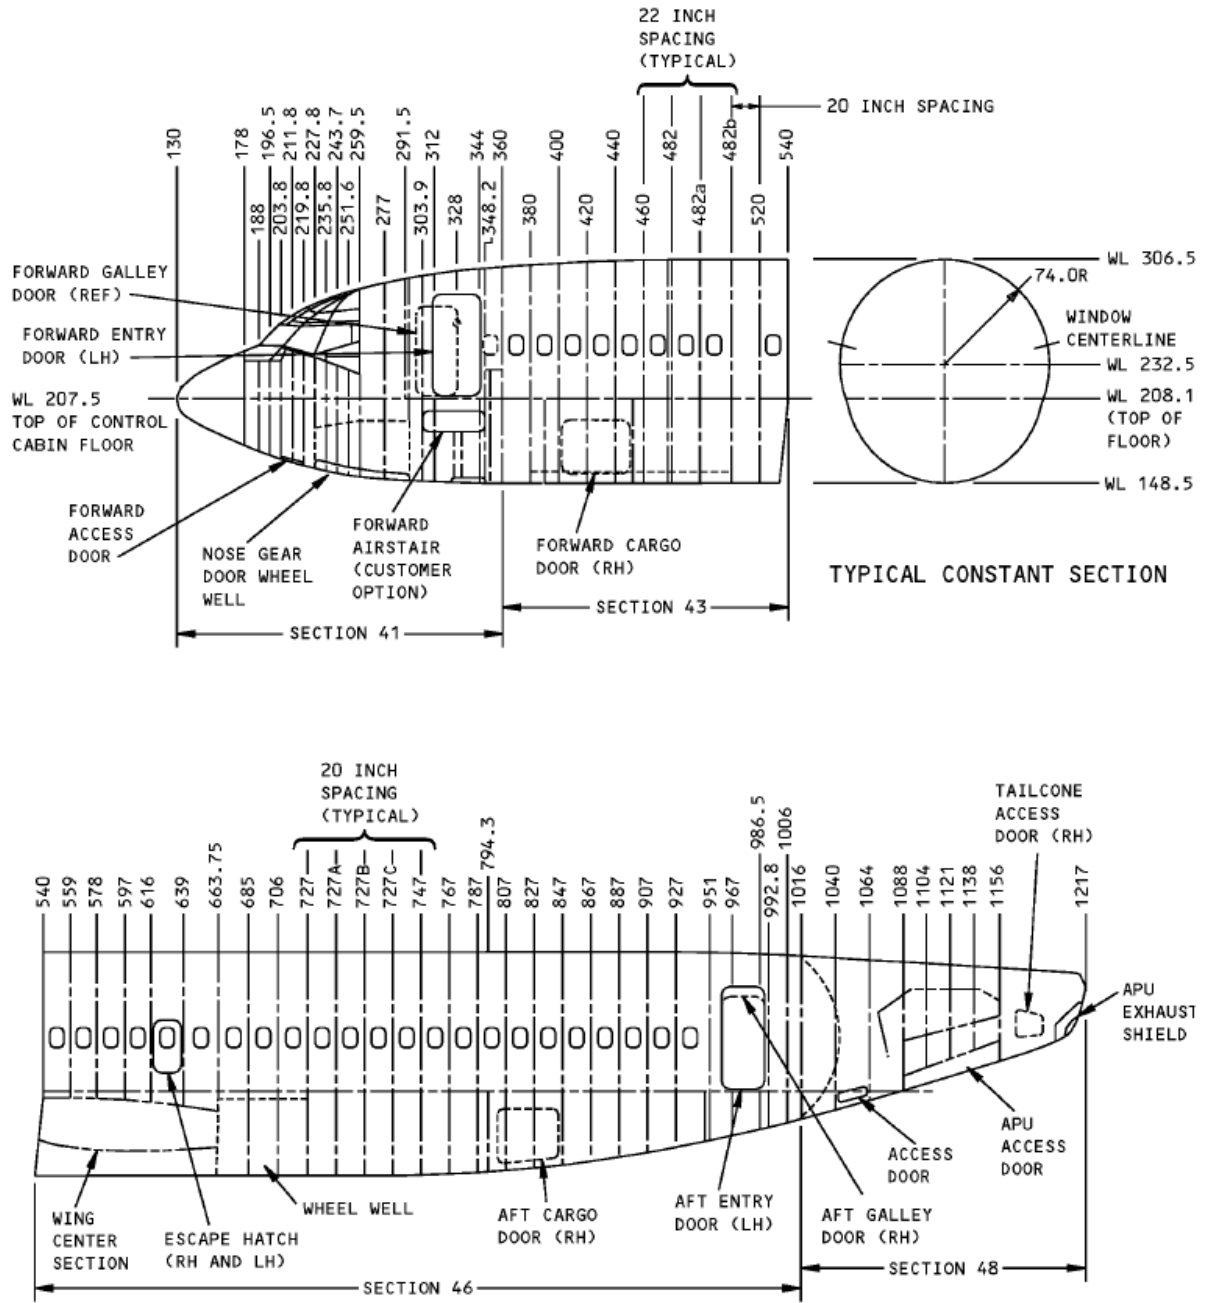
Figure 7 – Boeing 737-500 Fuselage Station Diagram

See Figures 7-11 for the Boeing 737-500 station diagrams. The fuselage was broken into two pieces in the vicinity of fuselage station 727B. The lower fuselage sustained significant scraping, denting, and buckling damage along its length. The right side of the fuselage sustained heavy fire damage from station 291 to station 887. A large section of the right fuselage was entirely consumed by fire. The forward and aft doors on the right side were open and reportedly opened by the first responders. The left side of the fuselage exhibited only buckling and denting damage but no fire damage. The forward and aft doors on the left side and the left overwing exit were in the open position.

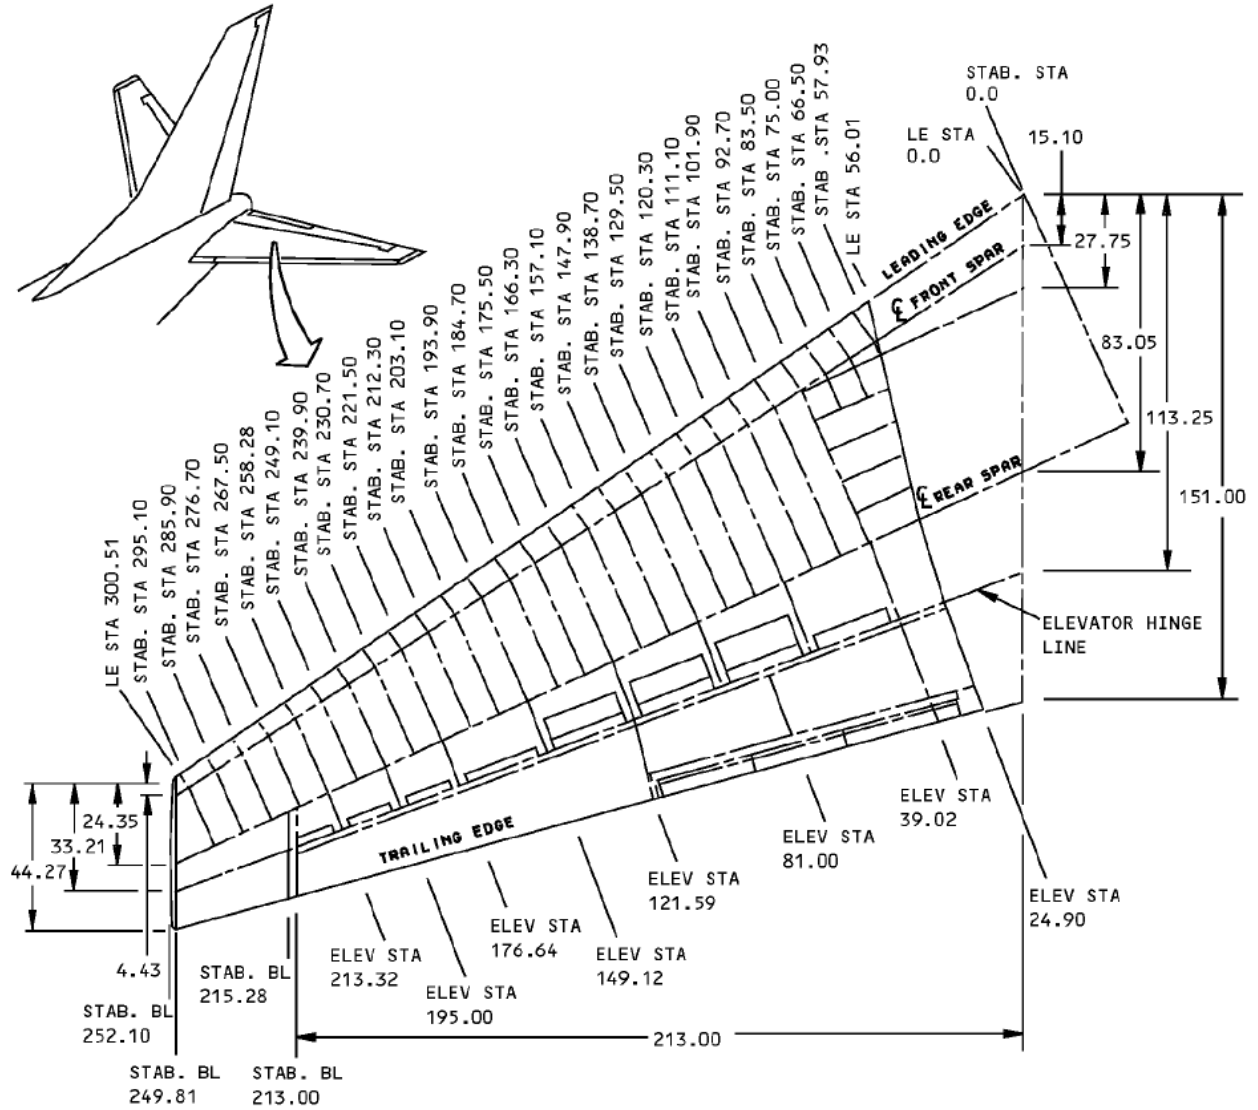
Figure 9 – Boeing 737-500 Horizontal Stabilizer Station Diagram

The empennage was intact and exhibited little damage. The right side of the vertical stabilizer exhibited light fire damage and charring while the left side was essentially normal. The left horizontal stabilizer was undamaged. The right horizontal stabilizer exhibited tearing and crushing damage between stations 203 and 221 that penetrated about 27 inches aft of the leading edge.
