NATIONAL TRANSPORTATION SAFETY BOARD

STRUCTURES GROUP CHAIRMAN'S FACTUAL REPORT

A. ACCIDENT: DCA06MA009
LOCATION: Chicago Midway Airport
DATE/TIME: December 8, 2005
AIRCRAFT: Boeing 737-700, N471WN
Southwest Airlines, Flight 1248

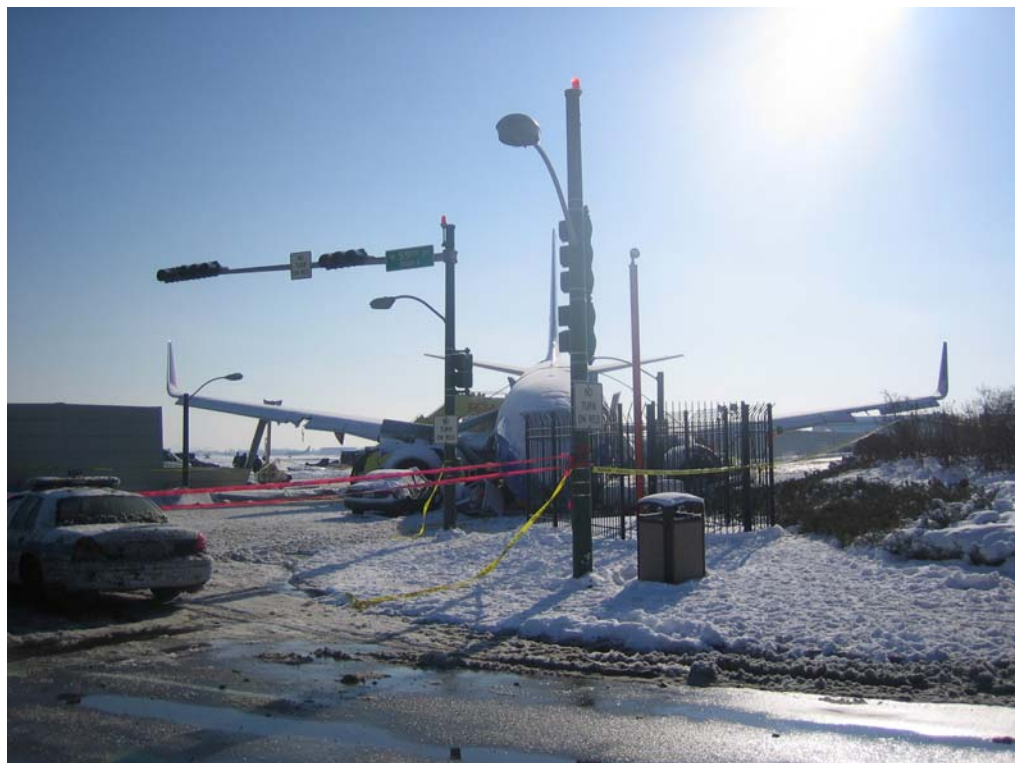
The airplane was found at the south side of the intersection of 55th Street (east/west) and Central Avenue (north/south), directly past the end of runway 31C. (See Figure 1) The heading of the fuselage was 340 degrees magnetic, with the airplane resting on the engines, both main landing gear, and the nose. The nose was on the west side of Central Avenue, with the nose landing gear folded aft and up into the electronics equipment bay.

Figure 1. Airplane oriented northwest, toward the intersection of 55th Street (east/west) and Central Avenue (north/south), with runway 31C in the background.

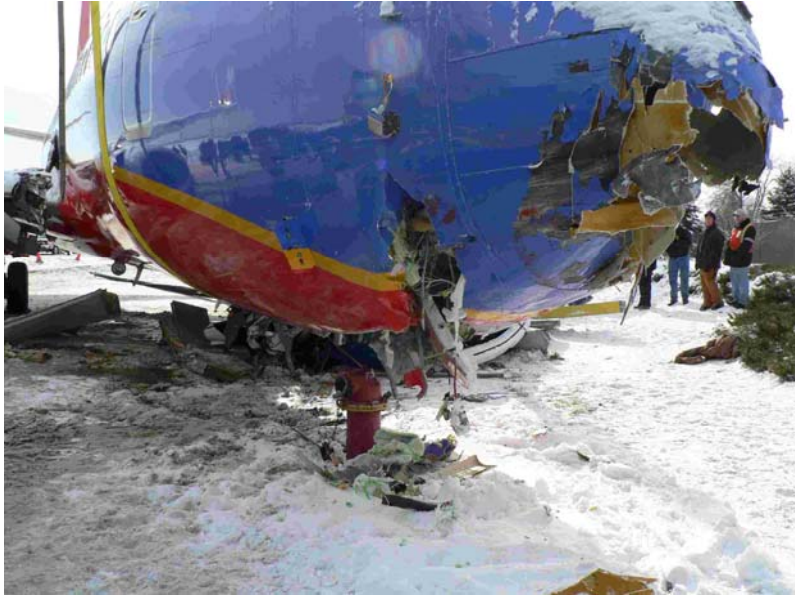
The nose of the airplane came to rest where a fire hydrant caught on the upper drag link (also known as the A-frame) of the nose landing gear. (See Figure 2)

Figure 2. Airplane being lifted off of the fire hydrant, upon which the airplane stopped.

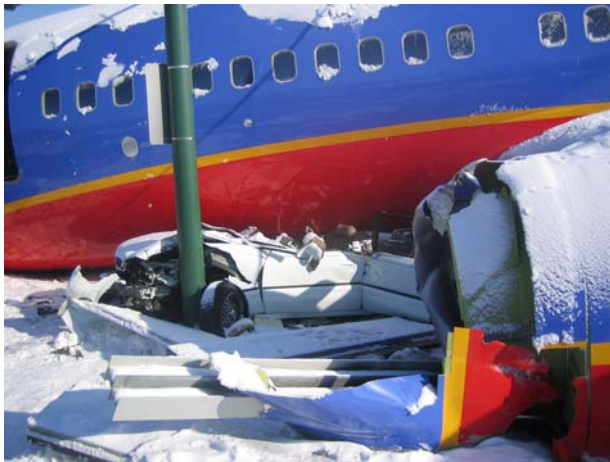
Figure 3. Relation of light post, Pontiac Bonneville, and airplane. A vertical I-beam support for the frangible airport perimeter fence is parallel to the bottom edge of the photo, beneath the left engine.

An I-beam from the frangible perimeter fence was protruding from the bottom of the left (#1) engine. (See Figure 3) Electrical conduit pipe from the airport perimeter fence was wrapped over the top of the airplane at about FS 540. Numerous frangible acoustic panels from the airport perimeter fence were found throughout the area, under the airplane, on the right wing root, and against the two cars. The smell of jet fuel was under the center of the airplane and with the slush in the street gutters. Heavy snow had been falling at the time of the accident and afterward, and snow was found covering the debris.

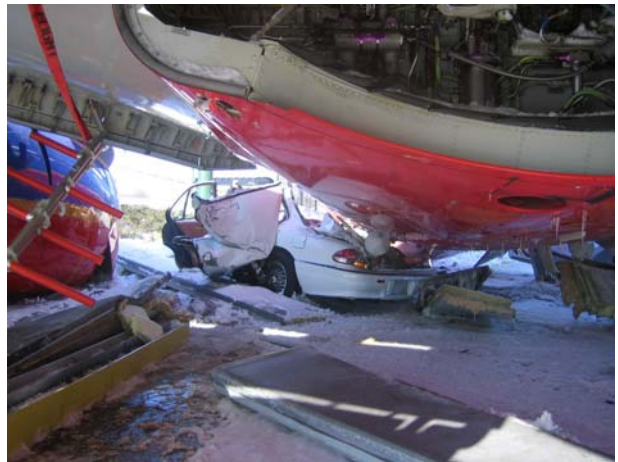
Figure 4. "As-found" relation of airplane and Pontiac.

A white Pontiac Bonneville was found under the lower left fuselage, forward of the wing with the nose of the car angled away from the airplane. (See Figures 3 and 4) The car was pinned between the airplane and the base of a street light, which went into the front left of the car from the left corner of the front bumper (at about the headlight) to the suspension A-frame. Under the airplane and wrapped around parts of the car were acoustic fence panels (5 inches thick each). A fragment of a nose landing gear door was found in the exposed portion of the trunk and black rubber transfers similar to the window seal were found on the fuselage of the airplane, above and below a deep gouge in the lower left fuselage.

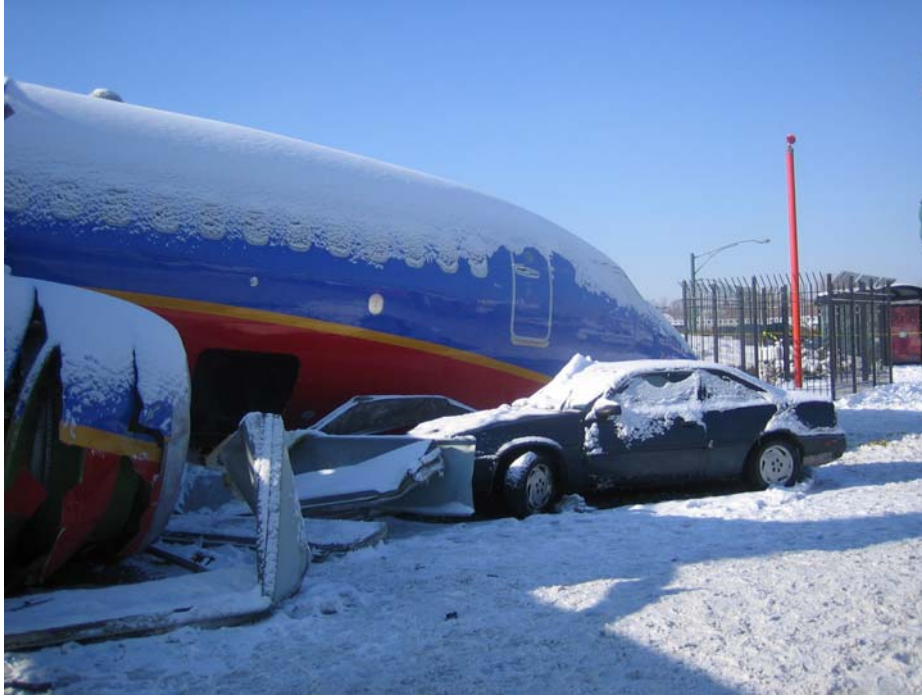
Figure 5. “As-found” relation of airplane and the Chevrolet Caprice. Light frangible acoustic panels from the perimeter fence are visible between the airplane engine and the car.

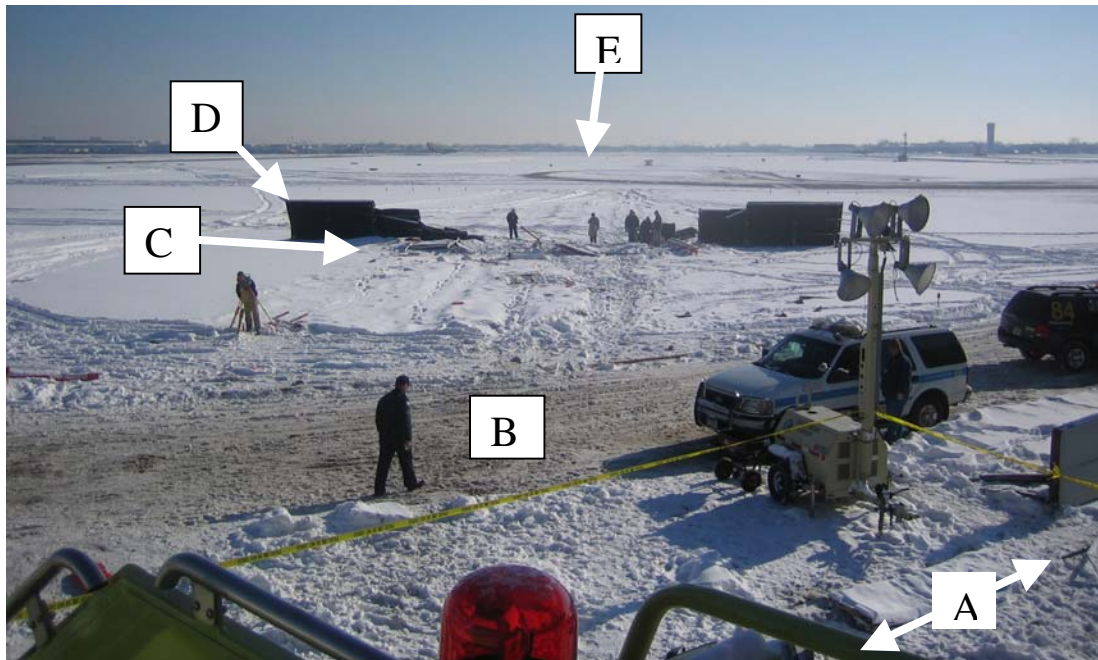
Moving from the airplane toward the runway was a 4” concrete curb, with earth rising about two feet from the street surface to the level of the airfield. (See Figure 6) The airport perimeter fence was open to the street, with the frangible vertical supports separated from fittings sunk into the ground. (See Figure 7) An airport perimeter road with yellow-painted curbs was 21 feet from the perimeter fence, and the road was 33 feet wide. An approximately 8-inch deep depression at the end of the nose wheel track was located 34 feet from the perimeter road, toward the runway. The base of the wood runway-end blast fence was 92 feet from the depression and the end of the pavement (runway over-run area) was an additional 25 feet from the blast fence. About 12 feet from the blast fence toward the street was an approximately 2-foot tall earthen berm that the runway localizer array was sitting upon.

Figure 6. View toward runway from aft right door of airplane, showing street curb (A) with a fragment of the frangible wall, vehicles parked on the perimeter road within airport property (B), destroyed instrument landing system array (C), and hole in blast fence (D). The runway (E) is beyond the blast fence.

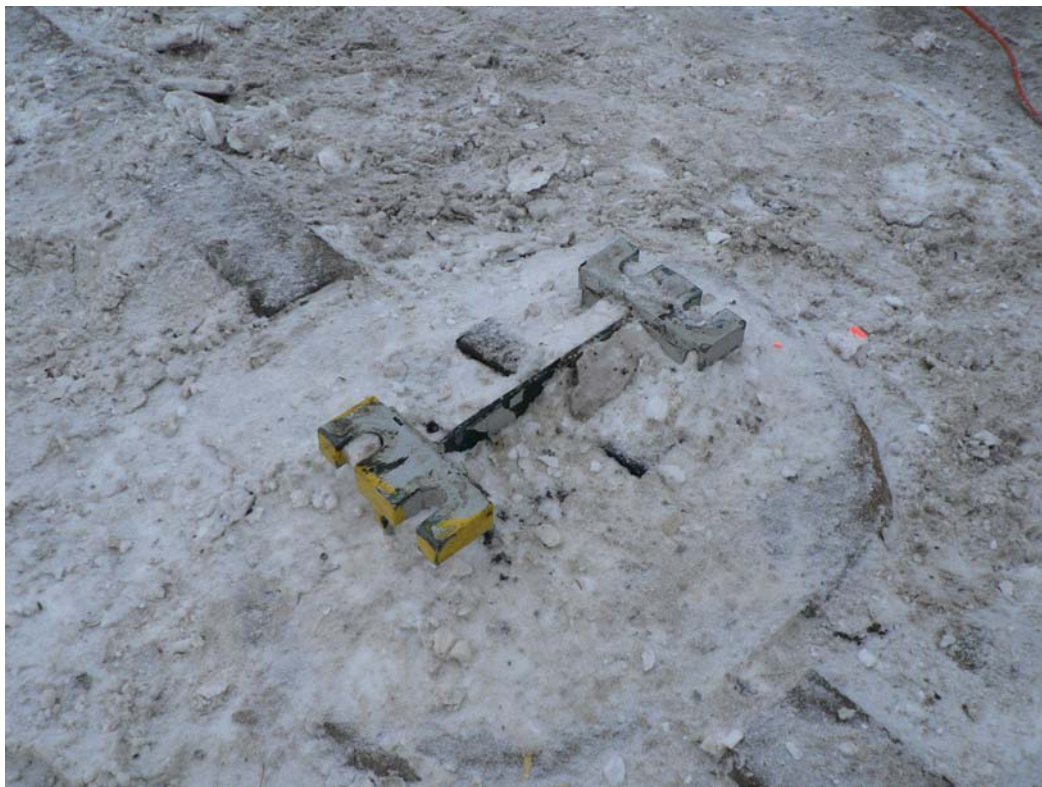
Figure 7. Base of vertical fence support, showing slots that the mounting bolts can be driven from in an impact. (For orientation, the runway is toward the lower left and street is to upper right.)

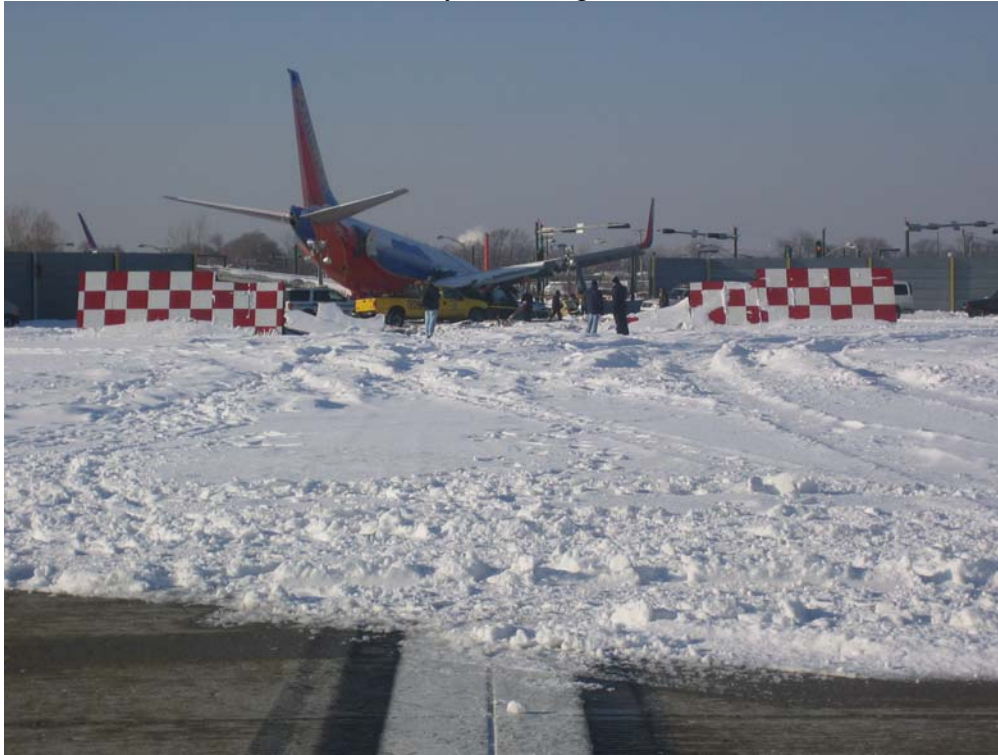
Using the groove in the runway centerline as a sighting device, the rear of the right engine was straight past the extended center of the runway. (See Figure 8)

Figure 8. Runway alignment with the airplane. The white stripe is the runway centerline.

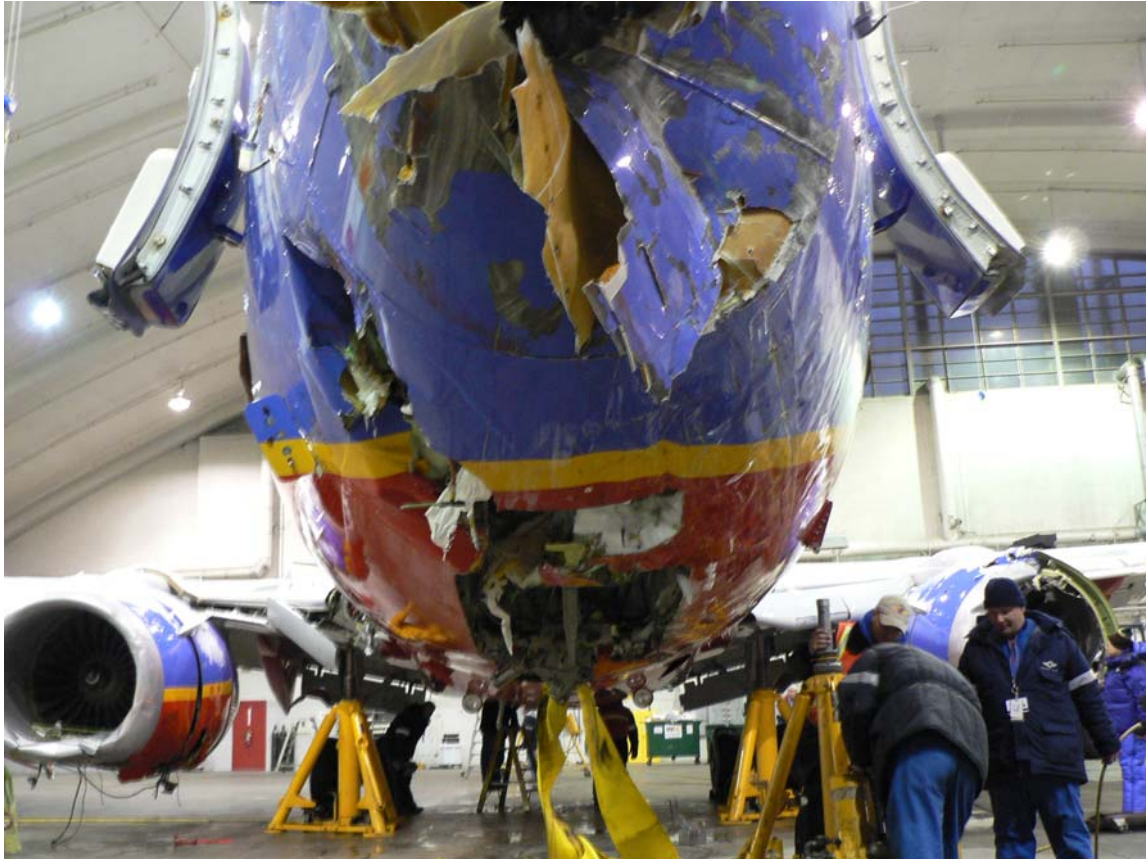
Most of the radome was found on the airplane, with the lower two-thirds extensively crushed and torn, especially toward the left. (See Figure 9) On the right side of the radome and skin behind it were dark red paint transfers that were similar to the dark red of the checkerboard pattern on the blast fence, and the red extended to approximately FS 285. White paint transfers on the left and right sides of the radome and fuselage extended back along the fuselage to approximately FS 360.

Figure 9. Radome and damage aft of it. A yellowish vertical crease matching the spacing and color of a vertical fence support existed slightly to the left of center on the radome and pressure bulkhead. The fire hydrant created the slash into the nose landing gear area.

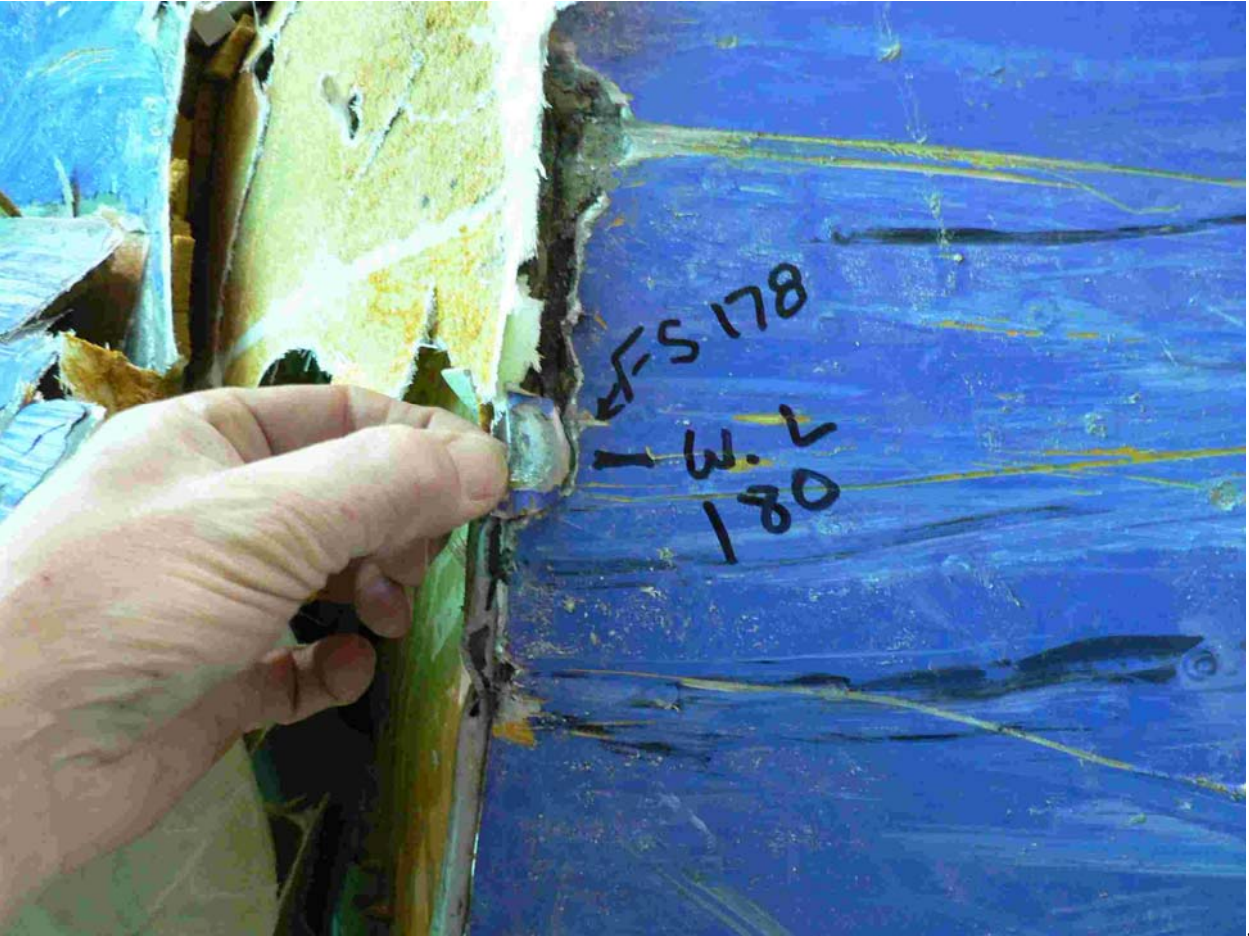
A crease that matched the edge of a frangible fence vertical support and dented structure were ahead of the forward E/E door, at about FS 188 to 205, from the centerline to about LBL 10. A longitudinal creased and dented path of about six inch width at the front extended from the torn skin at LBL 17 to about FS 295/LBL 30, where the path curved outboard, ending as a series of scuffs at about FS 310 to FS 325. In this general area of the lower left of the airplane nose was a missing piece of aluminum skin found later in the Pontiac, plus a deep gouge and series of paint transfers that matched the color of the white Pontiac Bonneville. (See Figure 10) (A later section of this report contains further details about the Pontiac.)

Figure 10. Aluminum skin fragment later found beneath the rear window of the Pontiac.

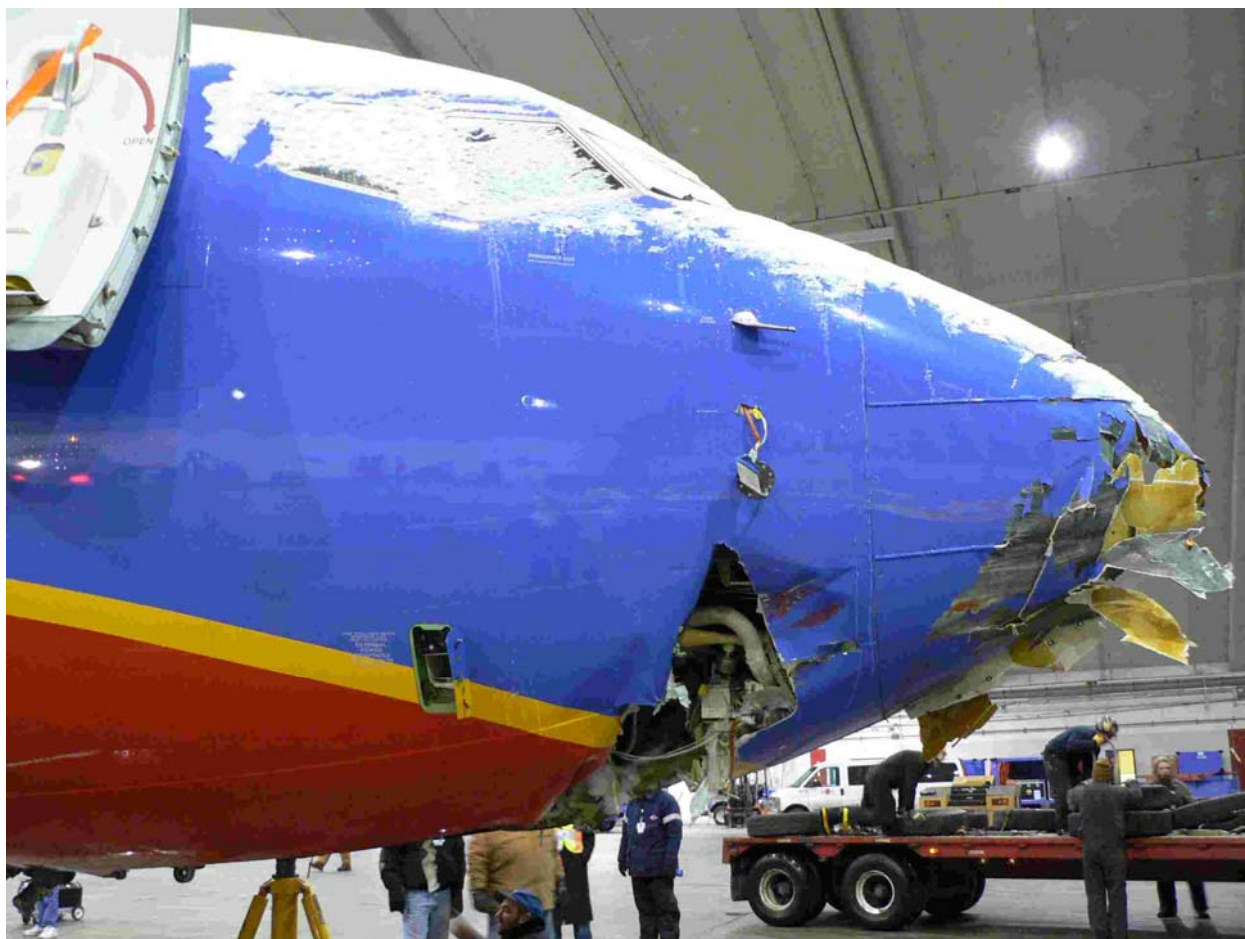
On the right side of the nose, the vane for the angle of attack (AOA) probe was broken off and missing from FS 193/WL 205. (See Figure 11) The pitot tube immediately above (WL 213) the AOA probe was broken and the upper pitot tube (WL 225) was intact. A line of scuffs and light dents extended from about FS 180/WL 205 to about FS 225.

Figure 11. The broken pitot tube and wire for the missing angle-of-attack probe are above the triangular hole, which is where the fire hydrant entered the bottom of the fuselage.

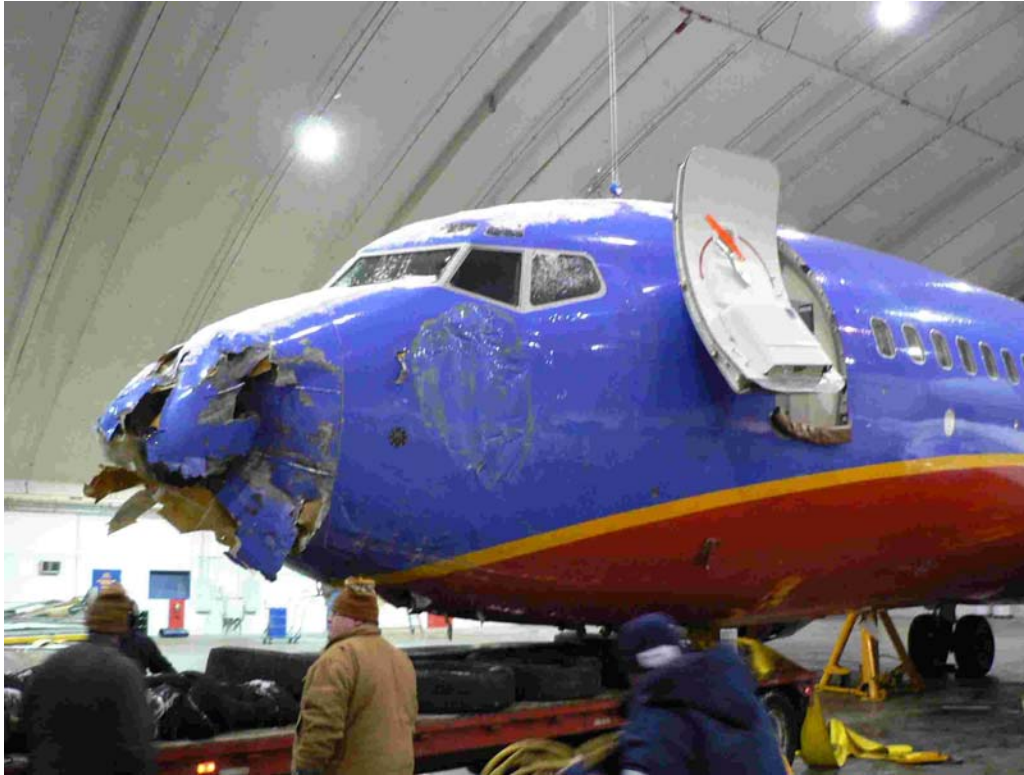
The left side of the nose had impact damage from the missing AOA vane and broken pitot tube (FS 194, WL 195 to 235) aft to the lowest point beneath the Captain's side window (FS 225) and the area was covered with green paint transfer. (See Figure 12) A light scuff continued aft to about FS 256. Along the ground path of the airplane was only one green item, which was the light pole at the left front of the white Pontiac. The paint on the pole was scratched from the base to slightly less than five feet above the ground. Further aft on the left forward fuselage, minor dents and gouges were found to about FS 519, between S-14L and S-25L. The #1 VHF antenna was loosely attached to the airplane bottom center of the airplane at FS 470, separated from the base and displaced aft.

Figure 12. Left side of airplane nose.

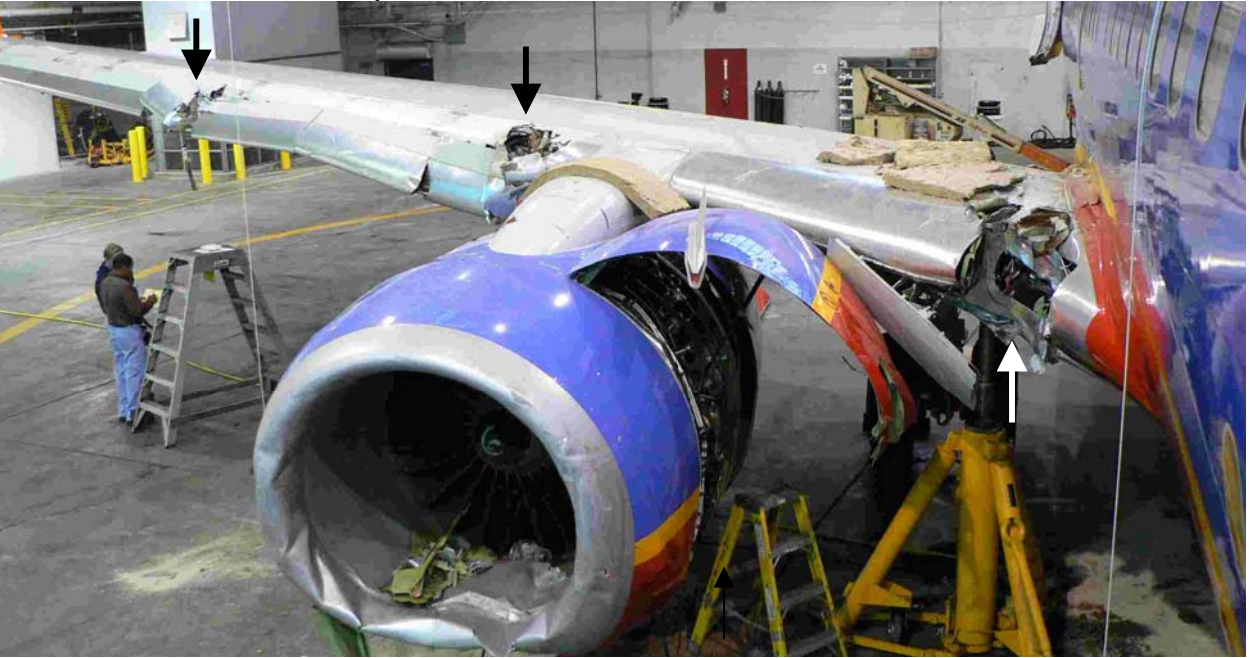
Figure 13. Even spacing (shown by arrows) of damage along right wing matches spacing of vertical I-beam supports for frangible fencing. Using the same spacing, the next vertical damage to the right of the photo was to the radome, on the nose of the airplane. (See Figure 8)

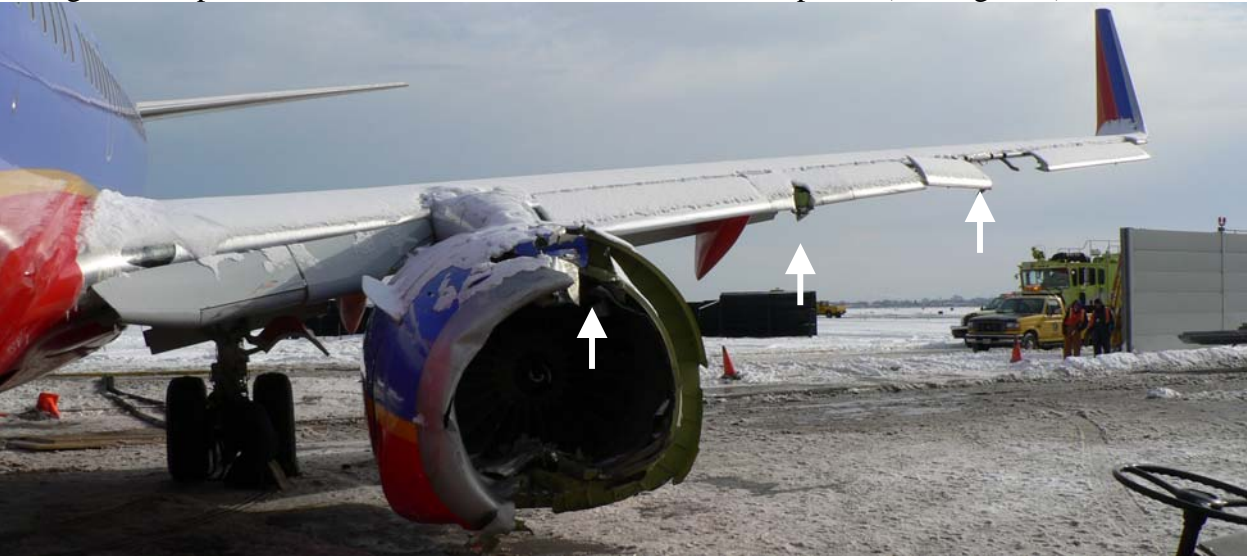
Figure 14. Even spacing (shown by arrows) of damage along left wing matches spacing of vertical I-beam supports for frangible fencing (beneath winglet, at the right edge of photo). Using the same spacing, the next vertical damage to the left of the photo was at the radome, on the nose of the airplane. (See Figure 8)

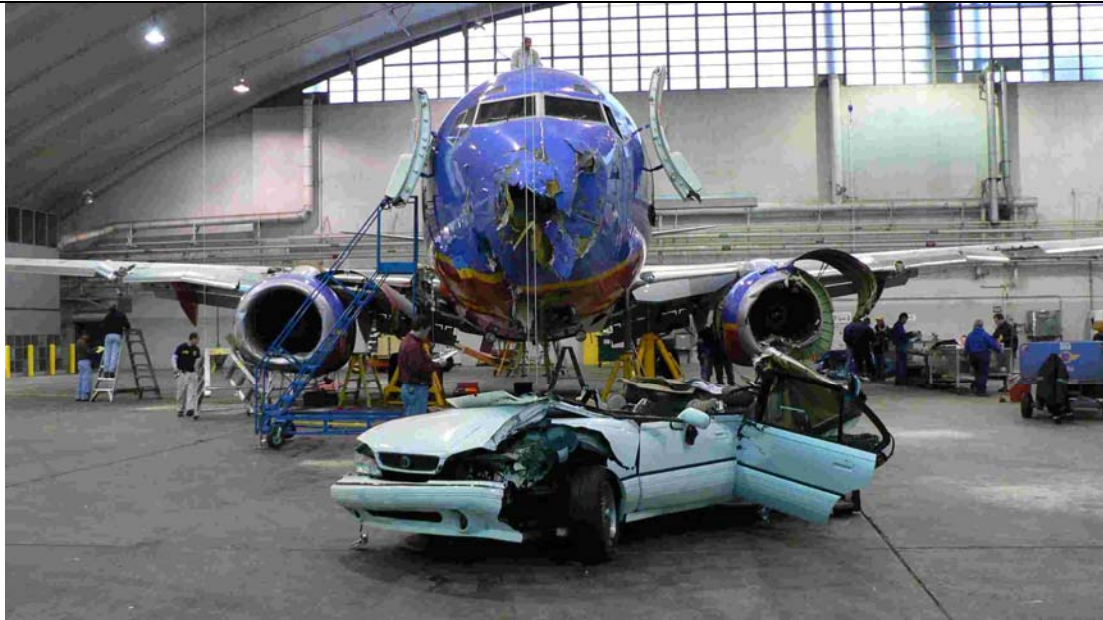
During reconstruction in the hangar, the group placed the car in front of the airplane at about the angle of the street to the runway. (See Figure 16) This orientation was different than how the car came to rest beneath the left side of the airplane. (See Figure 3) Scratches and paint transfers on the roof and on the aft right corner of the trunk spoiler were at about the orientation of the runway to the street. The scratches on the top right surface of the car's spoiler were oriented at 20 degrees from the right of a projected centerline. (See Figure 17) On top of the left portion of the spoiler were additional red and yellow paint transfers in orientations that ranged from 41 to 60 degrees from the left of direct aft.

Figure 16. The photo shows orientation of scratching on corner of rear spoiler and is approximately the orientation of the runway to the northbound lanes of the street. The colors of the scratches match the airplane colors.

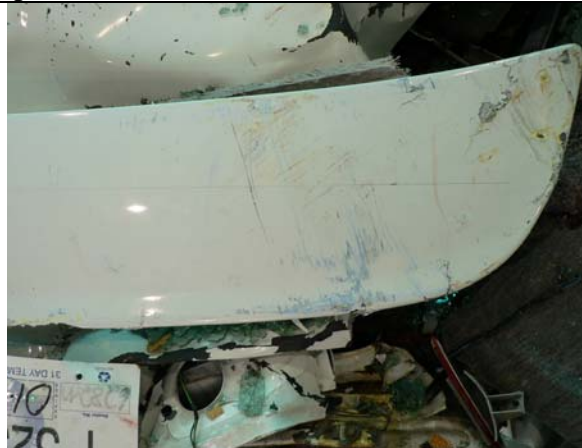
Figure 17. The car was placed in front of the airplane at about the angle of the street to the runway. This orientation was different than how the car came to rest beneath the left side of the airplane.

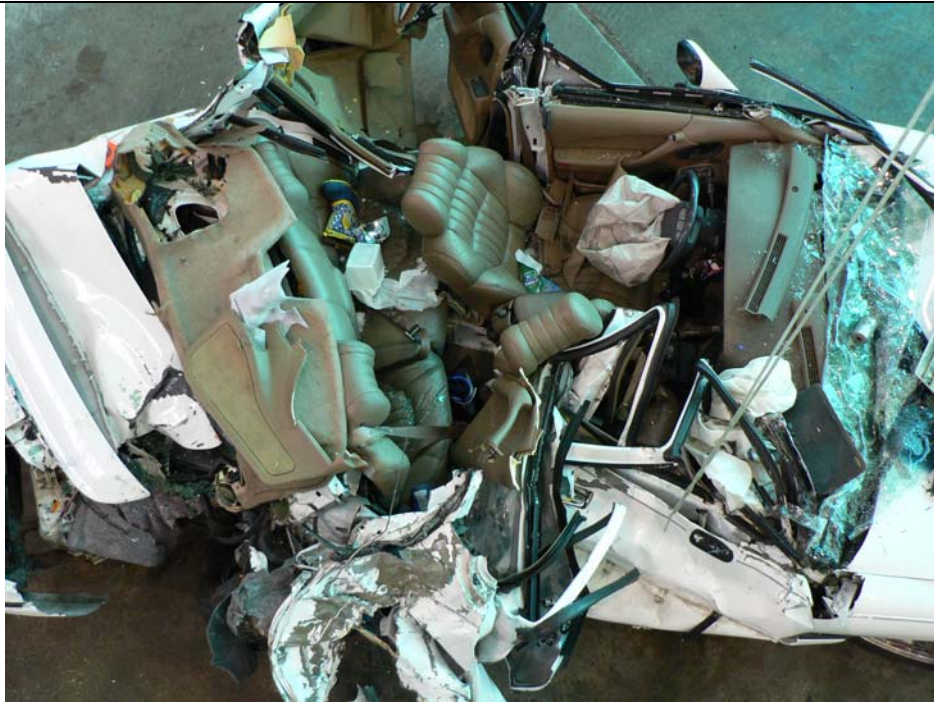
The car in general was buckled with the aft half displaced to the right. (See Figure 18) The aft right portion of the car had crush damage oriented from aft forward. The left aft roof pillar had compression damage downward and to the left. The right rear of the roof had compression damage and blue paint matching the airplane was found 7 inches aft of the windshield and 15 inches inboard from the front right corner of the roof. The direction of the scratches on the roof were the same direction as those on the right rear of the spoiler, oriented from aft to forward. The right rear quarter panel of the white car had blue, yellow, and red paint transfers at 23 inches aft of the right rear door and 28 inches from ground level (if undamaged). The colored paint transfers along the

Figure 18. Downward view on the Pontiac, showing crush and deformation. The nose of the car is to the right and the tail is to the left. In relative terms, the airplane came from the lower left of the photo into the northbound traffic lanes that the Pontiac had been in. This direction aligns with scratches on the trunk spoiler and roof. With the front left of the car (upper right in the photo) as-found, wrapped around the post of the street-light, the relative direction of travel for the airplane was from the upper left of the photo toward the lower center, in the direction of deformation.

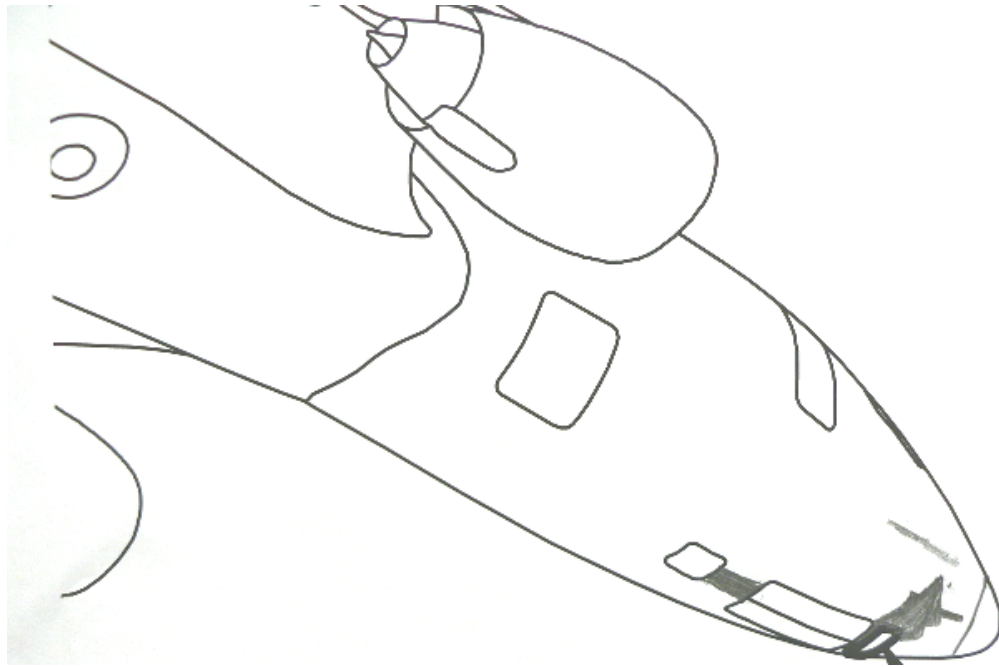
Figure B1. Cuts in bottom of fuselage from fire hydrant and nose landing gear collapse, as drawn by Mike McConnell.

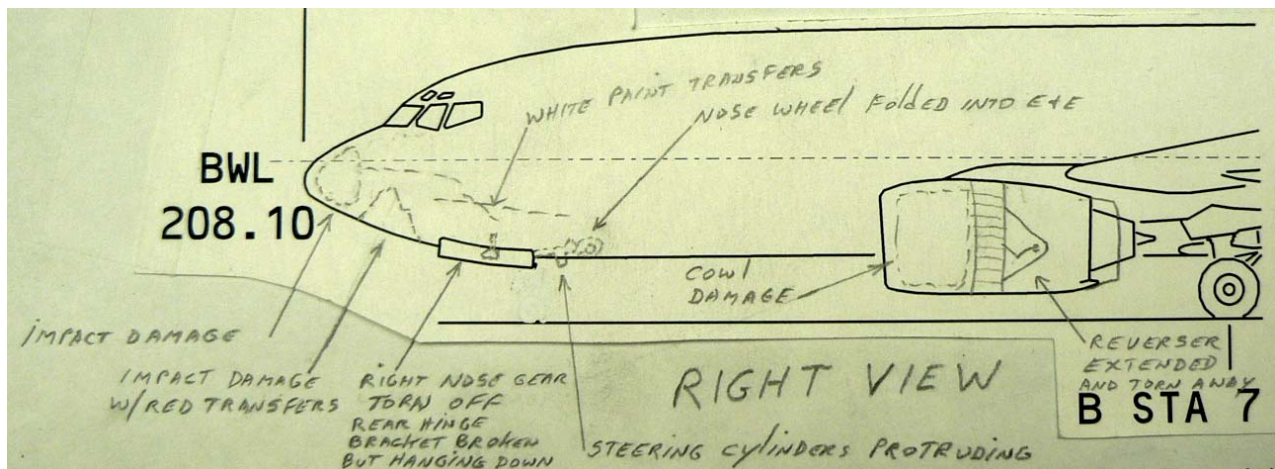
Figure B2. Right side damage shown on illustration from the left, as drawn by Marshall Gildermaster.

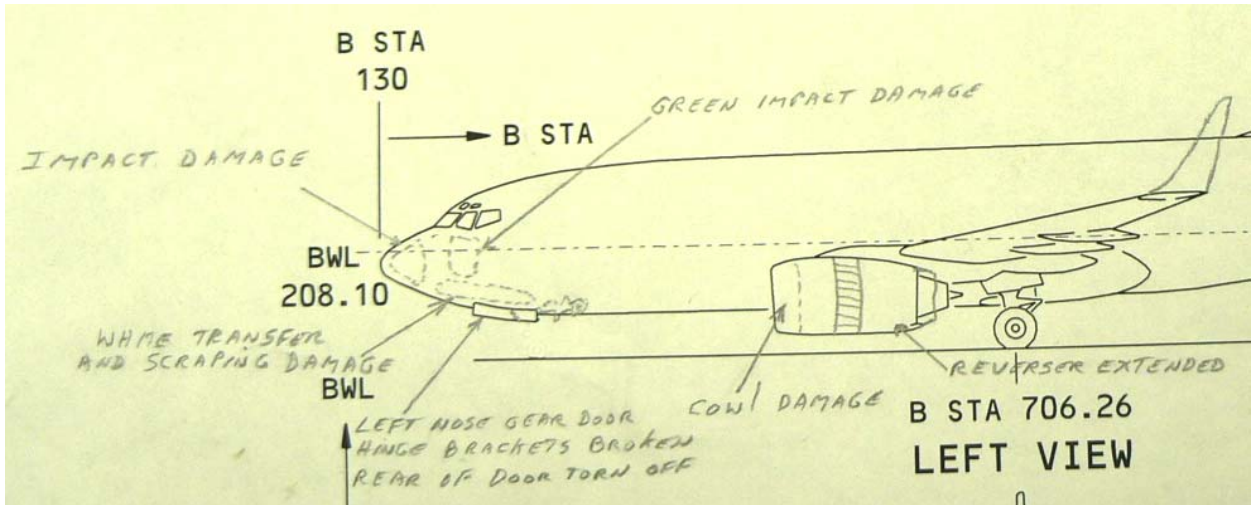
Figure B3. Left side damage sketch, as drawn by Marshall Gildermaster.

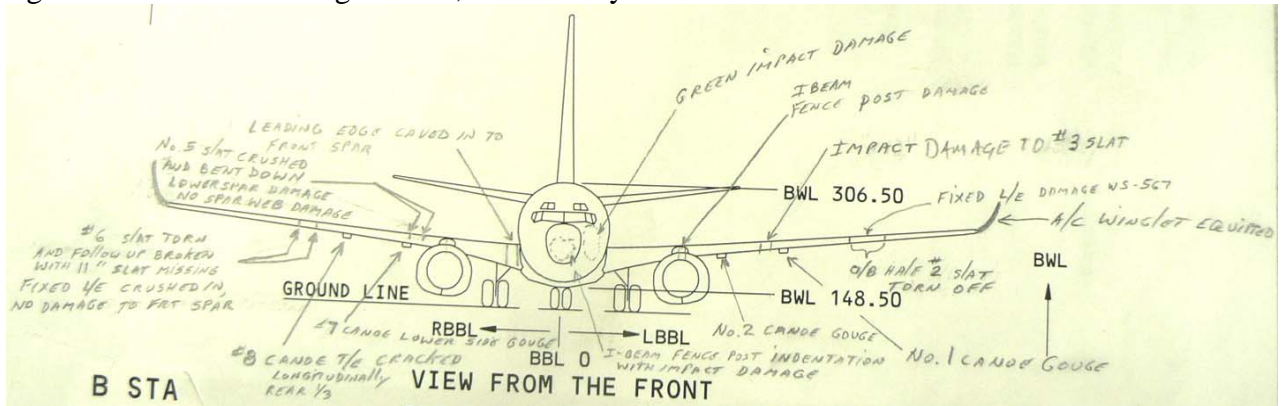
Figure B4. Frontal sketch, as drawn by Marshall Gildermaster.

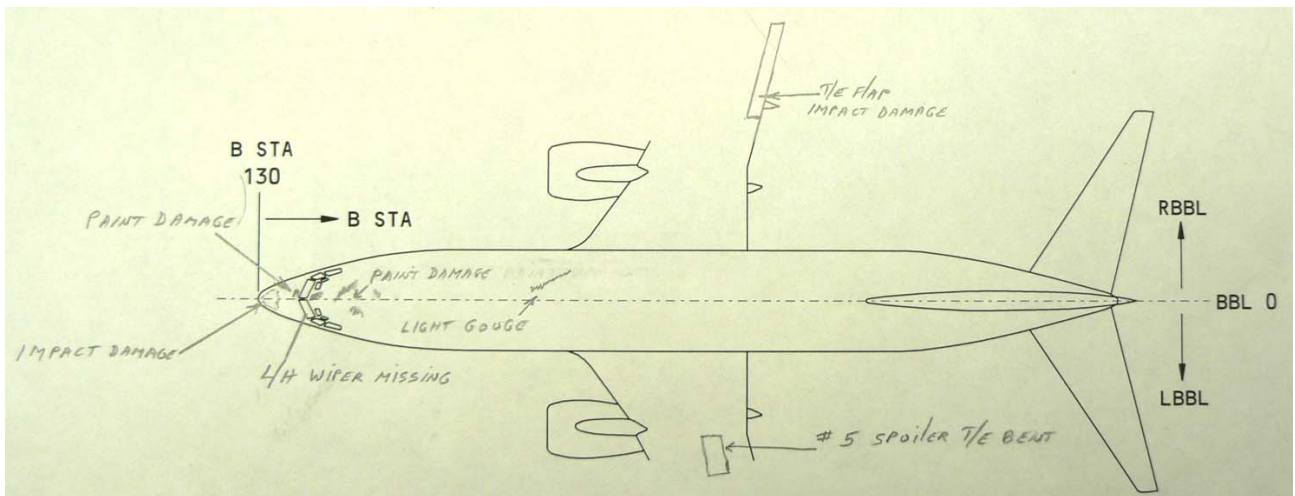
Figure B5. Plan view sketch, as drawn by Marshall Gildermaster.

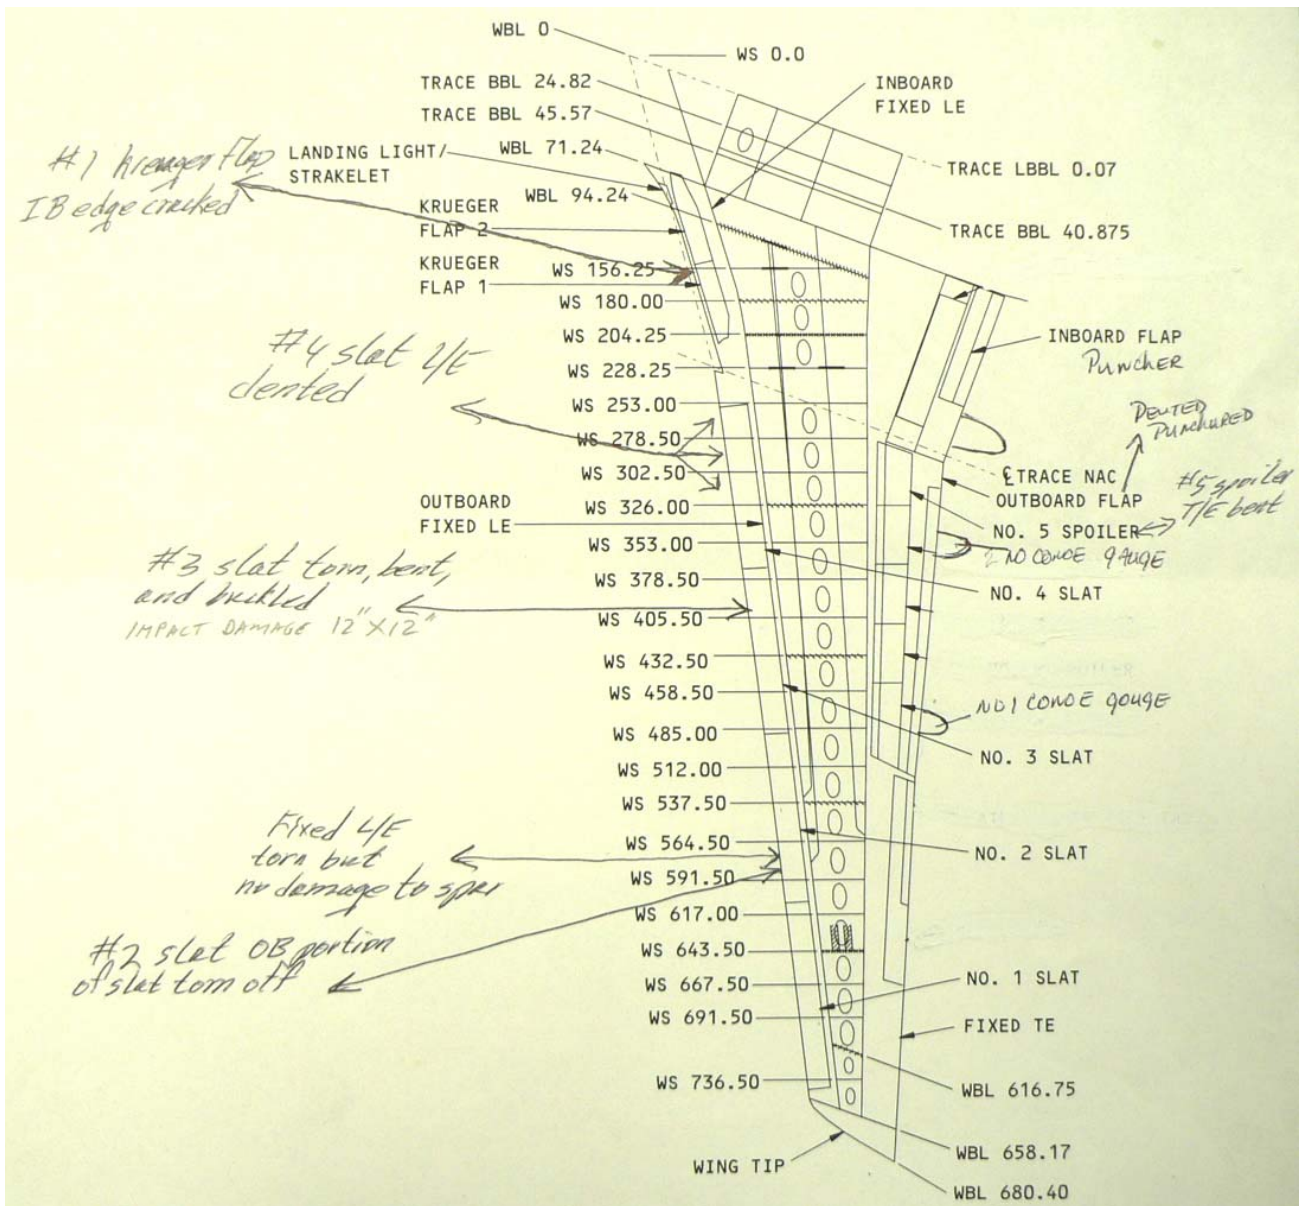
Figure B6. Left wing damage sketch, as drawn by Mats Sabel.

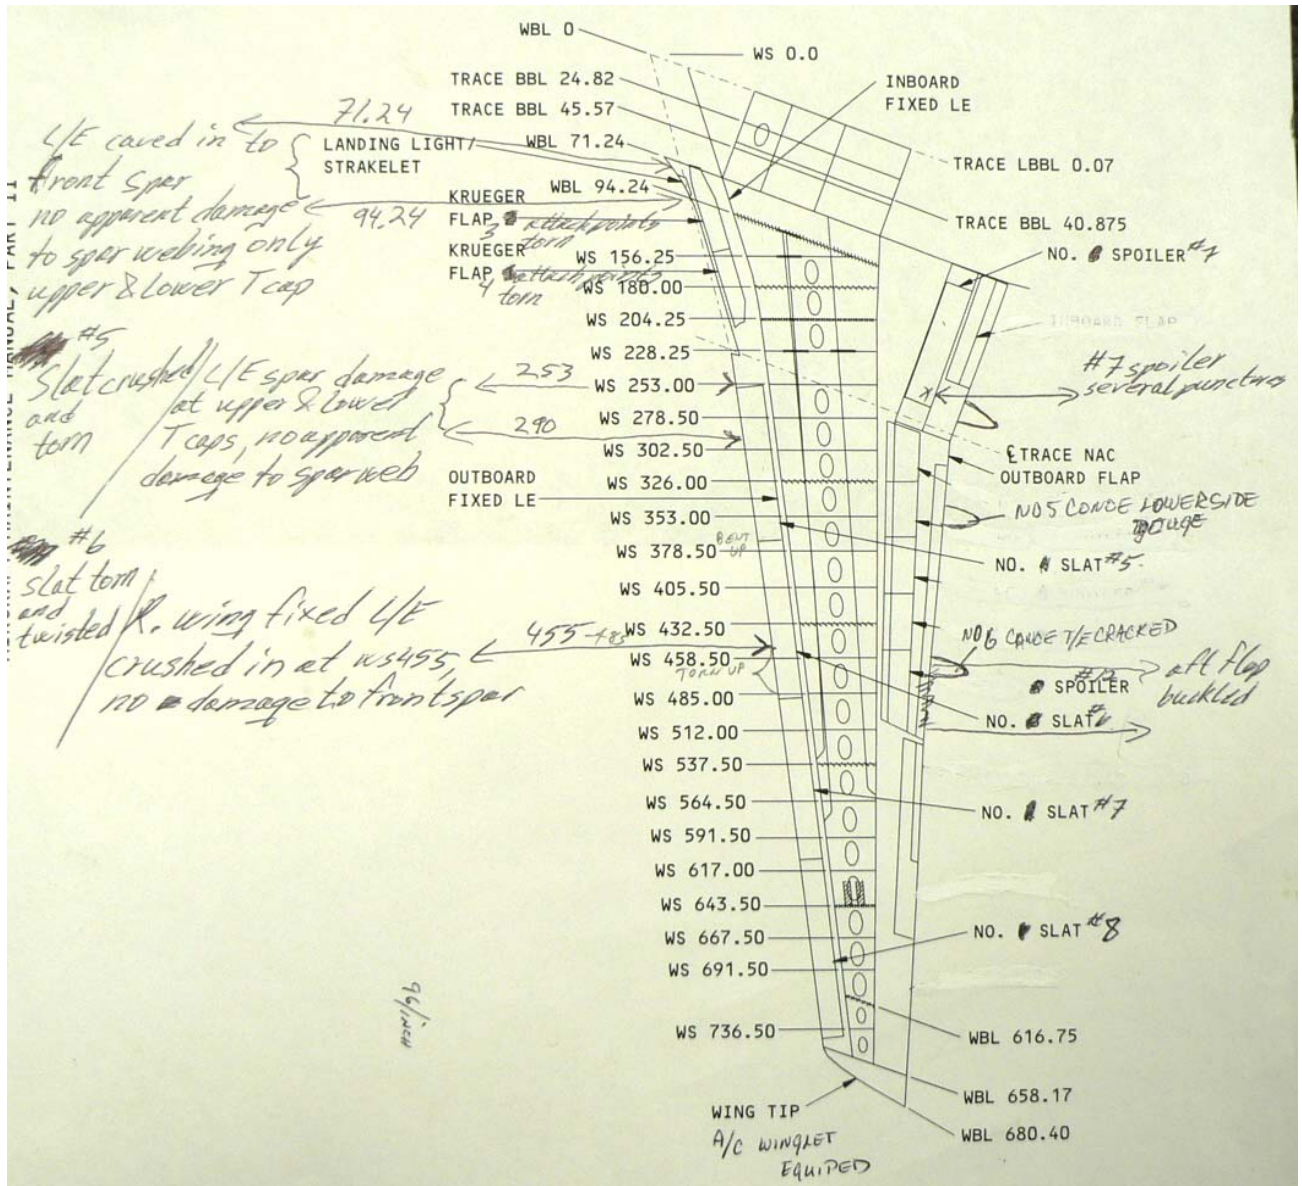
Figure B7. Right wing damage sketch, as drawn by Mats Sabel.

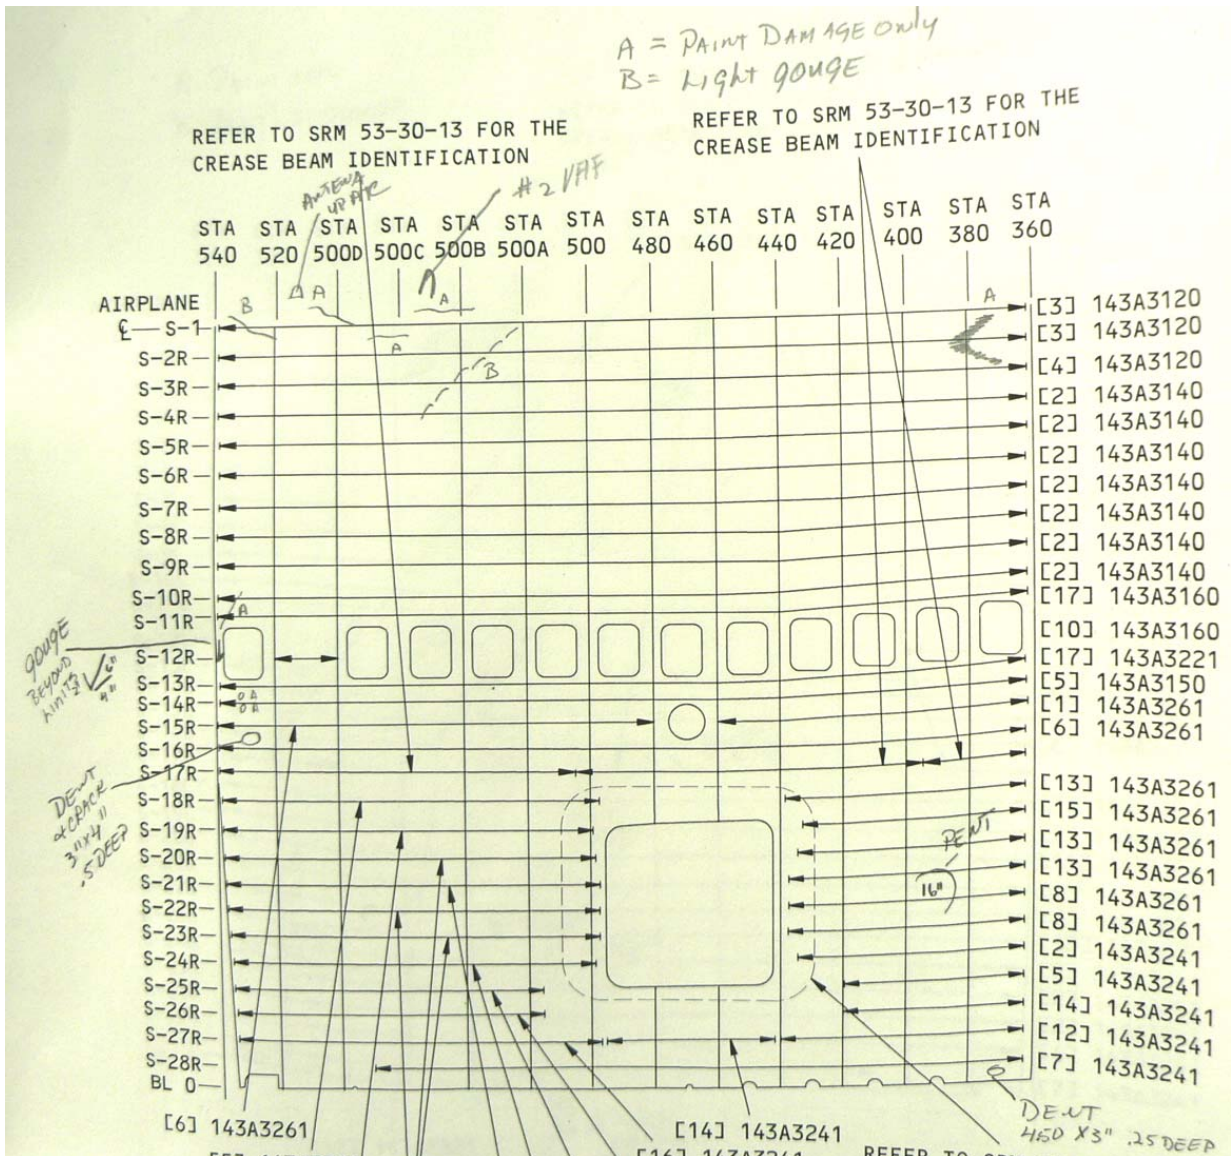
Figure B8. Damage sketch of forward right fuselage, as drawn by Randy Roberts.
