NATIONAL TRANSPORTATION SAFETY BOARD

STRUCTURES GROUP CHAIRMAN'S FACTUAL REPORT

A. ACCIDENT: DCA06MA009
LOCATION: Chicago Midway Airport
DATE/TIME: December 8, 2005
AIRCRAFT: Boeing 737-700, N471WN
Southwest Airlines, Flight 1248

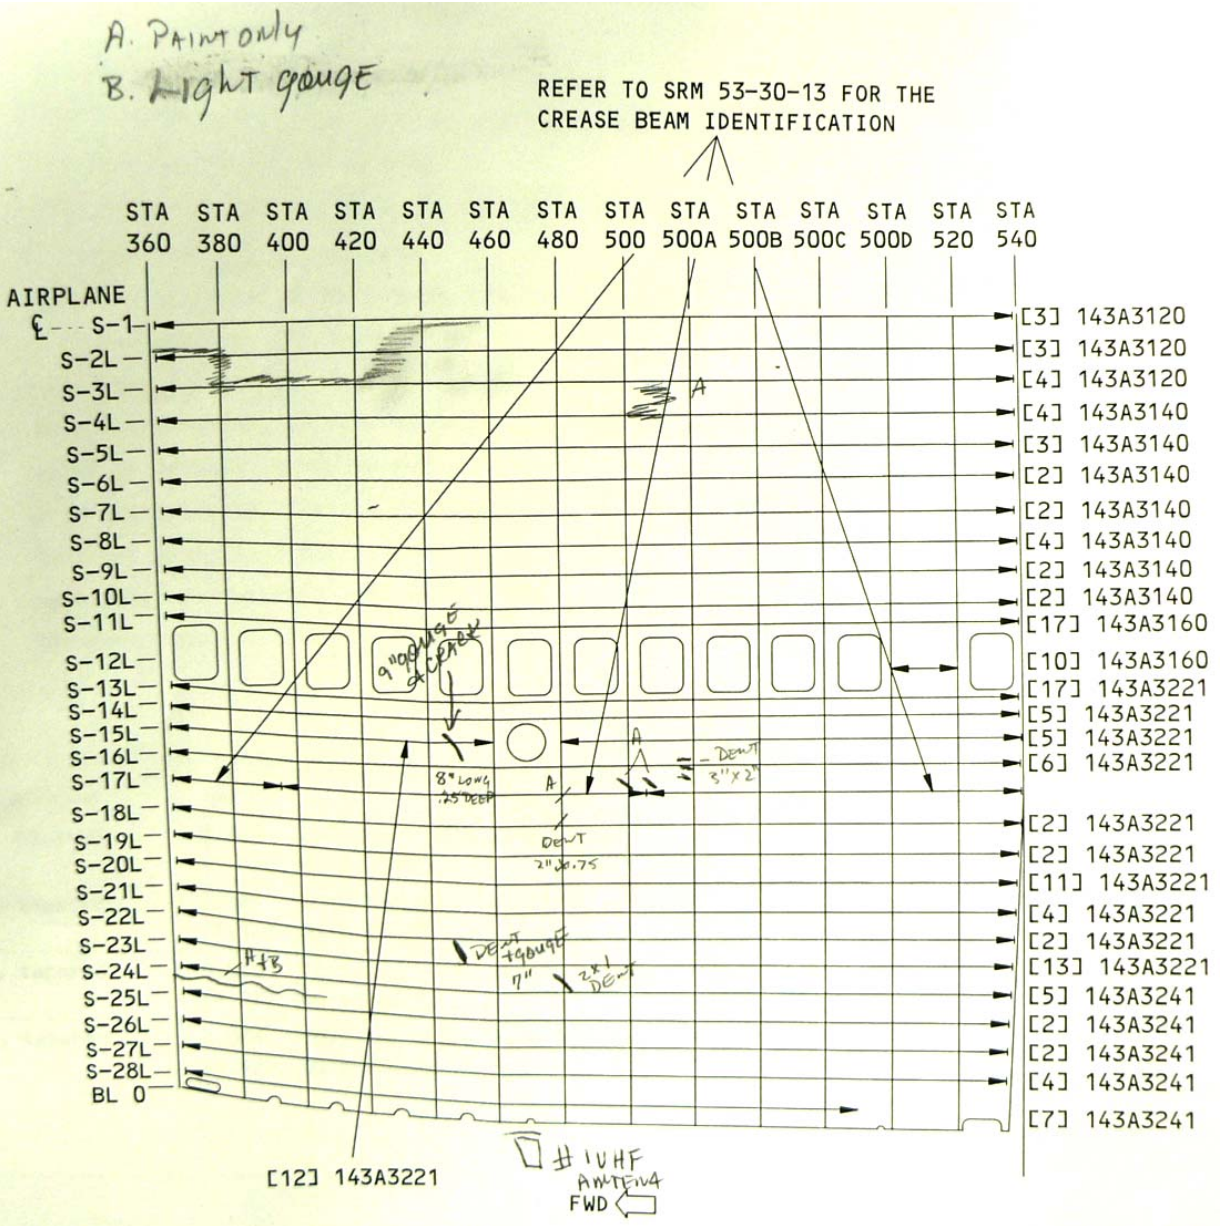
Figure B9. Damage sketch of forward left fuselage, as drawn by Randy Roberts
