FATIGUE

Front Spar lower horizontal chord - existing fatigue cracking

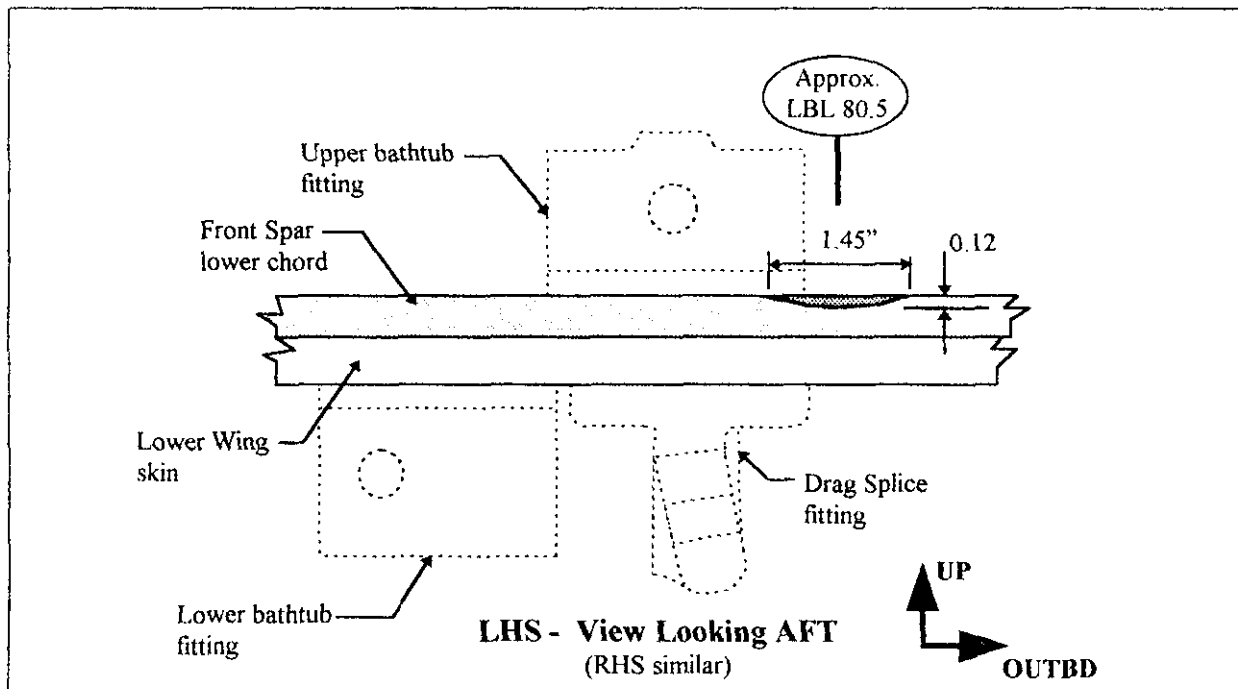
Fatigue cracks were found in the Front Spar lower horizontal chord in the fillet radius just outboard of the Drag Splice fittings at RBL/LBL 80. The existing cracks were approximately 1.2 inch and 1.45 inch on the RHS and LHS, respectively. The cracks originated at the inside fillet radius and were part through cracks, progressing approximately one third through the chord thickness (approximately 0.10 inch deep and 0.125 inch deep on the RHS and LHS, respectively).

The lower horizontal chord in the vicinity of the fatigue cracking is subjected to inspection under the Supplemental Structural Inspection Document (SSID) program. A previous instance of cracking at this location was found on a different 747-100. Those cracks were longer than those on TWA800 but also did not extend through the thickness of the chord. This region is affected by SB 747-53-2064 for adjacent ring chord cracking. The modification per SB 747-53-2064 had been installed in 1982, installing two bathtub fittings on the Wing Center Section lower skin panel and a double bathtub fitting on the fuselage skin. These fittings are immediately adjacent to the drag splice fitting and serve to provide an alternate load path for the drag splice forward/aft loads. It is apparent from the bathtub fitting arrangement that the post-modification configuration is very stiff and the deflection that would have initiated the fatigue cracking has been significantly limited. Without continued deflection, the fatigue growth cannot continue, indicating that the fatigue cracking existed prior to the installation of the bathtub fittings.

Visual examination of the ductile rupture surfaces adjacent to the relatively short, shallow cracks did not reveal any indication of wear. This is indicative of the gross fracture precipitating from something other than the fatigue cracking. The NTSB Materials Laboratory has examined the larger of the two fatigue cracks and will issue a separate report.

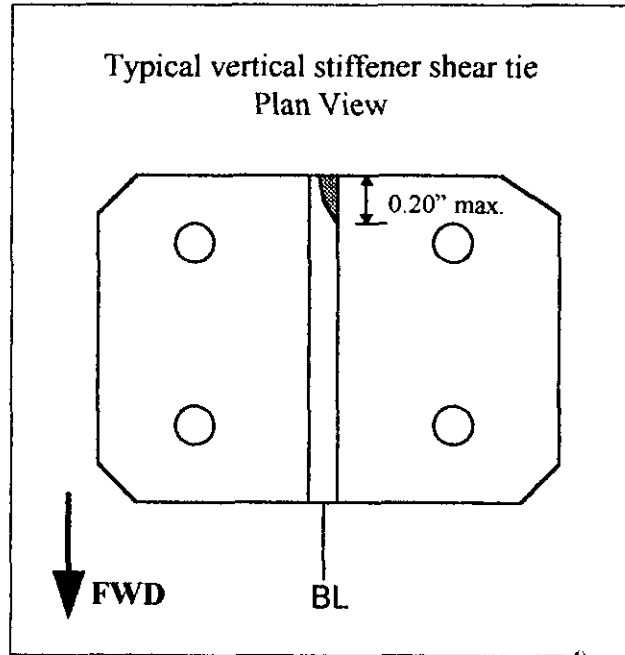
Front Spar vertical stiffener shear ties - existing fatigue cracking

Small existing fatigue cracks were found in the vertical stiffener shear ties at RBL 83.24 (lower), RBL 75.92 (upper and lower), LBL 75.92 (upper and lower), and LBL 83.24 (lower).

The cracks were all in the shear tie radius near the base of the leg that attaches to the vertical stiffener at the aft edge. This cracking is the subject of SB 747-57-2249. The Service Bulletin was issued in 1989 after reports of in-service cracking. The maximum crack length on the subject airplane was 0.20 inch long. In service, operators have reported cracks ranging from 0.50 inch to 1.5 inch long without complete part fracture, demonstrating the capability of these shear ties to withstand cracking in excess of the 0.20 inch detected cracking under normal operating conditions.

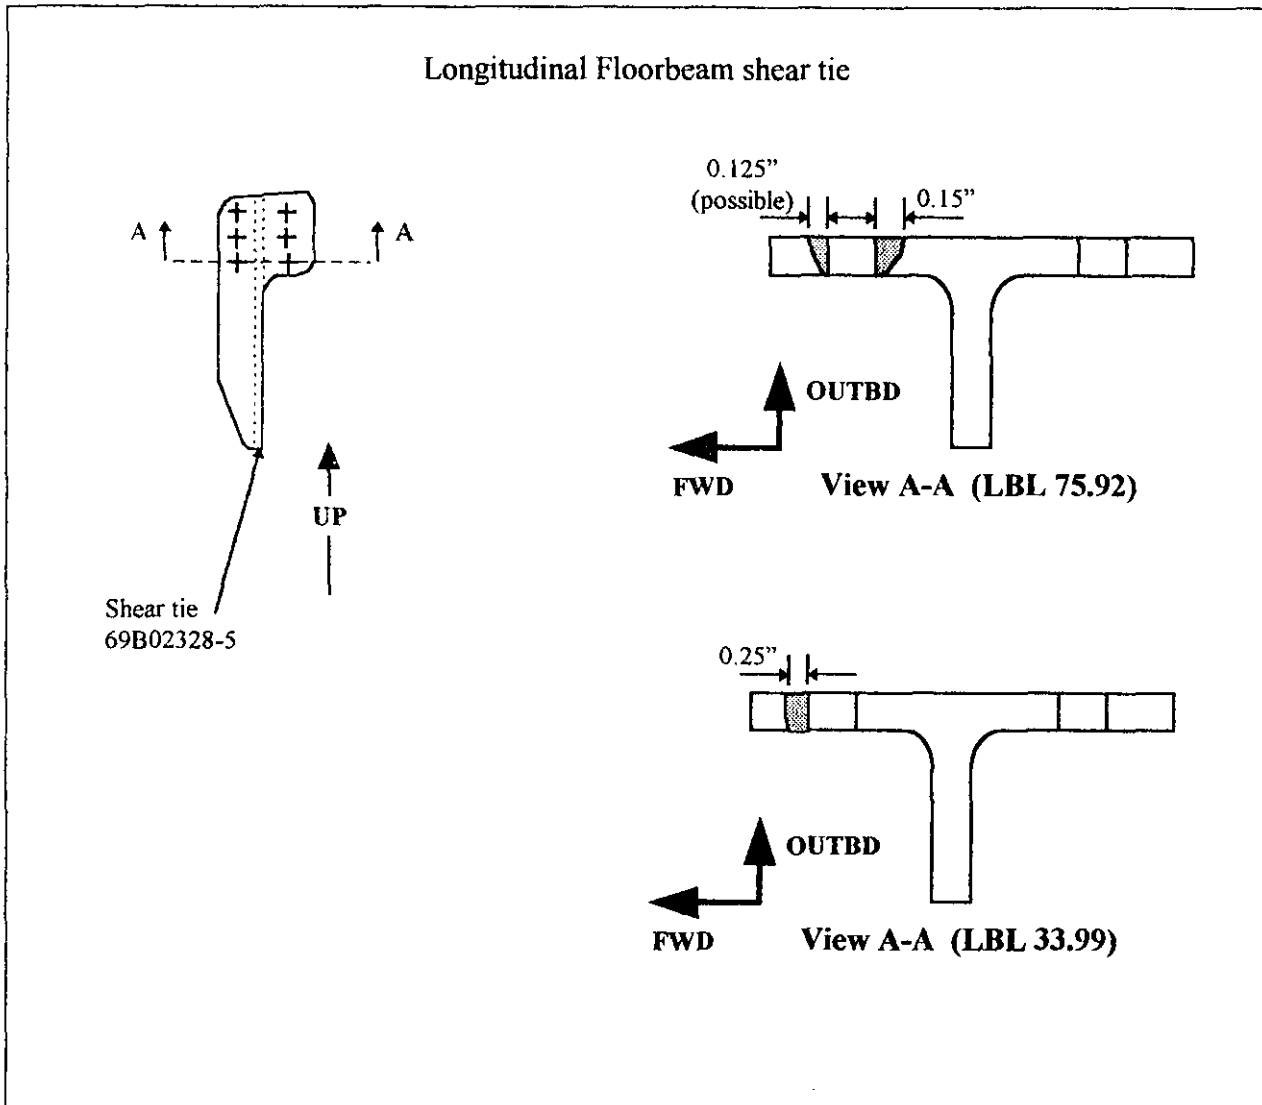
Longitudinal Floorbeam at Front Spar - existing fatigue cracking

Small cracks were found in the shear tie of the LBL 75.92 and the LBL 33.99 longitudinal floorbeams at the intersection with the Front Spar upper chord at STA 1000. The LBL 75.92 shear tie has a 0.15 inch fatigue crack emanating from the aft side of the hole and a possible 0.125 inch fatigue crack emanating from the forward side of the hole as shown. The LBL 33.99 shear tie has a 0.25 inch fatigue crack emanating from the forward side of the hole.

The component is a secondary attachment for floor structure and does not contribute to carrying primary operating loads.

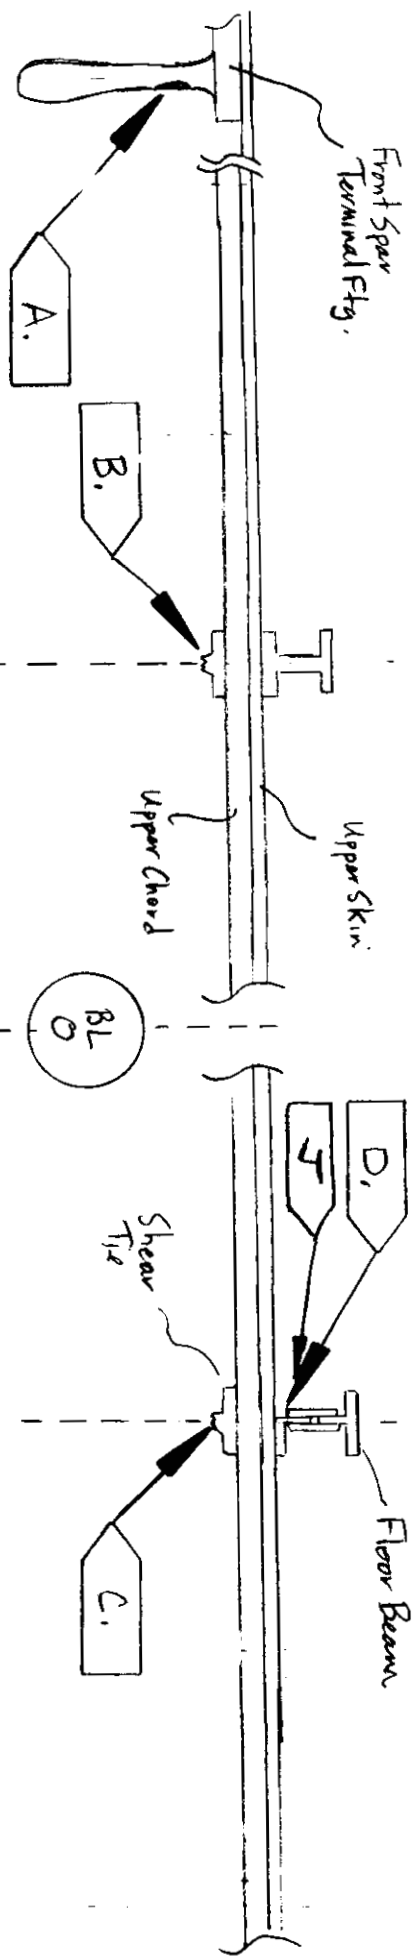
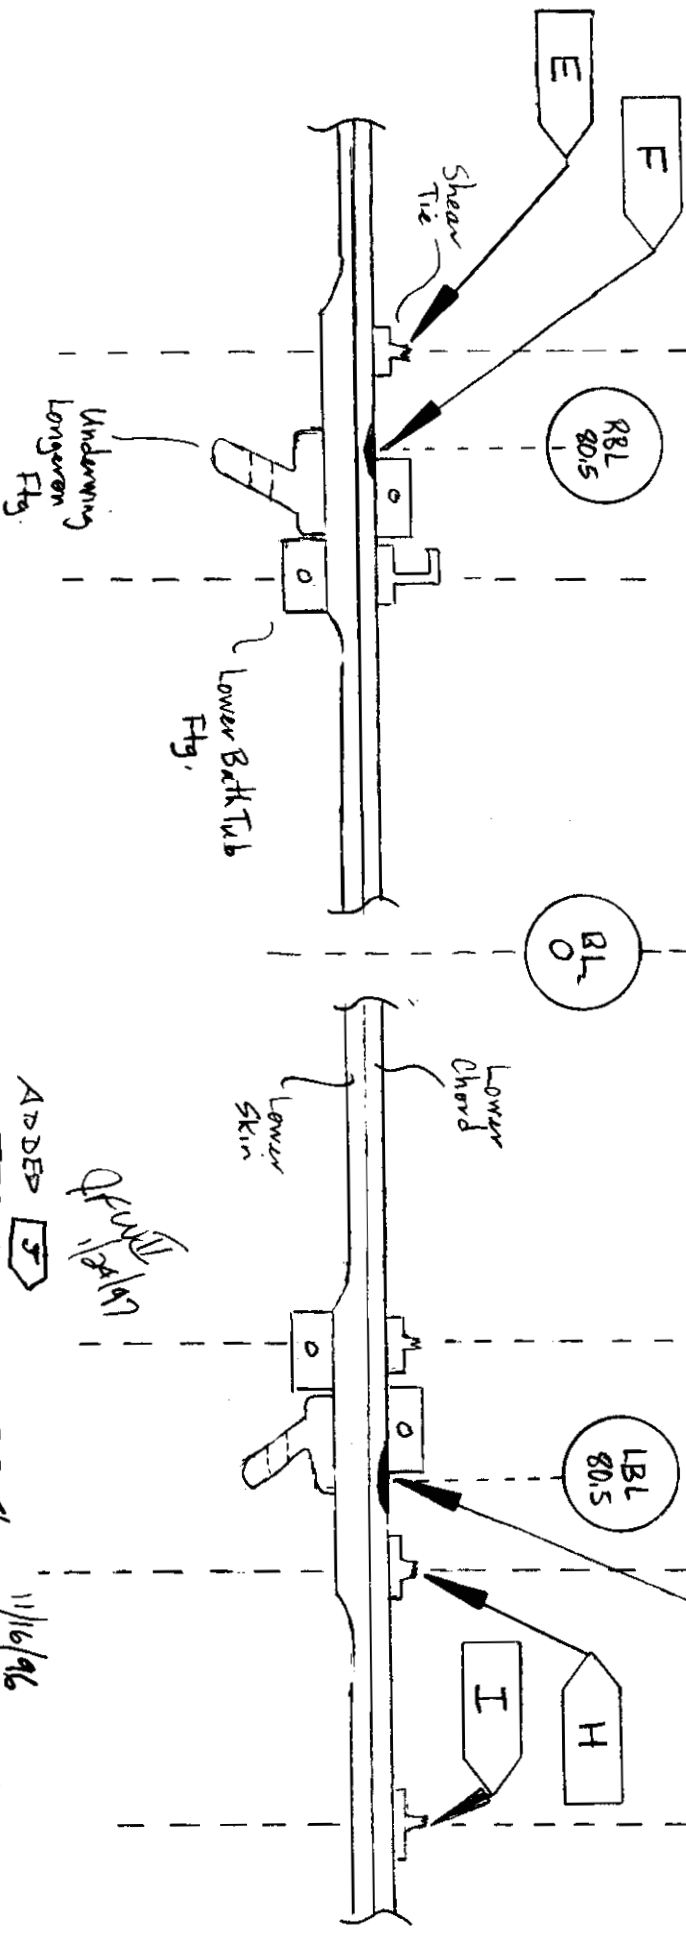
Front Spar
View Looking
AFT

Front Spar areas with apparent fatigue cracks

- A** RH Upper Wing Terminal Fitting approx. 2 inch below upper wing skin. Crack initiated from INBD Side. Crack dimension ≈ 0.6 " long $\times \approx 0.1$ " deep. Mechanical damage. JE 12/4/96 L.H.

- B** Upper Chord to Stiffener Shear Tie at RBL 75.92. Crack initiated at AFT/OUTBD Corner. Crack dimensions ≈ 0.1 " \times 0.2 ". JE 12 LH.
- C** Upper Chord to Stiffener Shear Tie at LBL 75.92. Crack initiated at AFT/OUTBD Corner. Crack dimensions ≈ 0.15 " $\times \approx 0.20$ ". JE 12 LH.

- D** Floor beam to Upper Wing Skin Shear Tie at LBL 75.92. Crack initiated at fastener hole common to floor beam web. JE 12/4 LH.
- E** Lower Chord to Stiffener Shear Tie at RBL 83.24. Crack initiated at AFT/INBD Corner. Crack dimensions ≈ 0.1 " $\times \approx 0.2$ ". JE LH.

- F** Lower Chord at \approx RBL 80.5. Crack initiated at upper surface from multiple origins in the extruded radius. Crack dimension ≈ 1.2 " long $\times \approx 0.1$ " deep. JE LH.

- G** Lower chord at \approx LBL 80.5. Crack initiated at upper surface from multiple origins in the extruded radius. Crack dimensions ≈ 1.45 " long $\times \approx 0.125$ " deep. JE LH.

- H** Lower Chord to Stiffener Shear Tie at LBL 83.24. Crack initiated at AFT/INBD Corner. Crack dimensions ≈ 0.08 " $\times \approx 0.2$ ". JE LH.
- I** Lower chord to Stiffener Shear Tie at LBL 91.14. Crack initiated at AFT/INBD Corner. Crack dimensions ≈ 0.1 " $\times \approx 0.2$ ". JE LH.

J SIMILAR TO **D** EXCEPT AT LBL 33.99, .25 IN. LONG APPROX., AND FROM FWD SIDE OF HOLE. J. TRZIL 1-23-97

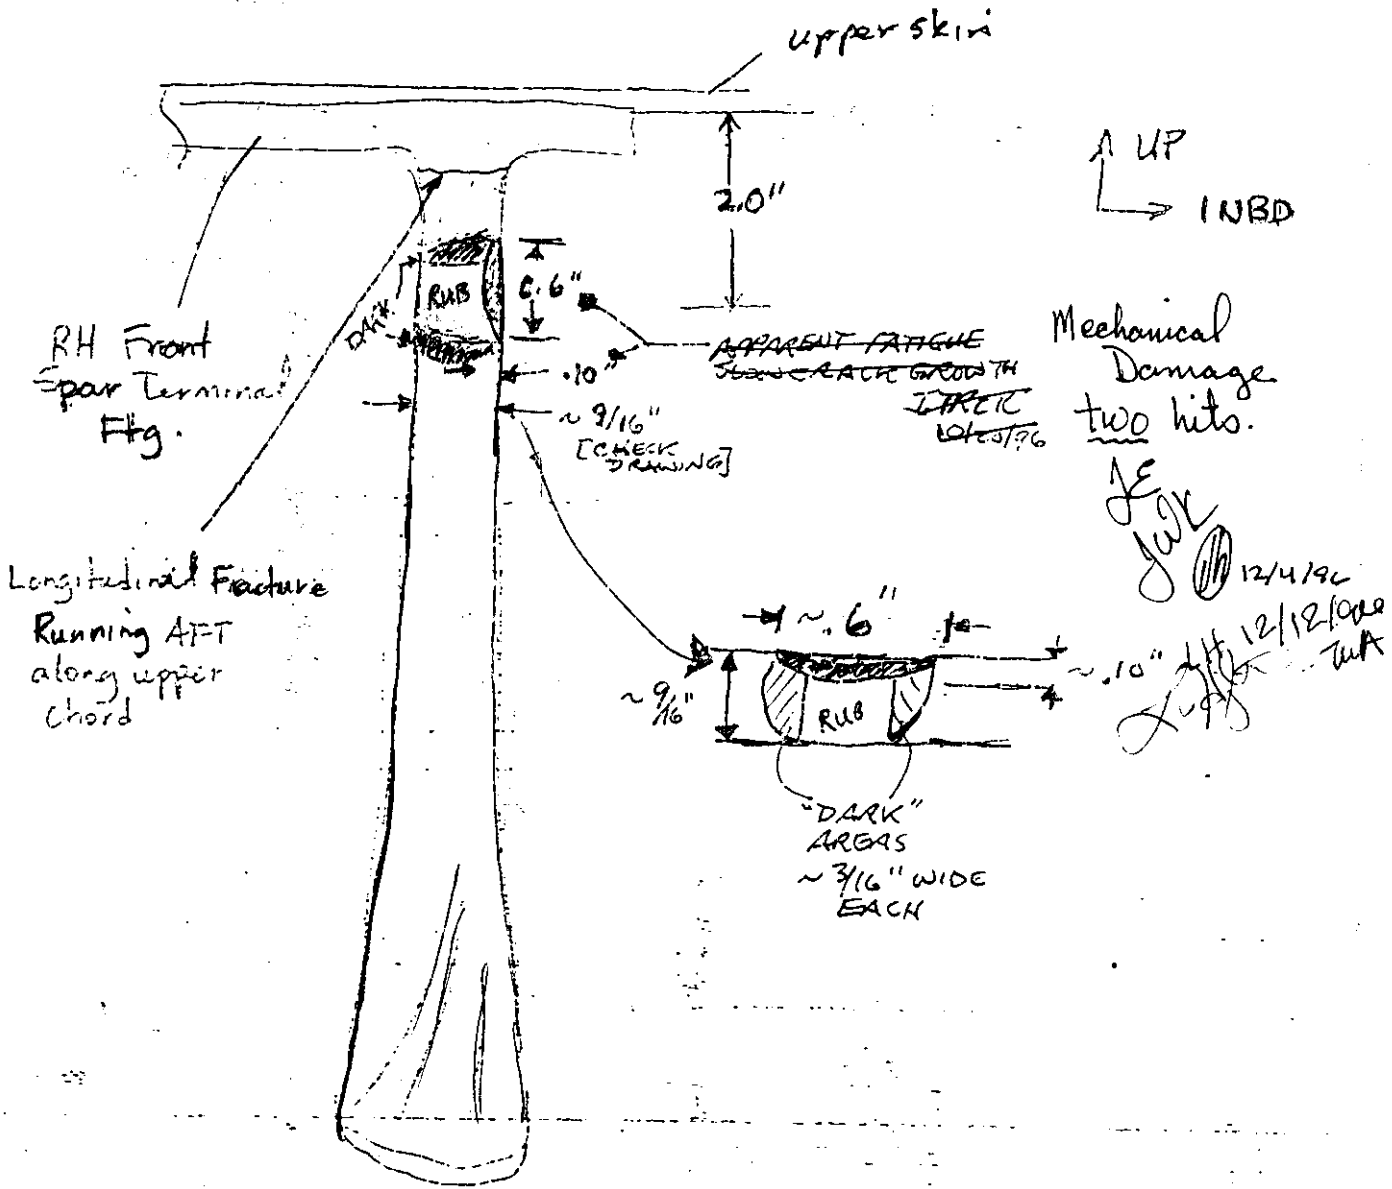
LOCATION **A**

Forward Fracture of RH Terminal Ftg at Upper Skin Att

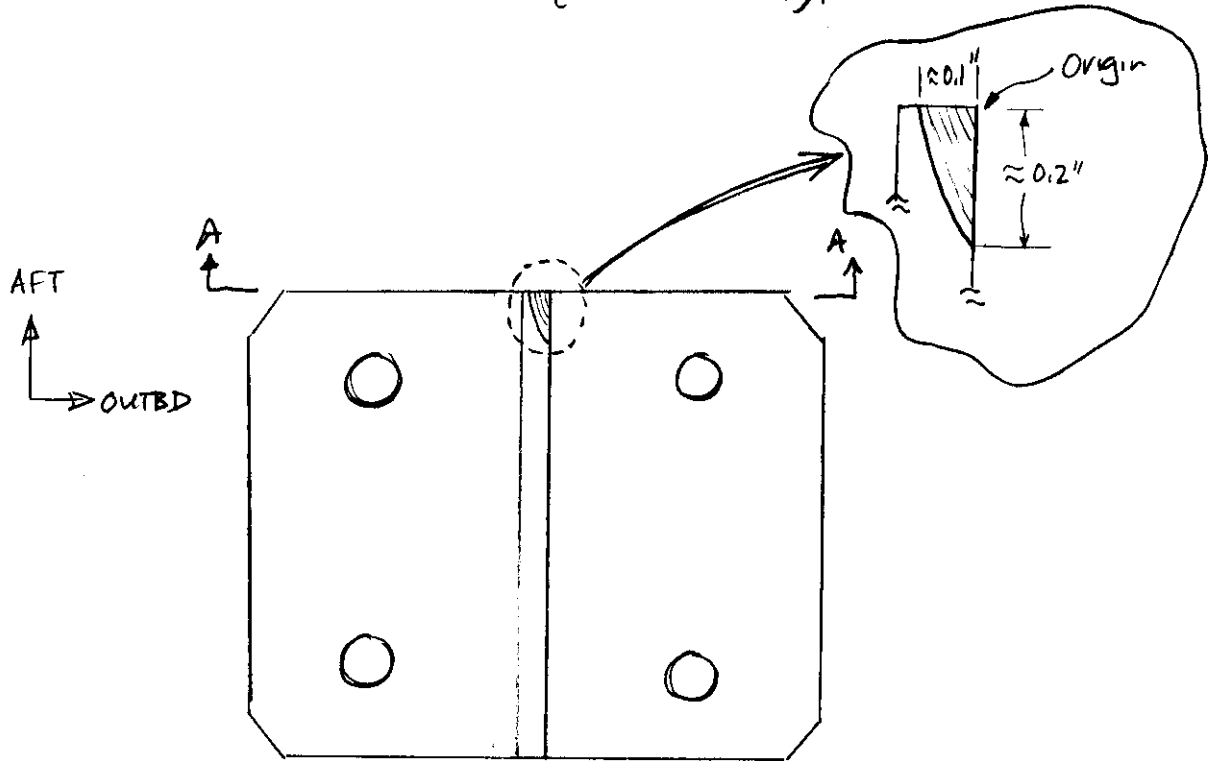
RBL
75.92

Apparent Fatigue Crack Location

- AFT End of Shear Tie Fracture at front Spar Stiffener to Upper Chord at RBL 75.92. Similar crack located at LBL 75.92 (see CW114).

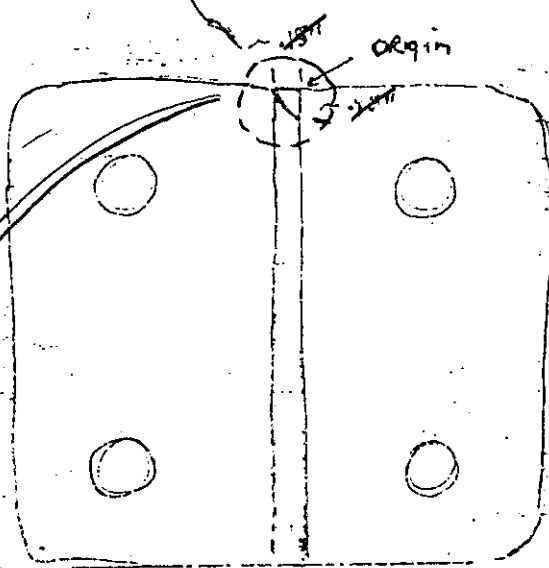
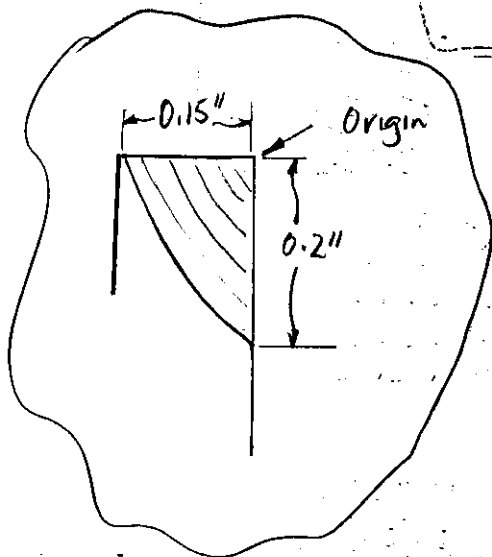
LOCATION **C**

APPARENT FATIGUE CRACK LOCATION

F.S. WPR CHORD SHEAR TIE

APR L/H CORNER #23028
~ 3mm x 3mm (~ 1/8" x 1/8")
~ 1/8" THICK

CRACK ~ .1" ABOVE SURFACE

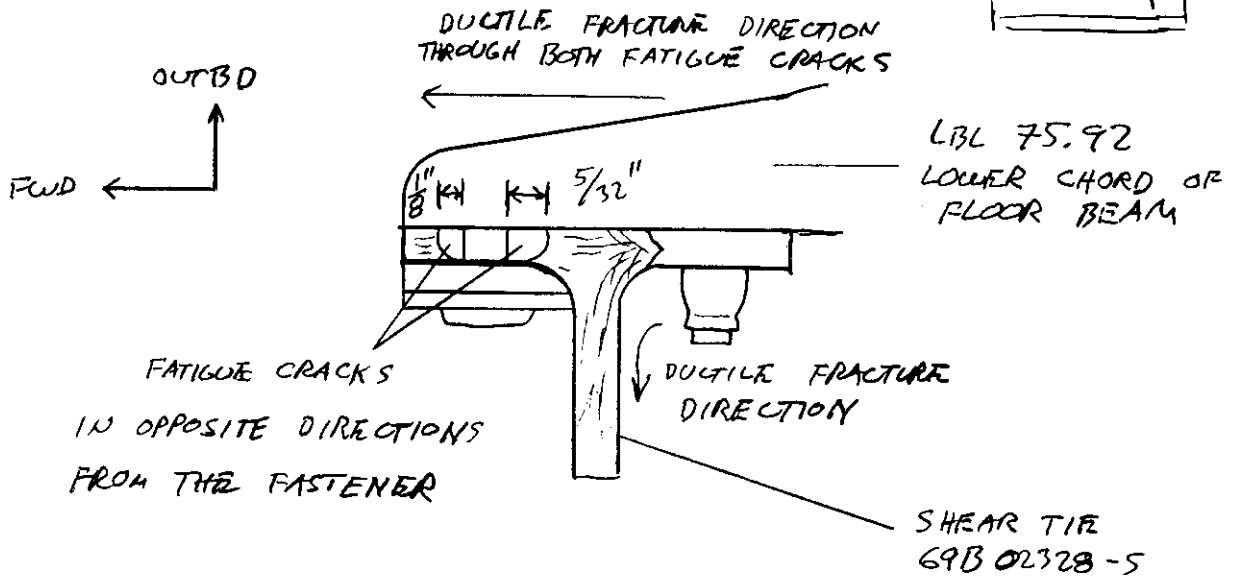
LOCATION D

FLOOR BEAM TO FRONT SPAR SHEAR TIE
AT LBL 75.92

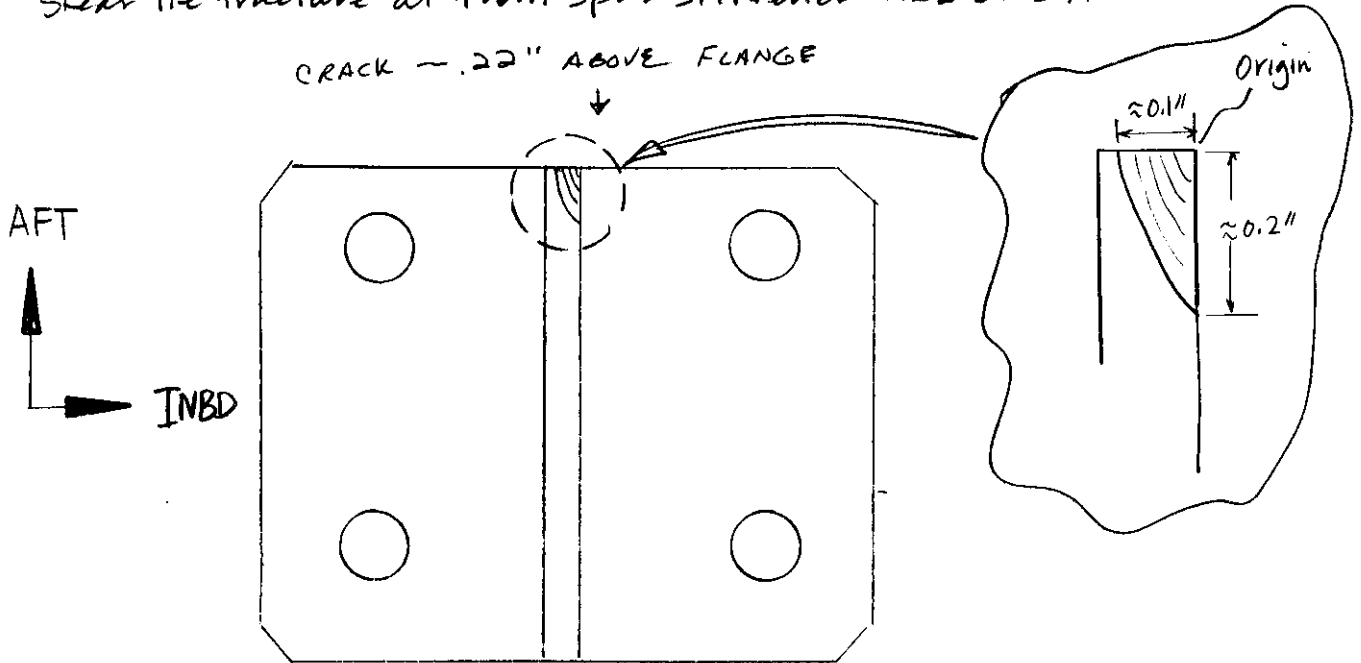
LOCATION E

Apparent Fatigue Crack Location - AFT/INBD Corner of
Shear Tie fracture at front Spar Stiffener RBL 83.24.

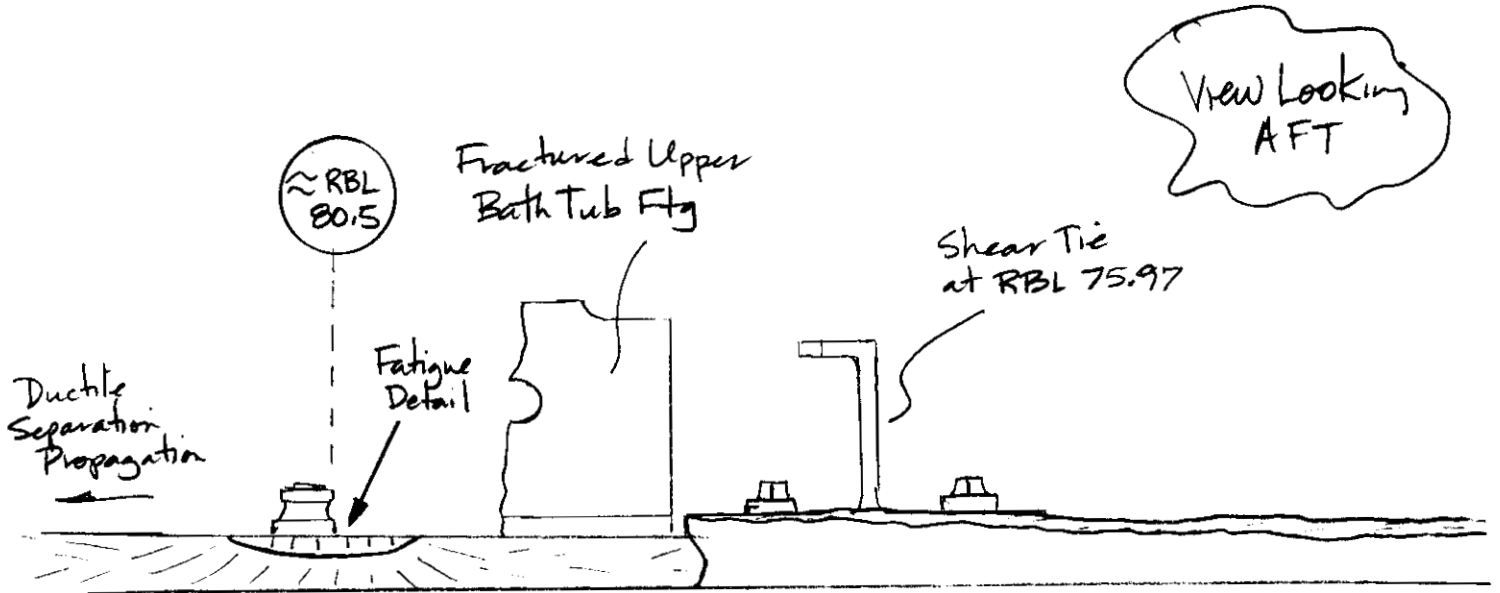
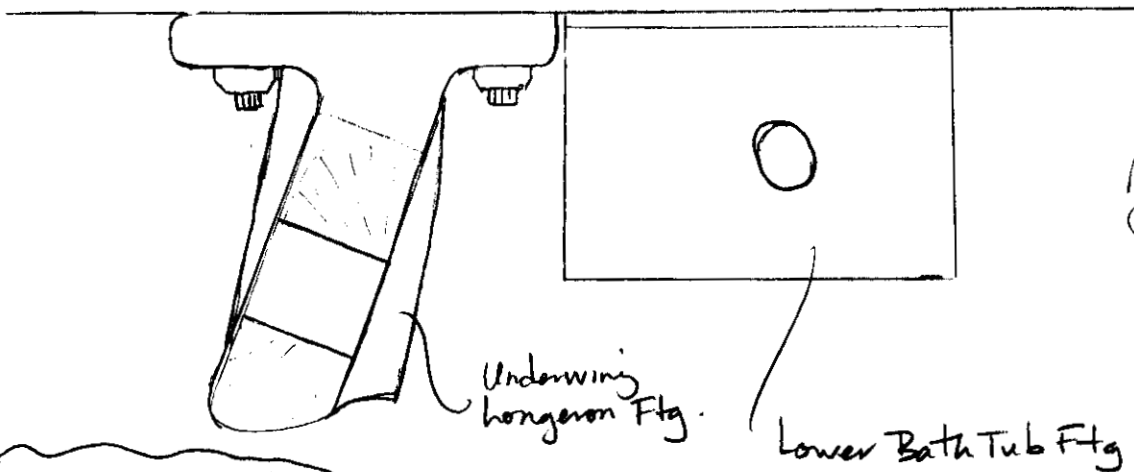
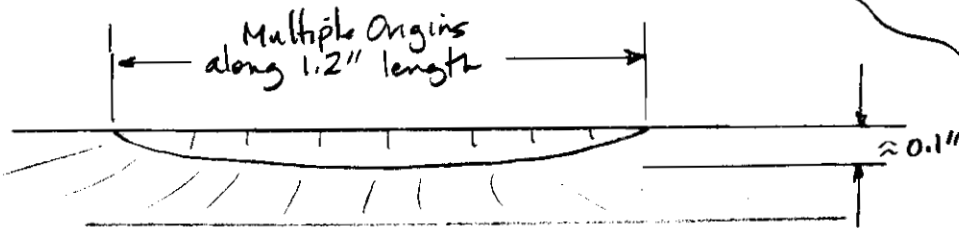
LOCATION F

Apparent Fatigue Crack Location -
Front Spar Lower Chord at \approx RBL 80.5

Fatigue Detail

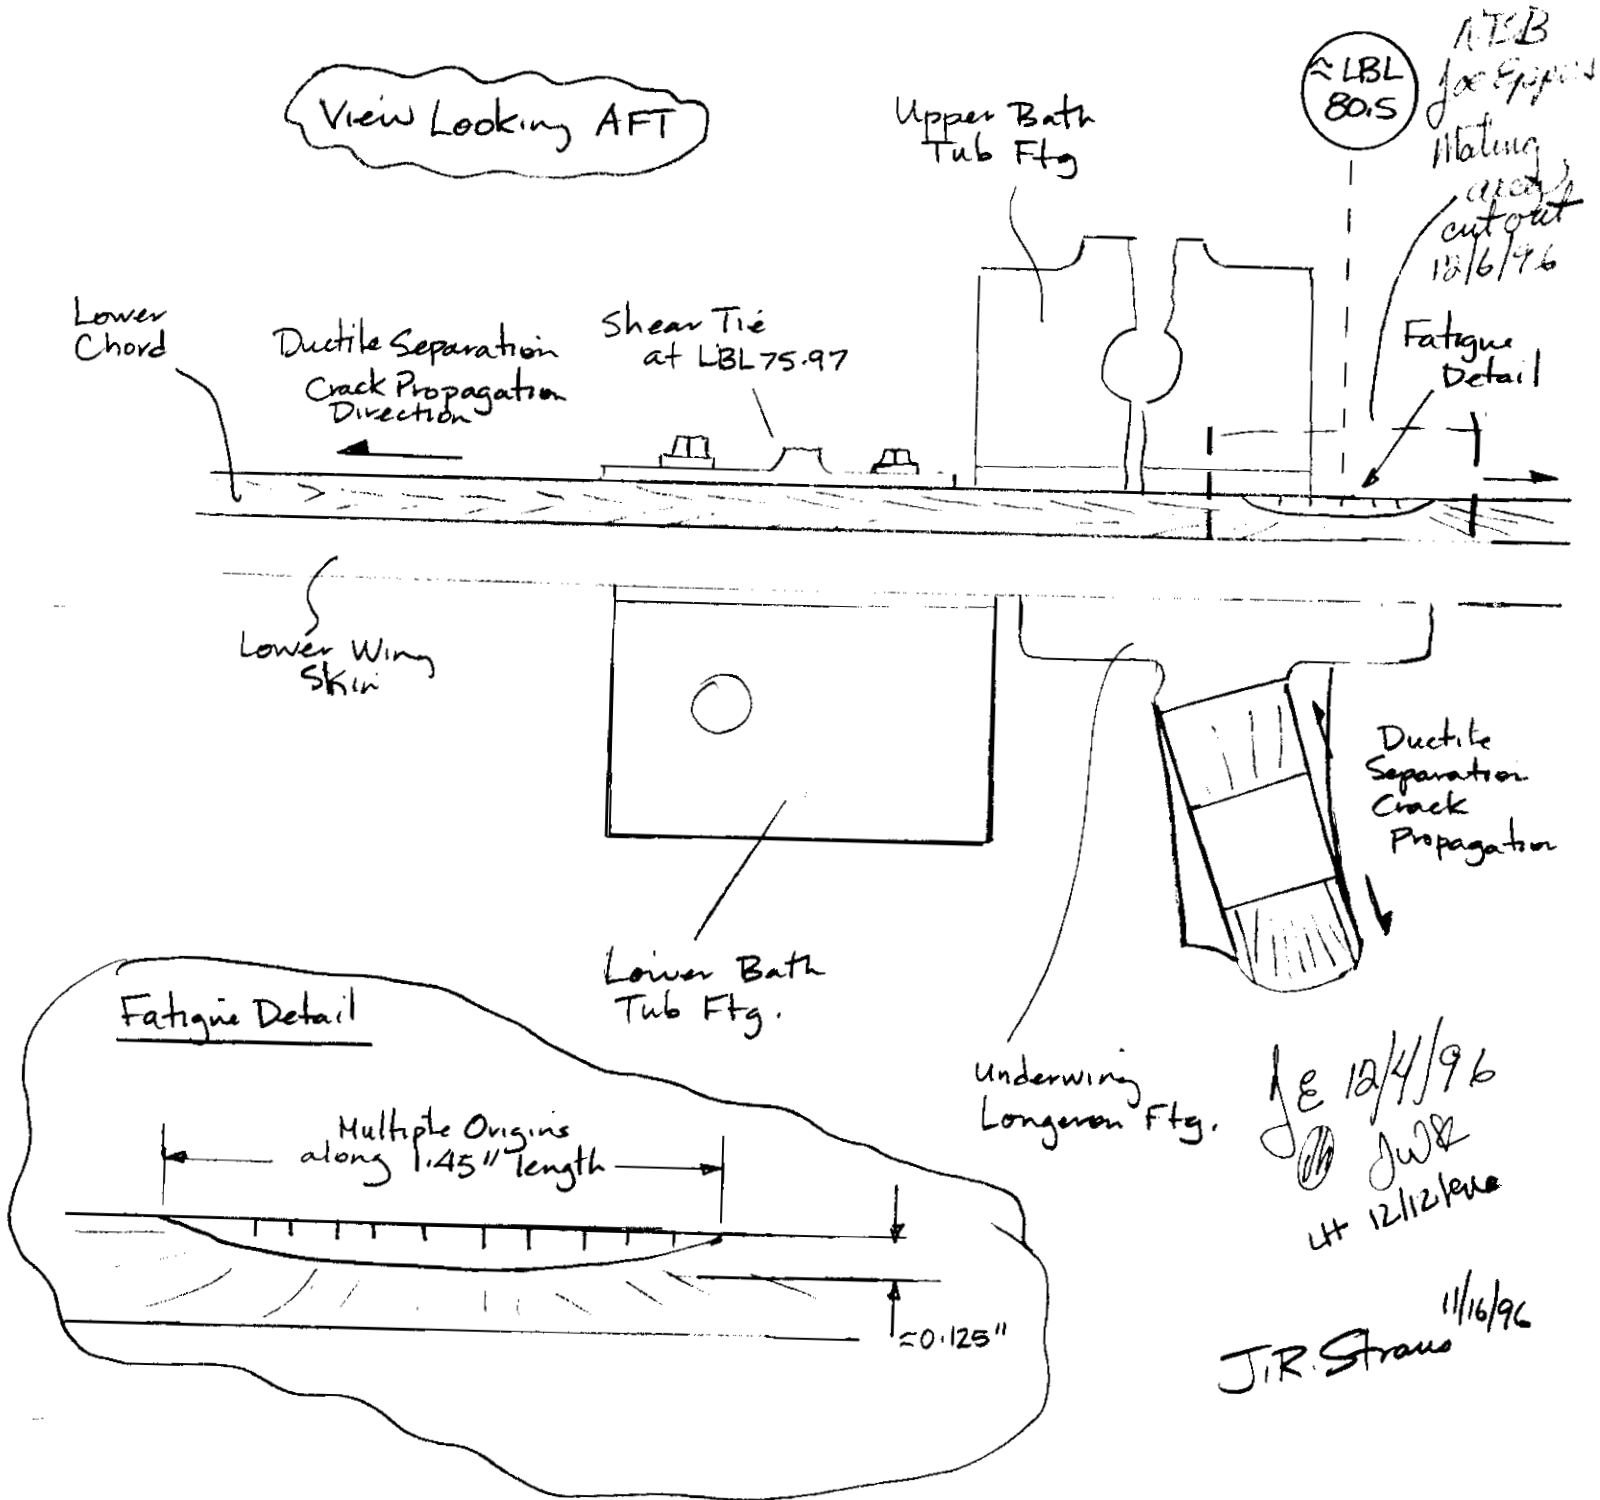
LOCATION G

Apparent Fatigue Crack Location -

Front Spar Lower Chord at \approx LBL 80.5.

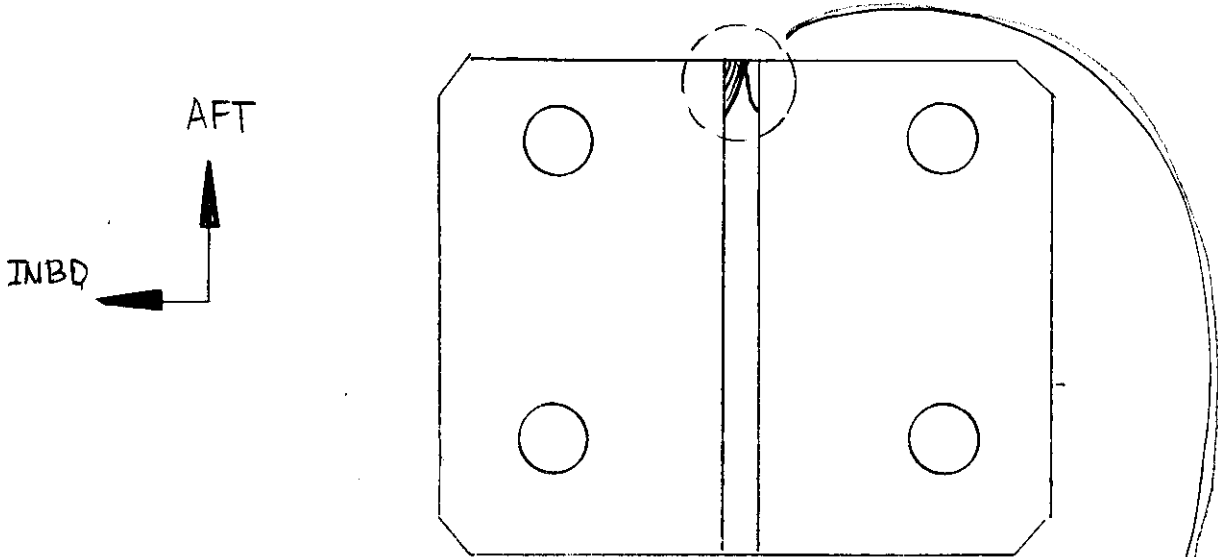
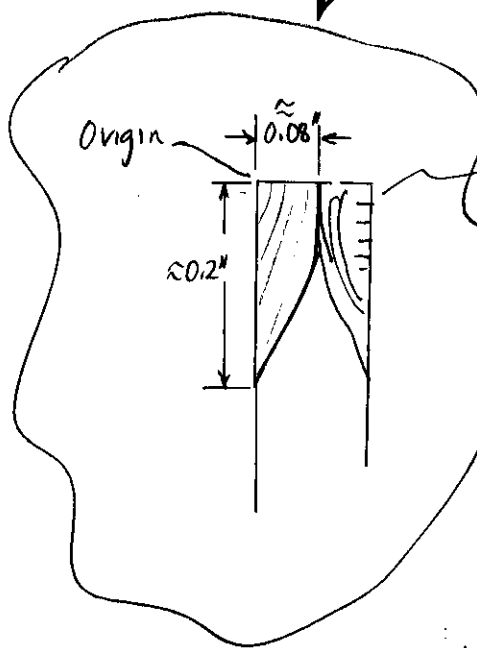
H

Apparent Fatigue Crack Location - AFT/INBD Corner of Shear Tie fracture at Front Spar Stiffener LBL 83.24.

CRACKS ~ .15" ABOVE FLANGE

possible multiple initiations on surface

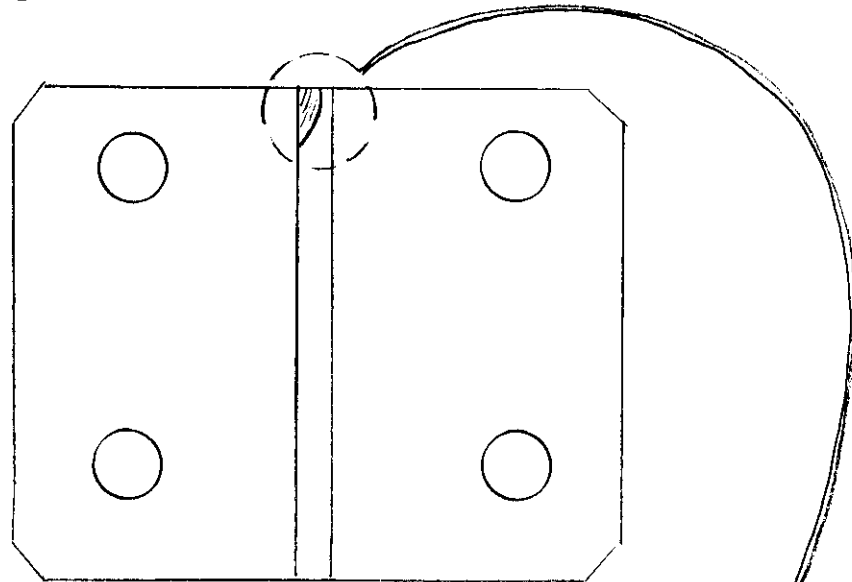
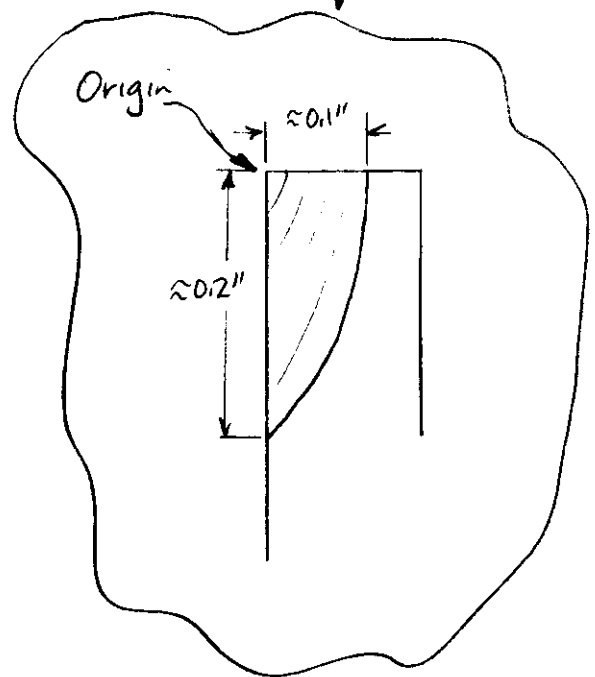
Apparent Fatigue Crack Location - AFT/INBD Corner of Shear Tie fracture at front Spar Stiffener LBL 91.14.

CRACK ~ .23 INCH ABOVE FLANGE

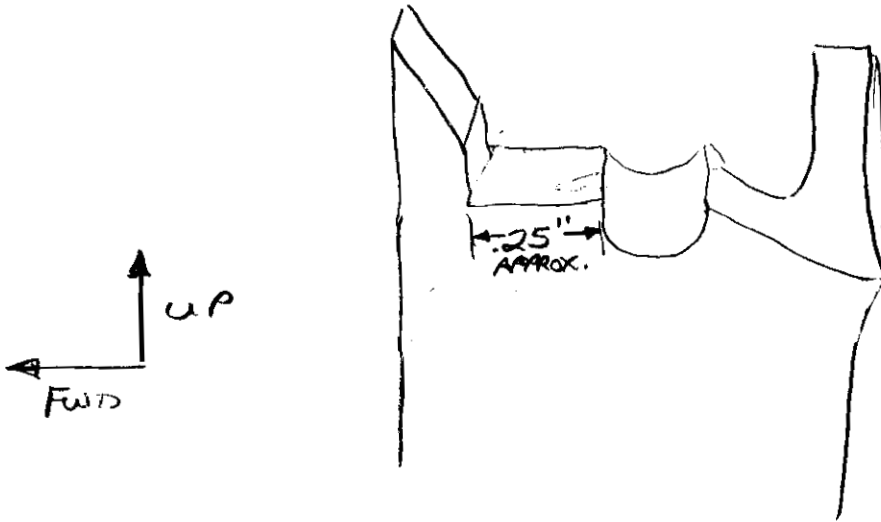
LOCATION J

FLOOR BEAM TO FRONT SPAR
SHEAR TIE AT LBL 33.99

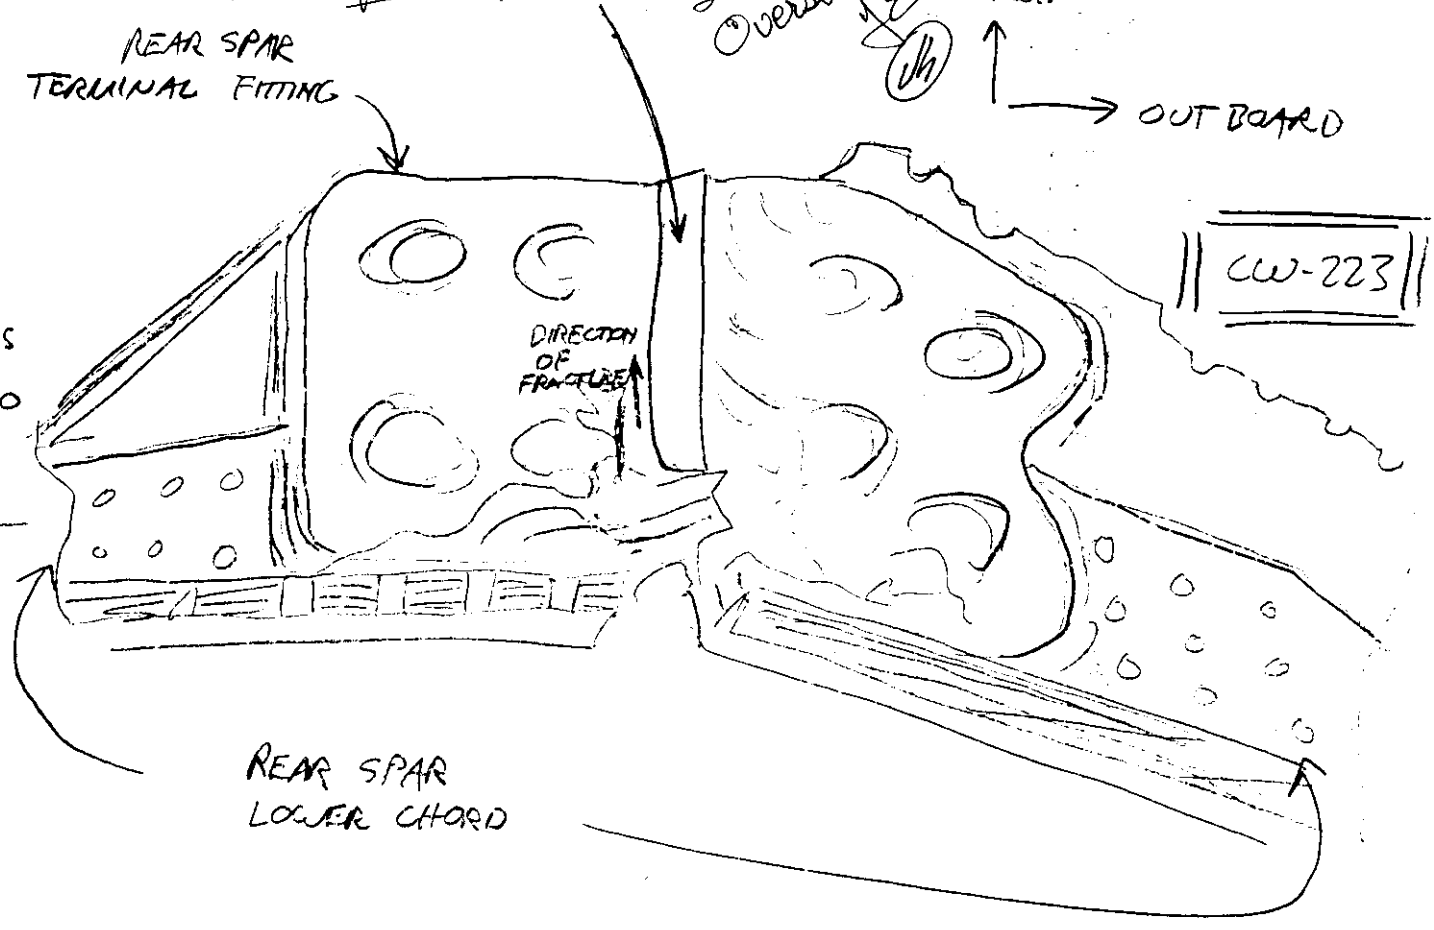
CW-223

FRACTURE POSSIBLY
15/17/96
Smearred & Mech Damaged
Overstress
12/12/96
12/4/96
Fwd

REAR SPAR
TERMINAL FITTING

REAR SPAR
LOWER CHORD

1. FLAT PROFILE FOR 1.0 - 1.25 INCHES
2. GENTLE TRANSITION TO SLANTED PROFILE
3. HAMMERED SURFACE (SHINEY) IN THE FLAT PROFILE REGION.

NOTE ! THERE'S A SECOND CRACK ABOUT 3/8" BELOW THIS FRACTURE, CAN'T CHARACTERIZE IT WITHOUT REMOVING SEALANT FROM THE AREA.
