**FLOOR PANELS**

**RED ZONE**

NTSB

FLOOR PANEL AND SEATTRACK CHORD INTERSECTIONS

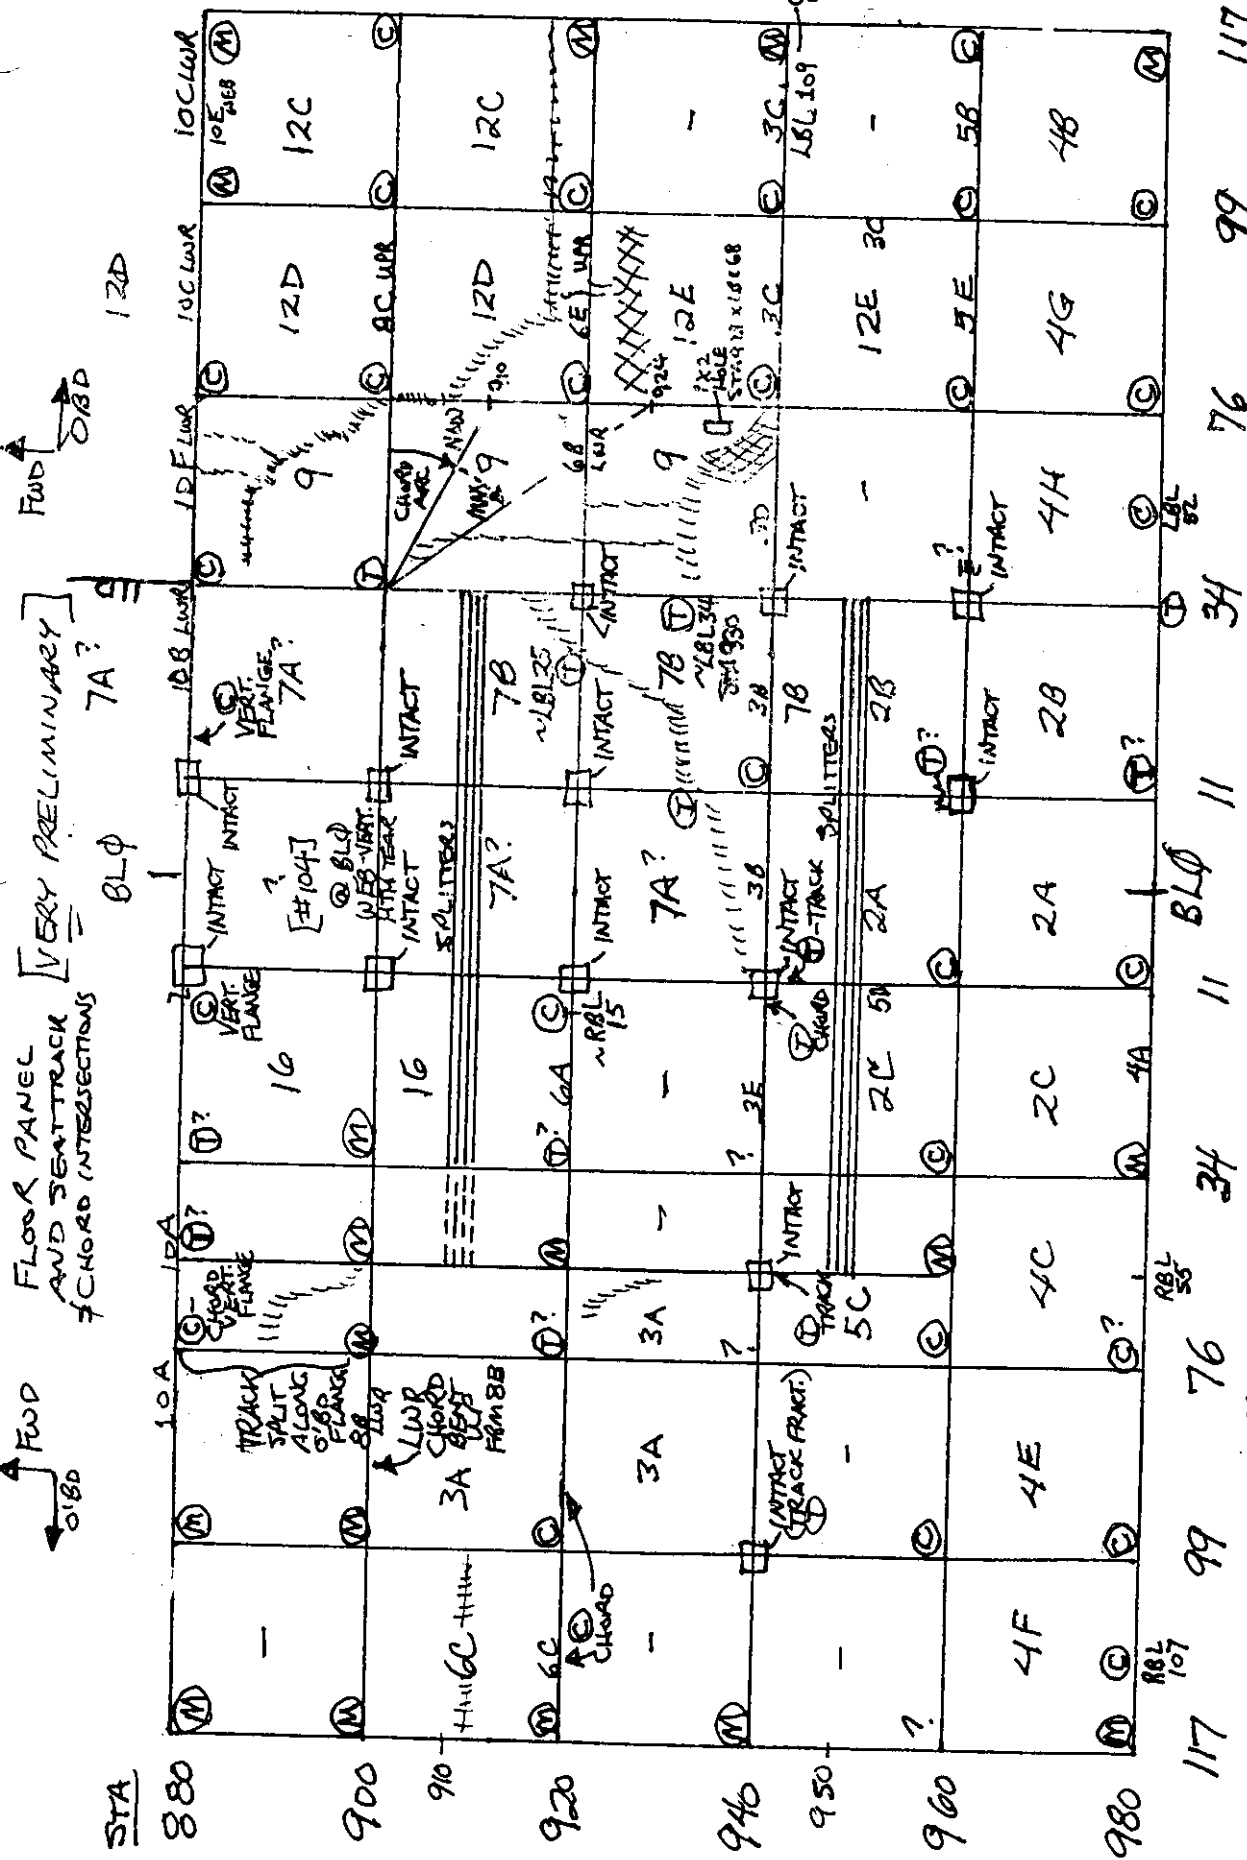
FYI 10/26  
FLOOR BEAMS ST 880-980  
RBL 117-120  
LOOKING AT BOTTOM OF PANELS AS LAID OUT ON FLOOR.  
ATTEMPT TO ASSES TRACK/CHORD INTERSECTION AS TENSION, OR COMPRESSION, RELATIVELY EASILY LOOK J. TRZIL

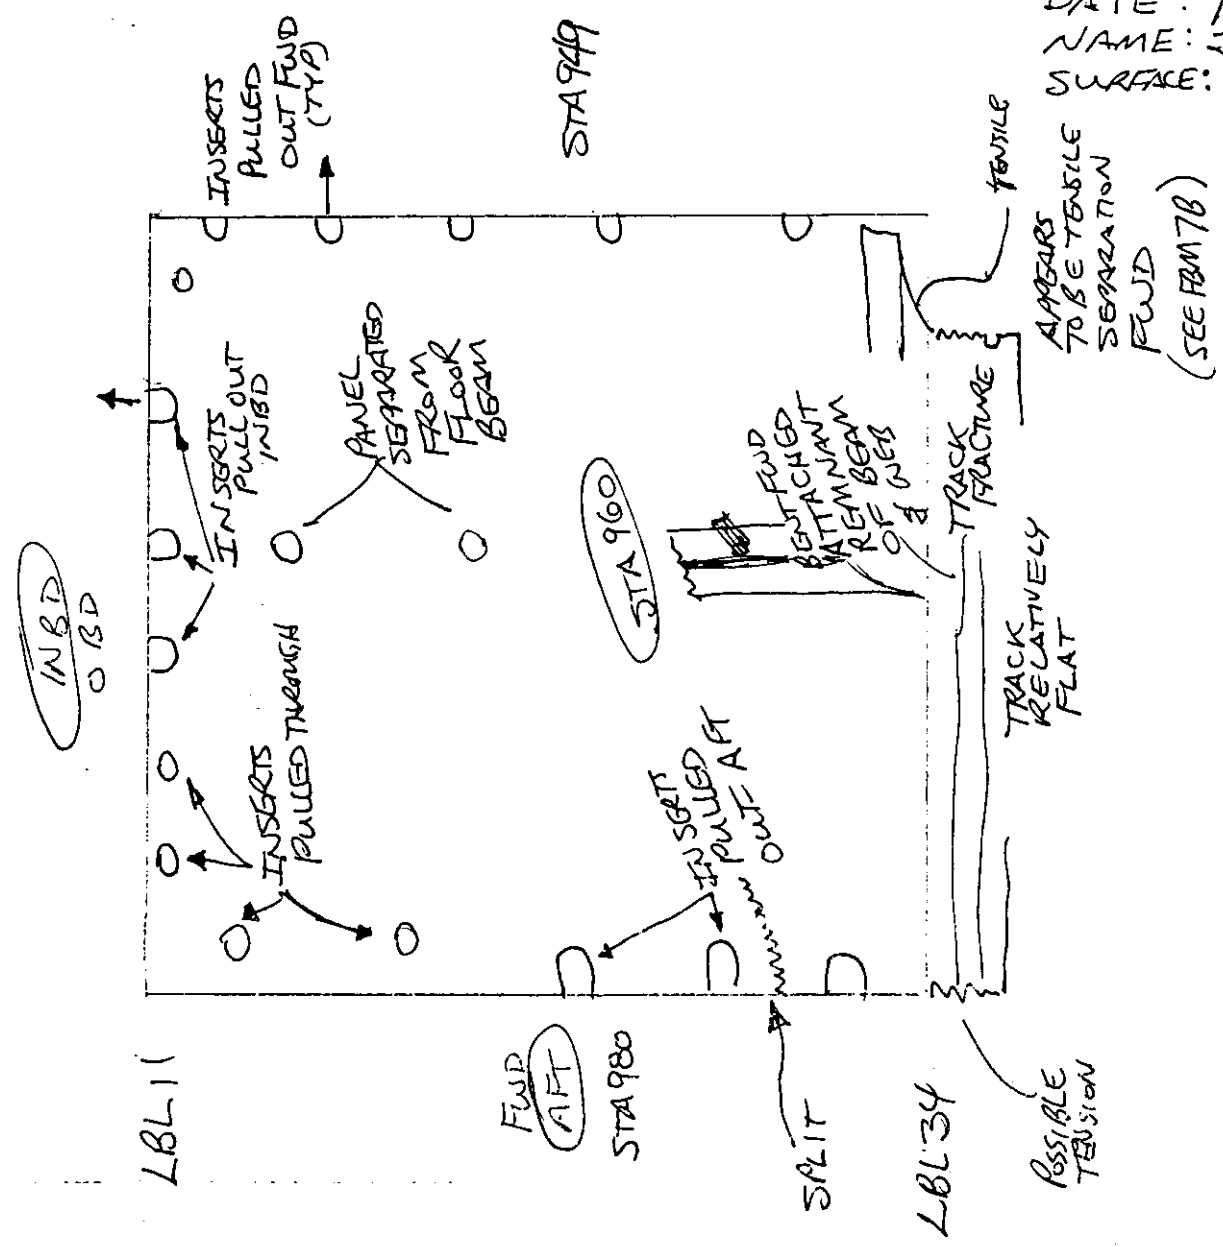
ITEM: FBM 2B  
 DATE: 10-23-96  
 NAME: J. TRZIL  
 SURFACE: LOWER

\* HOLE-TO-HOLE  
 \* (FLAT) TENSILE  
 \* SCANT  
 \* TEAR

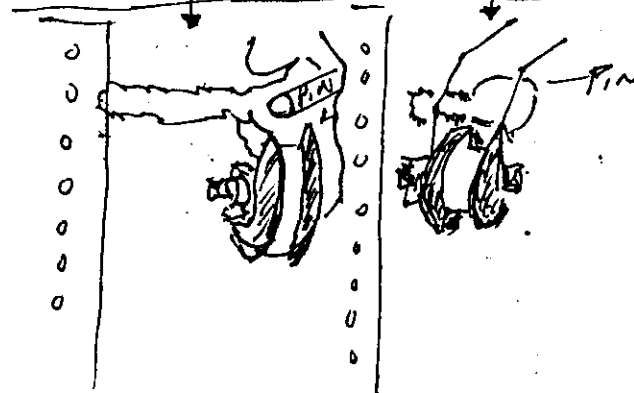
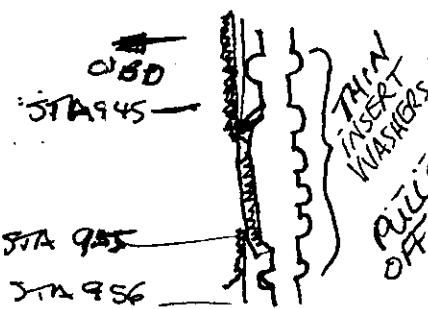
(A) FAIRLY HORIZONTAL SLIT ABOUT 1 5/8 INCH - 1 3/4 INCH BELOW UPR CHORD AT ABOUT 2-3 O'CLOCK FROM CABLE HOLE

SLIT FLOOR BEAM WEB AT ABOUT LBL 107 FROM CASLE ASSOCIATED WITH PULLEY (O'BD OF TWO PULLEYS) SLIT RUNS O'BD FROM PULLEY ABOUT 3 INCHES TO STIFFENER. SIMILAR SLIT FROM ADJACENT INBD PULLEY RUNS ABOUT 3/4 INCH O'BD WITH SLIGHT UPWARD ORIENTATION. O'BD PULLEY STILL ORIENTED MORE OR LESS FWD & AFT BUT SUPPORT SHEET METAL BKT DEFORMED & BROKEN AT O'BD HOLE FOR PIN ABOVE PULLEY. INBD PULLEY BENT O'BD AT ABOUT 30-45°. O'BD STIFFENER APPEARS TO HAVE IMPEDED O'BD MOTION OF PULLEY. BRKT (UPPER PORTION) APPEARS BENT AFT/OBD AT ABOUT 45°

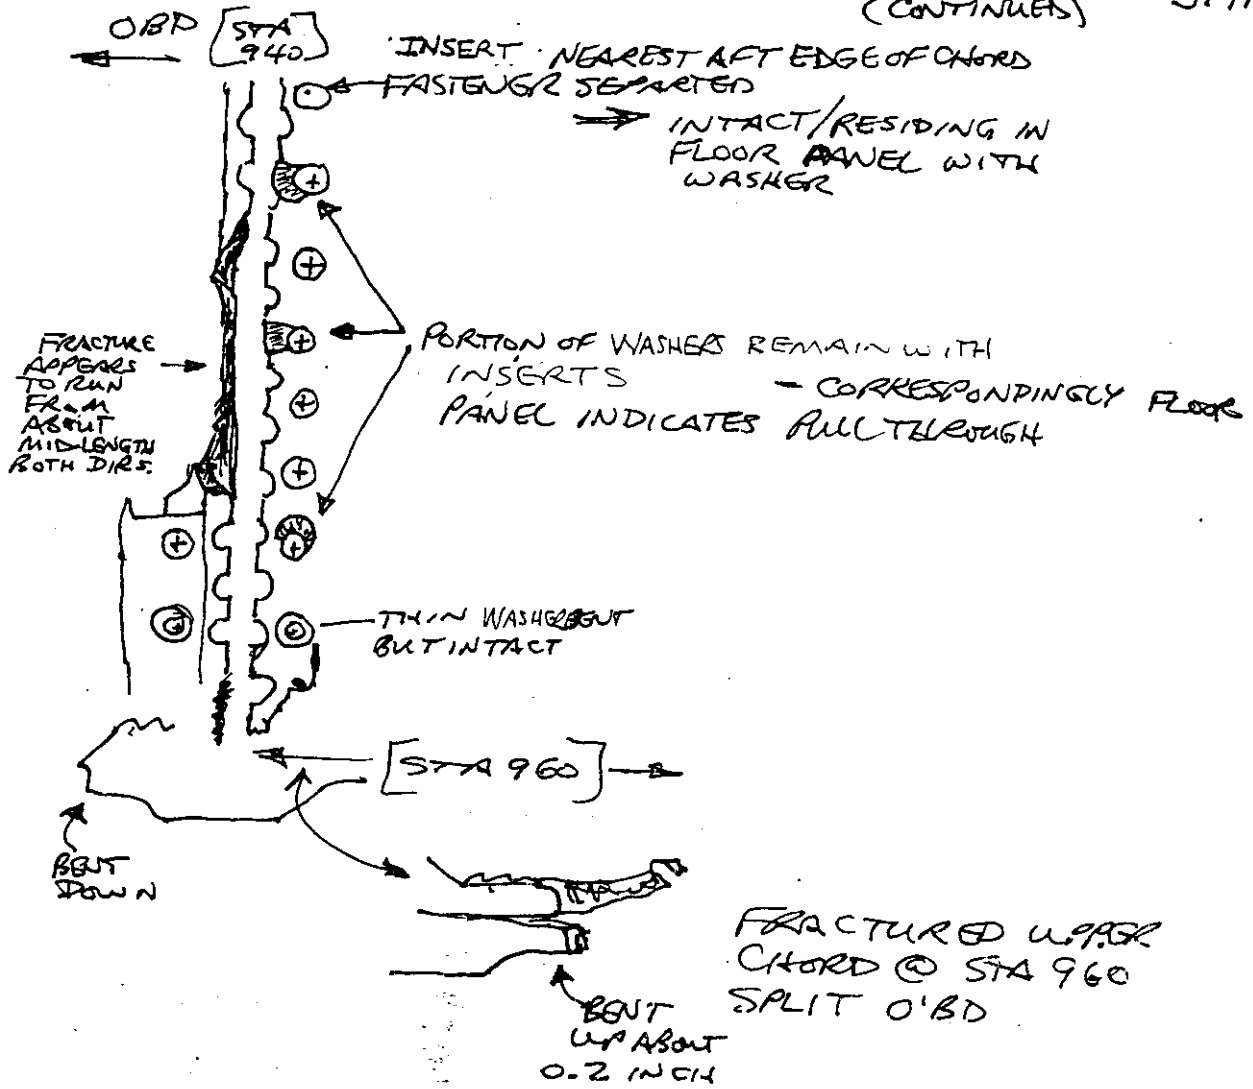
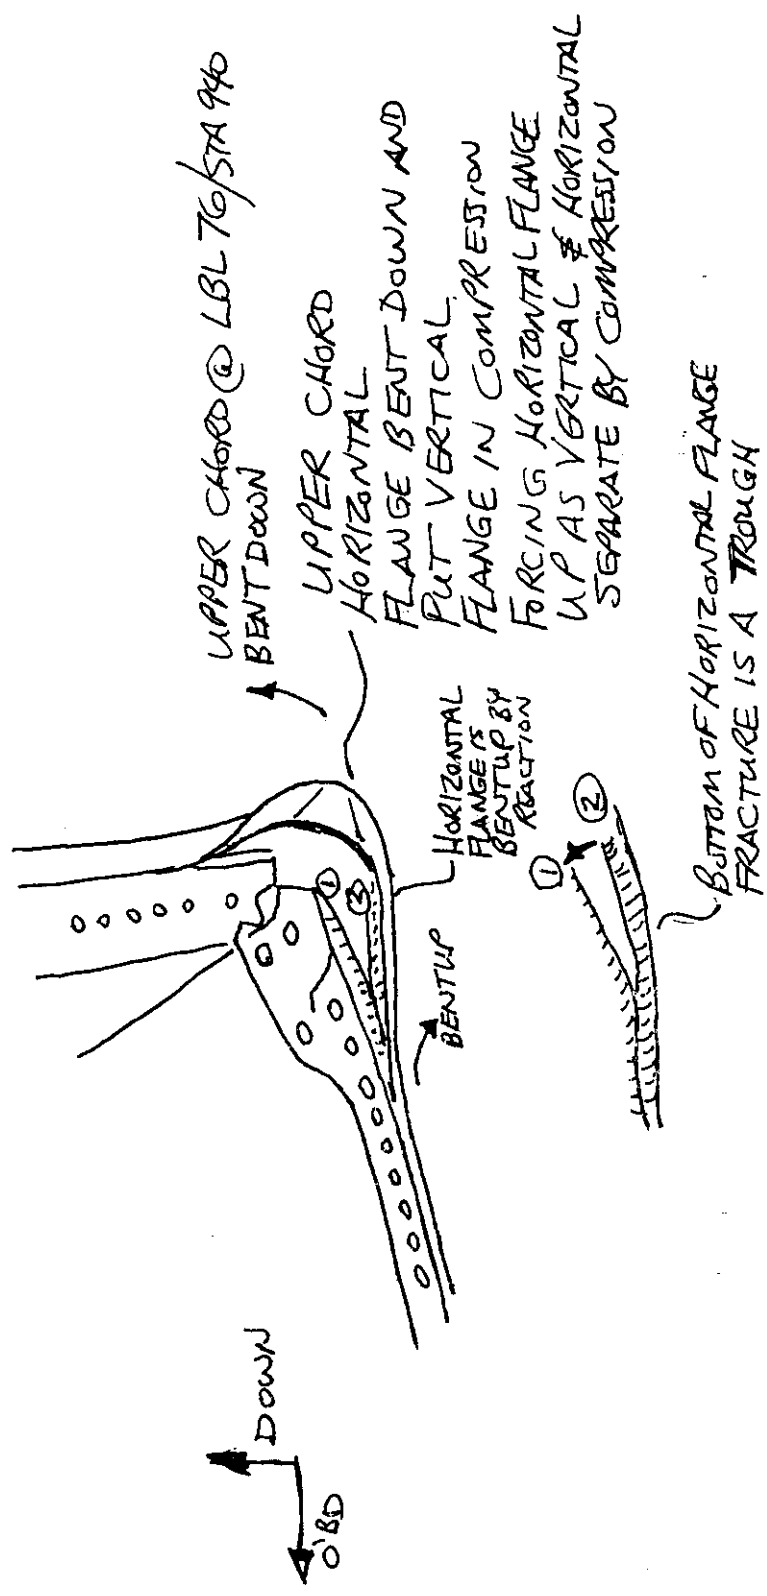
FBM-3C  
RED TAG A174  
(CONTINUED)

O'BD FLANGE OF SEAT TRACK AT LBL 99 FRACTURED FROM INSERT AT ABOUT STA 956 FWD TO FLOOR BEAM CHORD FWD EDGE. FROM STA 945 TO STA 955 FRACTURED O'BD FLANGE INCLUDED FRACTURE TO SEAT TRACK RAIL OBD ID/FILLET LEFT SIDE.

A TEE CHORD FRACTURED BY BENDING DOWN  
 CAUSING COMPRESSION OF THE VERTICAL FLANGE  
 WILL CREATE A TROUGH FRACTURE LIKE ② IN  
 THE HORIZONTAL FLANGE.  
 THE HORIZONTAL FLANGE WILL HAVE A BEND UNWINDS.

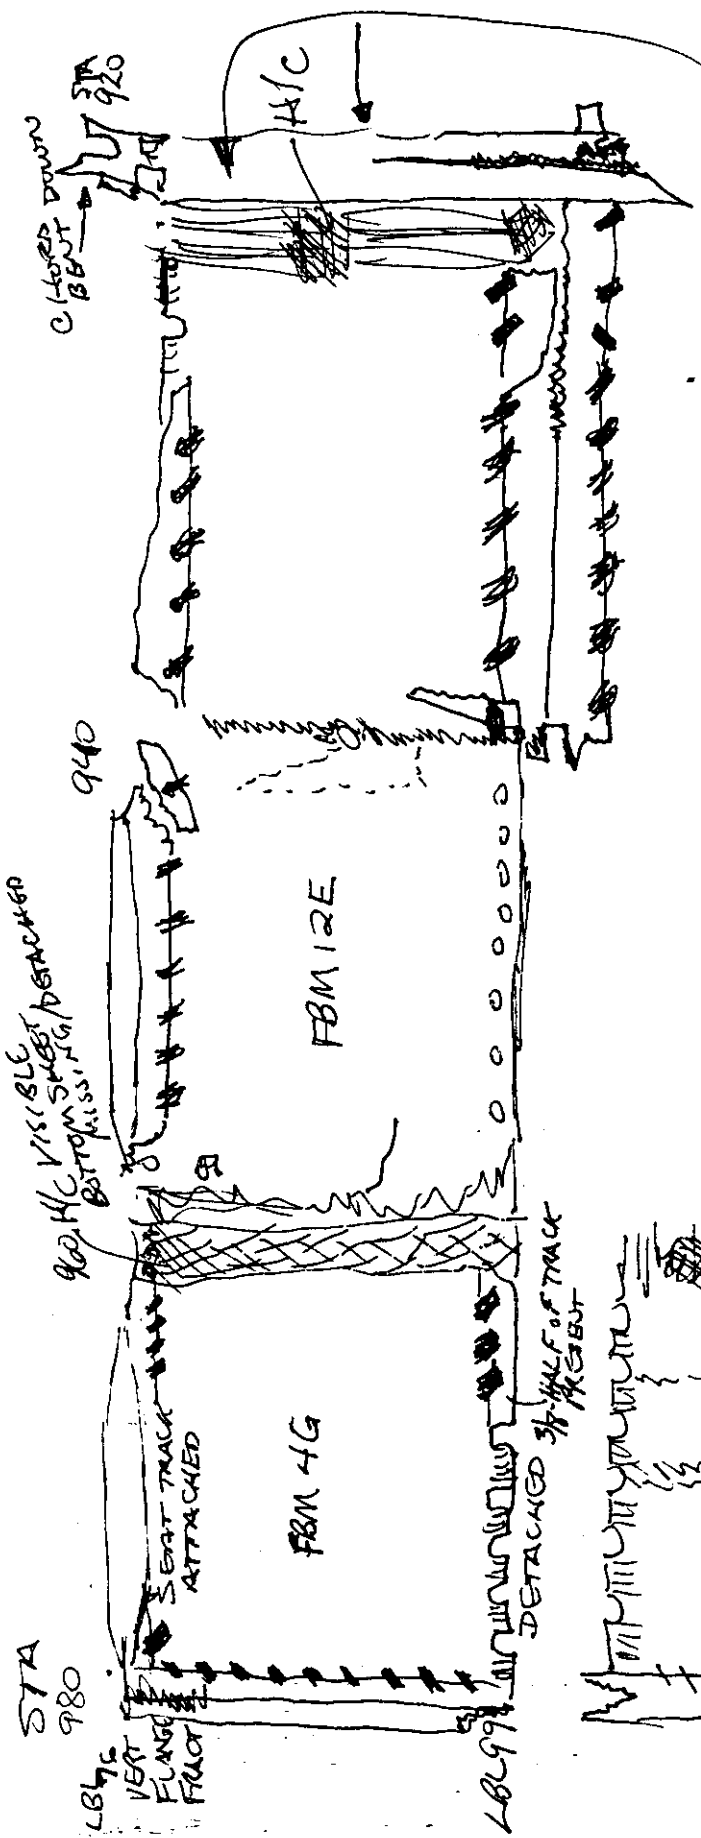
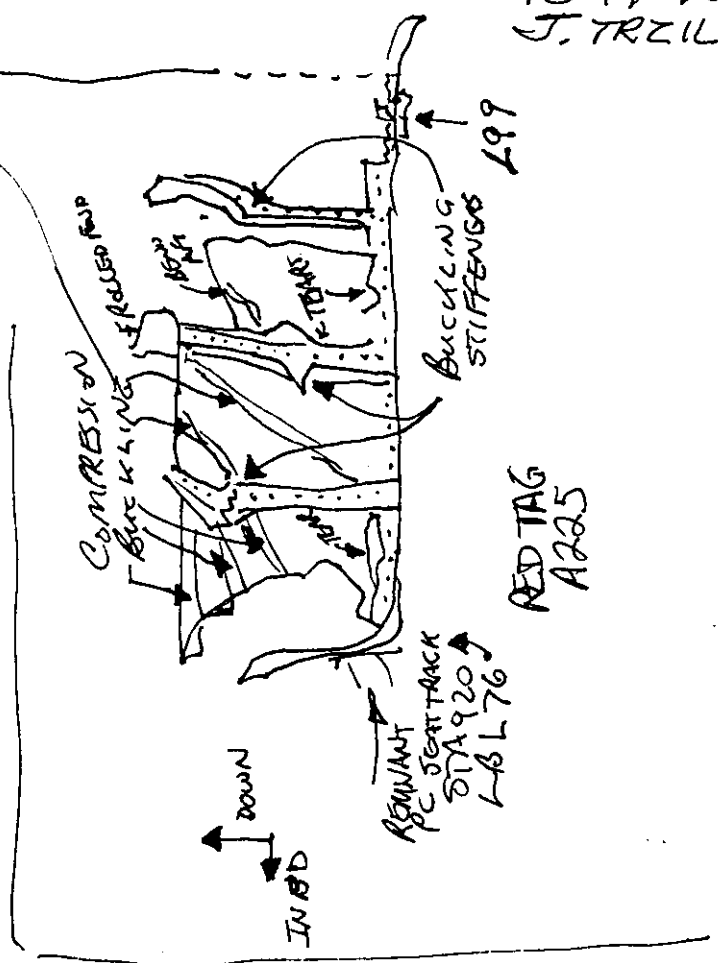
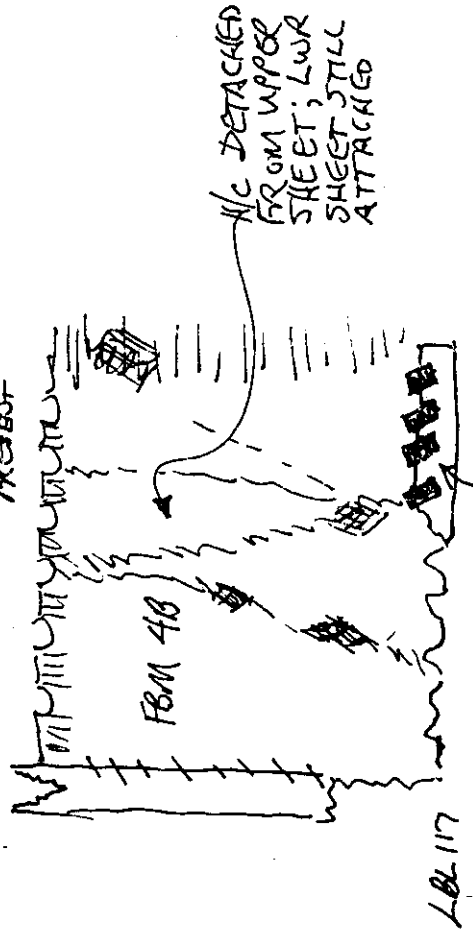
# FLOOR PANELS — LOOKING UP

FRACTURE DOWN <sup>WARDS</sup> @ LBL 99 & @ LBL 76  
FB4B FBM4G

SEAT TRACK FRACTURED INBD SIDE FROM  
STA 940 TO ~STA 925, MISSING TO ~STA 910,  
FRACTURED INBD SIDE TO 900, INTACT TO ABOUT  
STA 890, ABOUT 2-3 INCH PC MISSING AT  
STA 890.

STA 960, 940, 920, 900, 880  
FLOOR BEAM CHORDS SEPARATED FROM FLOOR.  
PORTION OF FLOOR BEAM CHORD IS ATTACHED AT  
STA 860, MISSING AT STA 840 AND LOOSELY  
ATTACHED AT LBL 76 AT STA 820  
MOST OF UPPER CHORD IS ATTACHED AT  
STA 800 FROM LBL 76 TO ABOUT LBL 97

FBM 4BE APPEARS TO HAVE BEEN BENT UPWARDS  
ALONG ~~THE~~ MIDSPAN ABOUT STA 970 *[Signature]*  
11-8-96  
AUST

FBM 4G APPEARS TO HAVE LIFTED <sup>UP AND</sup> ~~APT~~ FROM PIVOT LINE  
AT STA 960

FBM 1ZE APPEARS TO HAVE ROTATED UP & FWD  
FROM PIVOT LINE AT STA 960

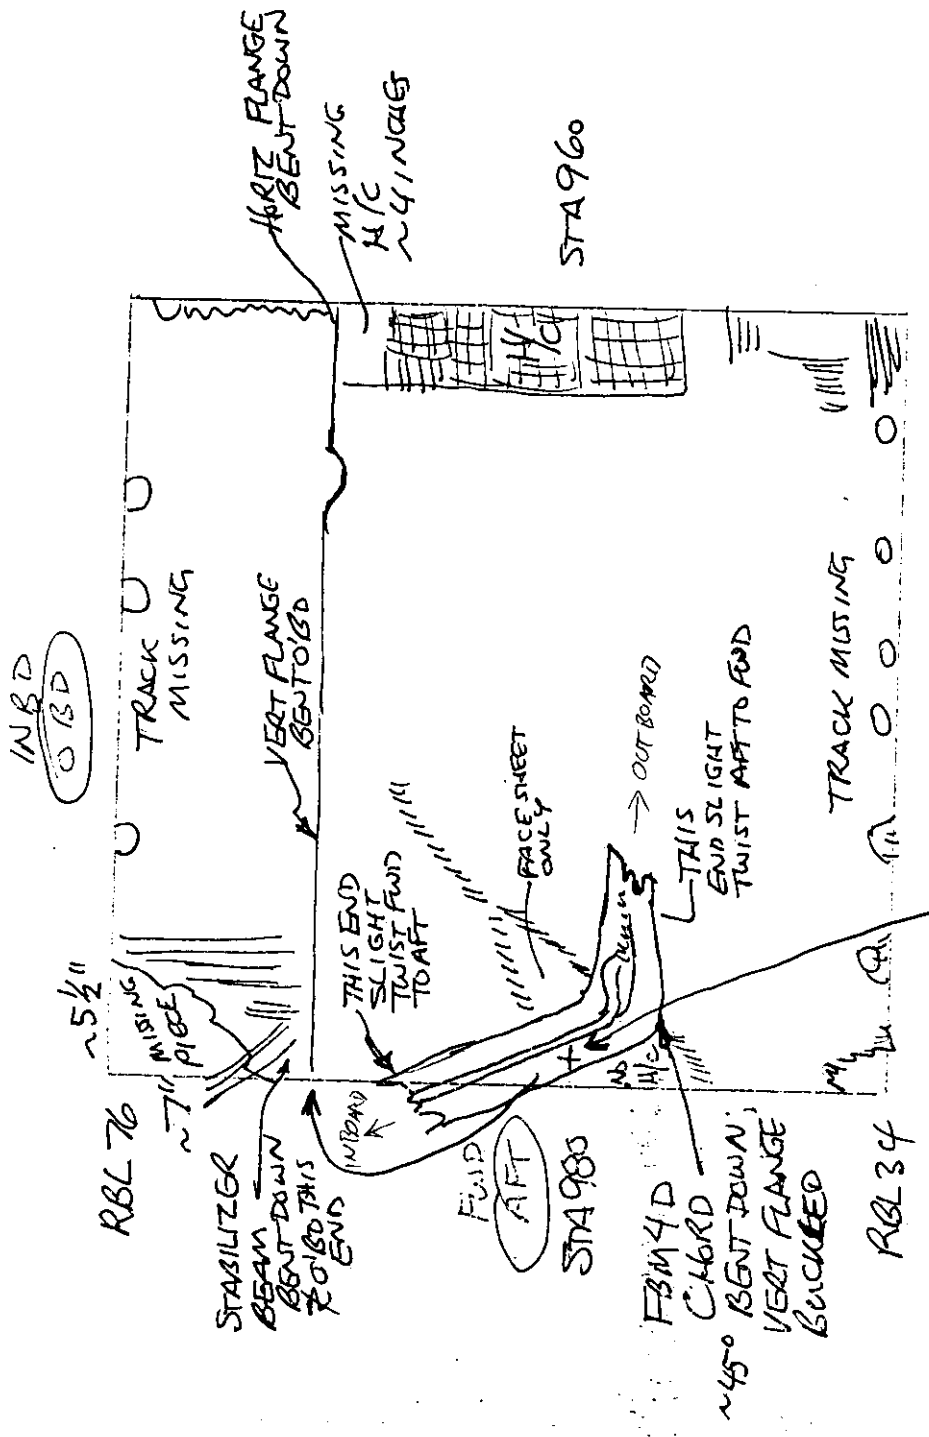
ITEM: FBM 4C  
 DATE: 10/23/96  
 NAME: JTRZIL  
 SURFACE: UPPER  
 LOWER

THIS PIECE OF UPPER CHORD IS MISLOCATED. THIS FASTENER HERE SHOULD MATCH WITH THE AFT END OF THE STABILIZER BEAM  
 G.F.L.E.S  
 10/24

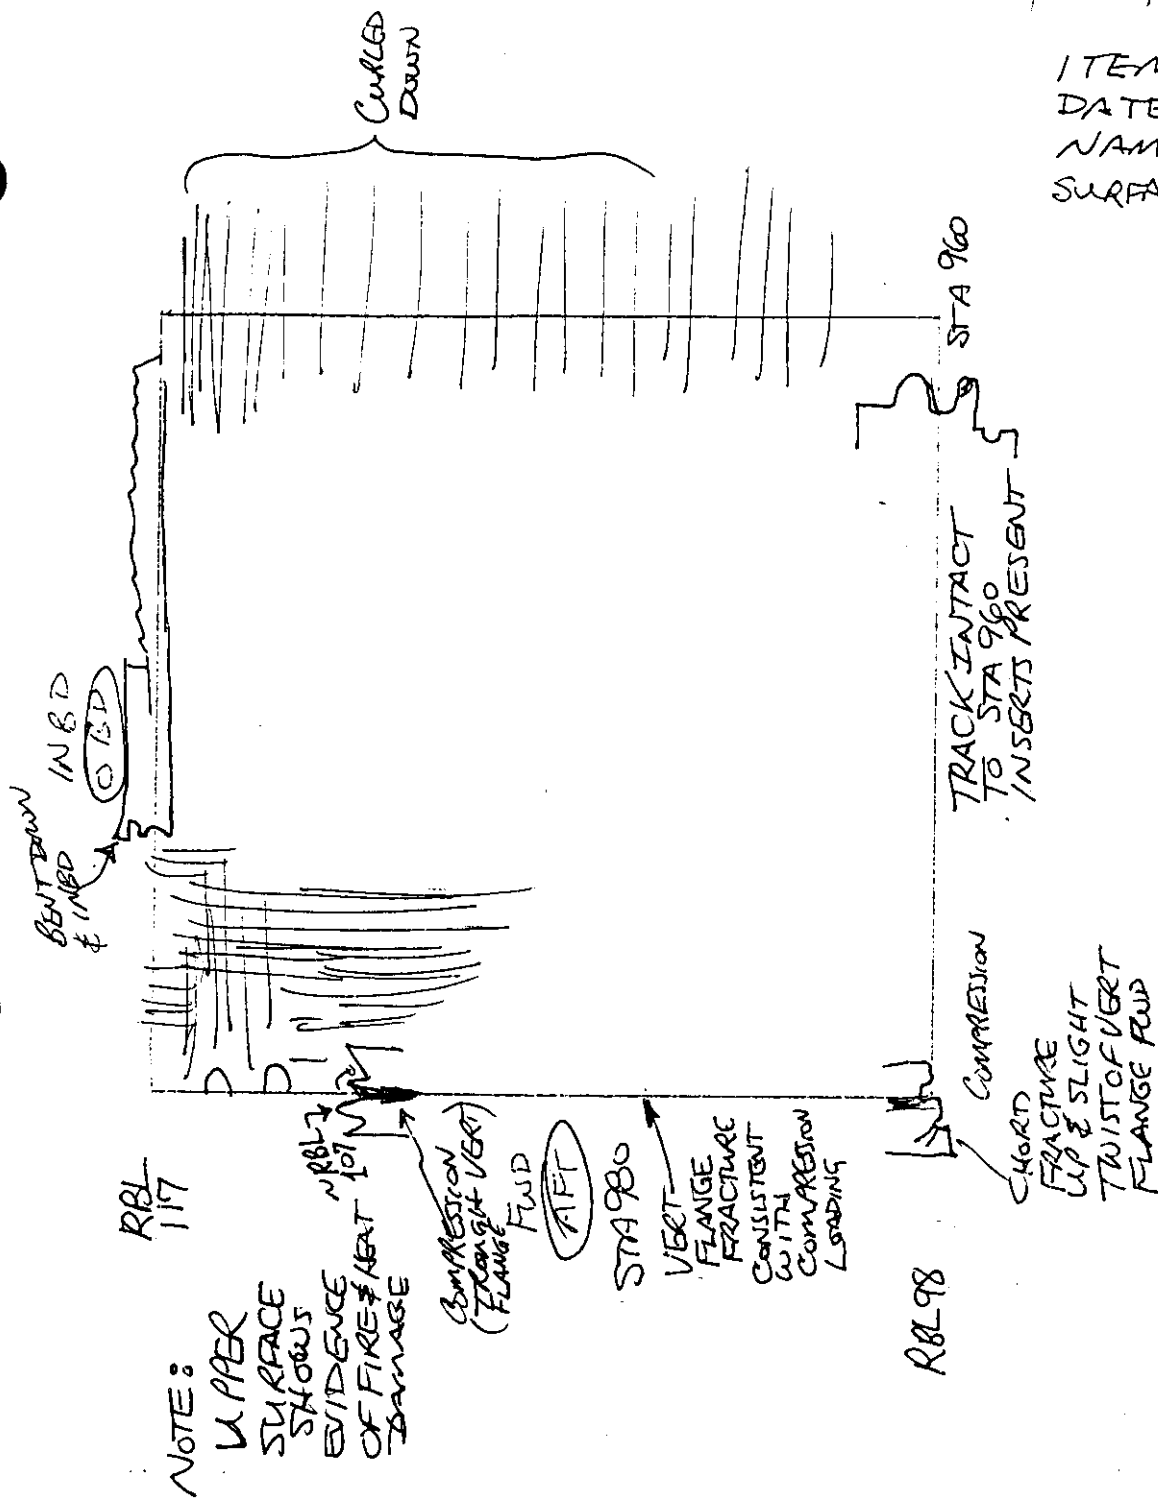
ITEM: FBM 4F  
 DATE: 10/23/96  
 NAME: J. TRZIL  
 SURFACE: UPPER  
 LOWER

UPPER SURFACE SHOWS EVIDENCE OF FIRE & HEAT DAMAGE

VERT FLANGE FRACTURE CONSISTENT WITH COMPRESSION LOADING

CHORD FRACTURE UP & SLIGHT TWIST OF VERT FLANGE FWD

NOTE: METAL FRACTURES - CLEAN

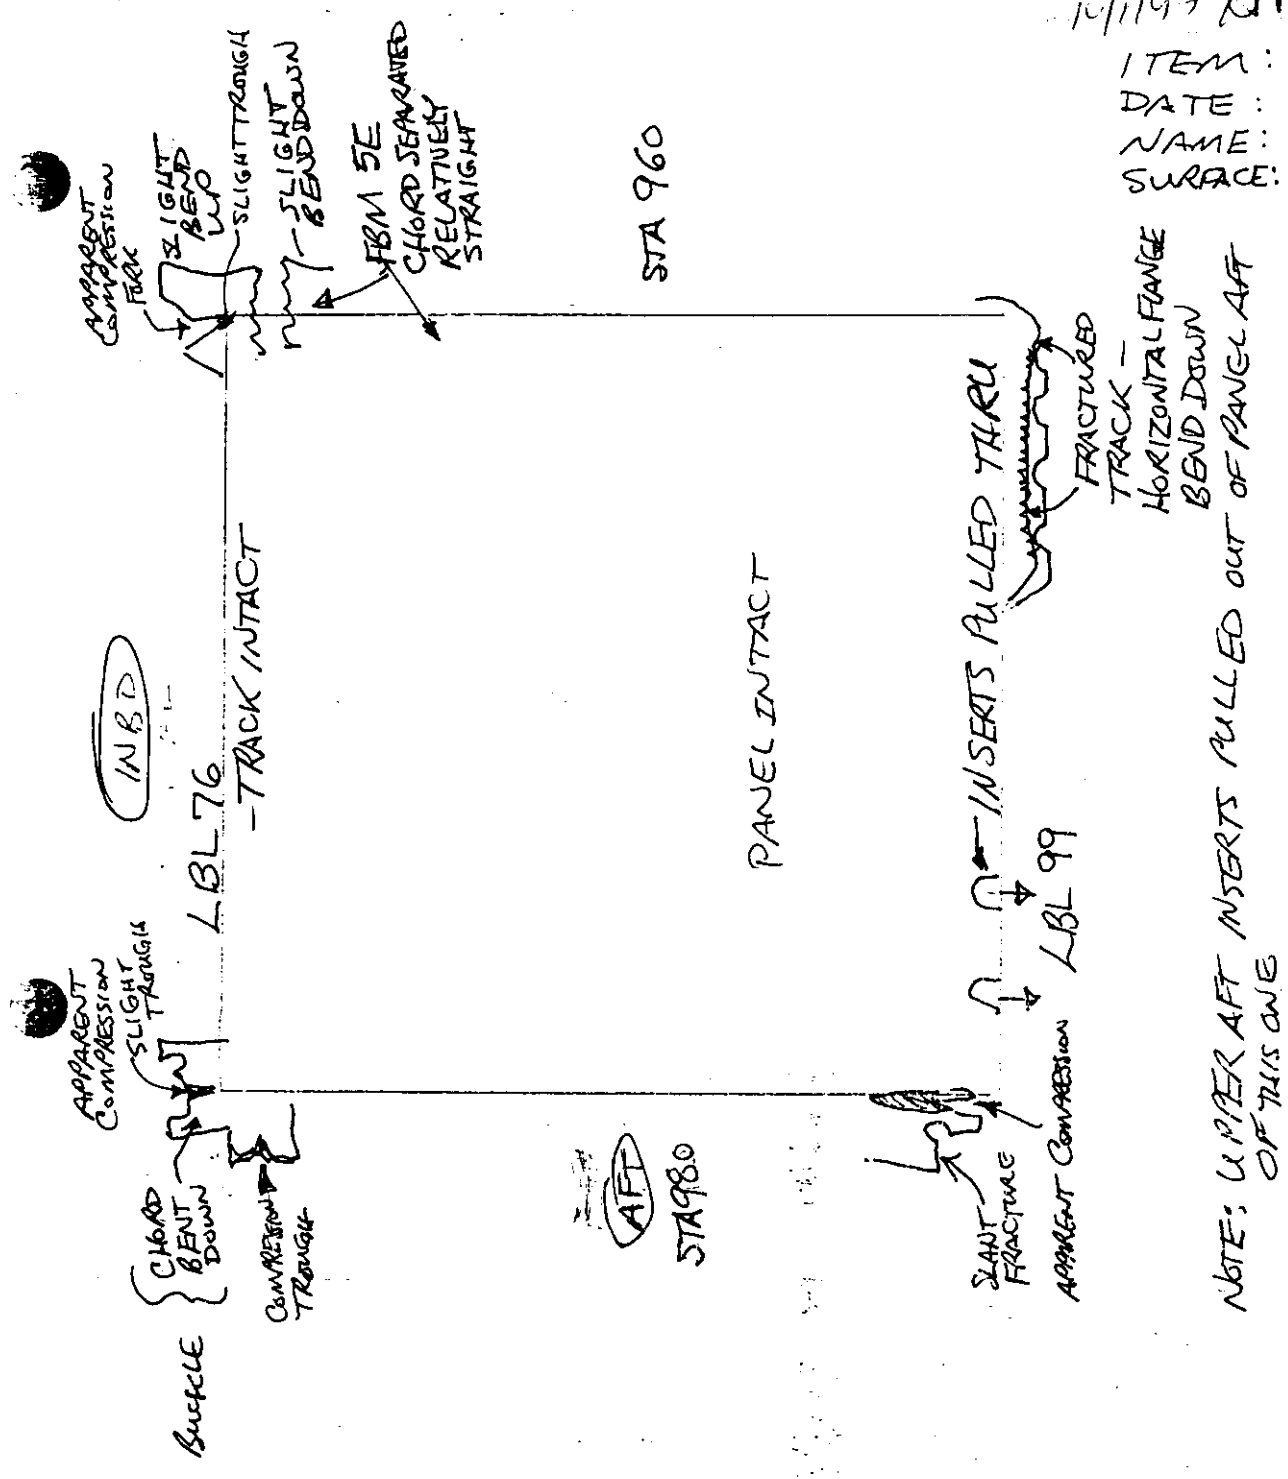
10/1/97 JTR  
 ITEM: FBM 4G  
 DATE: 10-23-96  
 NAME: J. TRZIL  
 SURFACE: LOWER

NOTE: UPPER AFT INSERTS PULLED OUT OF PANEL AFT OF THIS ONE

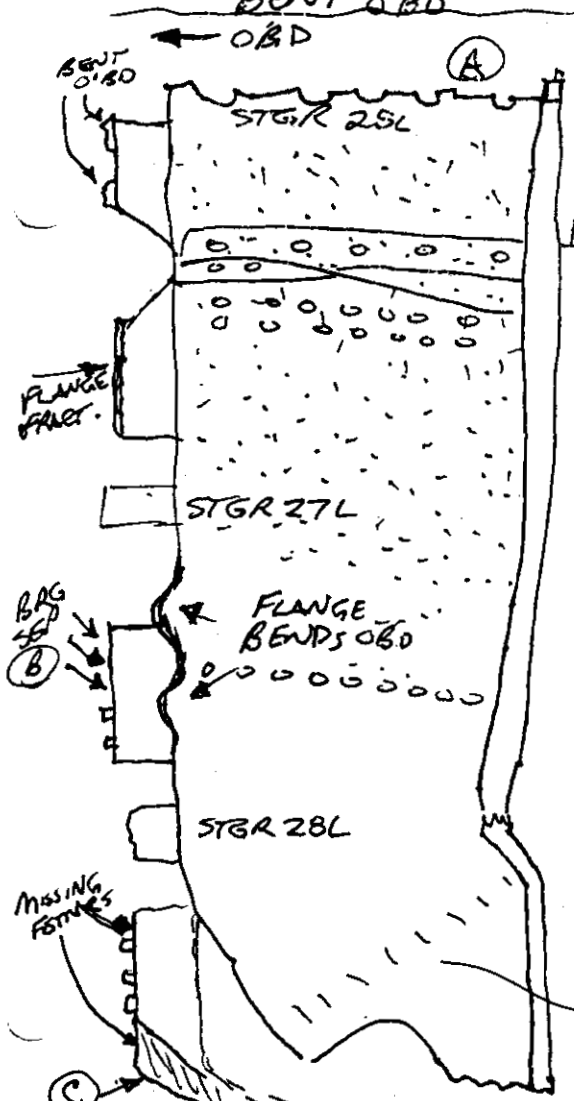
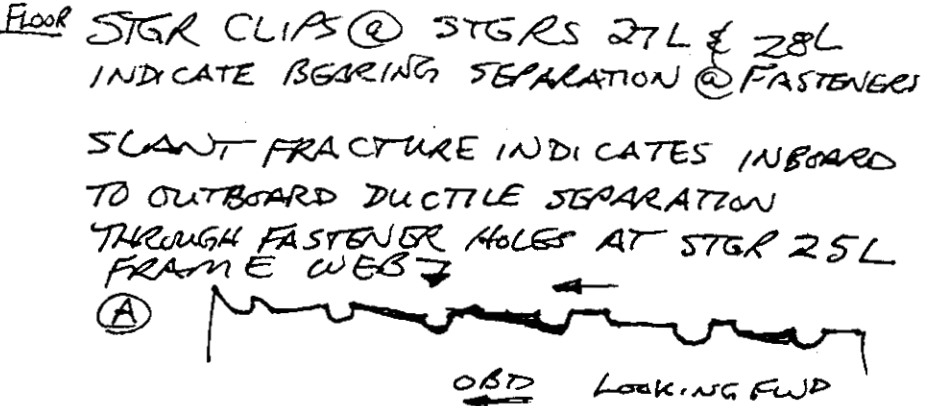
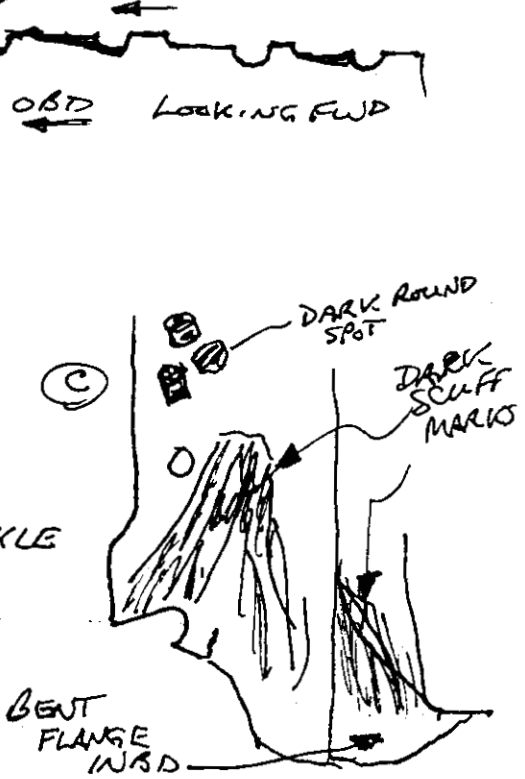
FRAME FBM-5A STA 960 LBL 125

SPLATTER AFT SIDE INBOARD DIRECTION  
UPPER HALF OF SEGMENT AND ON  
OBD FLANGE SURFACES  
UPPER TWO SHEAR TIE TO SKIN  
ATTACH FLANGES BROKEN OFF. (A)

LOWER SIX FASTENERS IN LWRTWO  
SHEAR TIES INDICATE SKIN-SHEAR  
TIE SEPARATION IN TENSILE [INBD-OUTBD]  
MODE. UPPER THREE FASTER HOLES  
IN 2ND FROM BOTTOM SHEAR TIE APPEAR  
TO HAVE SEPARATED BY BEARING (PULL OUT)

VERTICAL OUTER FLANGE SHOWS EVIDENCE  
OF POSSIBLE COMPRESSION BUCKLING  
AT LATTER SHEAR TIE - COULD BE JUST  
BENT OBD AT THESE TWO LOCATIONS

FLOOR STGR CLIPS @ STGRS 27L & 28L  
INDICATE BEARING SEPARATION @ FASTENERS

SLANT FRACTURE INDICATES INBOARD  
TO OUTBOARD DUCTILE SEPARATION  
THROUGH FASTENER HOLES AT STGR 25L  
FRAME WEB (A)

(A) UPPER MOST SHEAR  
TIE BETWEEN  
FLOOR BEAM &  
STRINGER 25L -  
FLANGE REMNANTS  
BENT OBD

DARK RUB/SCUFF  
MARKS; BENT FLANGE INBD

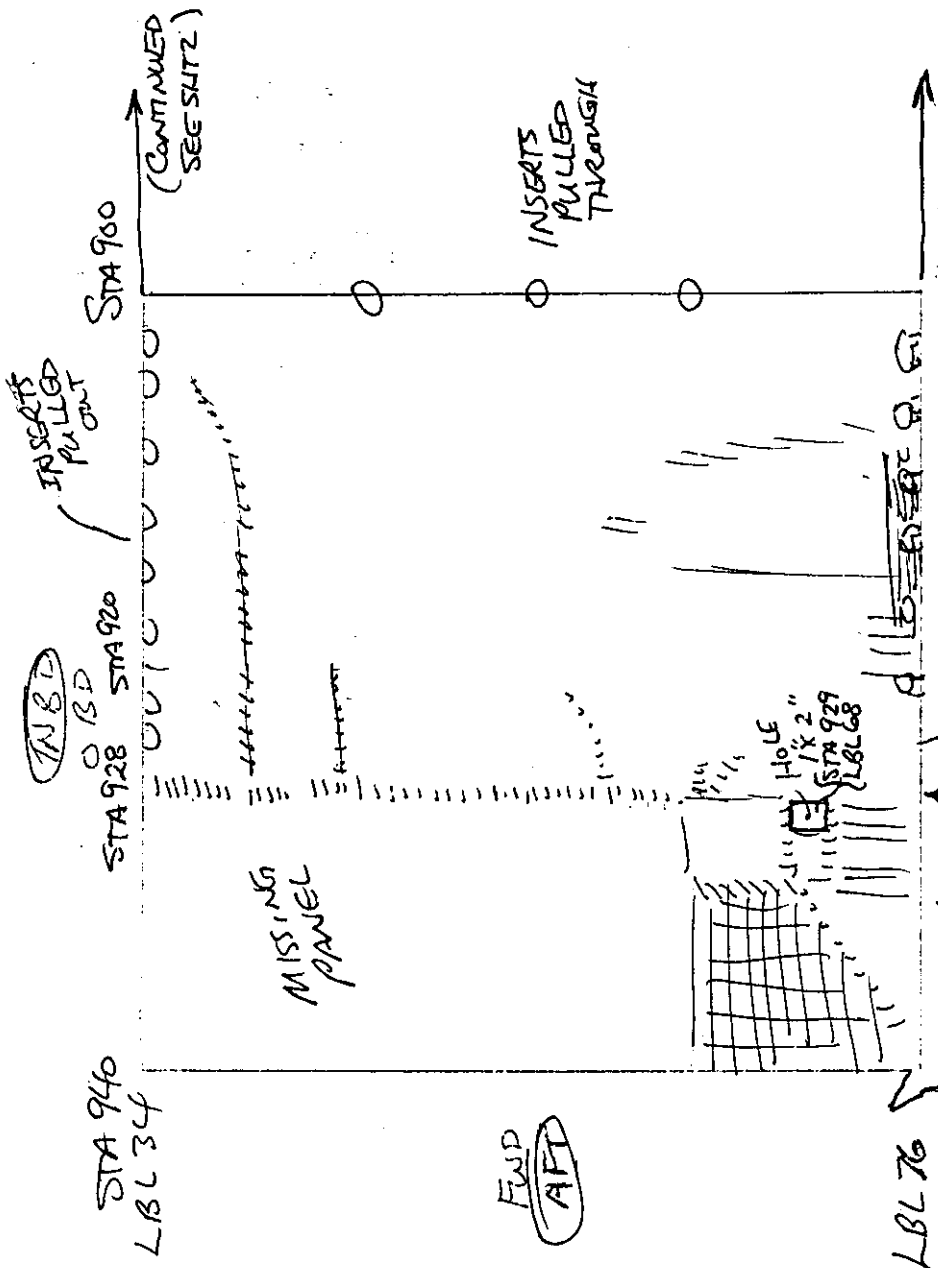
ITEM: FBM 9  
 DATE: 10/24/96  
 NAME: J. TRZIL  
 SURFACE: UPPER  
 LOWER

SEE FBM 78  
 STA 920 CHORD  
 IS BENT UP  
 FROM LBL 58 080

SECTION OF  
 TRACK IS  
 RELATIVELY  
 FLAT-TENSION  
 FRACTURES

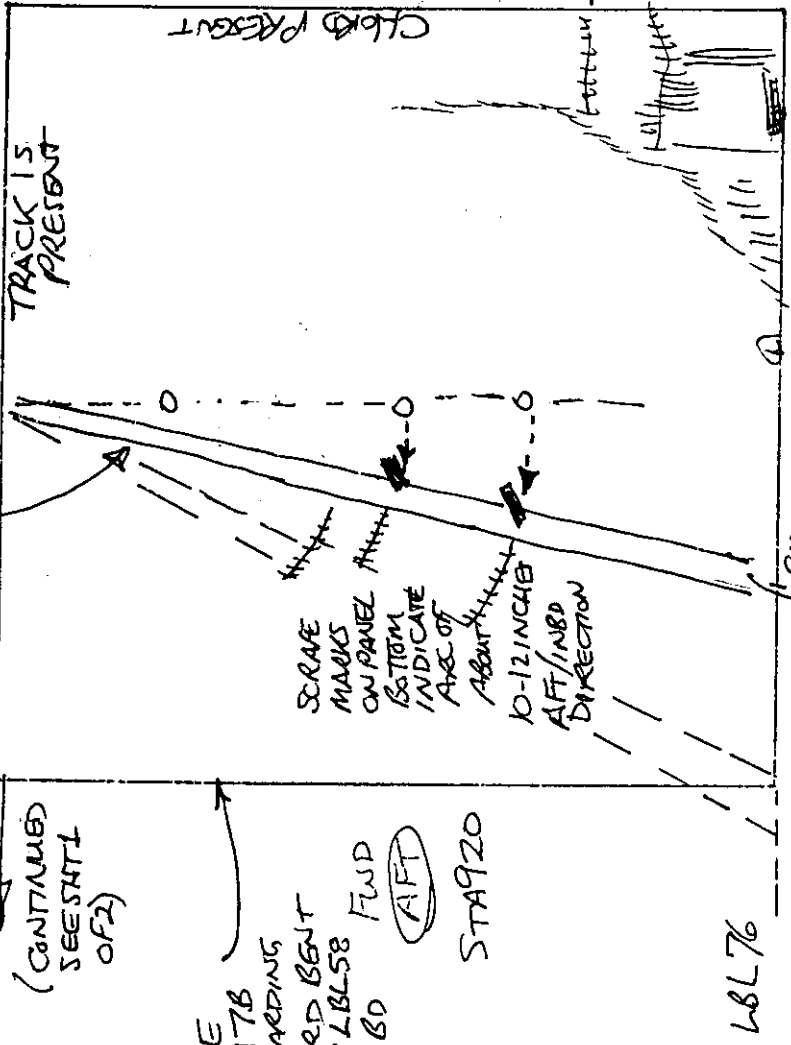
ITEM: FBM-9  
 DATE: 10/24/96  
 NAME: J. TRZIL  
 SURFACE: UPPER  
 LOWER

CHORD ATTACHED TO TRACK AT  
 STA 900 / LBL 33 INTERSECTION  
 IS ROTATED AFT ABOUT 30°  
 FROM BREAK AT STA 898  
 IN TRACK

910  
 SLIGHT  
 BEND DOWN  
 COMPRESSION  
 FRACTURE  
 VERTICAL  
 FLANGE

CHORD  
 LOCATION  
 ORIGINAL : STA 900  
 CURRENT : ~ 910  
 MAX : ~ 924

CORNER IS  
 BENT DOWN.  
 ATTACHED  
 CHORD IS BENT  
 DOWN VERTICAL  
 FLANGE HAS BEEN  
 BRACKLED.

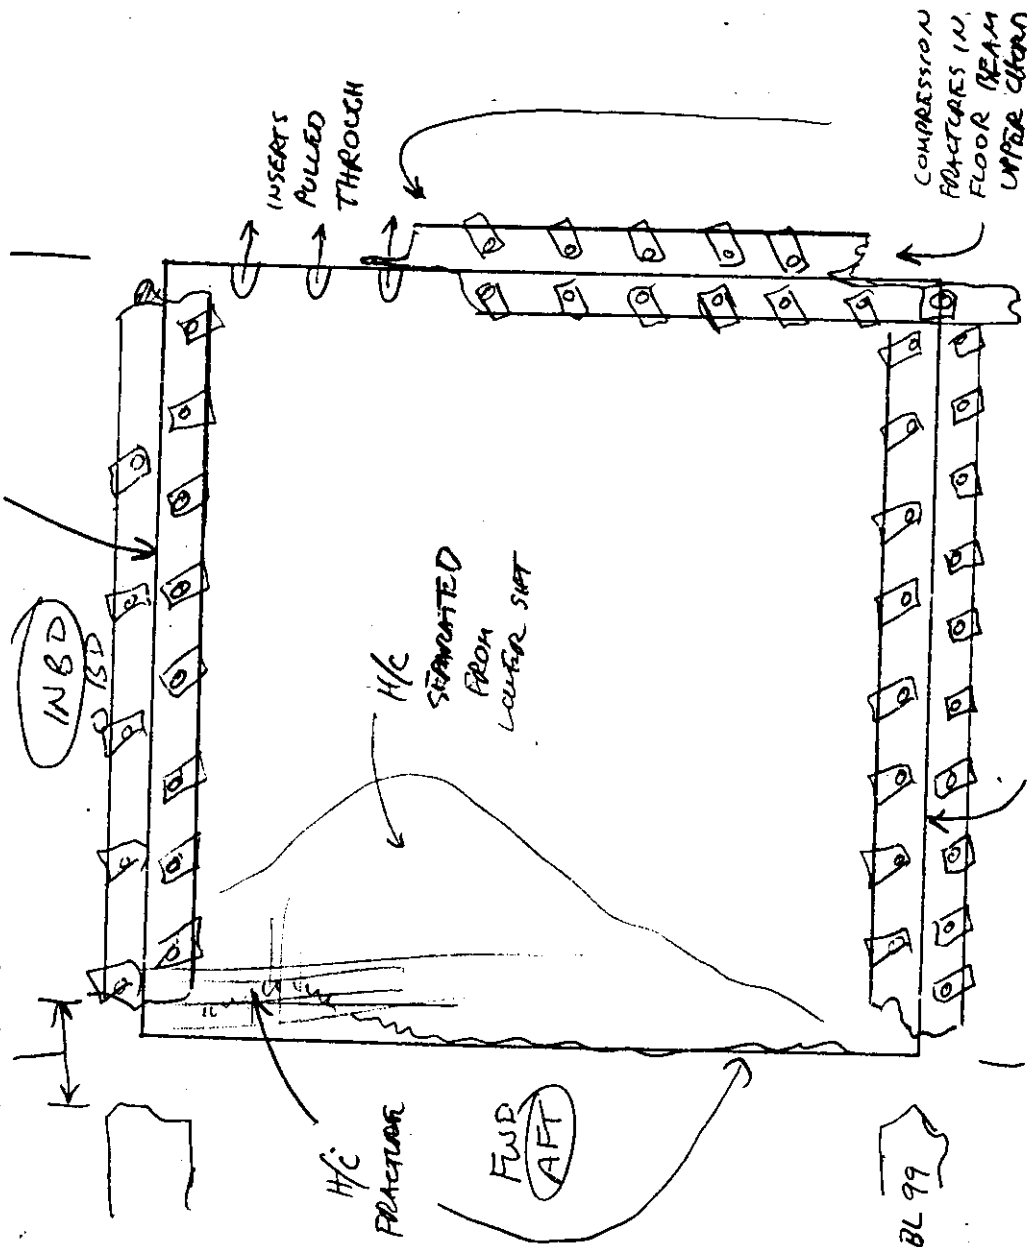
10/1/97 HFH  
 ITEM: FBM 12D  
 DATE: 10/30/96  
 NAME: G. FLEIS  
 SURFACE: UPPER  
 LOWER

VERTICAL WEB AND LOWER CHORD INTACT

SECTION OF SEAT TRACK FRACTURED AWAY LBL 76 AND LBL 99

SMALL RECR (2" x 6") OF VERT WEB (NO LOWER CHORD) REMAINS WITH SEAT TRACK, SLIGHT CURV IN BD AT STA 940

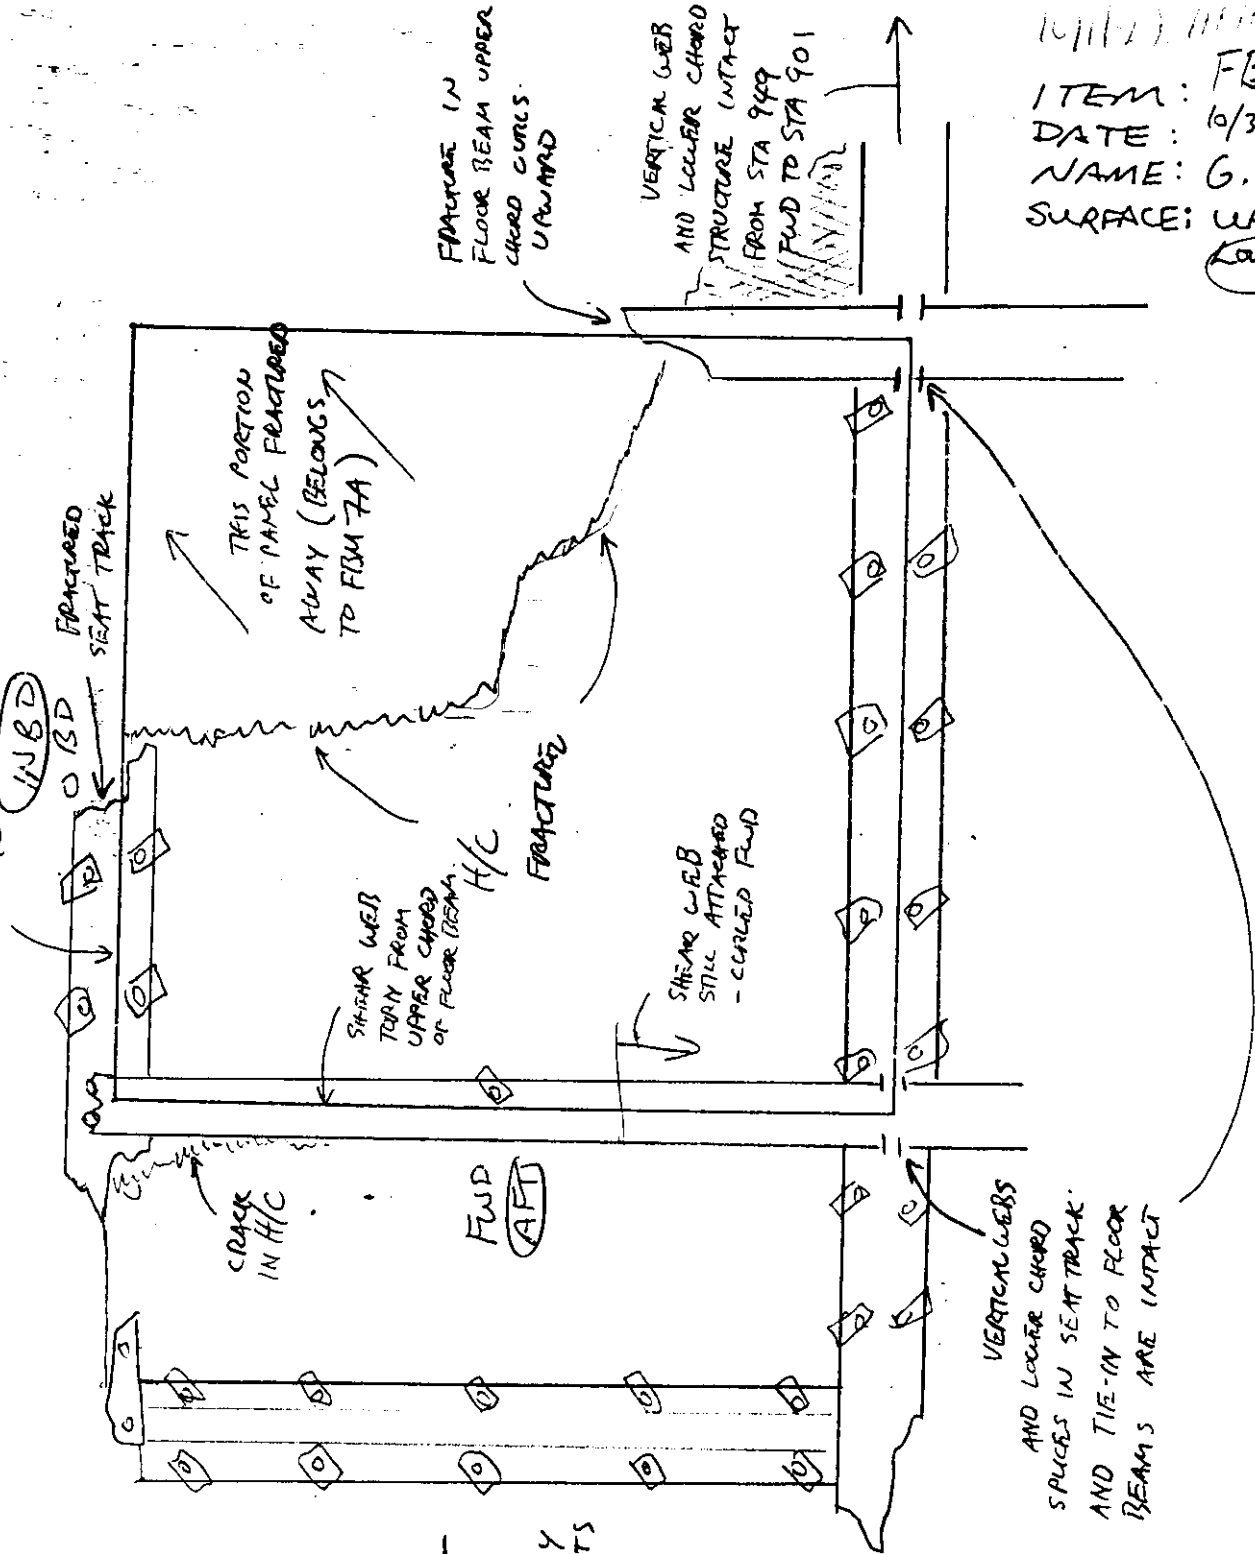
ITEM: FBM 7B  
DATE: 10/30/96  
NAME: G. FLEIS  
SURFACE: UPPER  
LOWER

PANEL FBM 7B PULLED AWAY FROM INSERTS

VERTICAL WEBS AND LOWER CHORD SPICES IN SEAT TRACK AND TIE-IN TO FLOOR BEAMS ARE INTACT
