**FLOOR PANELS**

**RED ZONE**

NTSB

FLOOR PANEL AND SEATTRACK CHORD INTERSECTIONS

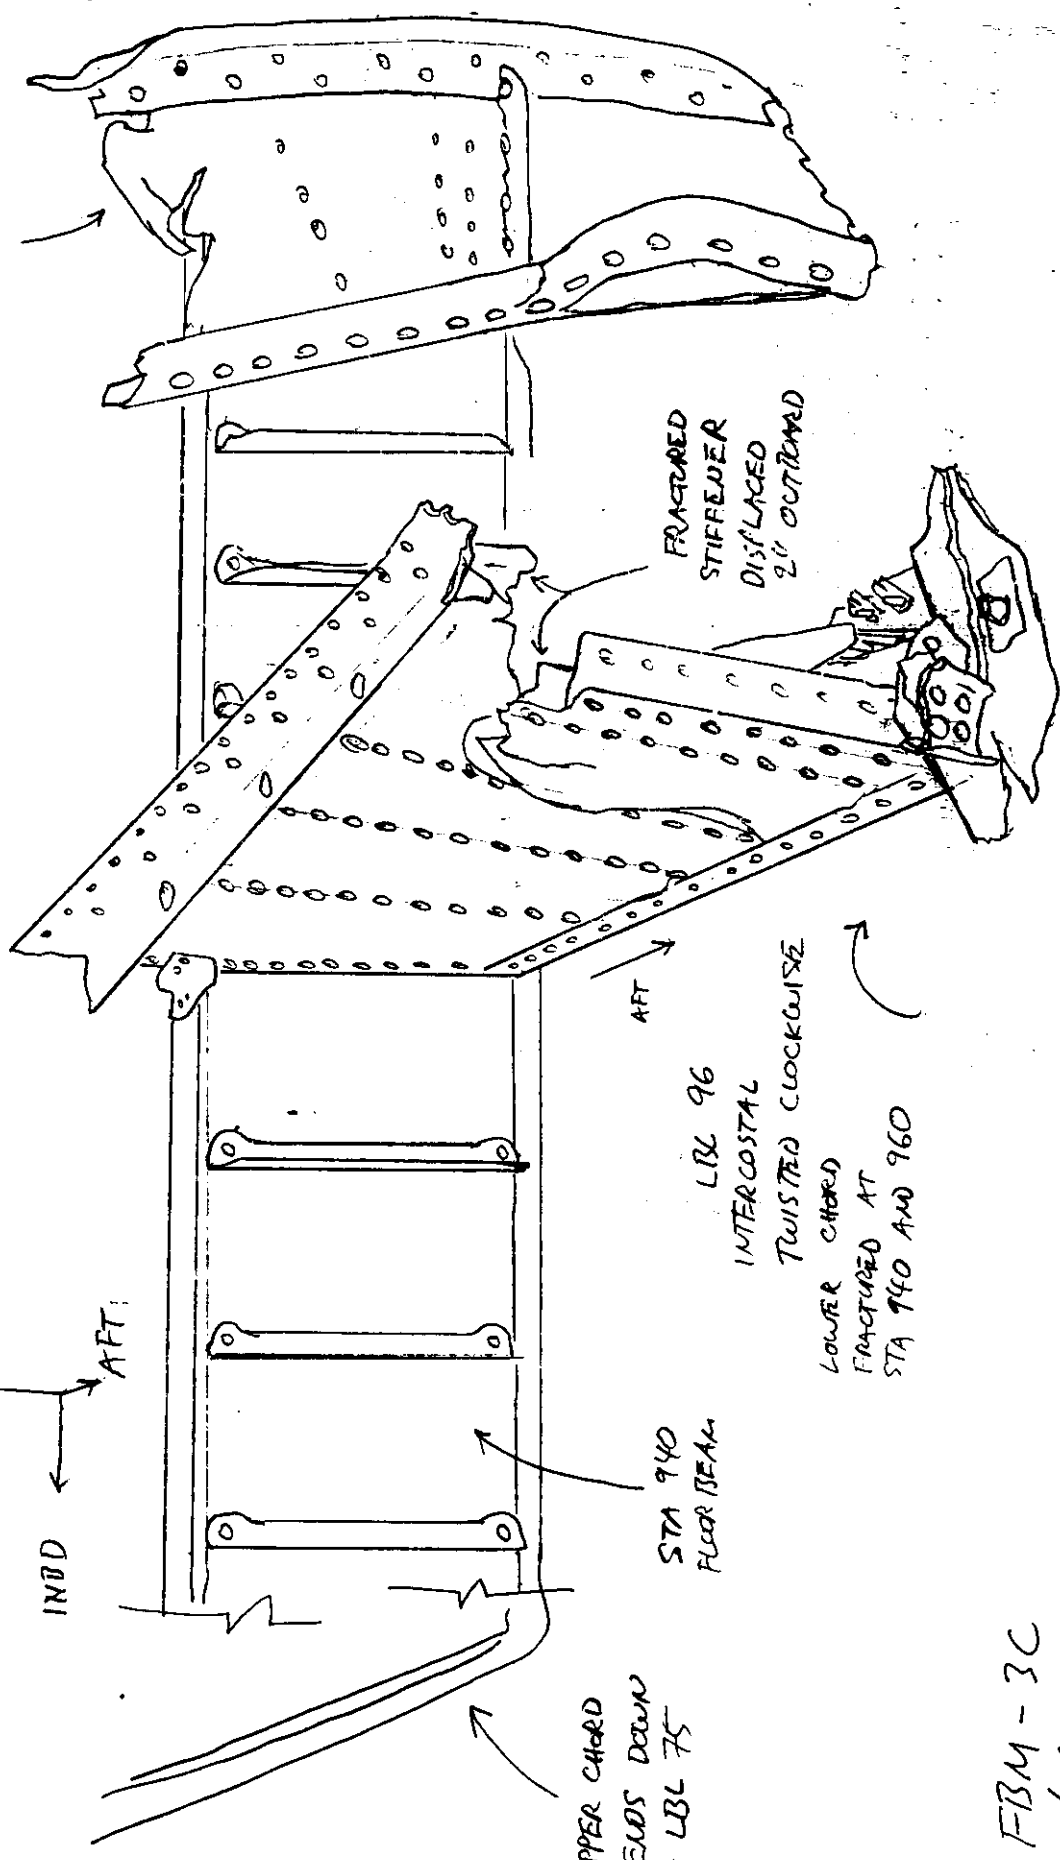
FBM-3C  
11/7/96 G. FLEIS

FRAME WEB CORRS  
FWD & OUTWARD

FRAGURED  
STIFFENER  
DISPLACED  
2" OUTWARD

LBCL 96  
INTERCOSTAL  
TWISTED CLOCKWISE  
LOWER CHORD  
FRAGURED AT  
STA 940 AND 960

UPPER CHORD  
BENDS DOWN  
AT LBCL 75
