FUSELAGE

Red Zone Fuselage Pieces: Fracture Directions / Deformations

Internal Overpressure Indication and Fracture Direction Survey

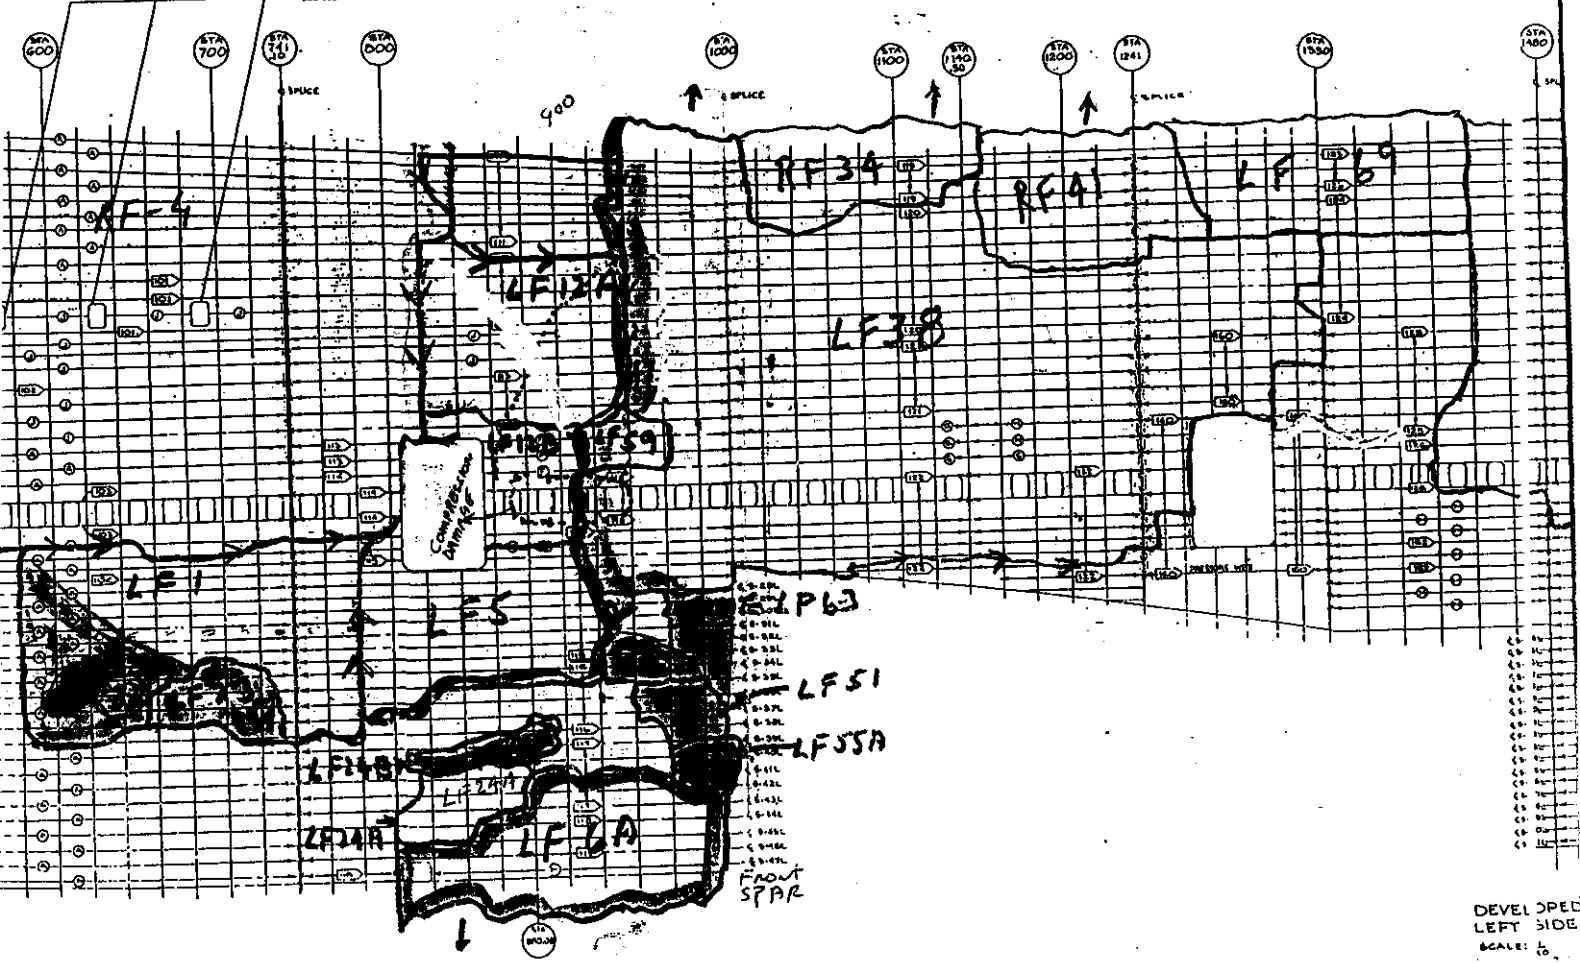
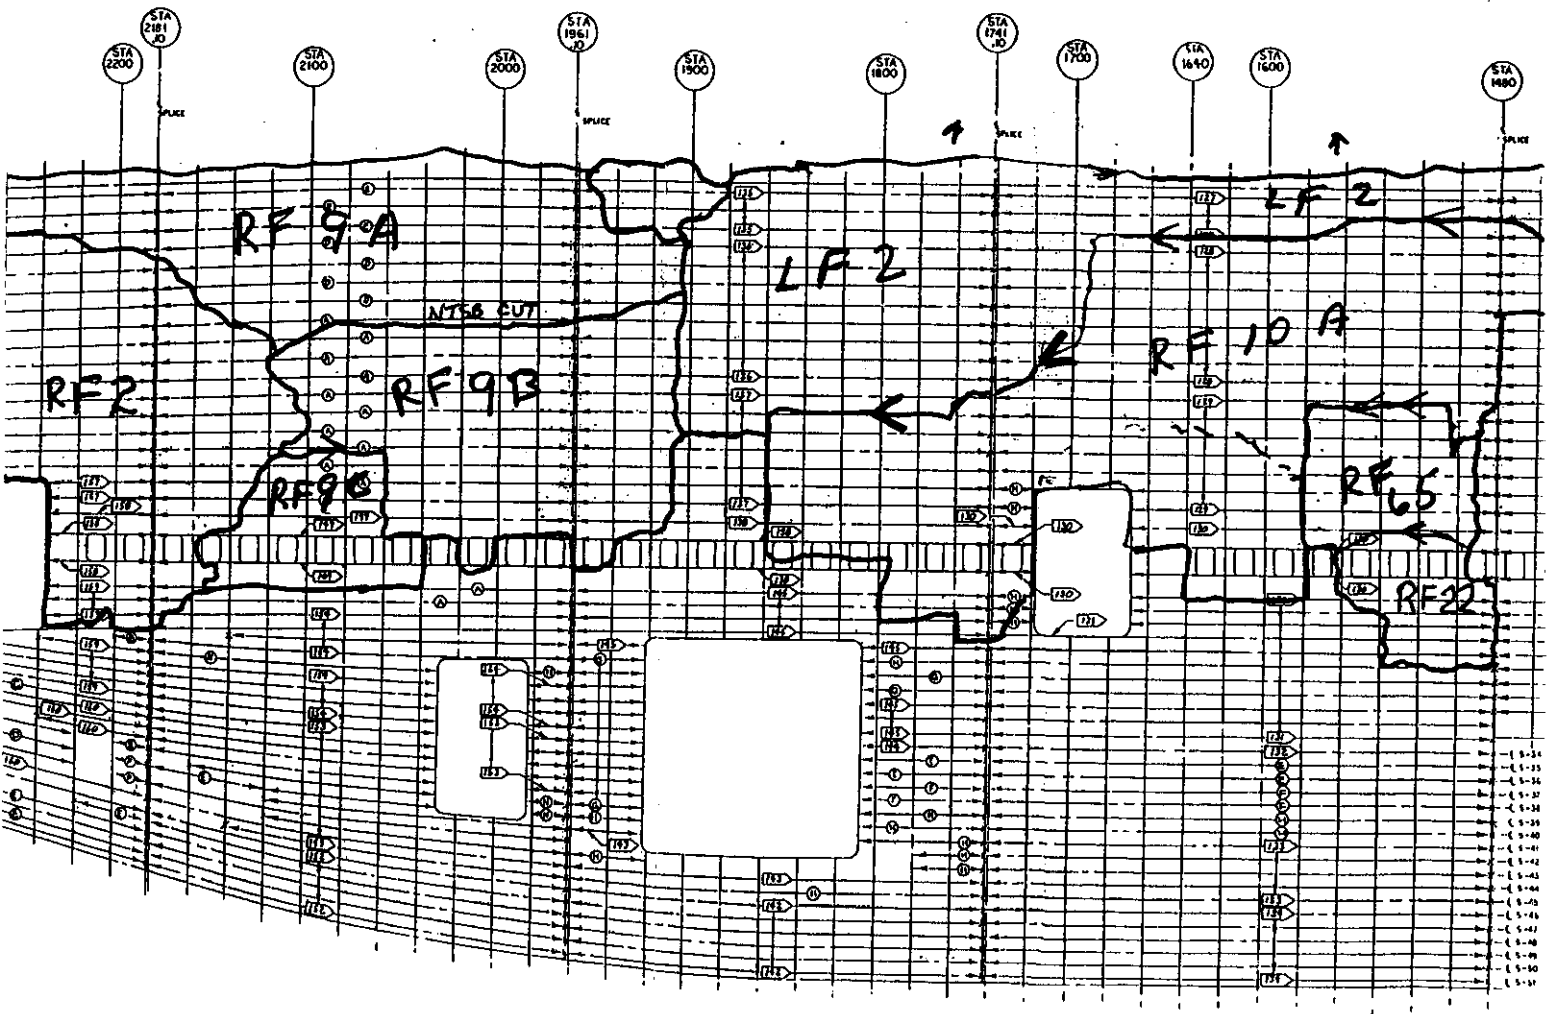
DRAWINGS
1, 2

Longitudinal fractures through rivet lines were examined for evidence of "net area tension" (direct circumferential tension, crack initiation equally from both sides of the rivet holes). The area with the most predominant features of net area tension was on the right side of the fuselage, between pieces RF95 (green zone) and LF6A (red zone), along stringer S40R, and at the aft end of the forward cargo bay (forward of FS 1000 to about FS 940). This area is indicated by the solid red line in the accompanying drawing. A second area with possible net area tension was found on the left side of the fuselage, at the lower end of piece LF5, along stringer S34L and between FS 820 and 900. It was noted that the skin in this area was separated along the lower rivet line of the lap joint, through the underlying skin piece, and that the lower end of the upper skin piece was deformed outward over much of this area. This area is indicated by a dashed red line in the accompanying drawing.

Crack directions in the skin were determined where ever possible, based on the rivet-to-rivet fracture pattern, separations in the shear ties, etc. The directions of skin cracking, where determined, are indicated by the red arrows in the accompanying drawing. (DRAWING 1, 2)

Many of the red zone pieces exhibited peeling deformation to the skin. The direction of peeling was determined to be as if the pieces were moving away from the fuselage, with the final point of separation being the end of the curl in the peeled area. This point generally had the greatest amount of deformation. The points at the ends of peels are indicated by red dots in the accompanying drawing. The extent of the peel area is indicated by the grouping of red lines associated with the red dots. On pieces where the peeling extended to an edge instead of a point, multiple red dots were used. Only two pieces (RF1 and LF5) that were located below the window belt level contained peels. These pieces were nearly symmetric in appearance and were peeled up and aft into the window belt.

Both window belts and skin above the belts contained compression buckling deformation from compression loads in the longitudinal direction. In the skin above the belts, the compression damage was generally more severe adjacent to the belts and extended upward almost to the top of the fuselage. On the right side, the compression in the window belt extended from the aft side of the R2 passenger door (FS860) to FS960. The skin compression damage on the right side extended upward from this portion of the window belt approximately to the top of piece RF35 (stringer S6R). On the left side, the compression damage in the window belt extended from the aft side of door L2.

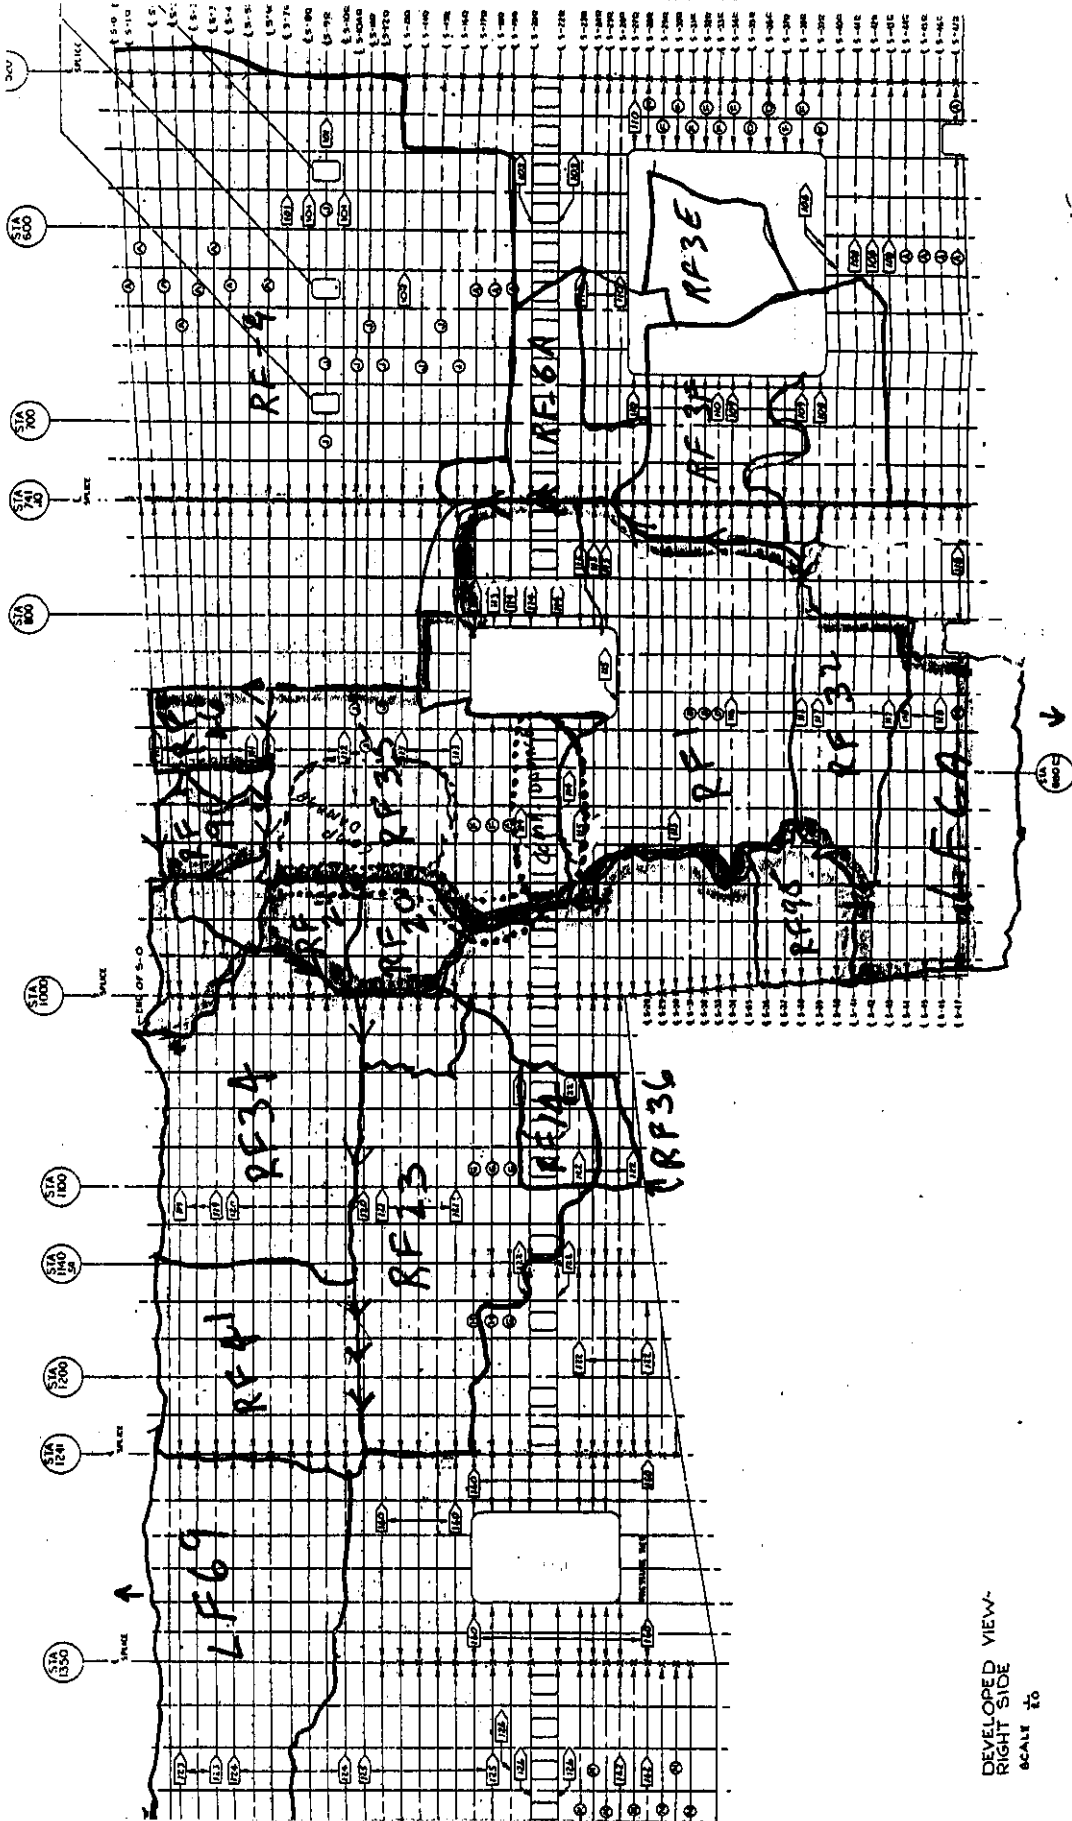
DEVELOPED VIEW-
RIGHT SIDE
SCALE 1/2"

Because of the complex fracture pattern on the red zone pieces on the lower right side of the fuselage, the fracture locations in this area were plotted on a slightly larger scale (see attached drawing). (DRAWING 3)

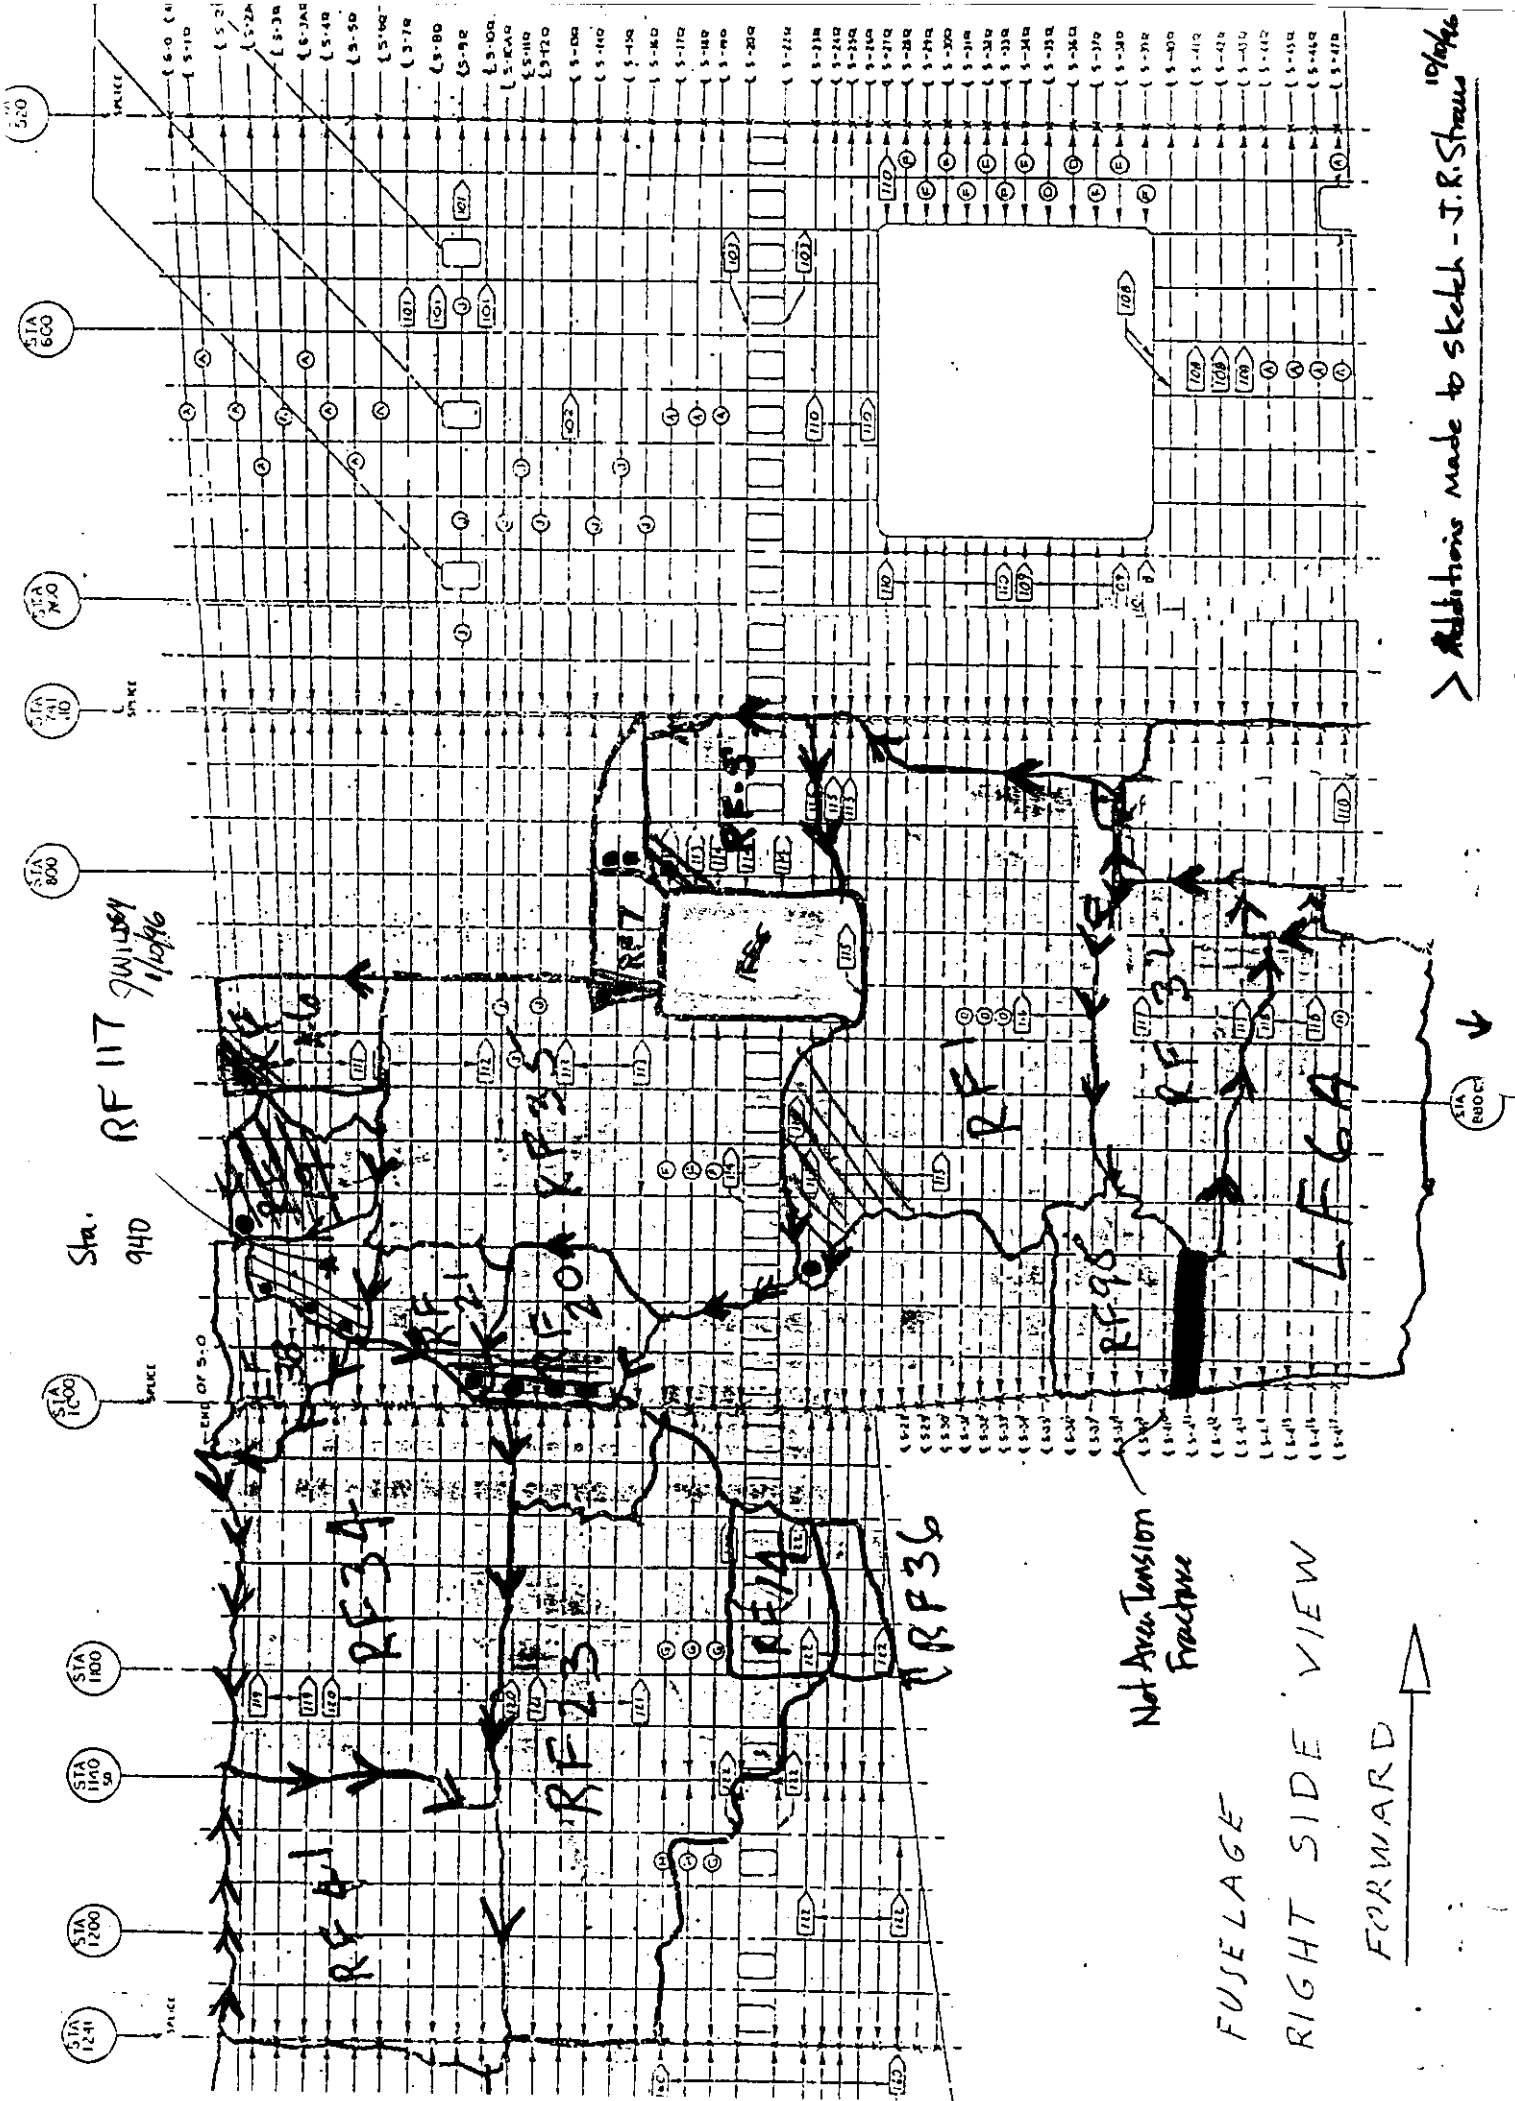
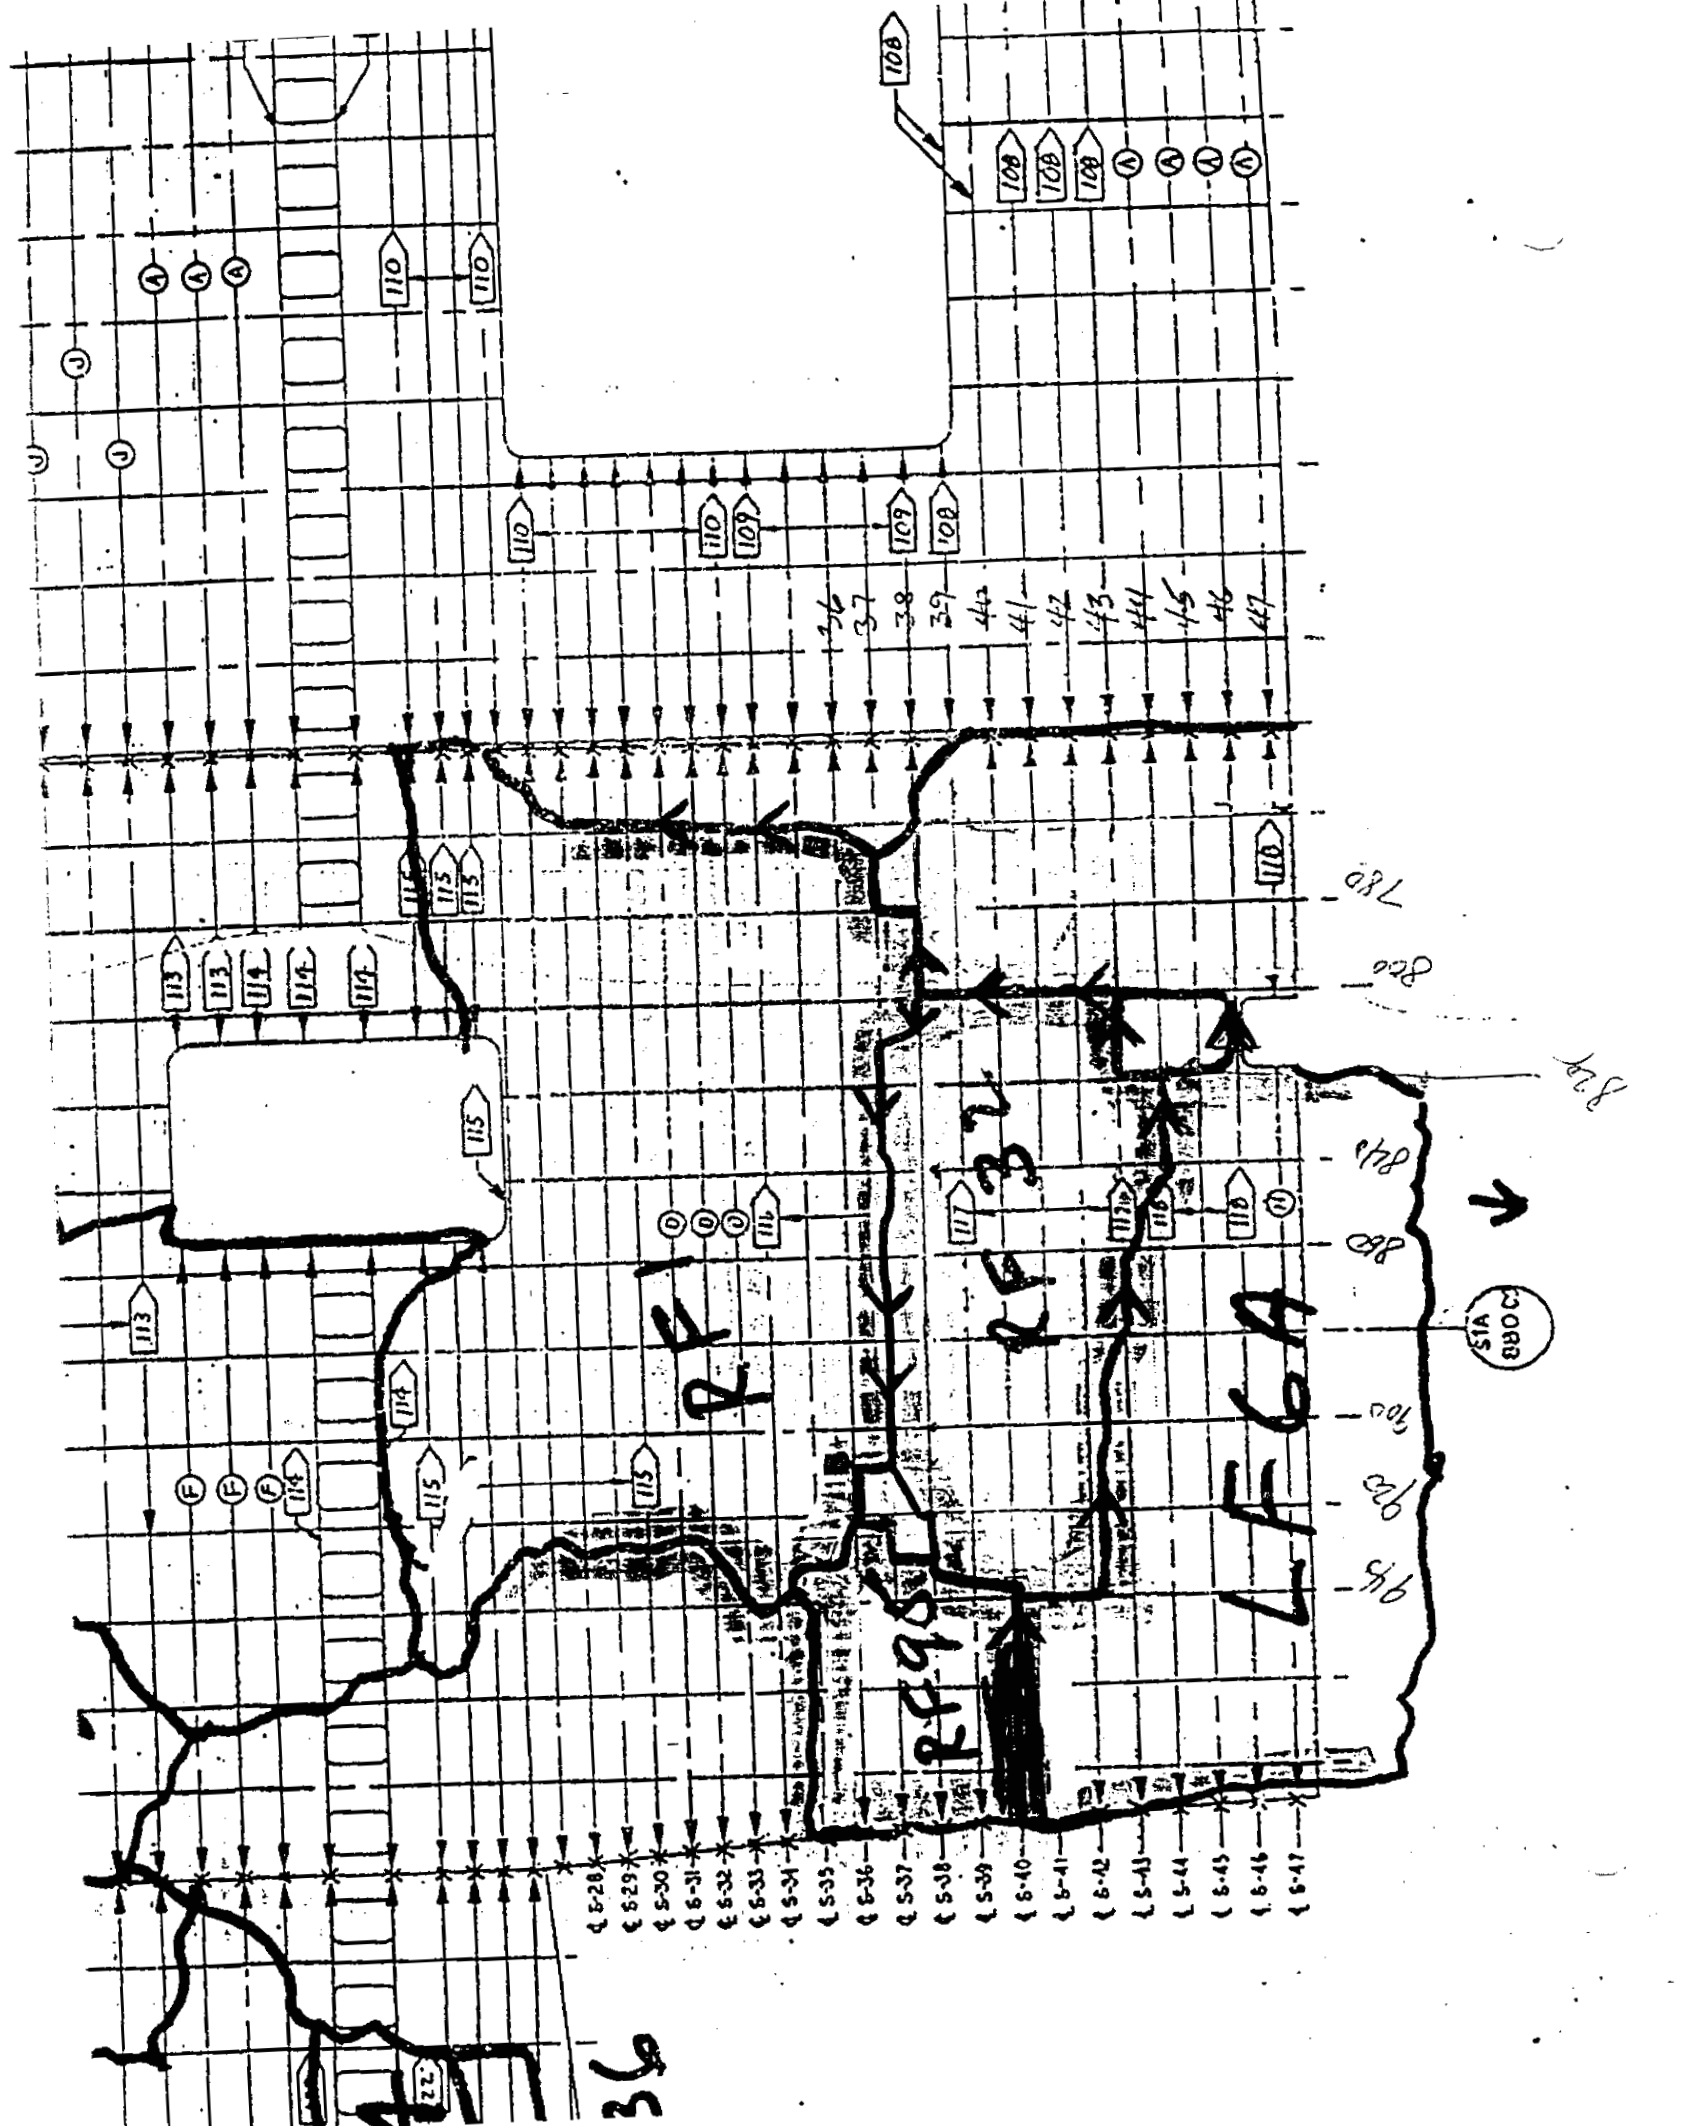
DR 4-5

Major longitudinal fractures in the green zone pieces (aft of the red zone pieces) were also examined for evidence of net area tension, and no such areas were found. All examined fractures that progressed along rivet lines were running fractures, mostly in the aft direction. (DRAWING 4 and 5)

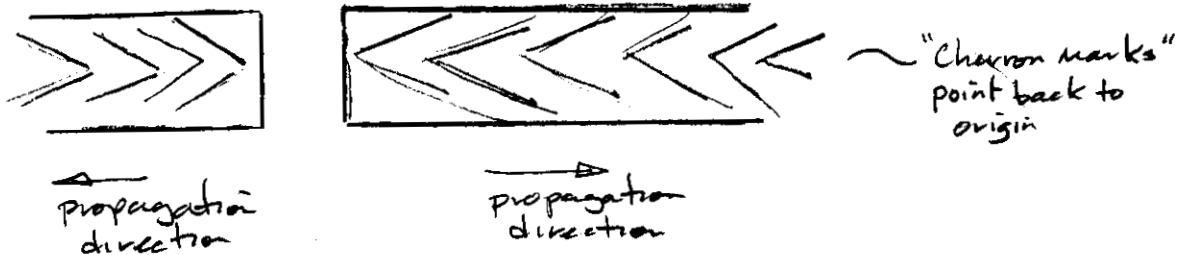
- Thick structure - evidence of chevron marks indicating direction

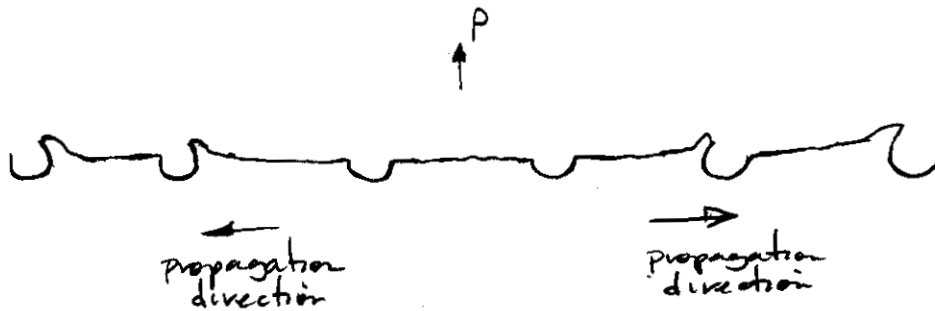
- Thin structure - hole to hole fracture profile. Viewing the fracture profile of a crack running through a series of fastener holes.

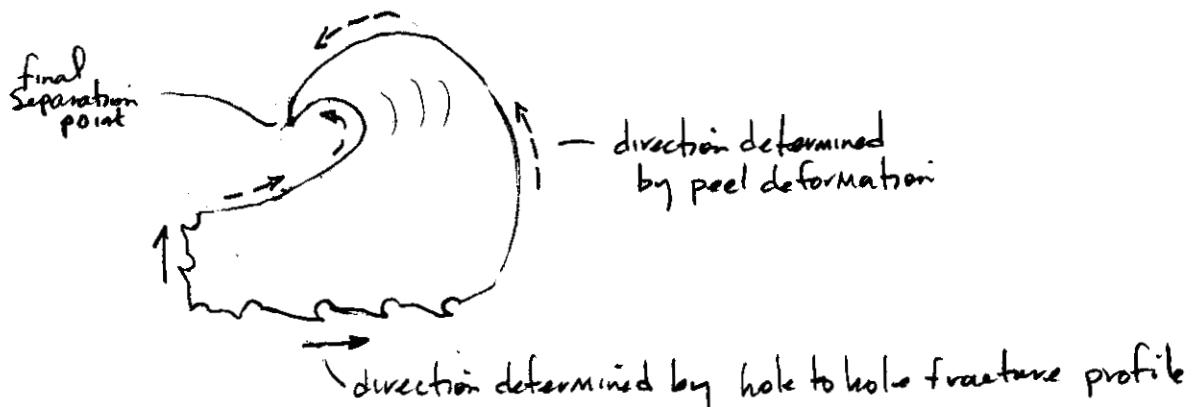
- Peeling deformation - final separation point being the end of the curl in the peeled area. (Most common in thin structure),

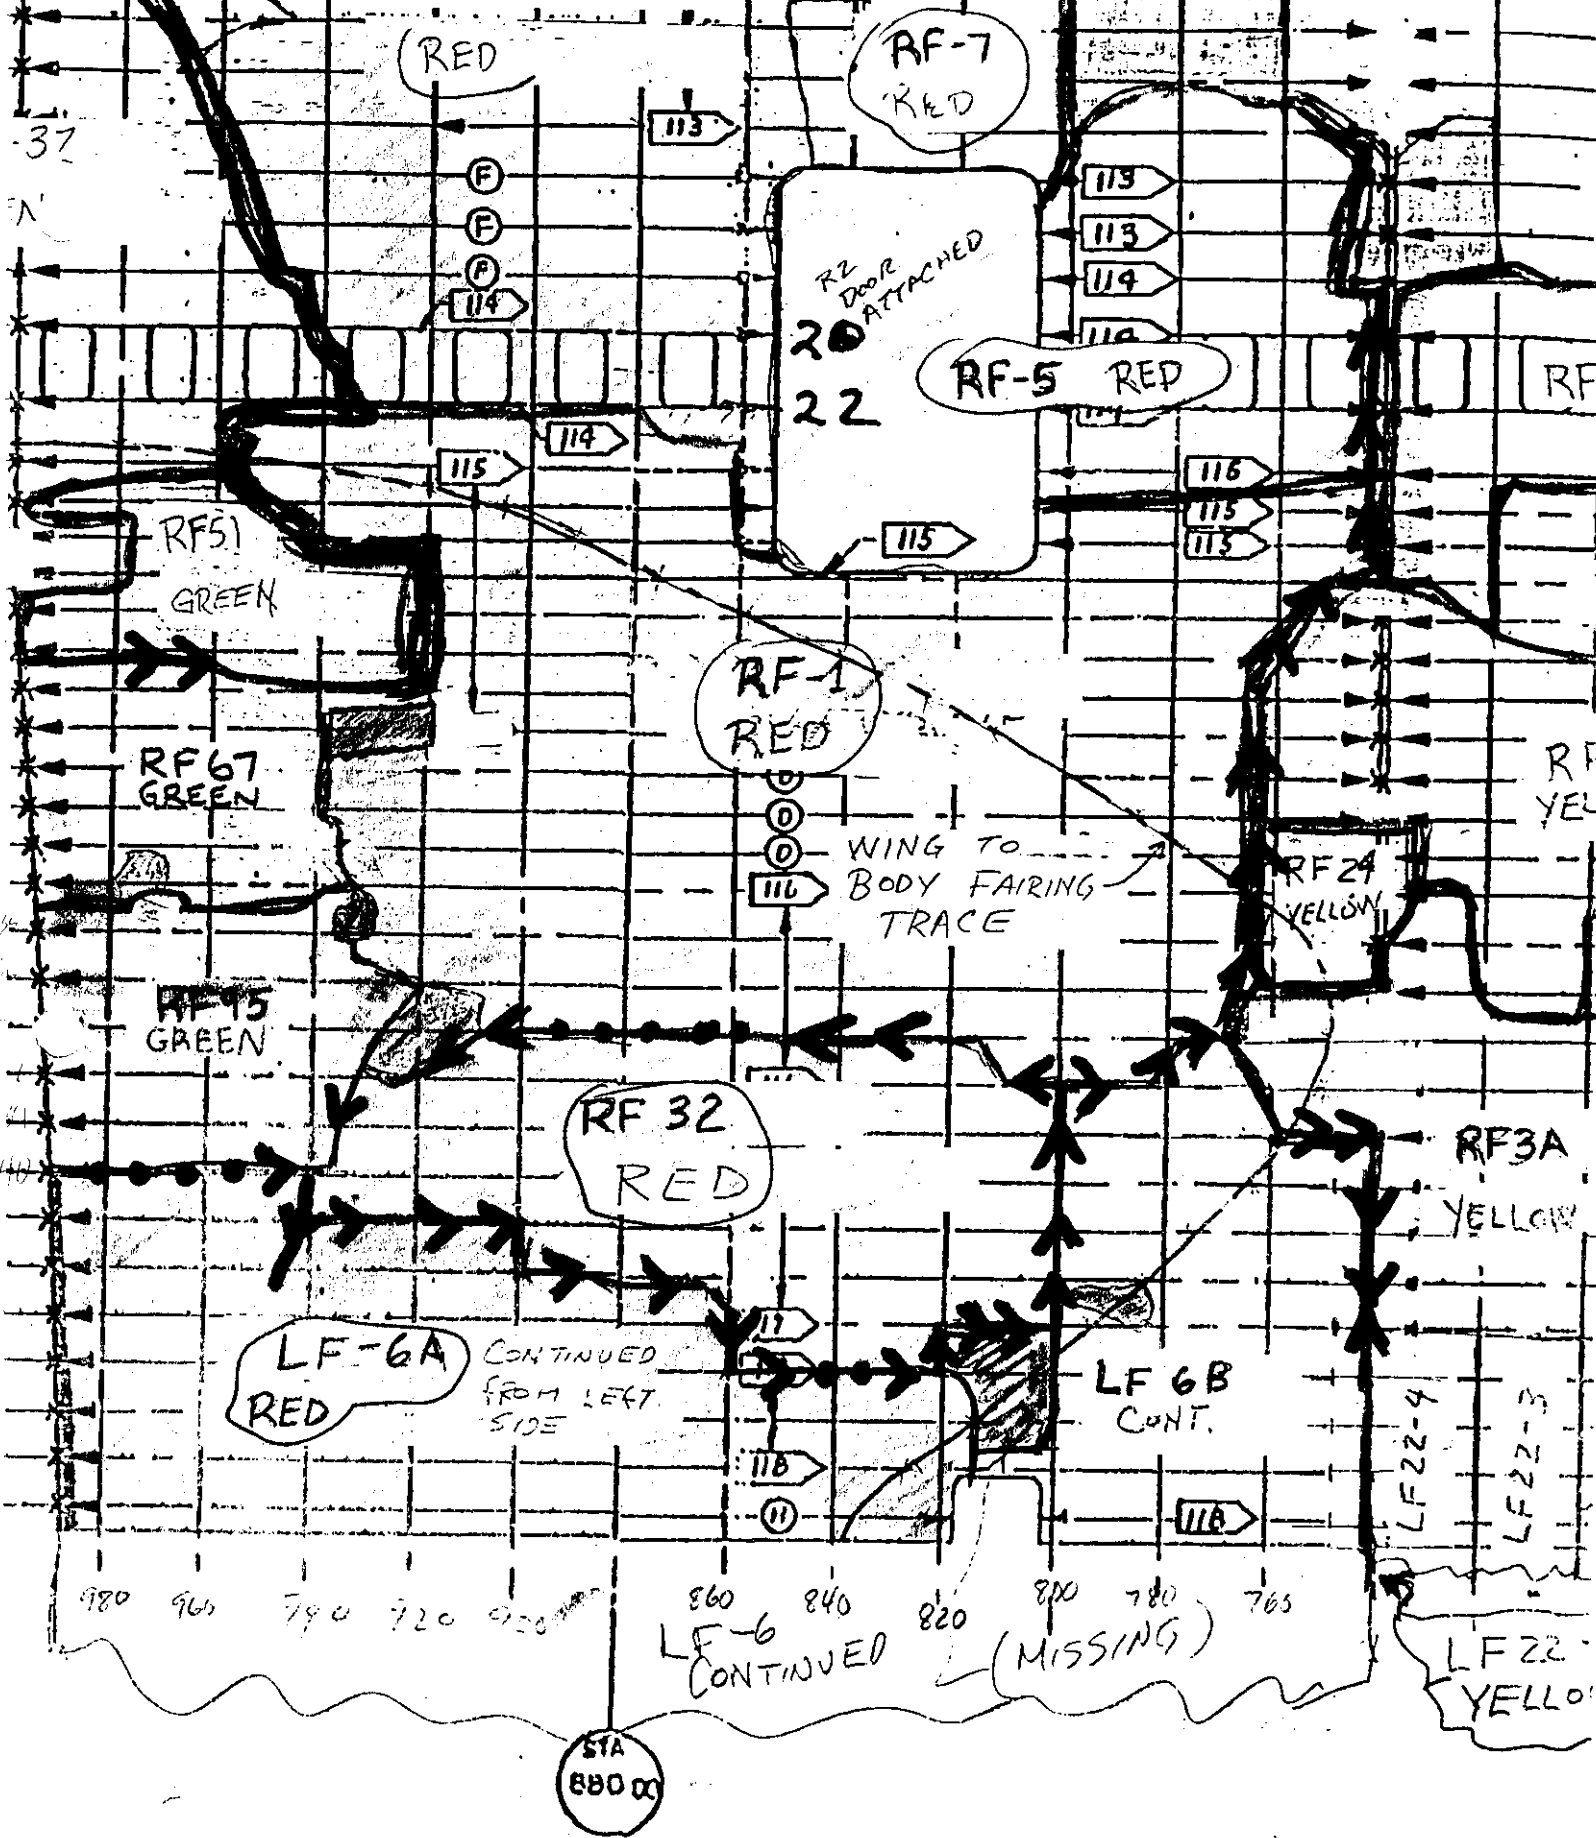
Fracture Direction Documentation - Red Zone (Supplement)

Two additional areas of net area tension through the longitudinal fastener line were observed along S-37R from Station 850-900 and along S-44R from Station 830-840. Unlike the previously documented areas containing net area tension, the fracture directions leading to and departing from these newly identified areas of net area tension were the same.

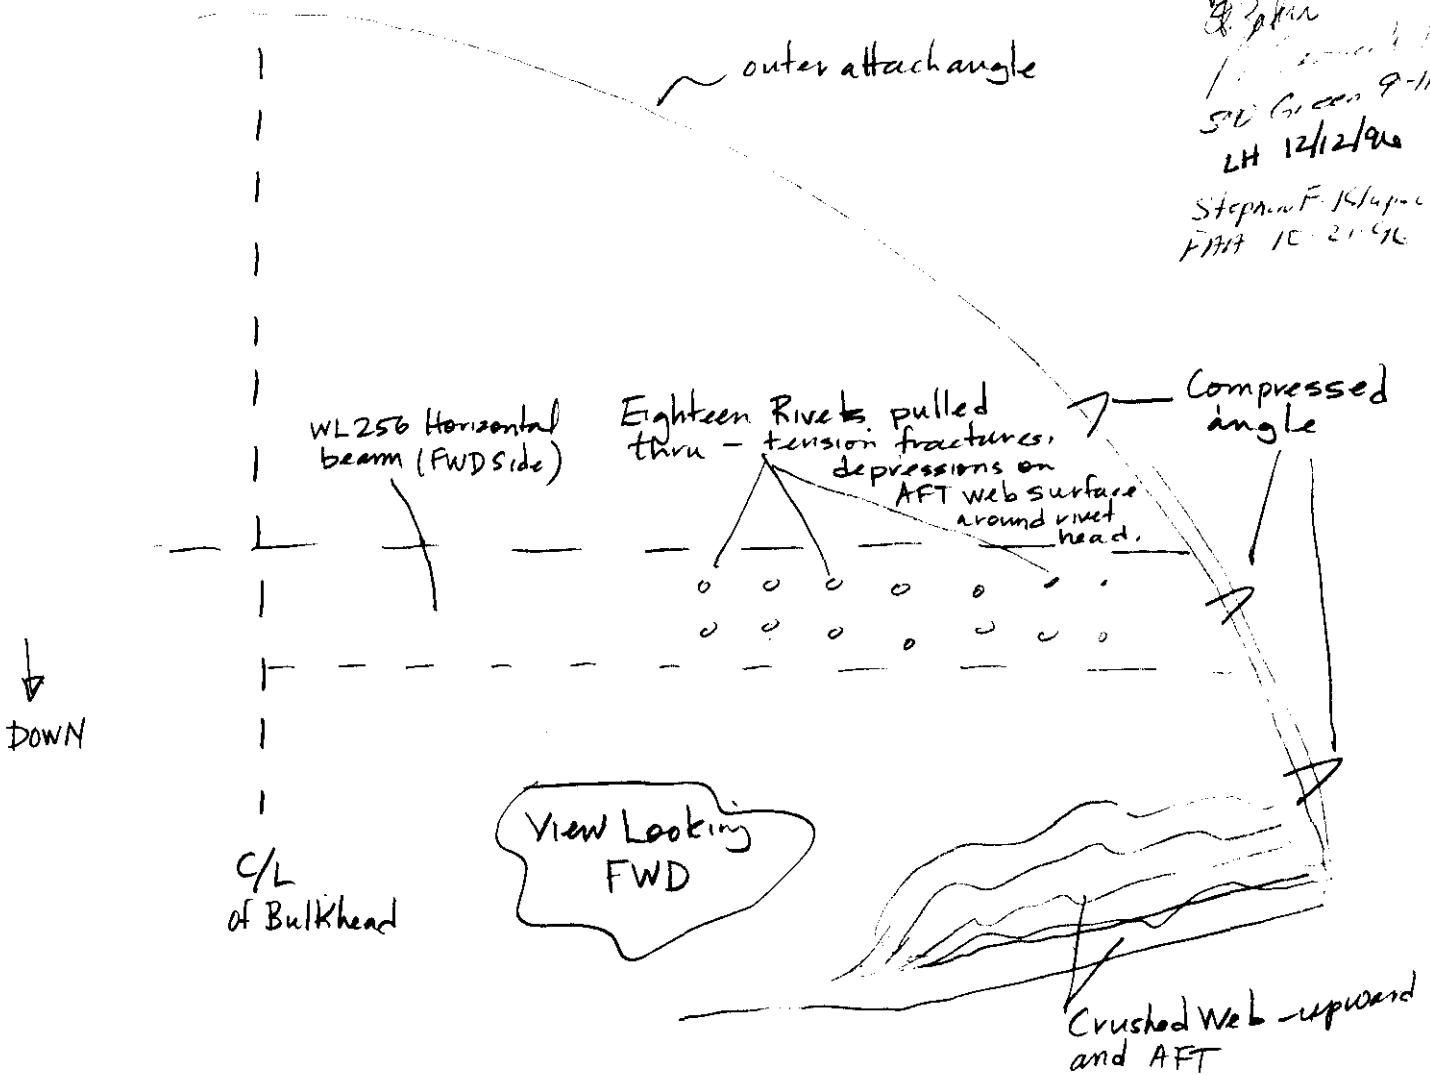
UI - R PORTION of
STA 140 BLK4D

The upper ^{left to center} portion of the web is bent AFT and the bottom right portion is crushed upwards and AFT. Eighteen rivets on the far right side common to the upper horizontal beam (WL 256) (above the crushed bottom right portion of the web) were pulled in tension and a dimple depression is seen on the AFT surface of the web. The web in this area is pushed FWD due to the crushing damage in the web below. The circumferential outer attach angle above the noted rivets shows signs of compression damage. The bulkhead web exhibits no obvious signs of overpressurization. Examination of fracture surfaces revealed ductile separation fractures with no evidence of any slow growth mechanisms. Many of the fastener holes in outer right side web are sheared out or elongated in the OUTBD direction.

WEB FOLDED AFT

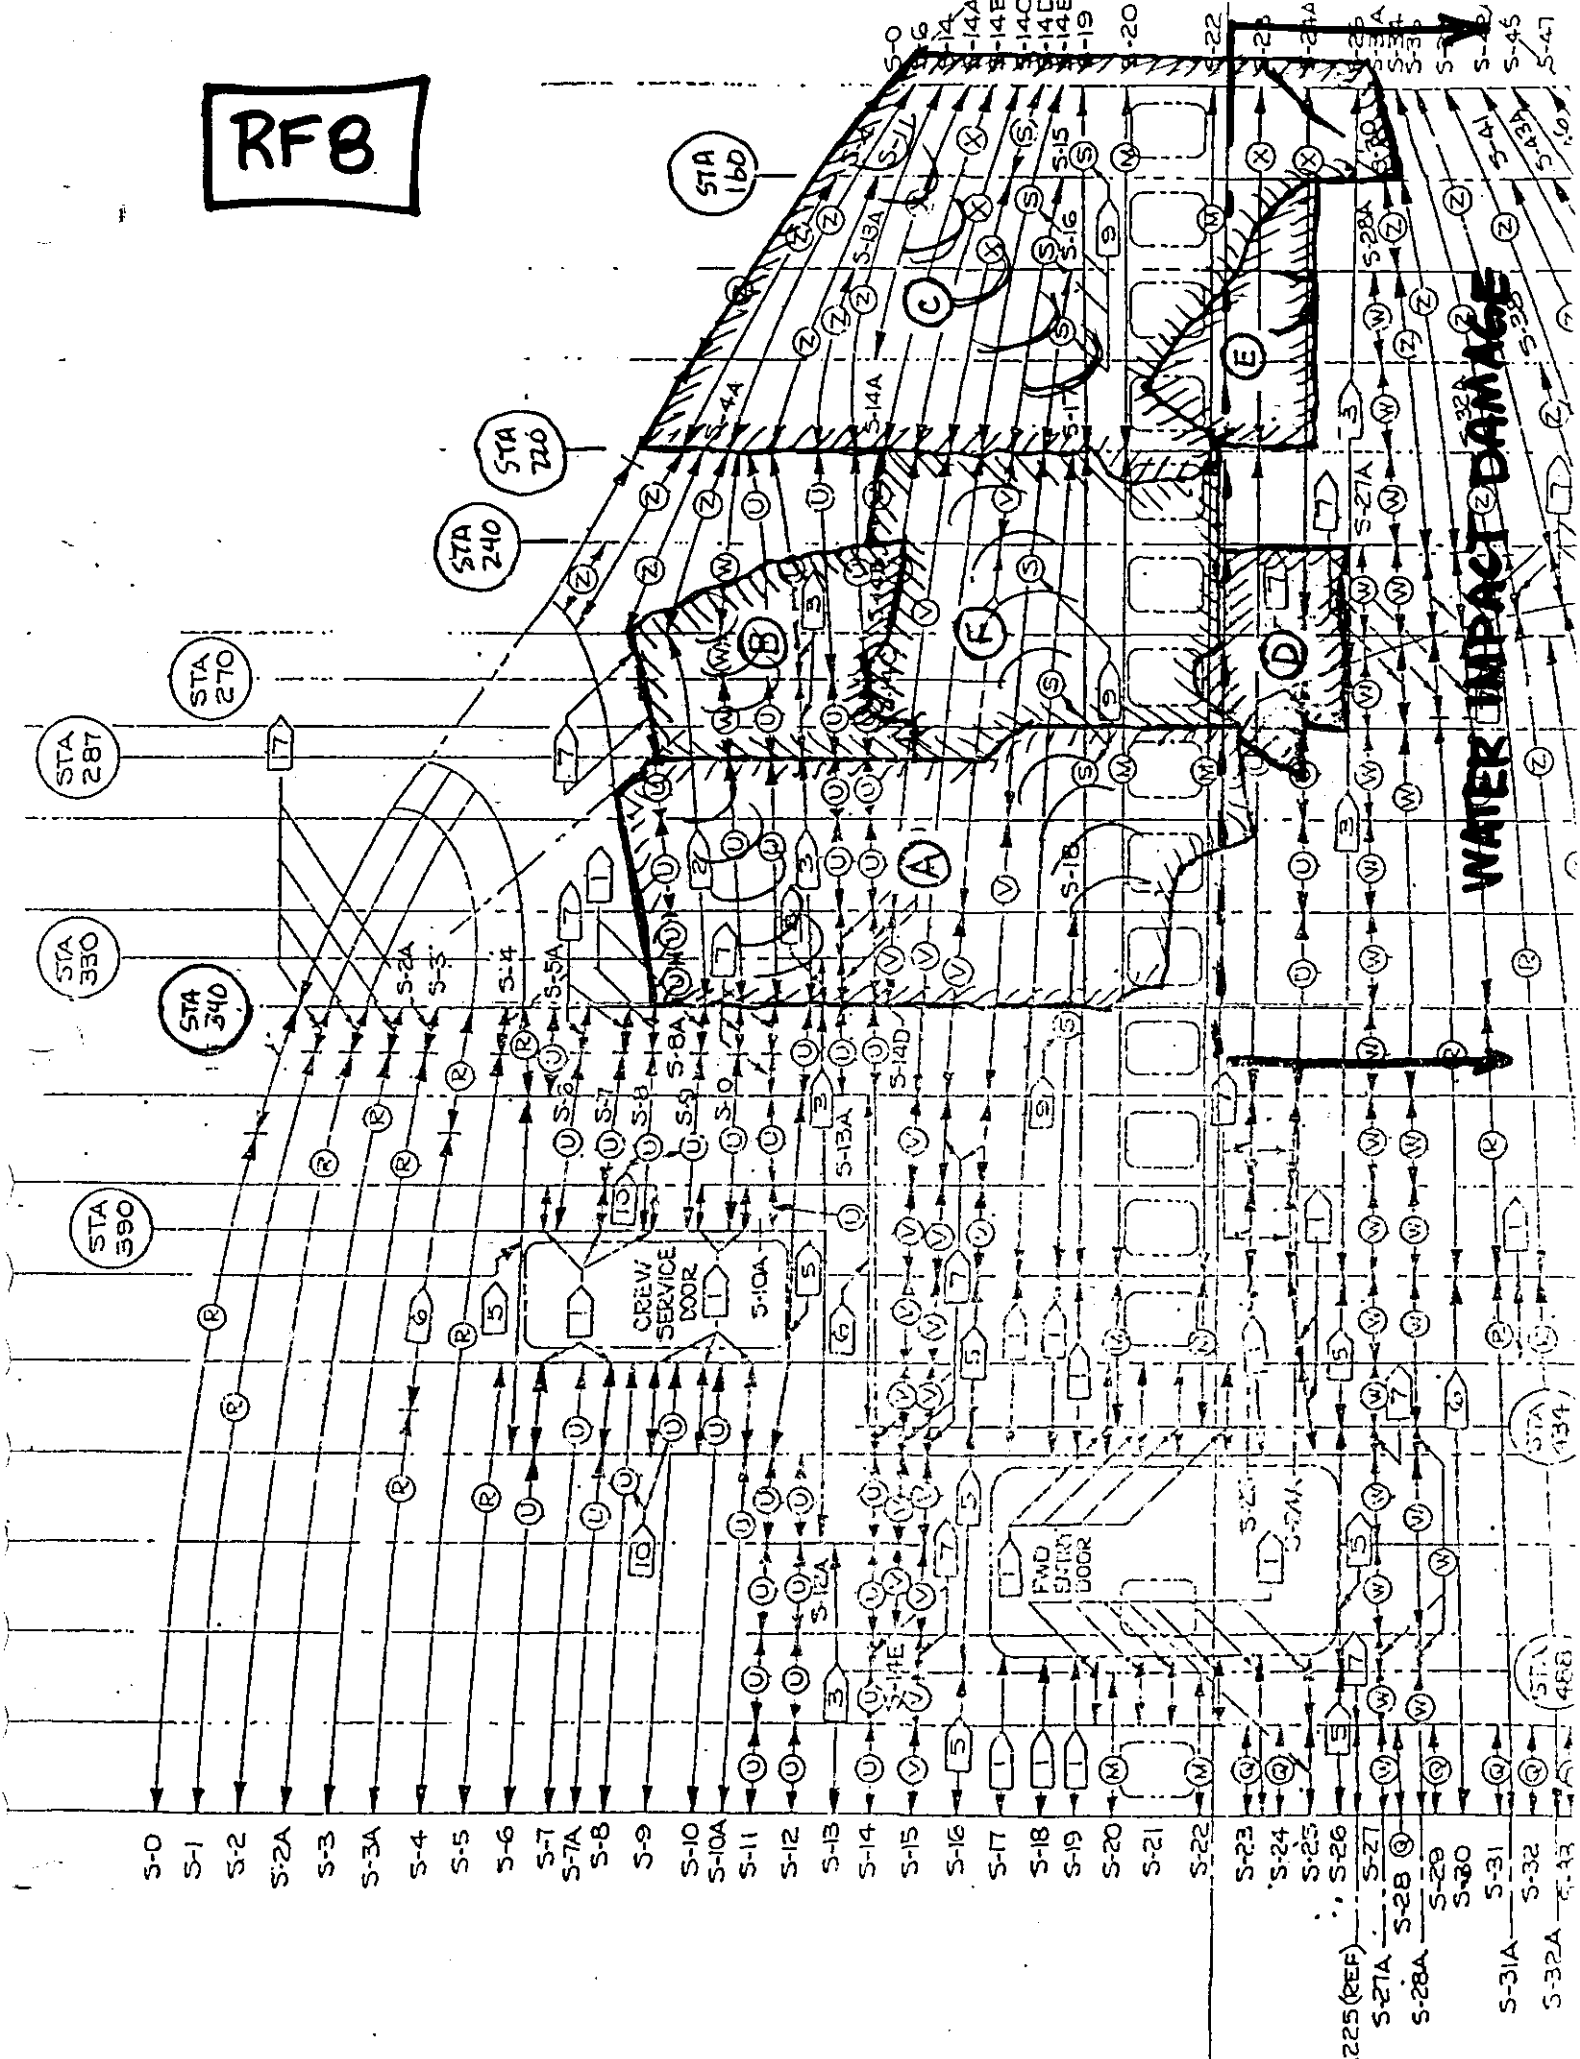
RF8

• All sections below the window line exhibit evidence of water impact damage based on the following observations:

- Flattened stringers, frames, or shear ties
- Inward distorted skin
- Heavy twisting in skin panel
- Exterior paint badly damaged from skin yielding and impact

WATER IMPACT DAMAGE
