FUSELAGE

Red Zone Fuselage Pieces: Fracture Directions / Deformations

Internal Overpressure Indication and Fracture Direction Survey

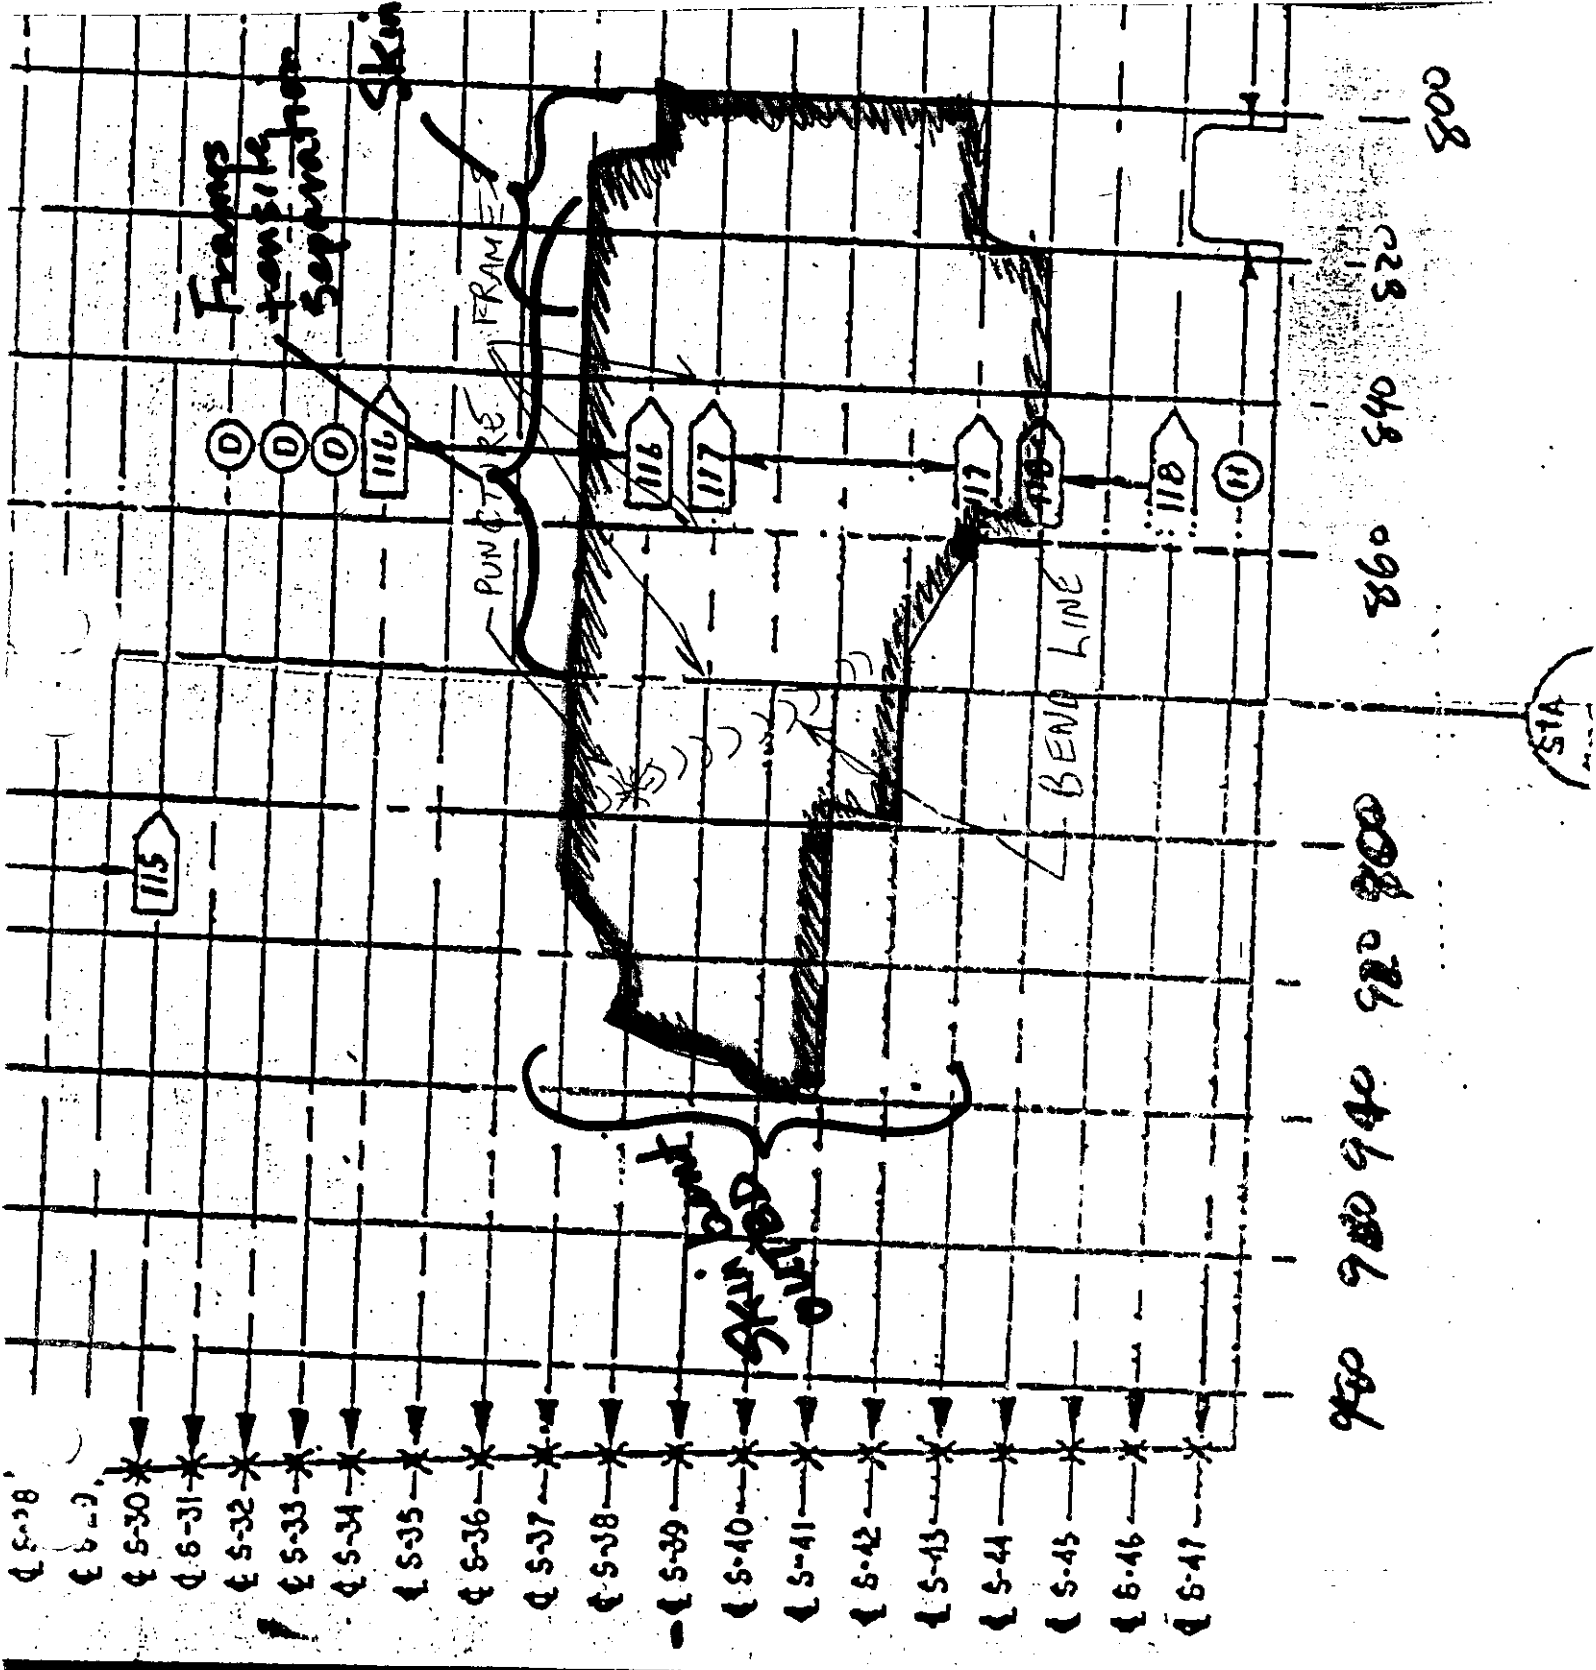
RF1 - RH Fuselage Sta. 760-960, S-22R to S-37R

Skin bent
OUTBD

- Stringer fractures AFT of Sta. 900 exhibit evidence of outward bending.
- Stringers FWD of Sta. 780 exhibited evidence of tensile fractures.
- The lower fractures of frames ^{Sta.} 820-900 exhibit evidence of tensile separation with slight bending on the lower flange.
- Bottom skin from Sta. 760-860 is bent OUTBD. Mating stringers 34, 35, 36 are bent OUTBD. (at FWD end)
- No evidence of water impact damage noted.

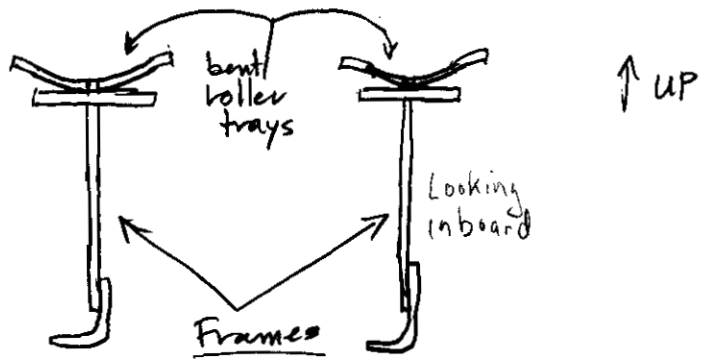
Roller trays at \approx BL30 fractured due to compression as displayed by the remaining sections of roller tray attached to adjacent frames bent upward (see figure below).

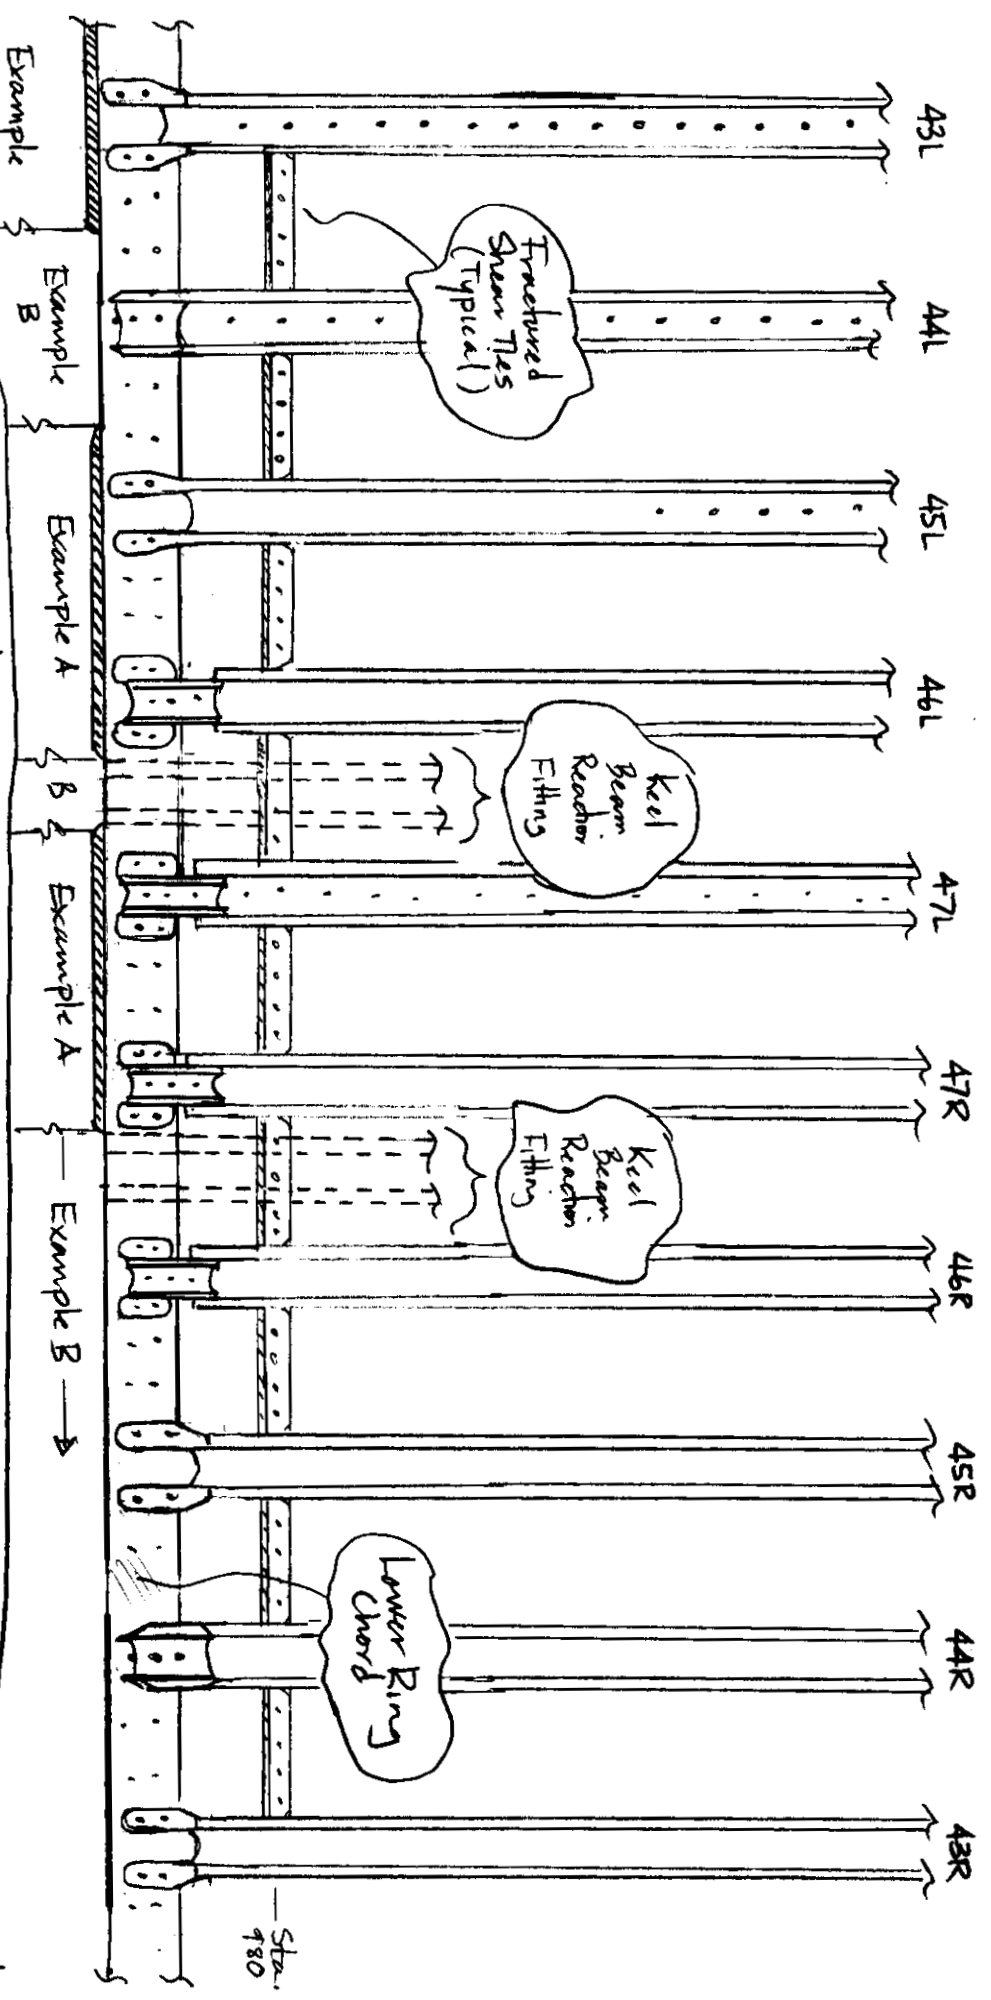
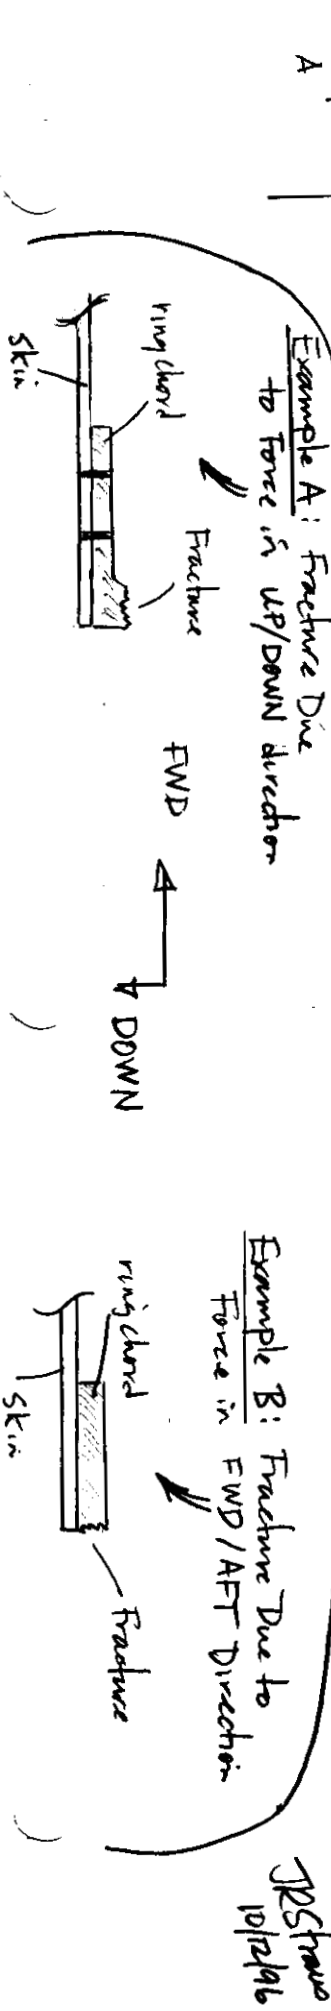
Looking Down on LE6A showing fracture Orientation of Ring Chord

Lower wing chord at Sta. 1000 exhibited predominately tensile separation in the UP/DOWN direction left of stringer 444 and in the FWD/AFT direction for the remainder of the panel.

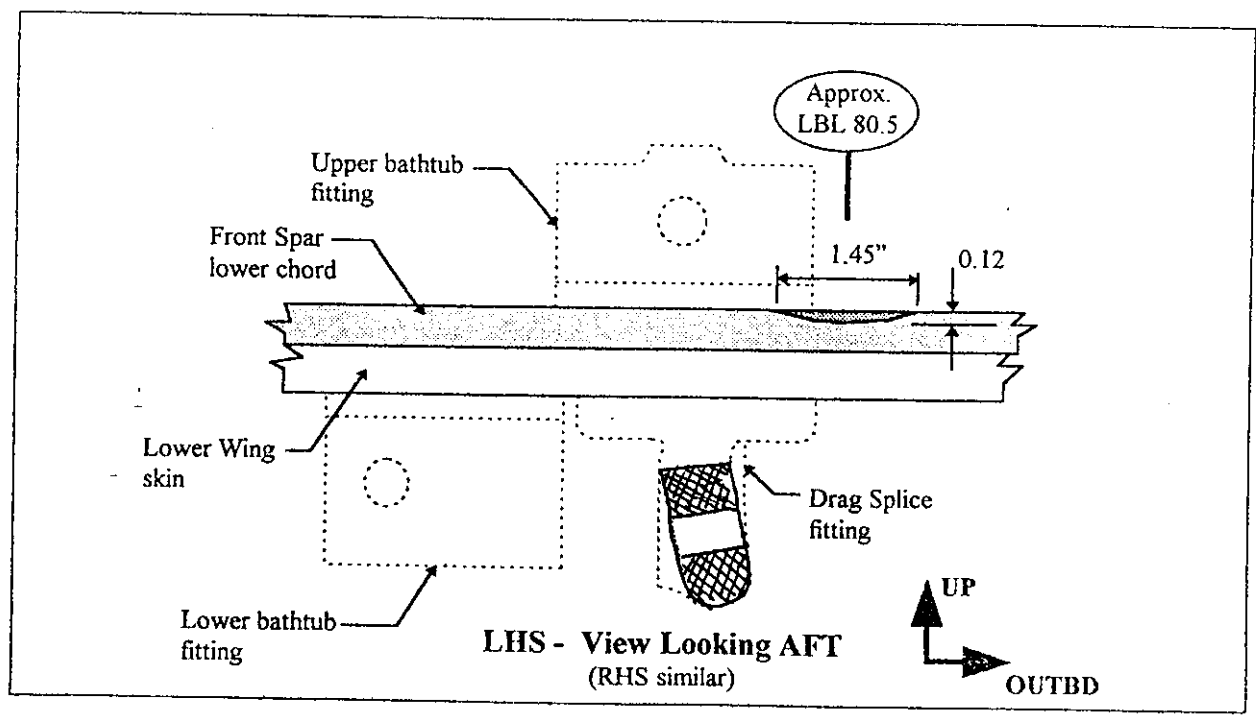
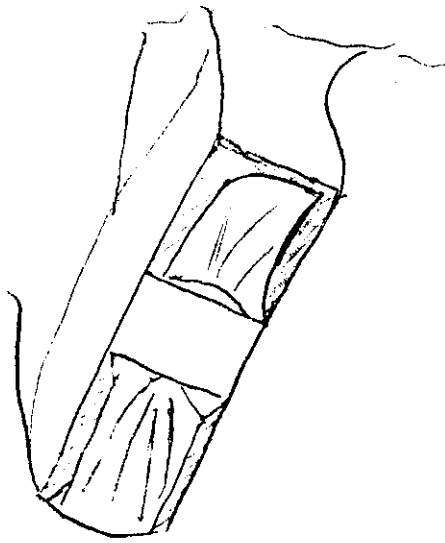
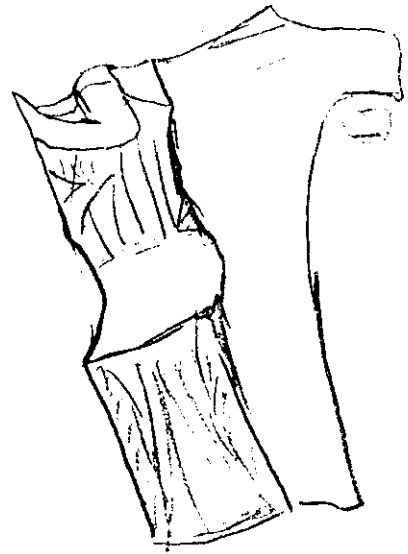
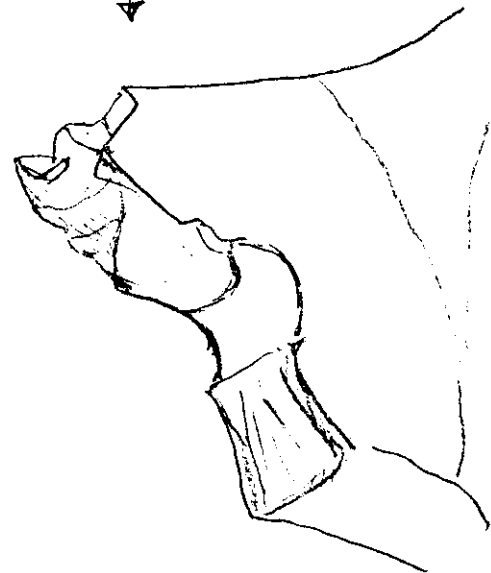
DRAG SPLICE FITTING FRACTURE FACES
(SEE ALSO RF95 AND LFS1)

THE DRAG SPLICE BETWEEN THE FUSELAGE AND THE LOWER SKIN OF THE CUT WAS BROKEN AT THE FIRST ATTACHMENT BOLT IN THE FUSELAGE FITTING ON BOTH SIDES OF THE AIRPLANE. ON BOTH SPLICES, THE FRACTURE INITIATED FROM THE UPPER AND LOWER EDGES OF THE BOLT HOLE. OVERSTRESS FRACTURE WAS TYPICAL OF TENSION ~~AND~~ PERHAPS WITH SOME BENDING. DRAG SPLICE IS CROSS HATCHED IN DRAWING BELOW (BORROWED FROM FATIGUE SECTION OF METALLURGY BOOK).

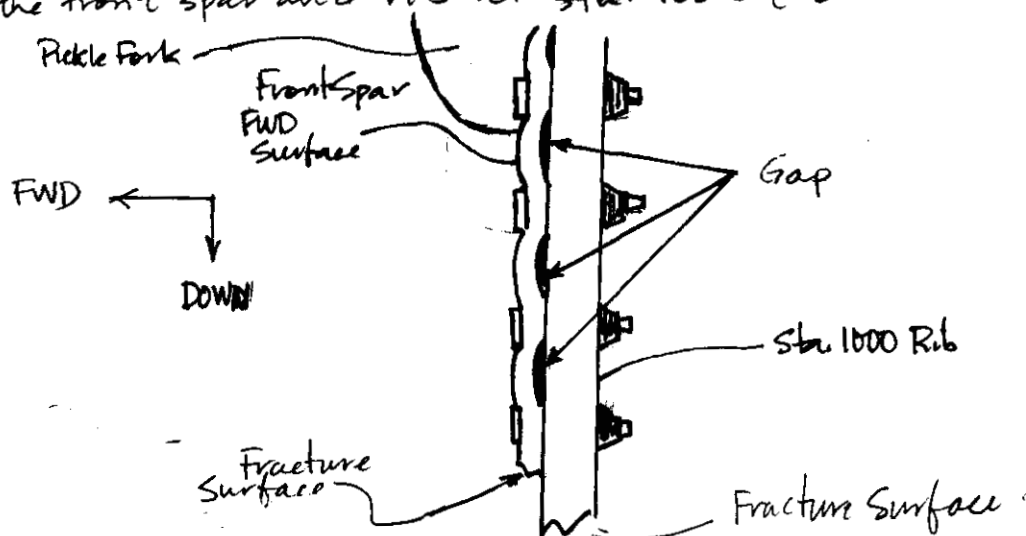
- A gap in the FWD direction between fasteners exists on the front spar and rib at Sta. 1000 (See sketch)

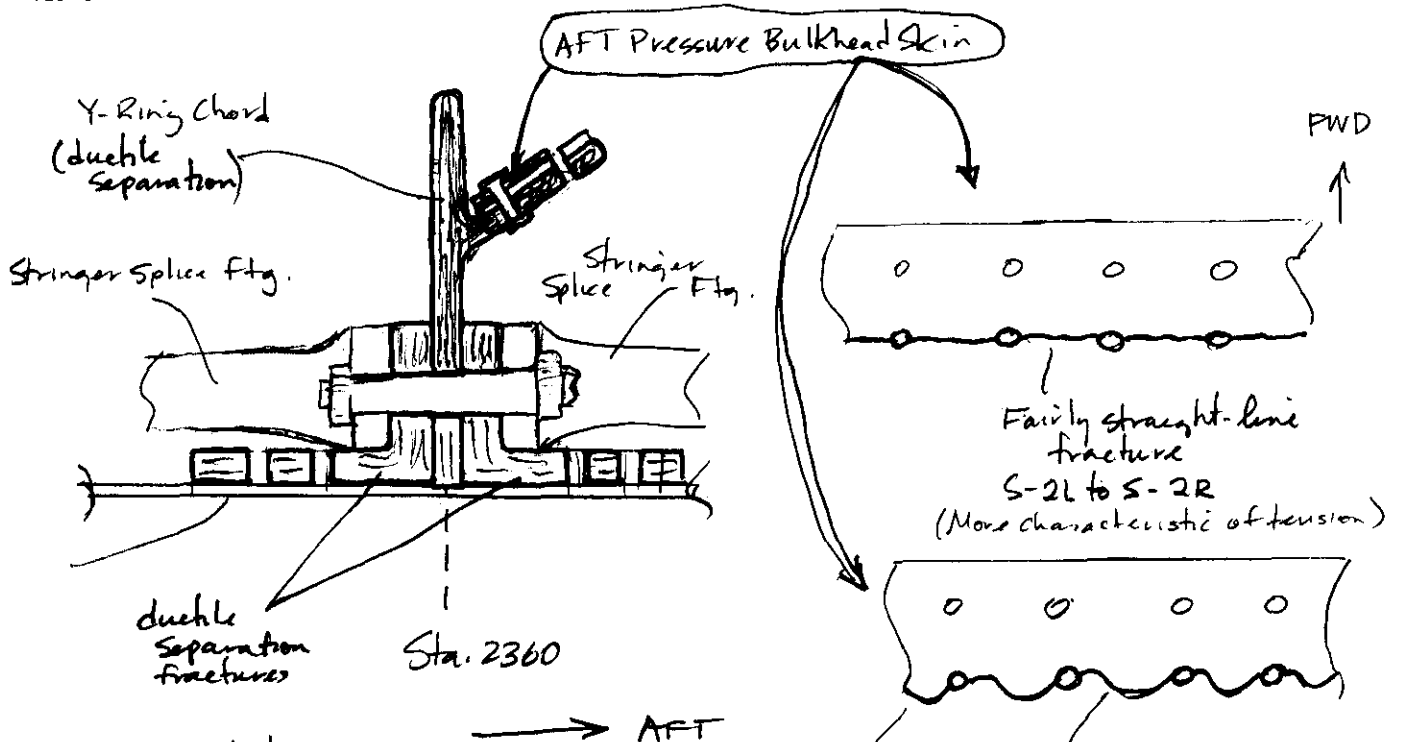
LF26 - LH Aft Body Skin, Sta. 2285 to 2360, S-8L to S-24L

- o All stringers on the FWD end of the panel fractured in tension based on the following observations:
 - fairly straight transverse fractures
 - elongated fastener holes in the FWD/AFT direction in the skin
 - No evidence of bending
- o The Y-ring chord at Sta. 2360 is compressed below S-12L and at least below S-12R (missing section from S-12R to S-7R). The Y-Chord fractured by ductile separation, S-4L, between S 4R; S 3R; S-9L & S-12L. ^{in 4 places} at
- o AFT Pressure bulkhead skin is fractured along the AFT-most rivet line at Sta. 2360. See below for description of fracture line.
