**NATIONAL TRANSPORTATION SAFETY BOARD  
OFFICE OF AVIATION SAFETY  
WASHINGTON, D.C.**

**STRUCTURES GROUP CHAIRMAN'S FACTUAL  
REPORT OF INVESTIGATION**

**A. ACCIDENT : DCA97MA055**

LOCATION : Newark International Airport, Newark, NJ  
DATE : July 31, 1997  
TIME : 0131 Eastern Daylight Time (EDT)  
AIRCRAFT : McDonnell Douglas MD-11, N611FE  
Operated by Federal Express Corporation

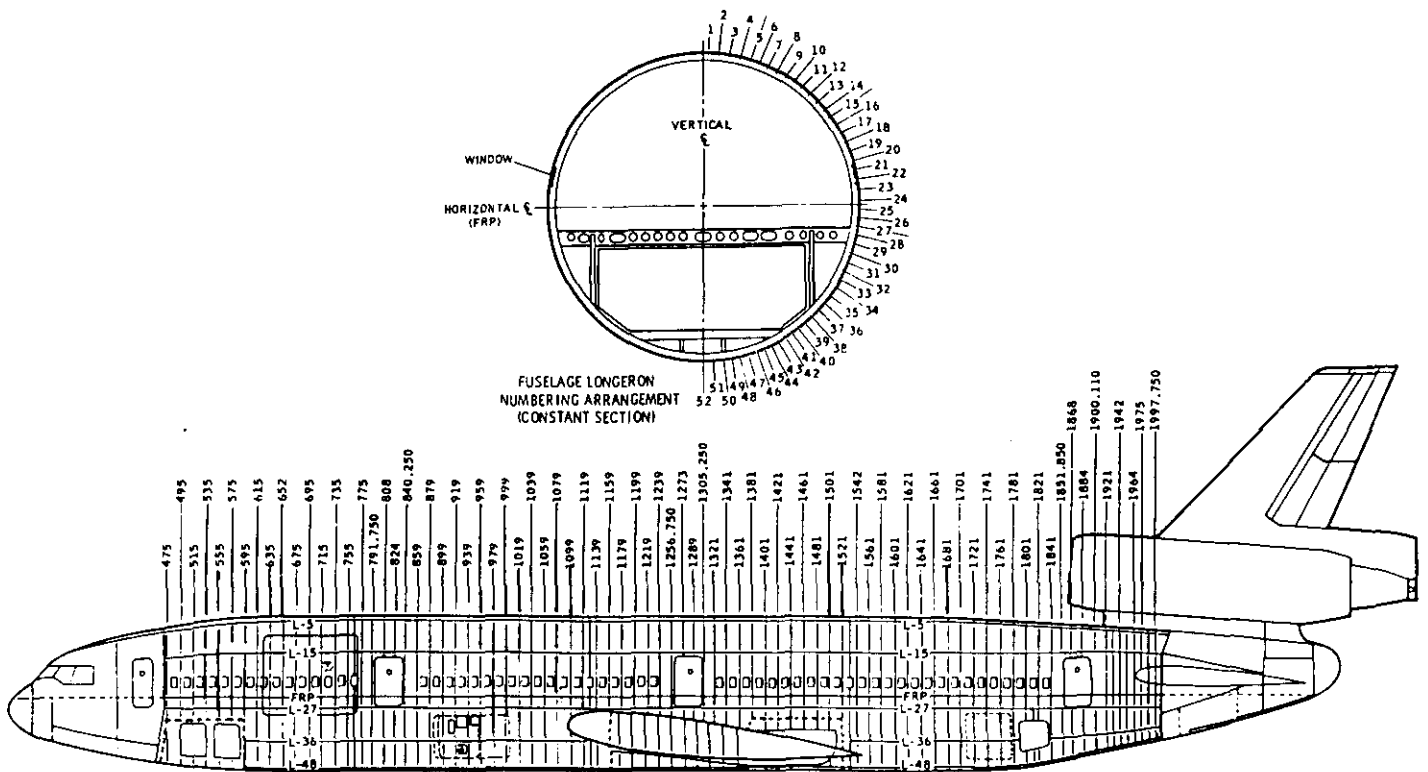
**Figure 1**  
**MD-11 Fuselage Station and Longeron Locations**

The R1 door was found open approximately 2 feet. The upper portion of the door, where the door track is installed was resting against the ground. The right side of the fuselage had extensive fire and soot damage with the outer fuselage skin peeled outward towards the crown of the fuselage between the R1 and R2 doors (See Figure 1, below, for MD-11 Fuselage Station and Longeron Locations diagram).

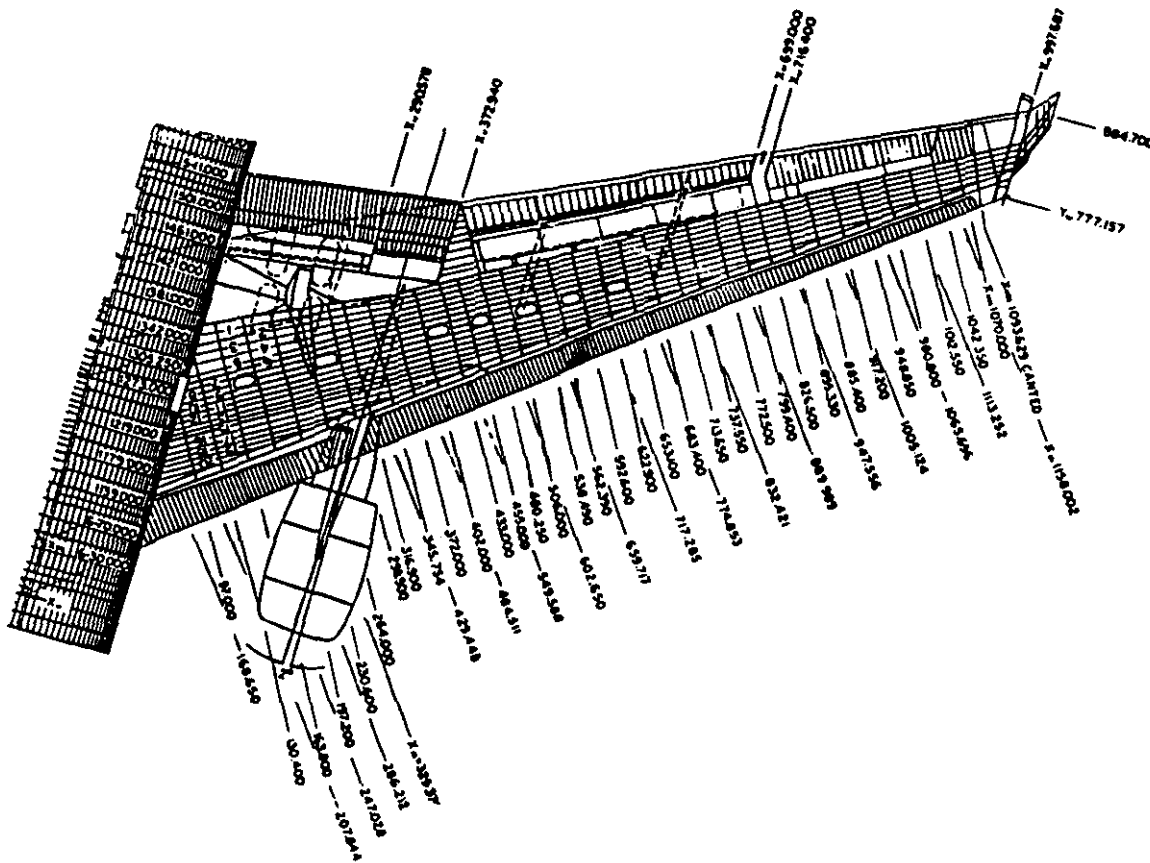
**Figure 2**  
**MD-11 Wing Station Locations**

The right wing separated from the fuselage just inboard of the inboard fuel closure bulkhead at wing station (WS) 264. The upper surface was intact and sooted. (See Figure 2, below, for MD-11 Wing Station Location Diagram.) The skin was buckled approximately 12 feet inboard from the outboard end on the top of its aft skin panel. The aft pylon mount was intact at the wing and the forward pylon mount was partially attached. The lower winglet separated from the wing tip at its attach interface. The upper right winglet remained attached and had heavy sooting and some burn damage to the composite skin. Strands of composite material were found hanging from the upper winglet.

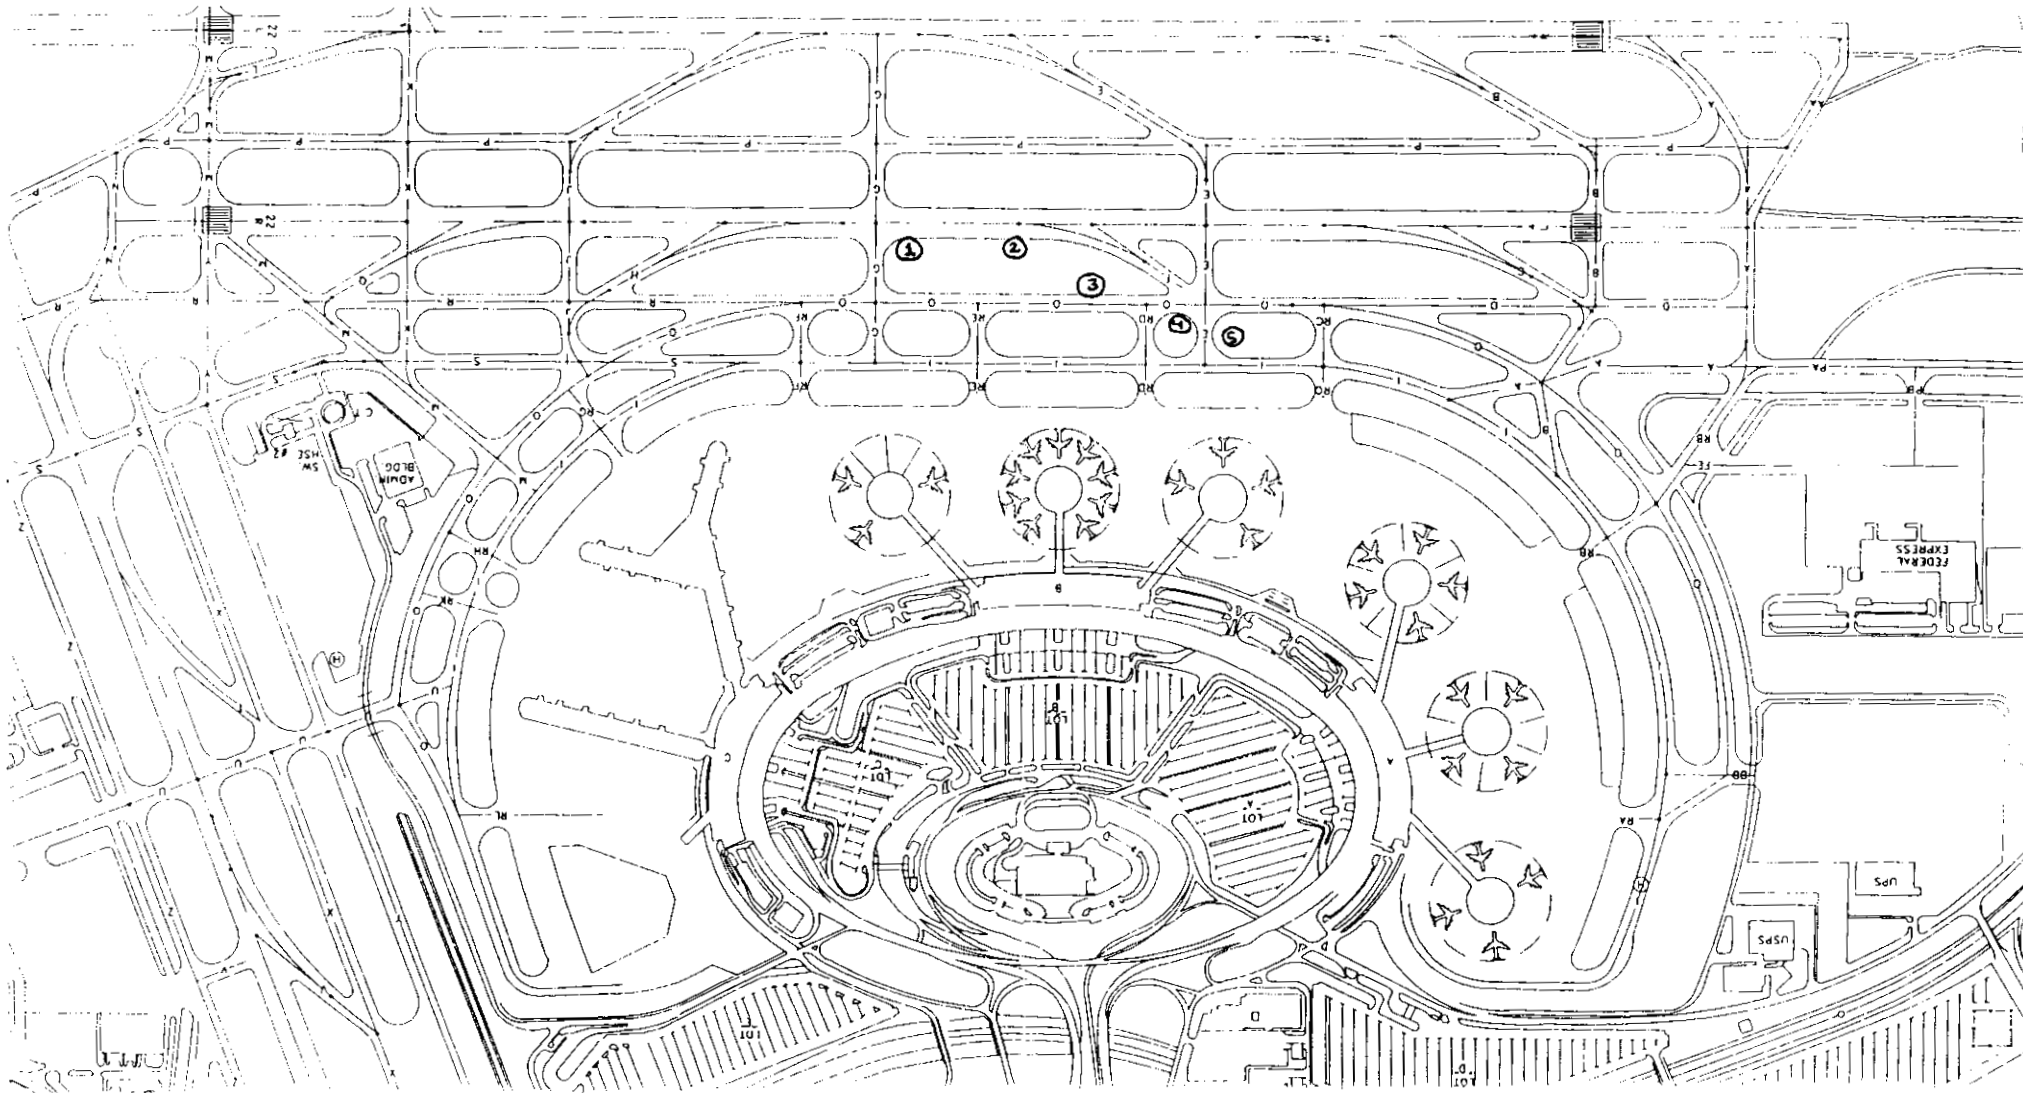
## Locations of Damaged Runway/Taxiway Signs

separated right wing was found 4,577 feet beyond the threshold. Five runway/taxiway signs along the right side of runway 22R were damaged or destroyed.
