LOG H-1 TAG#

NOMENCLATURE: HORIZ. CENTER TORQUE BOX.  
RIB'S BENT INB'D H-1

H1

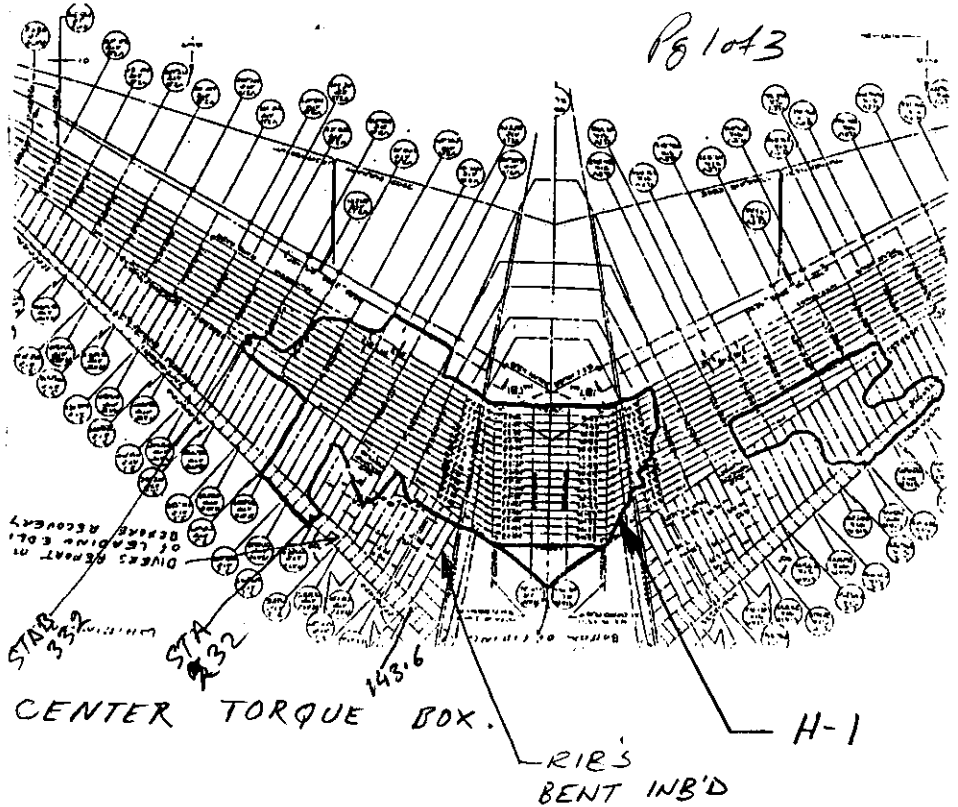
DESCRIPTION: HORIZ. STABILIZER CENTER TORQUE BOX MOSTLY INTACT. PLUS FOLLOWING ATTACHMENTS: 1) LEFT STABILIZER HINGE RH 12/10/96 SIDE AFT ATTACHMENT FITTING 2) RIGHT SIDE AFT STABILIZER HINGE RH 12/10/96 ATTACHMENT FITTING 3) BALL JOINT ATTACHMENT FORWARD AREA. 4) LEFT HAND HORIZ. STAB., SECTION ATTACHED FRONT SPAR AFT TO REAR SPAR STAB STA. 187 5) RIGHT HAND HORIZ. STAB., SECTION 19 FEET ALONG FRONT SPAR AND 10 FEET ALONG AFT SPAR. 6) LEADING EDGE STRUCTURE STAB. STA. 245 TO STAB. STA 296, RHS 7) TRAILING EDGE STRUCTURE ELEV. STA 81 TO ELEV. STA 131, RHS 12/10/96

- a) NO BURN DAMAGE RA 12/10/96
- b) PUNCTURES THROUGH UPPER SKIN.
- c) DAMAGE TO THE LEADING EDGE IS RA 12/10/96 ASSUMED TO BE AERODYNAMIC AND IMPACT RELATED

The right horizontal stabilizer inboard section remained attached to the horizontal stabilizer center torque box (H1). The outboard end of this section is at stab sta 360. The inboard leading edge from sta stab sta 143.6 to stab sta 232 are missing. The ribs and the web near stab sta 232 is crushed outboard. About 50 inches of the leading edge outboard of stab sta 235 remains attached. The outboard end of this section (stab sta 332) has a jagged fracture on its skins and stringers. The upper skin exhibited evidence of slightly downward bending. The lower skin stringers are bent up and forward. The rear spar remained attached to this section from the torque box to stab sta 285 and exhibited bending in aft direction at sta 285.

The torque box remained intact with few puncture holes on the upper skin. The rear spar of the torque box suffered no impact damage. The RHS stabilizer hing fitting's lug is rotated 10 degrees CCW approx when looking forward.

- 1)The upper chord at BL 0, is cracked through
- 2)The lower chord's vertical leg is fractured/separated from the horizontal leg from Stab LBL 14.5 to RBL 14.5.
- 3)This segment of web between LBL 14.5 and RBL 14.5 has a remnant of a diagonal buckle from the upper chord at RBL 14.5 to the lower chord at LBL 14.5. The web has broken out between the two mentioned BL's and has been displaced forward.
- 4)The RHS of the torque box is approx 1" higher than the LHS, at the front spar.
- 5)At the forward end of the LBL 14.5 rib web, there are diagonal-tension buckles going up and aft with a 10" tear perpendicular to the buckles. At the forward end of the RBL 14.5 rib web, there is a tear at he same orientation as the tear in the LHS web.

The jack screw extends above fitting by ten threads and is fractured at bottom end. The jack screw ball joint along with its mounting frames remained intact except the .25 diameter fasteners between the support frames are missing. These subject fastener holes are mis aligned on the upper supprt frames. There is minor deformation observed on the support frames of the screw jack, the LHS upper support has an 1/8" gap between support frames.

A portion of the left aft upper and lower skin from outboard of LBL 43.5 remained attached to the torque box. The upper and lower skin is bent upwards. The left lower stringers are bent slightly up and aft. The left upper skin and stringers are bent up and aft from 30 to 45 degrees. Approximately three feet of left rear spar remained attached to the torque box and is bent aft. The left front spar separated at the torque box, reference H5.

There are soot marks on the inside of the skin and stringers of the upper surface approximately 1 foot forward of the L.H. Rear Spar, about 3 feet from the root. Also there are other areas that are sooted.

There are blue paint transfer marks in the same location as noted above for the soot except on the skin upper surface.

*BOTH L & RHS OUTB'D ENDS EXHIBIT COMPRESSION TYPE FRACTURES ON THE UPR SURFACE & TENSION ON THE LOWER SURFACE.*
